Report on the investigation of
the grounding of the cargo ship

Carrier

at Raynes Jetty in Llanddulas, North Wales

on 3 April 2012

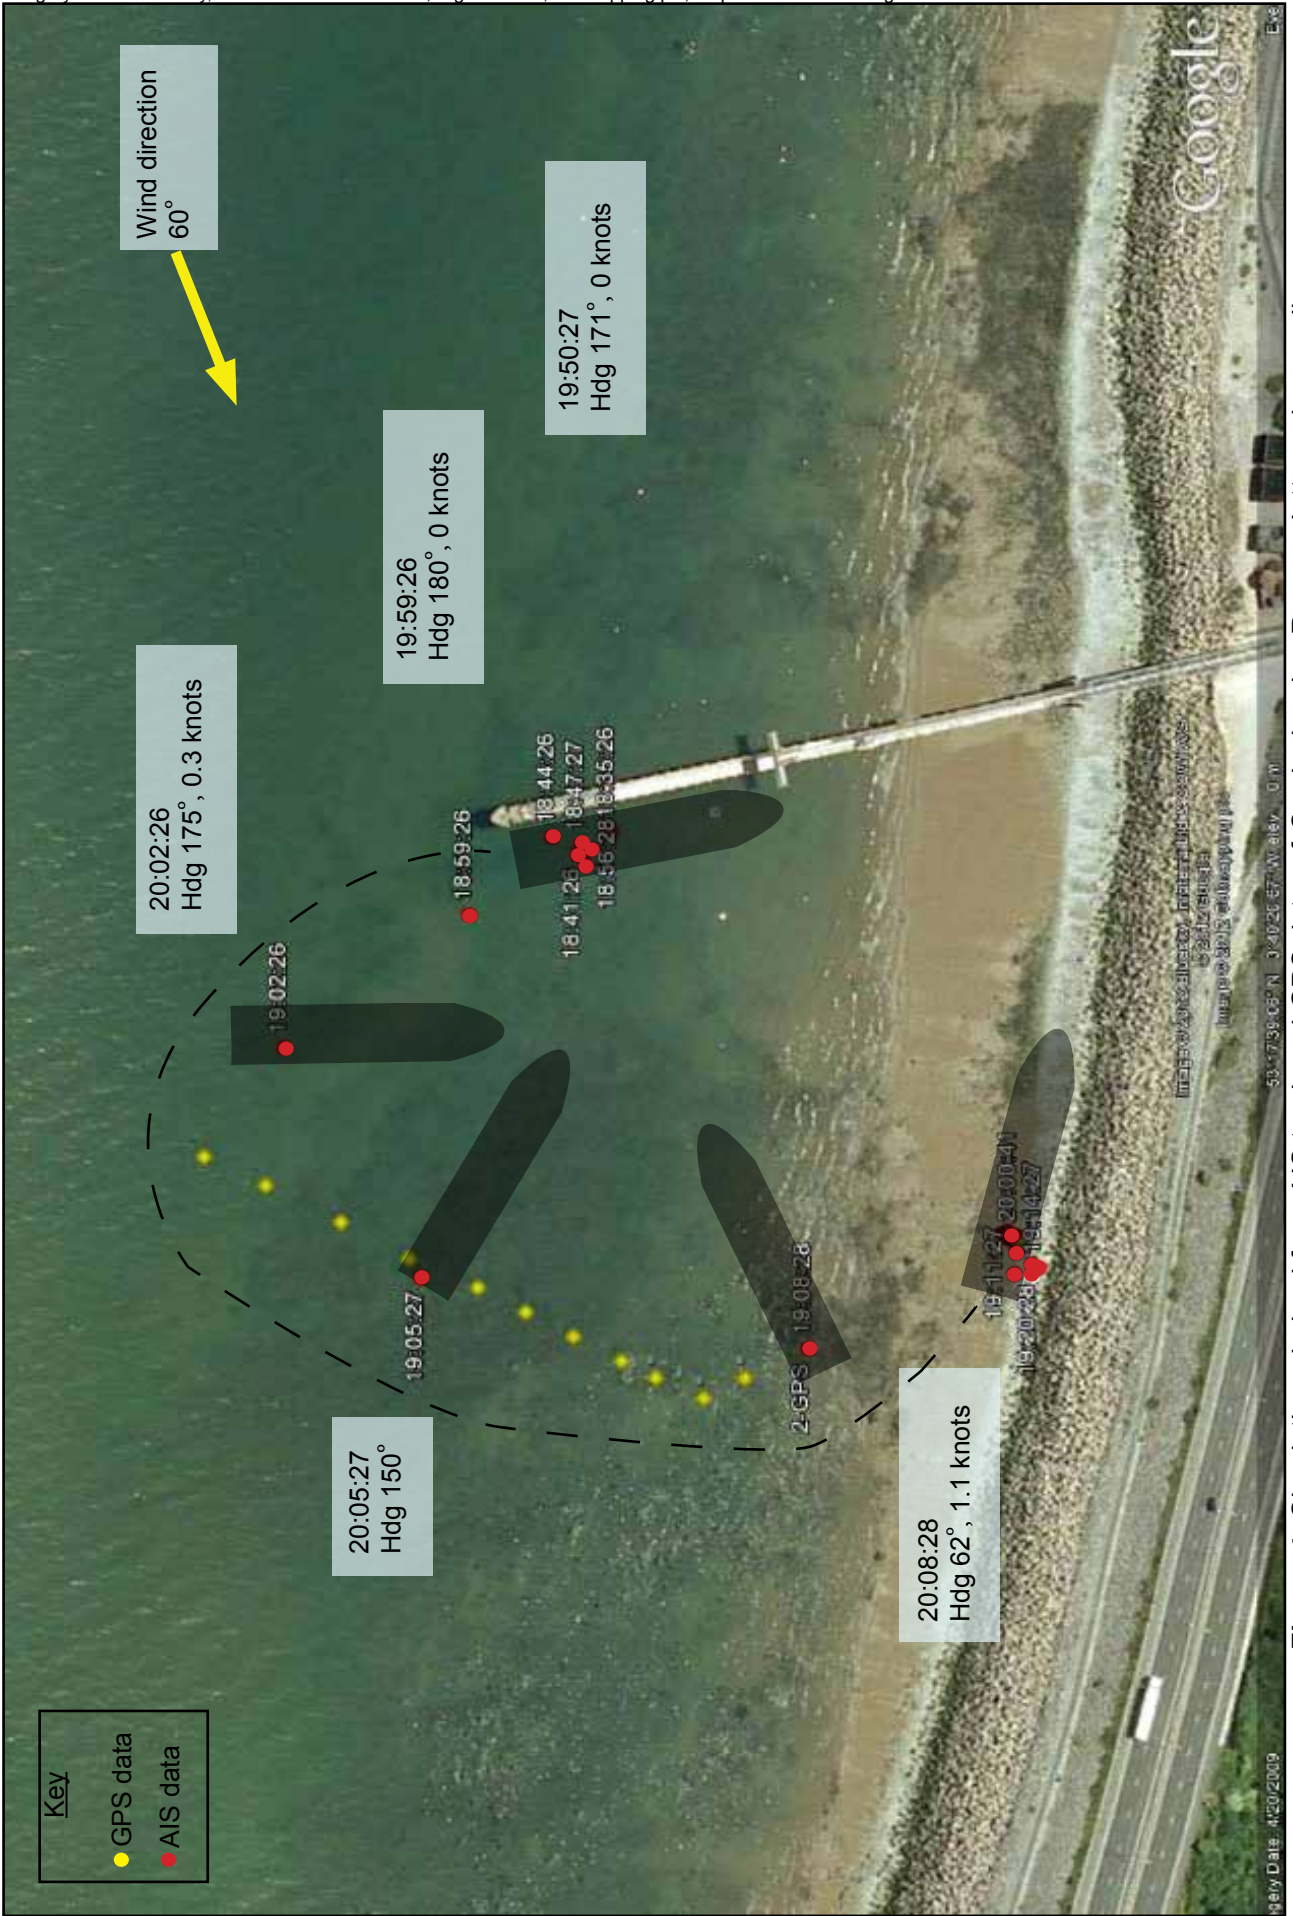
Figure 4: Simulation, derived from AIS track and GPS data, of Carrier leaving Raynes Jetty and grounding

Carrier was underway by about 2000. By this time, the sea had become very rough with wave heights in excess of 4m. The master attempted to keep the vessel parallel to the jetty and, although he increased the astern pitch, the vessel's speed did not exceed 1.4 knots. The waves washed on to the main deck and the master asked all the crew on deck to go up to the wheelhouse. With the forward most quarter of the vessel's length still overlapping the seaward end of the jetty, *Carrier* was pushed by wind and breaking waves approximately 50m to the west (**Figure 4**). Astern speed reduced to 0.3 knot.

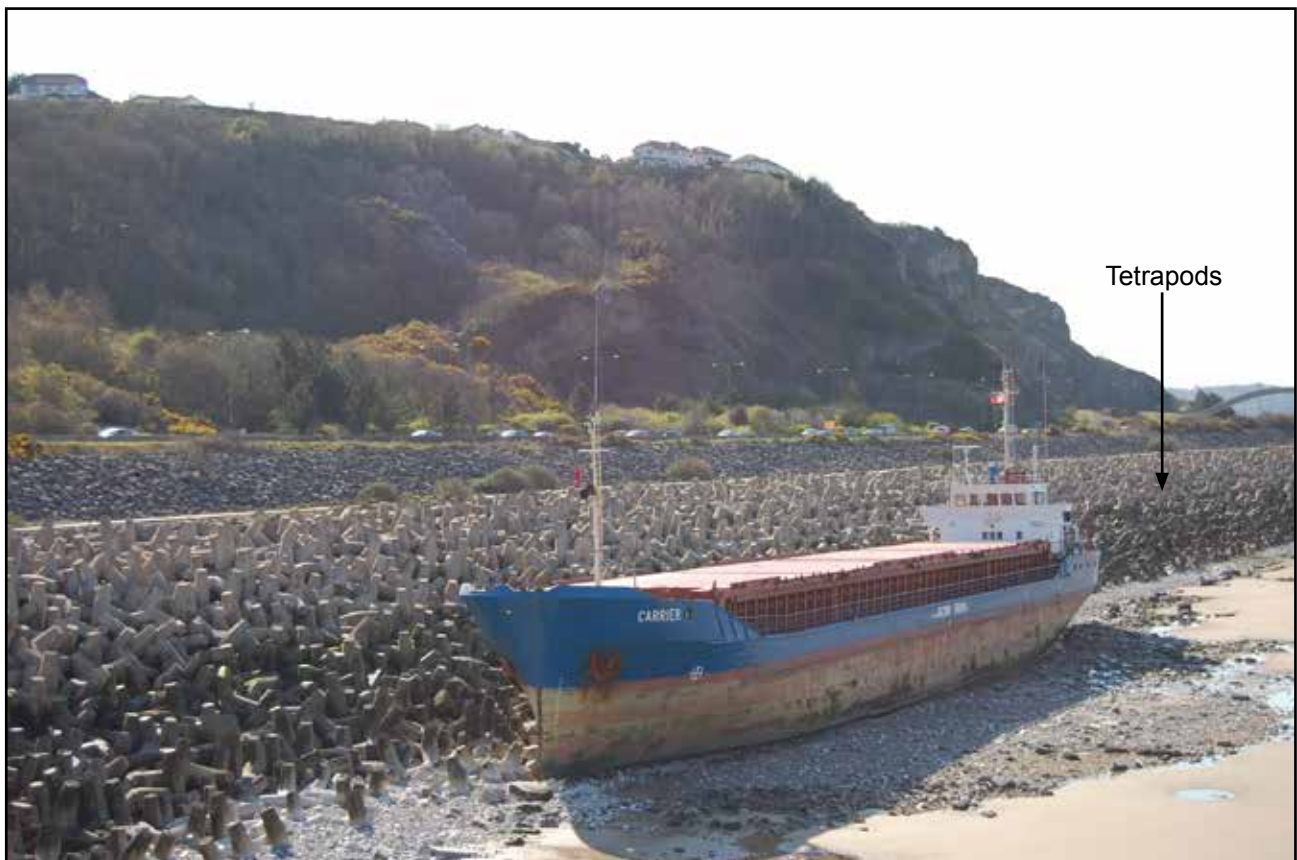
Figure 5: *Carrier* beached against the tetrapods lining the shore

Realising that the vessel was not making sufficient sternway and was beginning to be forced bodily towards the beach, the master put the CPP to full ahead and placed the steering hard to port. Although the vessel's bow turned partially into the wind, *Carrier* continued to be forced onto the beach until its stern grounded at 2008. The master informed the jetty staff that the vessel was aground, and at 2014 the jetty supervisor called the coastguard using the very high frequency (VHF) radio in the loading cabin. Coastguard officers at Liverpool Maritime Co-ordination Centre (MRCC) responded to the broadcast. Within the next 2 minutes, the vessel was blown beam on to the tetrapods² (**Figure 5**) that made up the coastal defences on the beach. The master called Liverpool MRCC and apprised them of the situation. He activated the engine emergency stop and called the chief engineer to the wheelhouse.

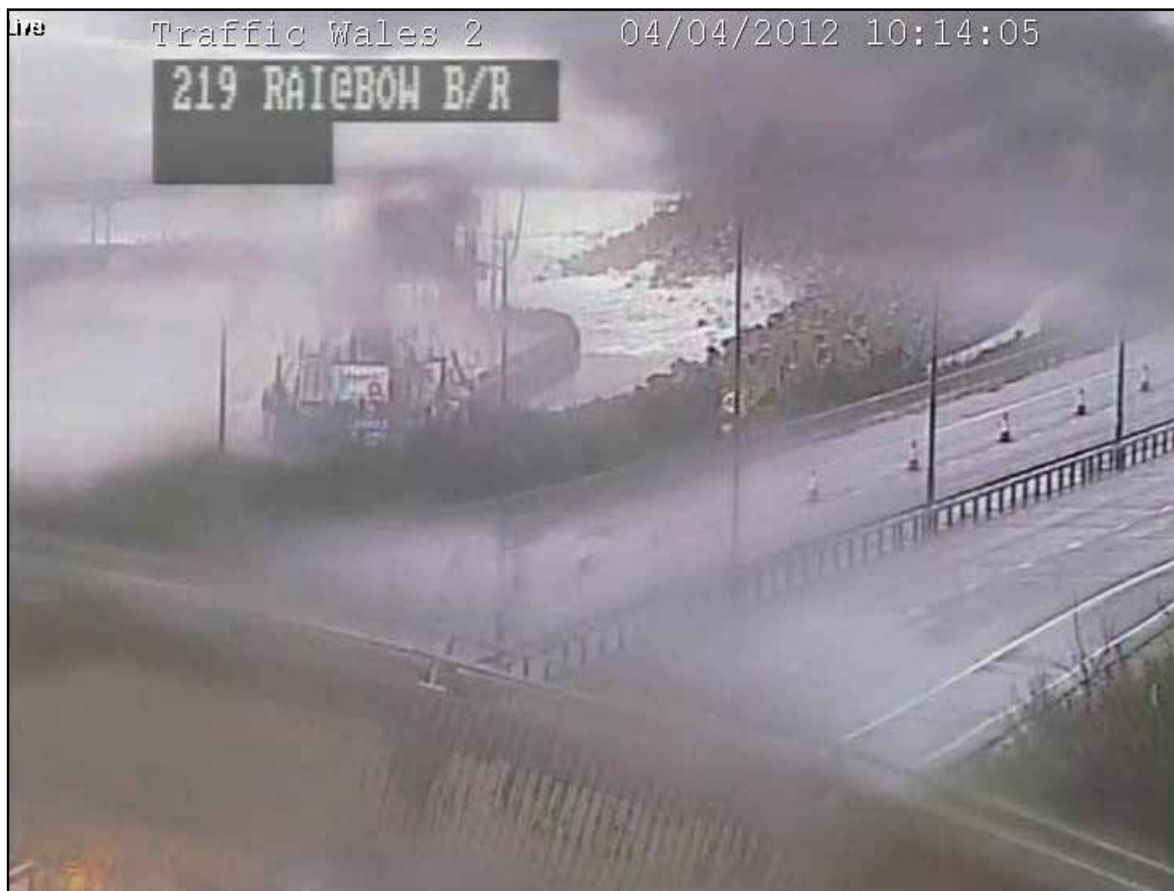
Figure 6: Continuing severe environmental conditions on 4 April 2012

The environmental conditions remained severe well into the next day (**Figure 6**) and the vessel continued to suffer further damage as it moved with tidal and wave effects. Almost all of *Carrier*'s double bottom tanks, and wing tanks on the starboard side that extended below the waterline, were breached. Approximately 33000 litres of gas oil, and a few hundred litres of lubricating oil from the main engine sump, leaked into the sea.

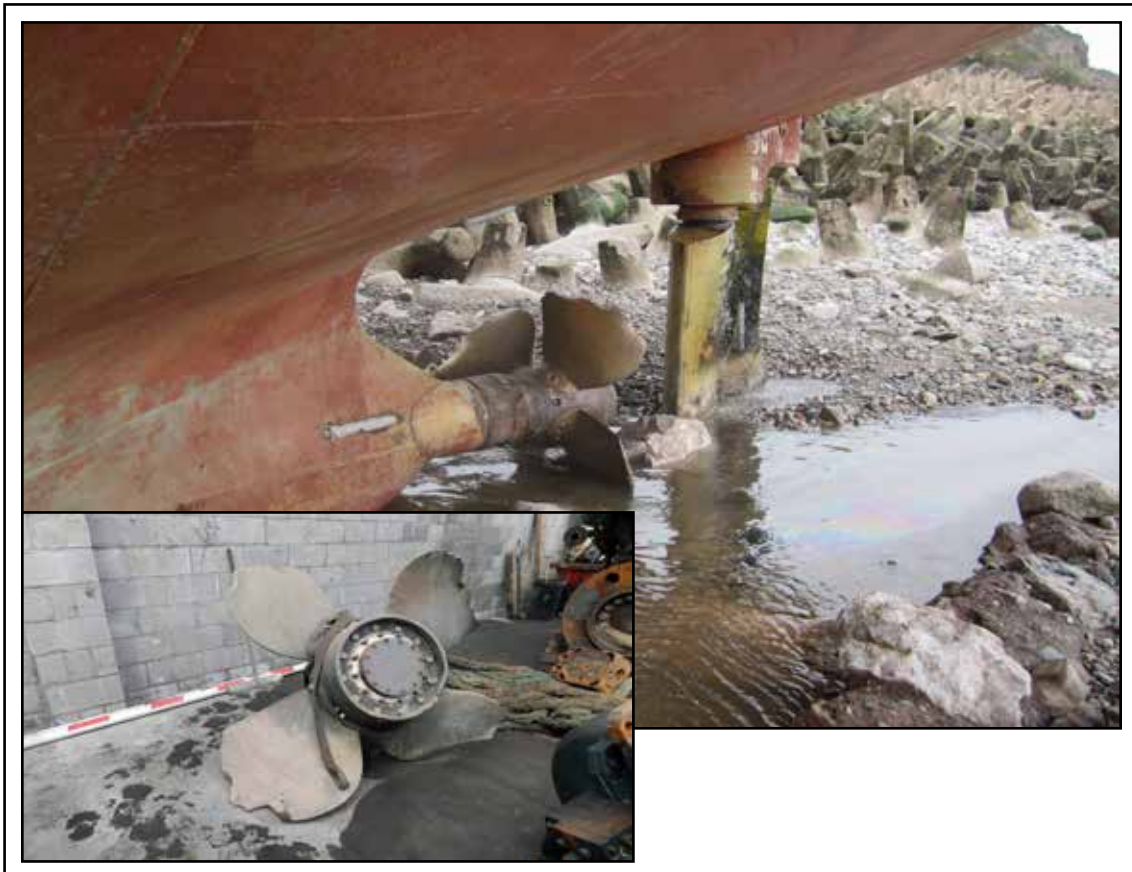
Figure 7: Propeller and rudder damage (**inset:** damaged blade tips)

Carrier's rudder and propeller were severely damaged during the grounding; the tips of all four propeller blades were lost (**Figure 7**). The vessel remained upright, despite wave action and the change of tides. After the grounding, parts of the tetrapods penetrated into the hull (**Figure 8**) and the engine room was breached. Accommodation bulkheads collapsed and a large number of fittings, both on the wheelhouse and in the accommodation, broke loose.

The uniform damage to all four propeller blade tips indicate that *Carrier's* propeller continued to turn under power until the master operated the main engine emergency stop after the grounding.

As the original adjustments for propeller pitch control were probably not altered when *Carrier's* original engine was replaced with a more powerful one, the greater power of the new engine was unlikely to have been fully utilised. Earlier trials had indicated that it took about 8 minutes to reach full astern speed. The effect of any increase in the new engine's speed or torque might have been noticed as an improvement in the vessel's acceleration; however, even though there was more power available, the pitch response needed to be re-calibrated to ensure that the extra power was transmitted into propeller thrust efficiently.

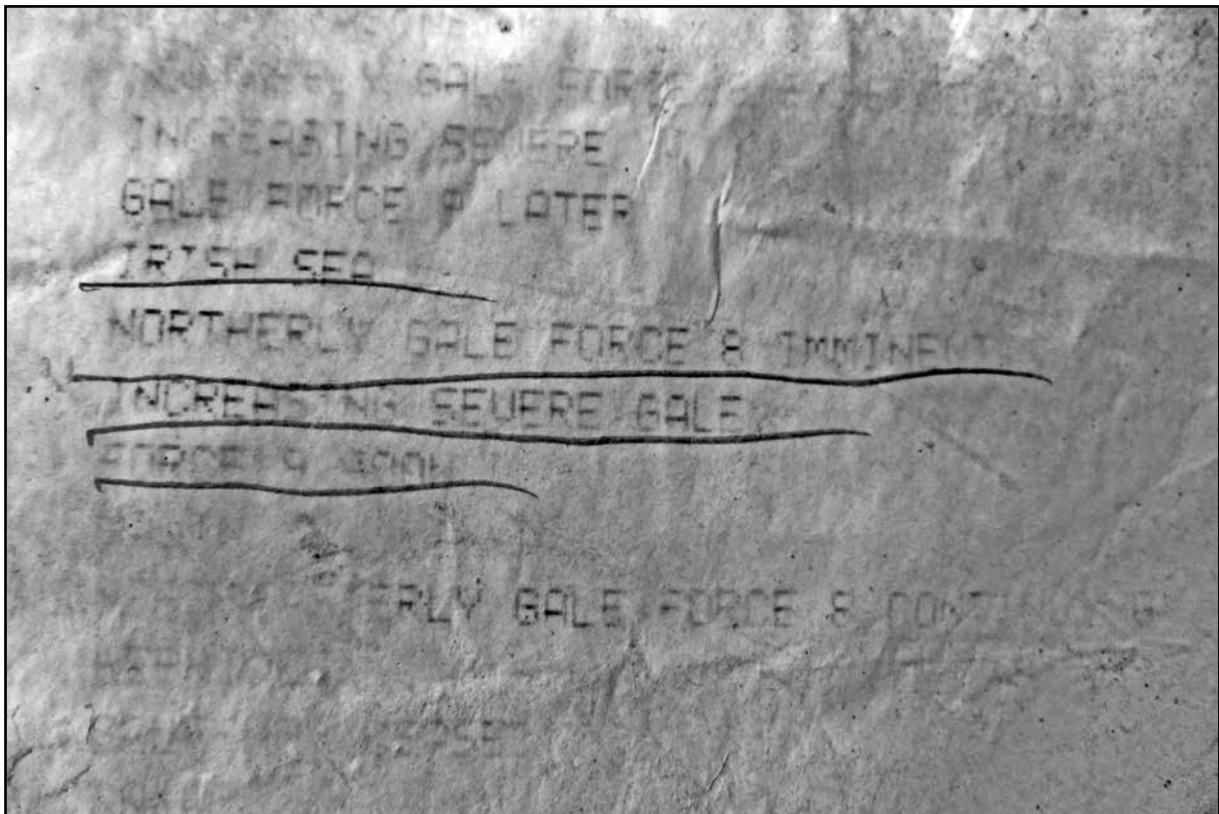
Figure 10: NAVTEX printout found on bridge deck

The sea areas as defined by the Met Office are shown in **Figure 9**; Raynes Jetty was in the Irish Sea area. The next gale warning transmitted by the Met Office was at 1032 on 3 April. A NAVTEX printout, partly defaced from being soaked in seawater, was found on the deck of *Carrier’s* bridge; the gale warning was underlined (**Figure 10**) and stated:

The NAVTEX message that was found on the bridge deck, warning of 'imminent' gale force winds, demonstrates that the master was aware that the weather was likely to deteriorate. What was clear from the investigation was that the master was confused by the terminology used in UK maritime weather forecasts. He did not appreciate the meaning of the term 'imminent' and, as a consequence, did not know how quickly the bad weather was expected to arrive.

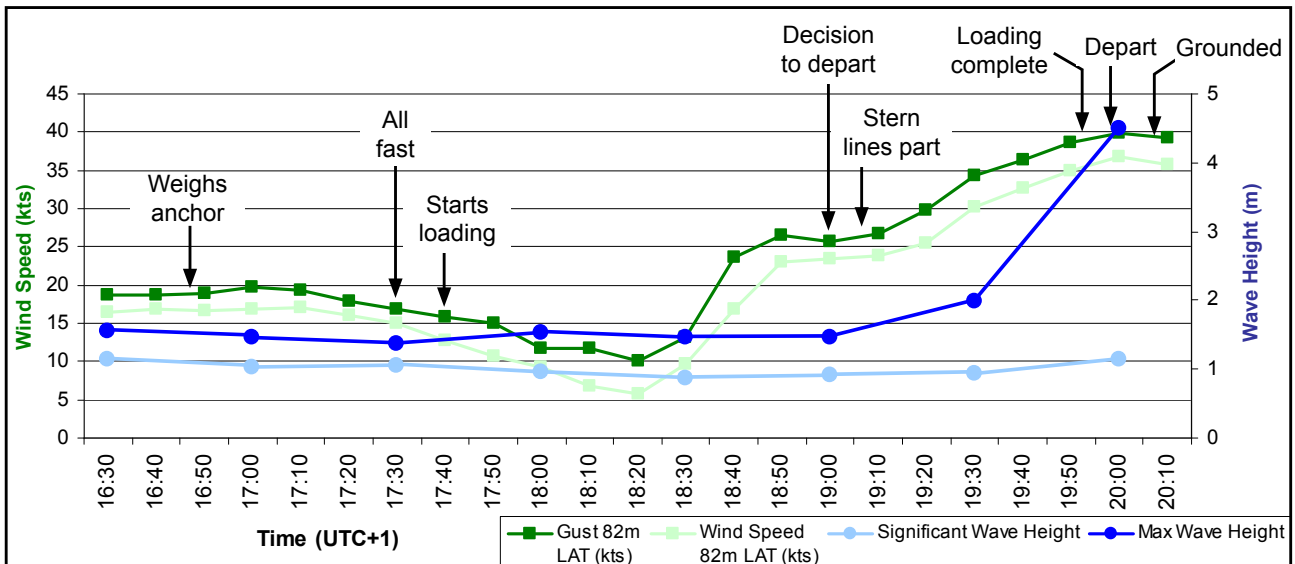
Figure 13: Timeline of events and environmental conditions

There were several actions which demonstrated the master's preoccupation with this decision, including: delaying the decision to depart until 1900 despite the significant increase in the wind speed from 1820; stopping cargo loading at 1923 and then restarting it shortly afterwards; and continuing to load as the wind speed and wave height increased until 1955, when the last of the hatch covers were closed (**Figure 13**).
