Report on the investigation of the
collision, capsize and foundering of the tug

Chiefton

with the loss of one crewmember
at Greenwich Reach, River Thames

on 12 August 2011

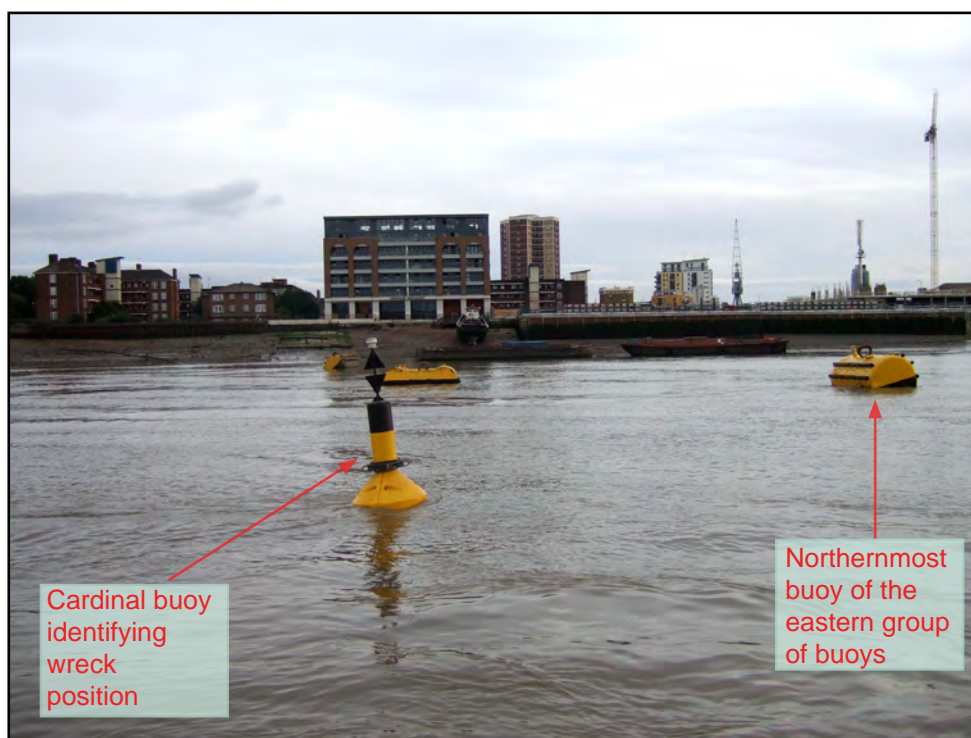
Figure 7: Greenwich Ship Tier - northernmost buoy of the eastern group of buoys viewed from the north side of the river looking south

The skipper, mate and deckhand/engineer were in the wheelhouse as *Chiefton* began being set to the south, towards the northernmost buoy of the eastern group of buoys (**Figure 7**). *Chiefton's* skipper assessed that the barge was unlikely to clear the buoy and, at an estimated distance of 70m from the buoy, he applied port helm to try to pull the barge away from it. As all the weight was now being taken on the starboard tow rope, the mate went on deck and pulled the now slack port tow rope inboard. At the same time, pilot 1 assessed that the tow was out of position, and shouted to pilot 3 that he was setting too far to the south.

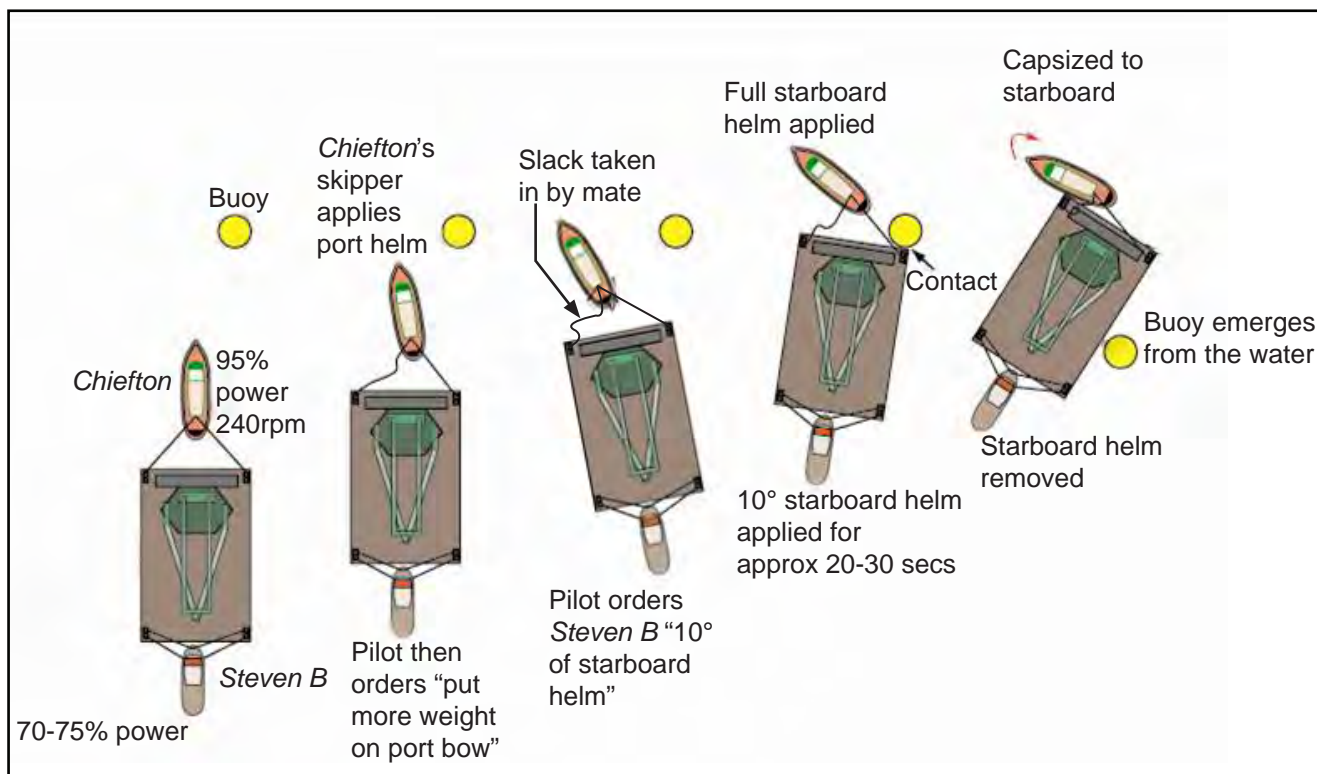
Figure 8: Schematic of the collision and capsize sequence of events

Pilot 3 then went to the forward end of the barge's deck. He met with the owner's representative and pilot 1 who had run forward with the two bargemen in case they needed to let go the forward tow ropes. They saw *Chiefton* on her starboard beam alongside the forward end of the barge. The tug remained briefly on the surface before capsizing and, at 1052, foundering with her tow ropes still attached. A schematic of the collision and capsize sequence is at **Figure 8**.

Steven B's skipper removed the starboard helm after about 20-30 seconds when he glimpsed *Chiefton's* wheelhouse rolling to starboard. Realising that the barge was forcing *Chiefton* under the water, he applied full astern propulsion as two of *Steven B's* crew transferred onto the barge to offer assistance. The skipper of *Steven B* then saw the submerged buoy leap out of the water to starboard, exposing its mooring chains.

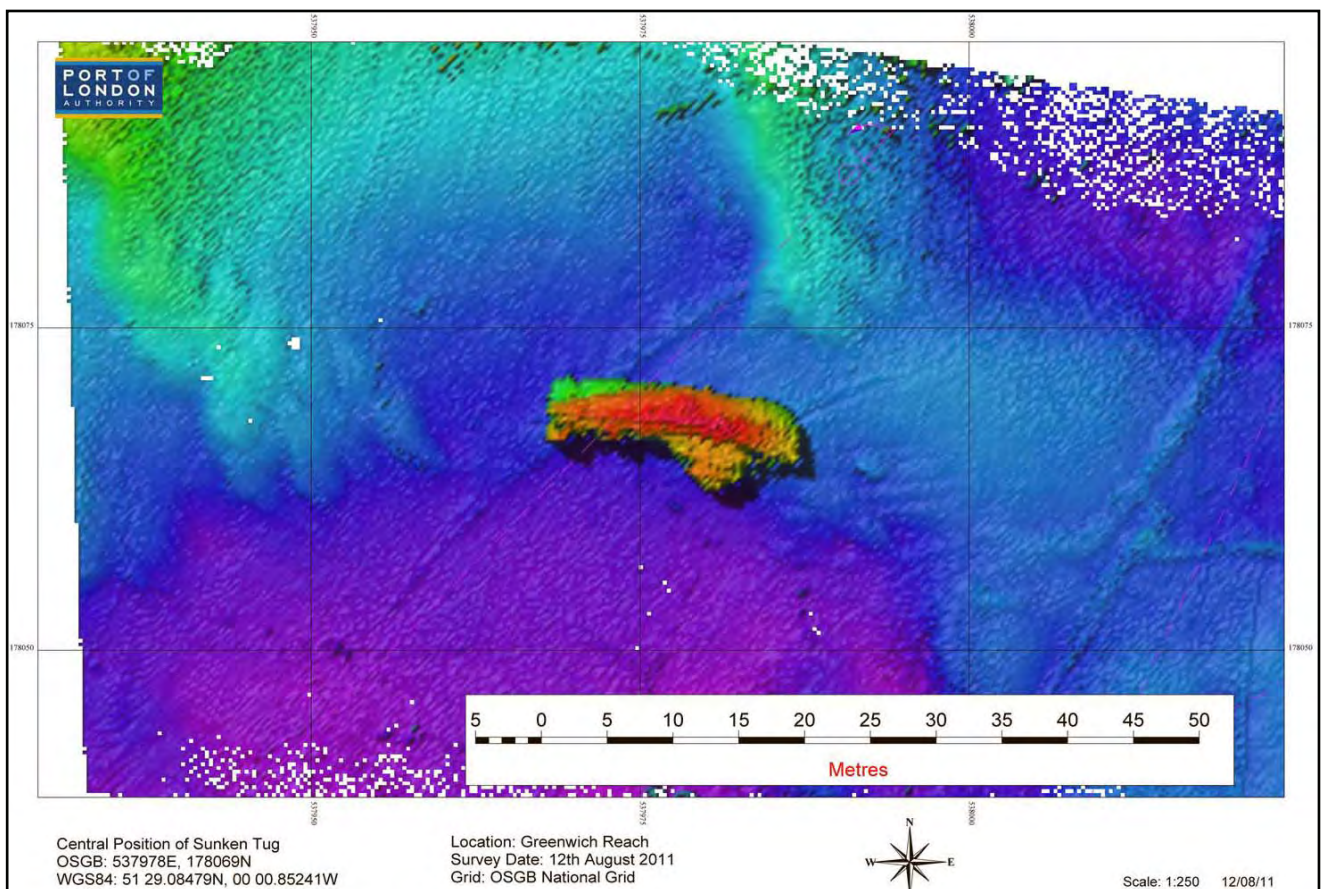
Figure 10: Image from the wreck survey conducted at 1425 on 12 August 2011

PLA's survey vessel *Galloper* completed a wreck survey at 1425 and recorded that *Chiefton* was lying on her starboard side, bows east, in approximately 8m of water (**Figure 10**). The wreck site was marked with four cardinal buoys a short time later.

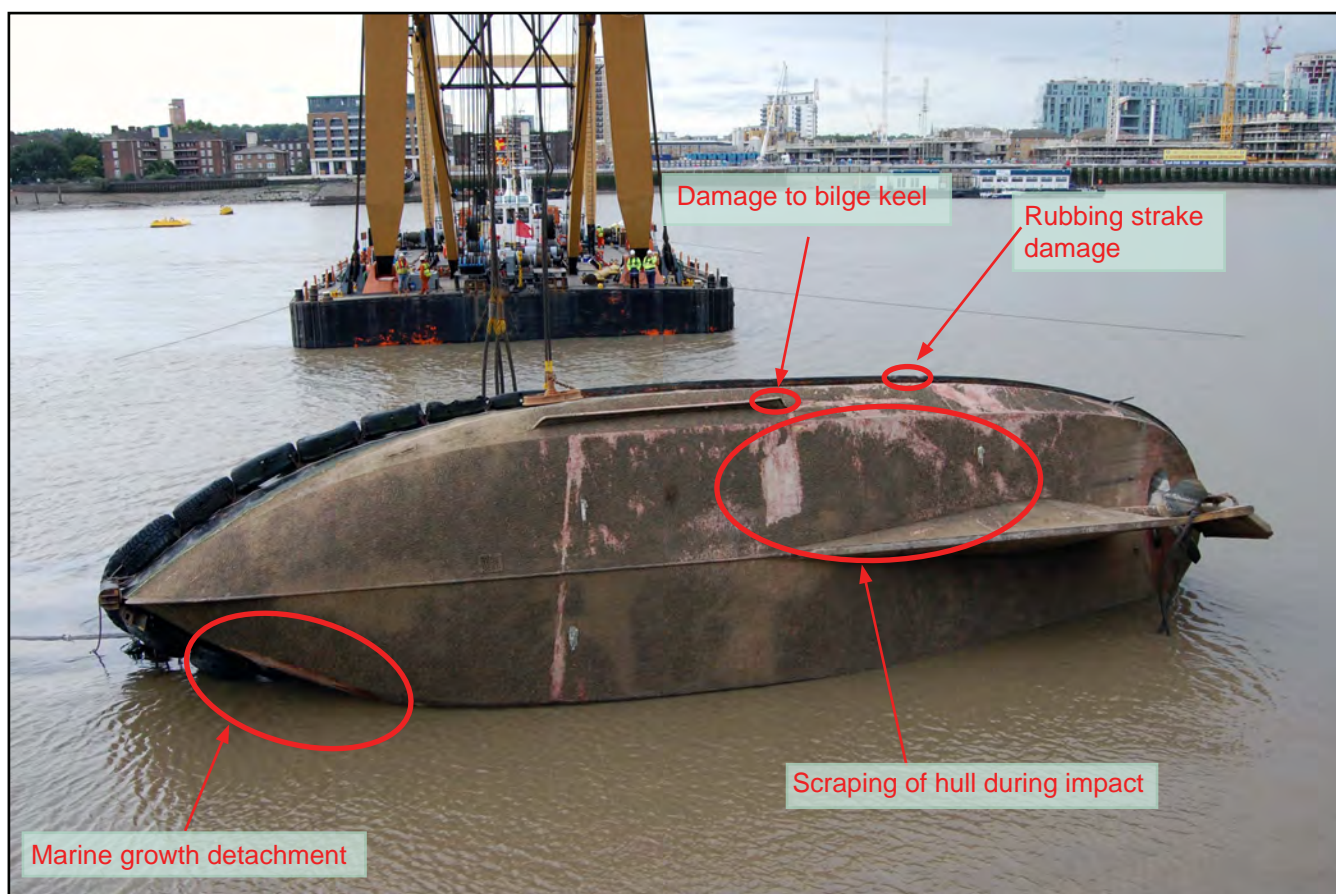
Figure 13: Hull damage and evidence of contact

Chiefton was lying on her starboard side with her rudder set hard to starboard. There was a large area of detached marine growth under the starboard shoulder and at the turn of bilge below the trailing edge of the port bilge keel, which itself had suffered impact damage. Marine growth detachment on the port side of the hull extended for much of the length of the skeg. There was also evidence of heavy scouring to the port side of the hull, just aft of the wheelhouse, and damage to the port rubbing strake (**Figure 13**).

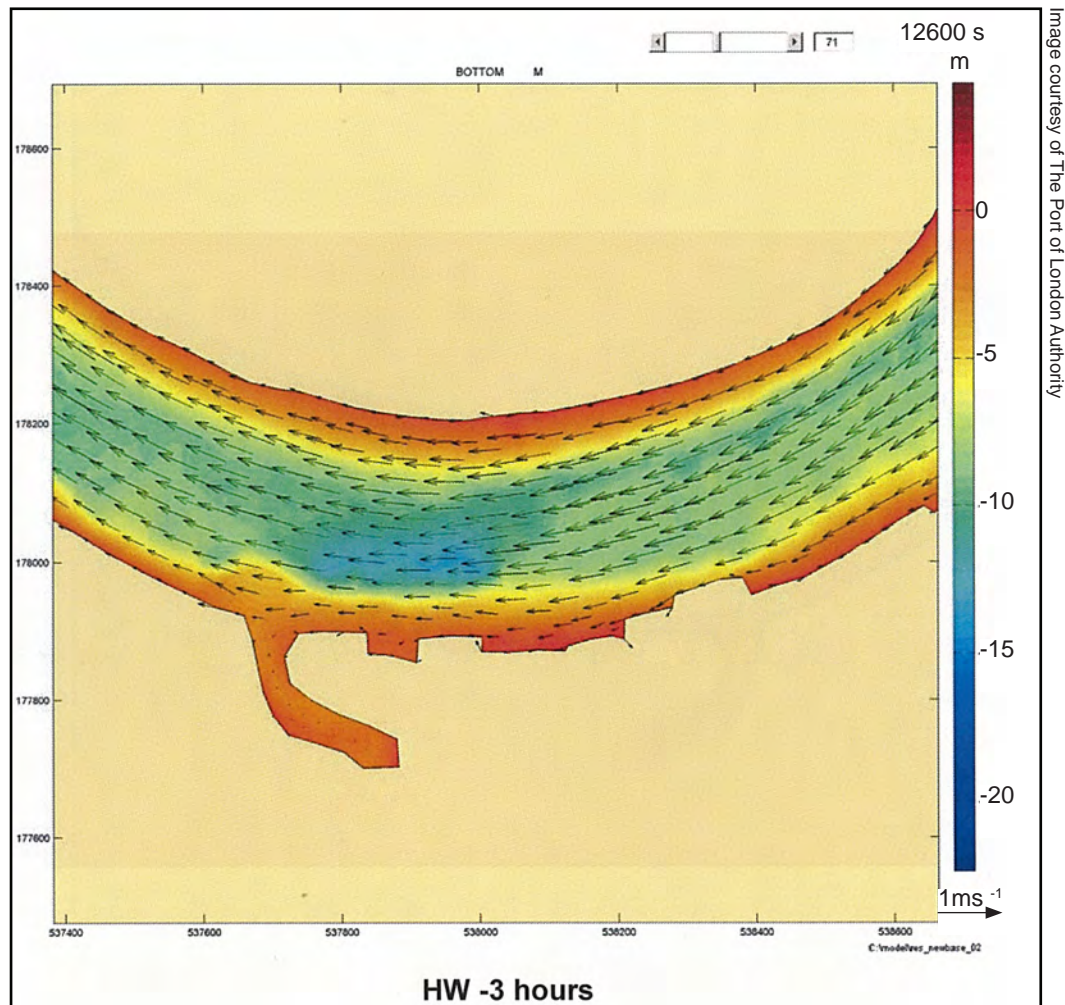
Figure 16: PLA's hydrographic tidal rate model for Greenwich Reach for 3 hours before high water at London Bridge on 12 August 2011

The Silvertown tide gauge recorded a height of tide of 5.67m at the time of the accident. The PLA's hydrographic tidal rate model for 3 hours before high water at London Bridge shows a tidal rate of between 2 and 3 knots at Greenwich Reach (**Figure 16**).

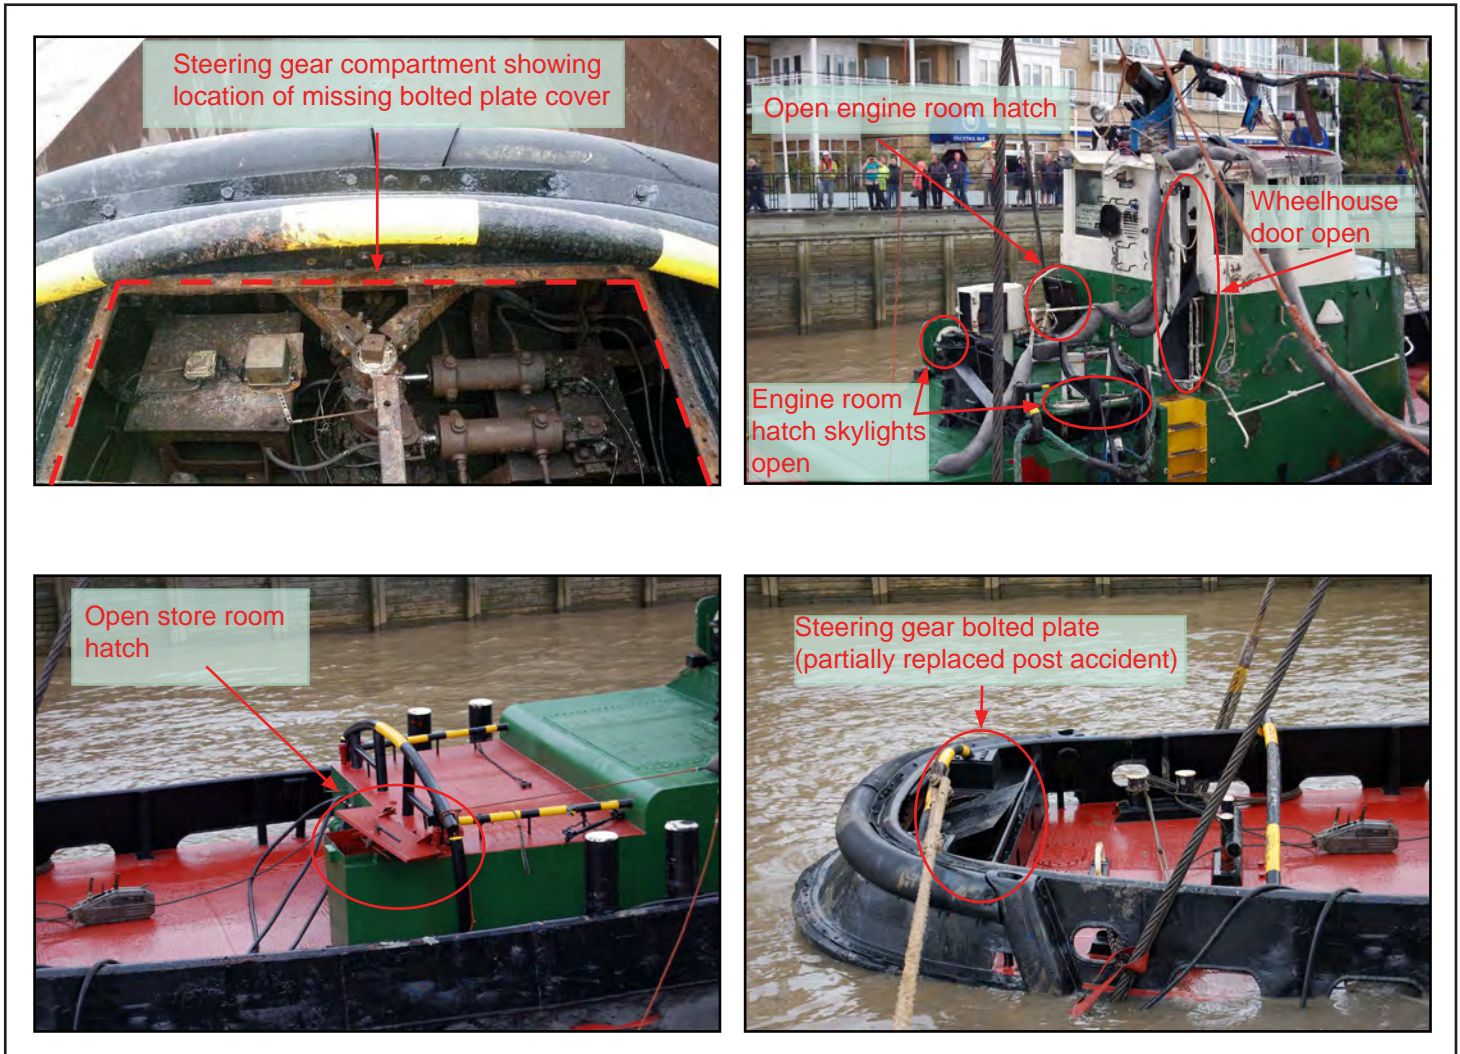
Figure 19: Composite showing watertight/weathertight closures

Upper deck access hatches to the engine room and store room were open⁵, as were the engine room port and starboard skylight hatches. The bolted cover plate for the shallow steering gear compartment was found lying on the steering gear compartment deck recess⁶.

Chiefton was fitted with clipped watertight/weathertight doors and hatches to the accommodation, wheelhouse, engine room, store and engine room skylights. A bolted plate was fitted on the main deck over the steering gear compartment. The arrangements are shown in the composite at **Figure 19**.

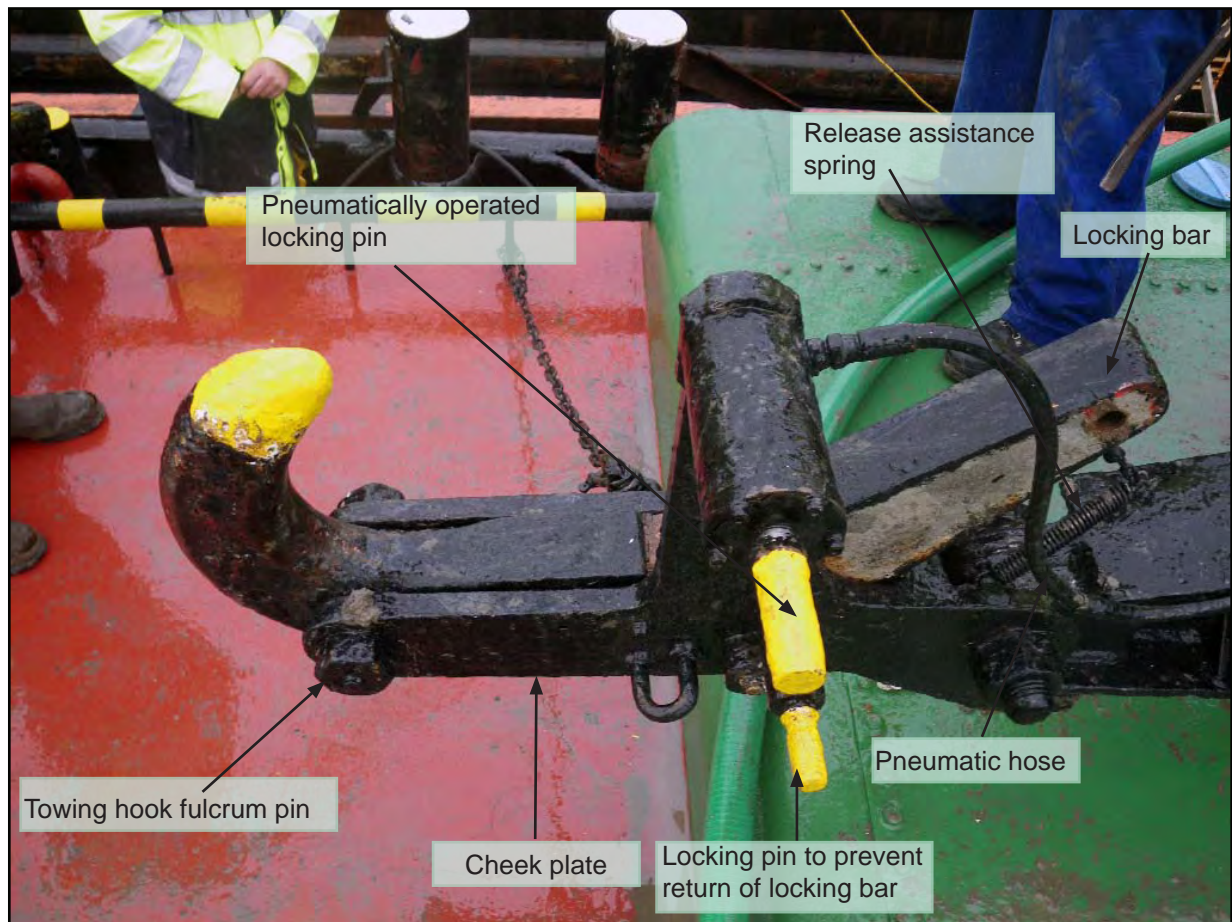
Figure 20: Towing hook components

The components of the towing hook are shown in **Figure 20**. The figure shows the locking arrangement in the released position although the towing hook has not dropped.

Immediately following *Chiefton's* salvage, the towing hook arrangement was inspected. The hook system had its full range of transverse movement, and the greased towing hook emergency release pin was found to be engaged and in the normal towing position. The hook fulcrum point was heavily painted and debris was jammed between the hook itself and its supporting cheek plates.

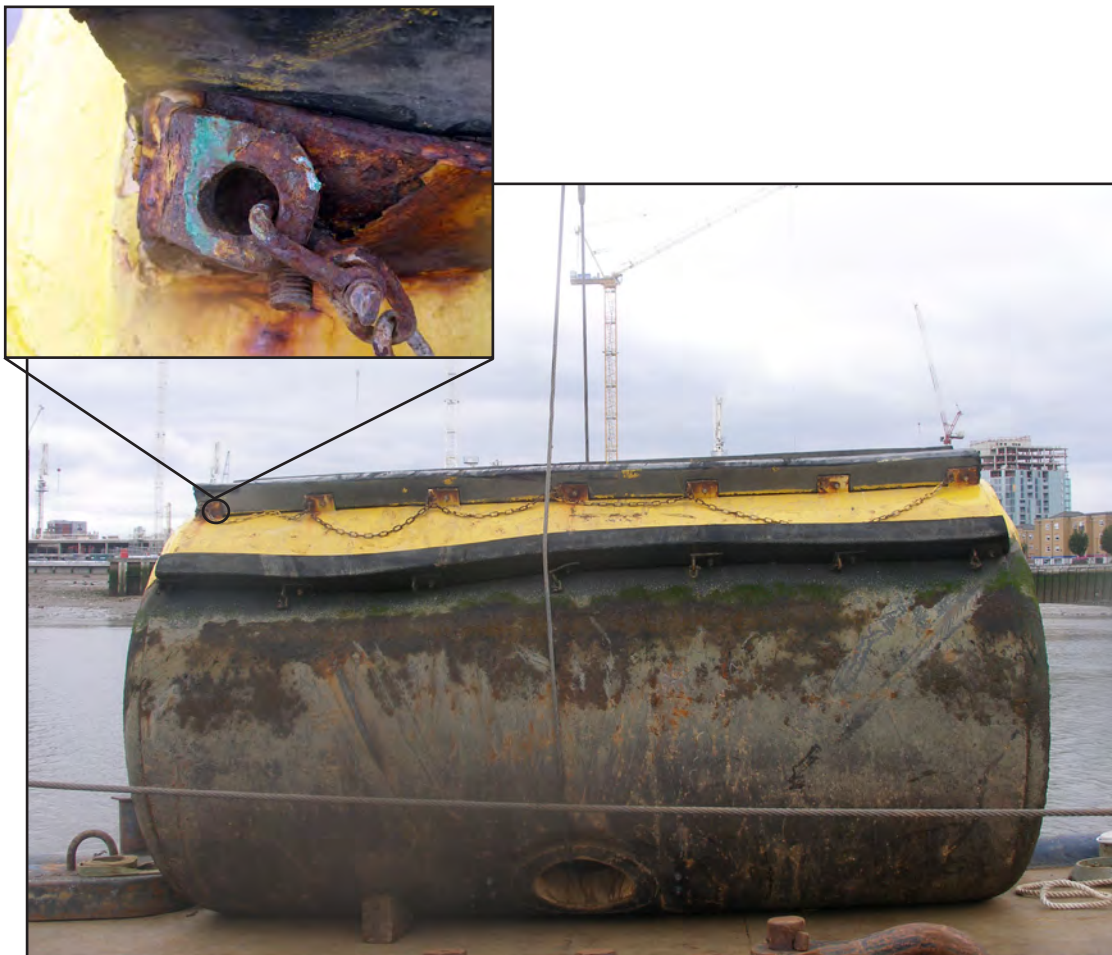
Figure 24: Contact buoy - fender support lug damage and (inset) evidence of paint from barge

It was found that there was scoring on the underwater section of the buoy, although some of the marking had been made during the slinging procedure. A chain and fender supporting lug, which was just above the waterline, had been set back and had clear evidence of paint transfer which matched that of the hull coating of the barge (**Figure 24**). There was also evidence of rubber fender and support damage directly under the damaged lug, although it could not be confirmed whether this was old or new damage.

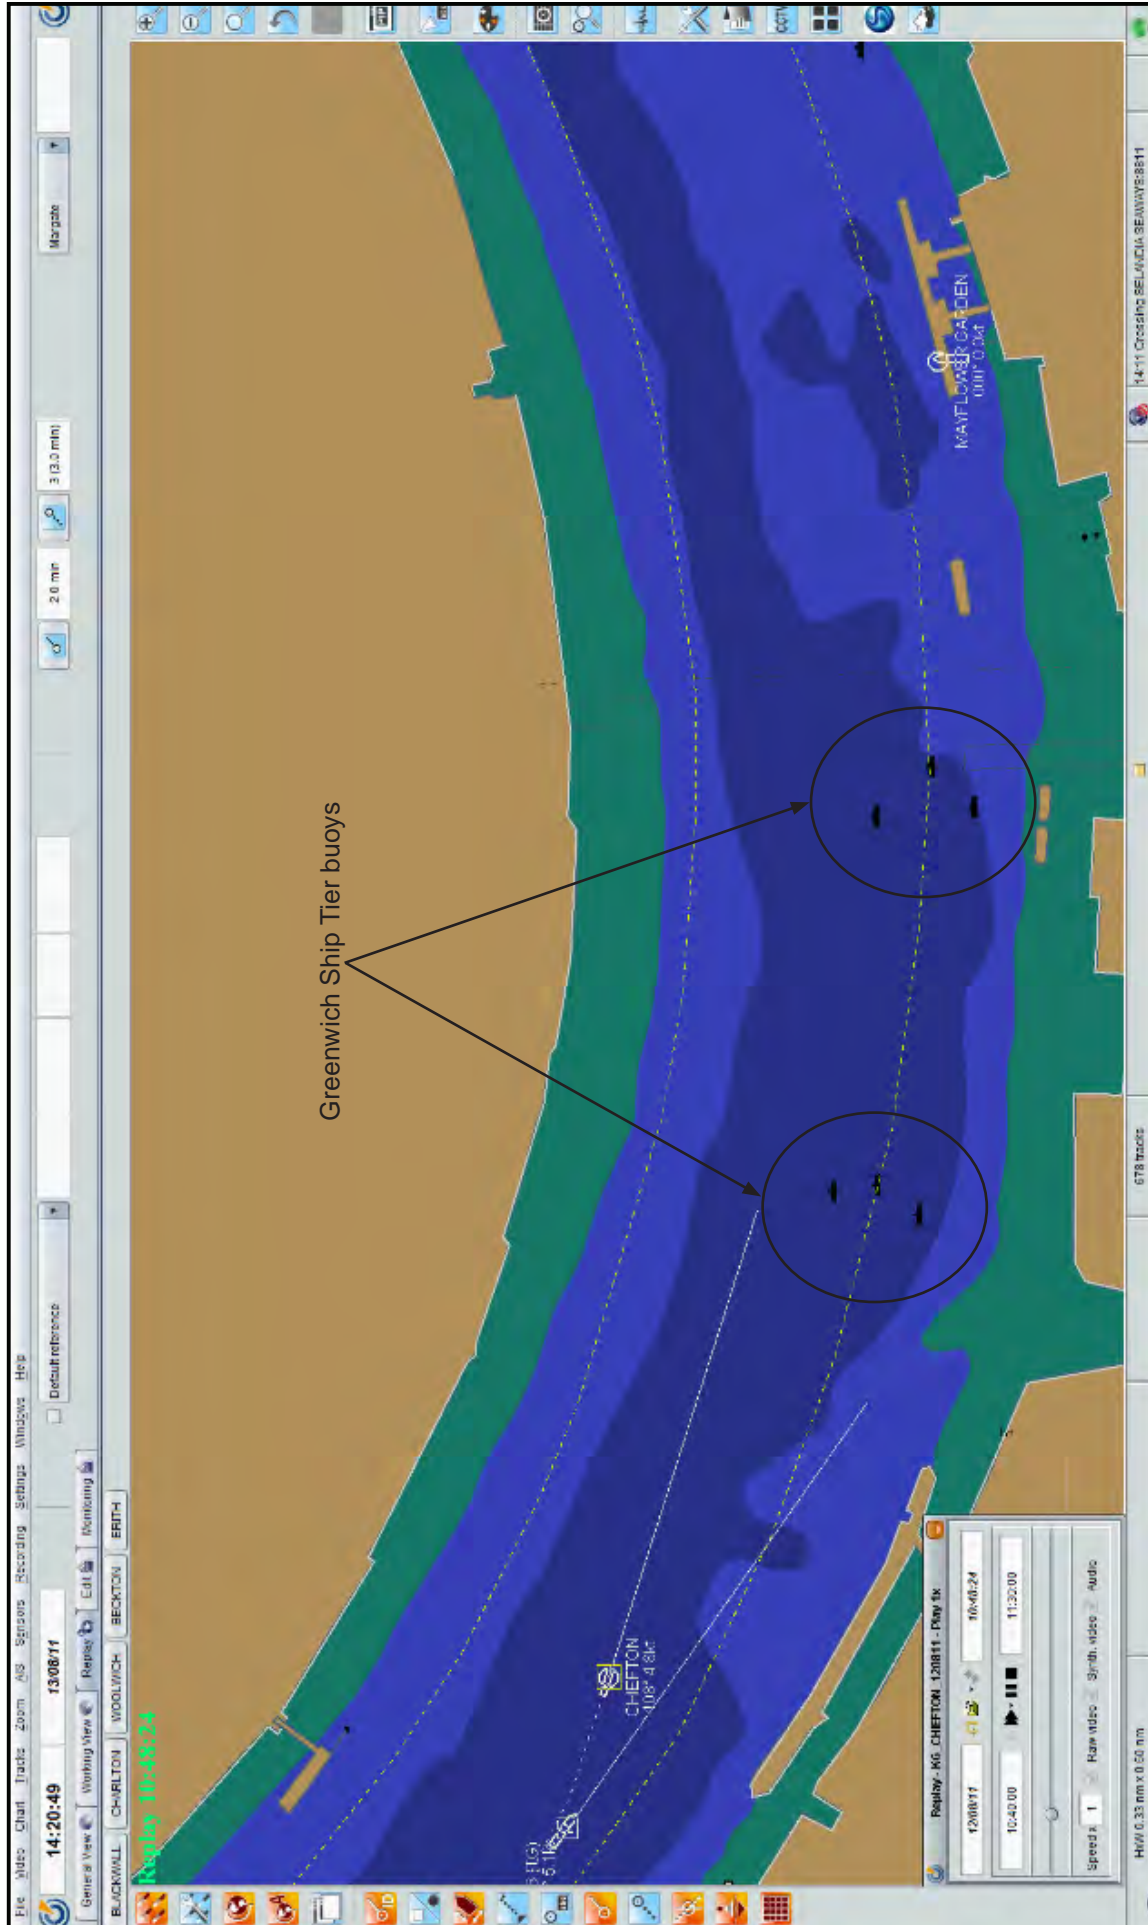
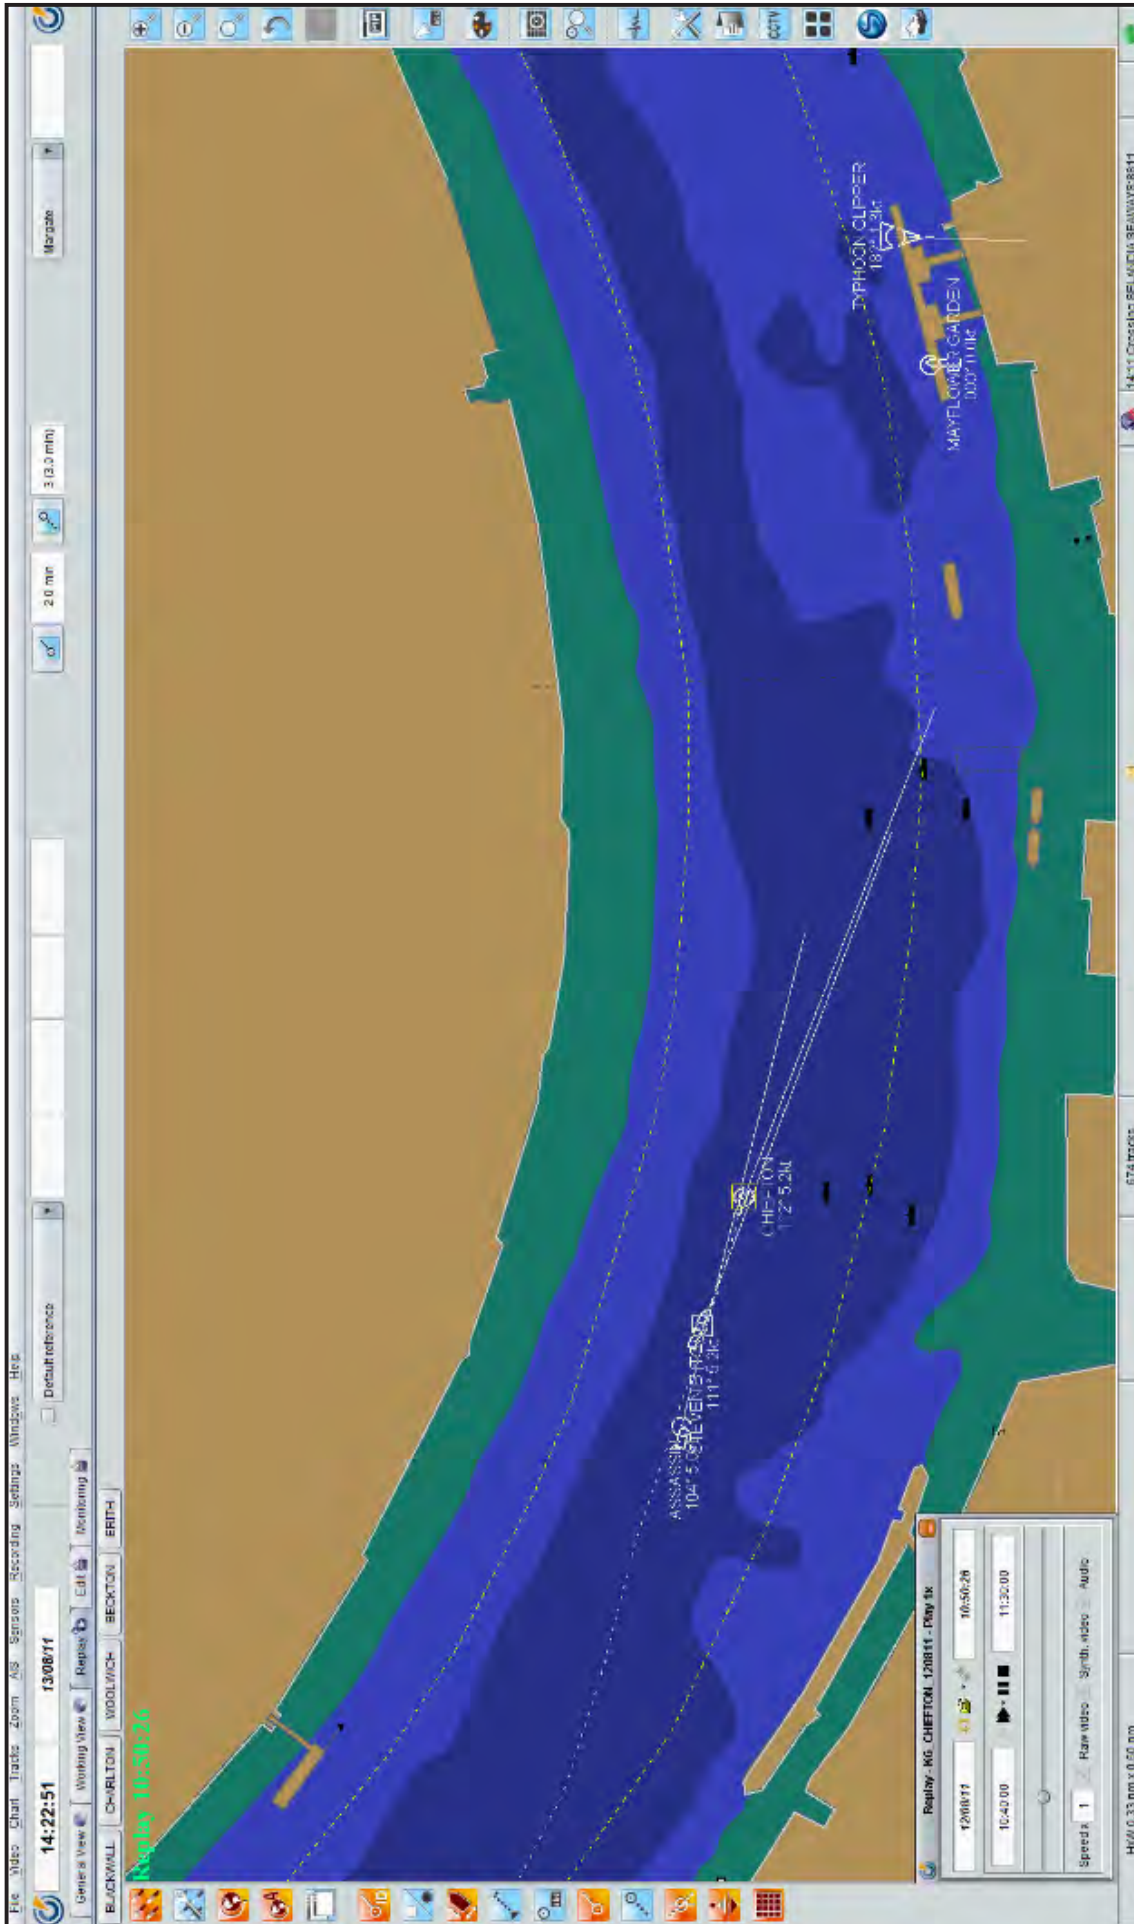
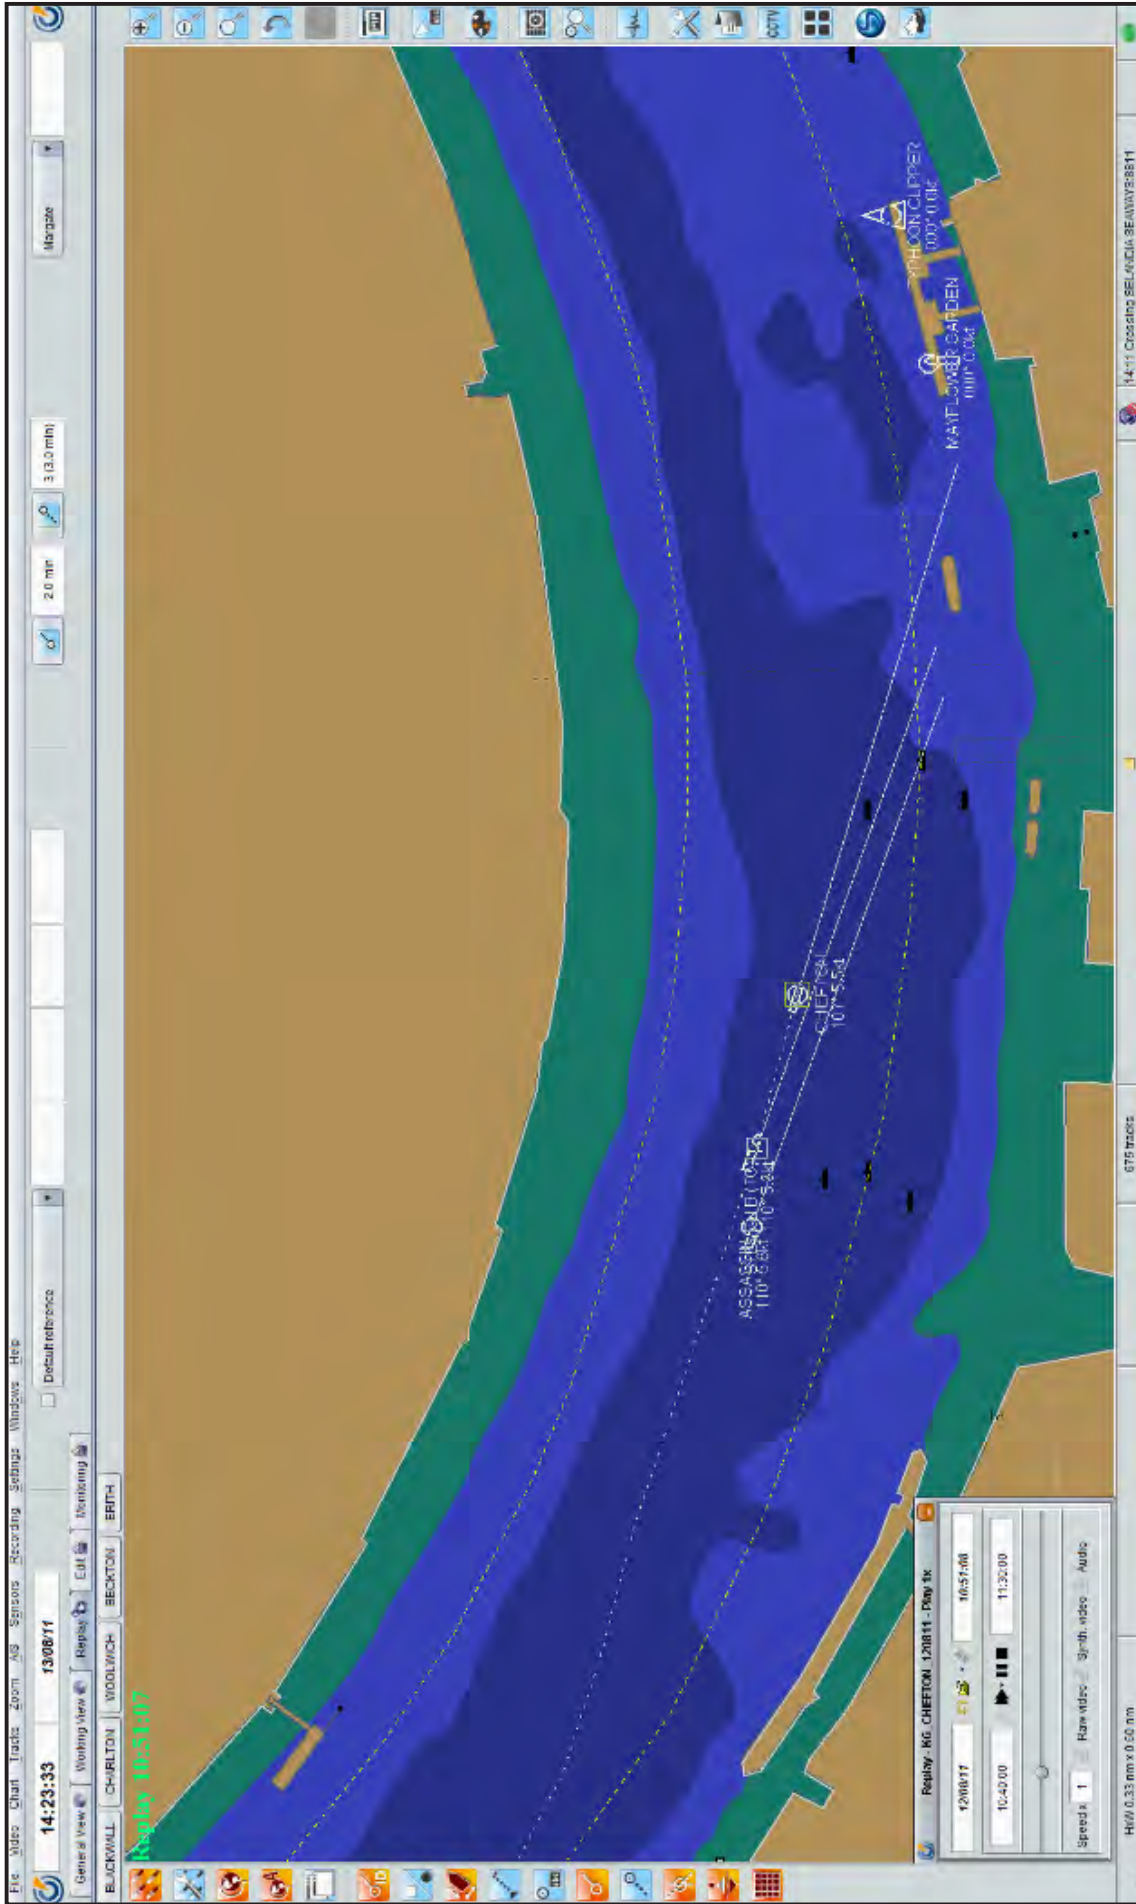
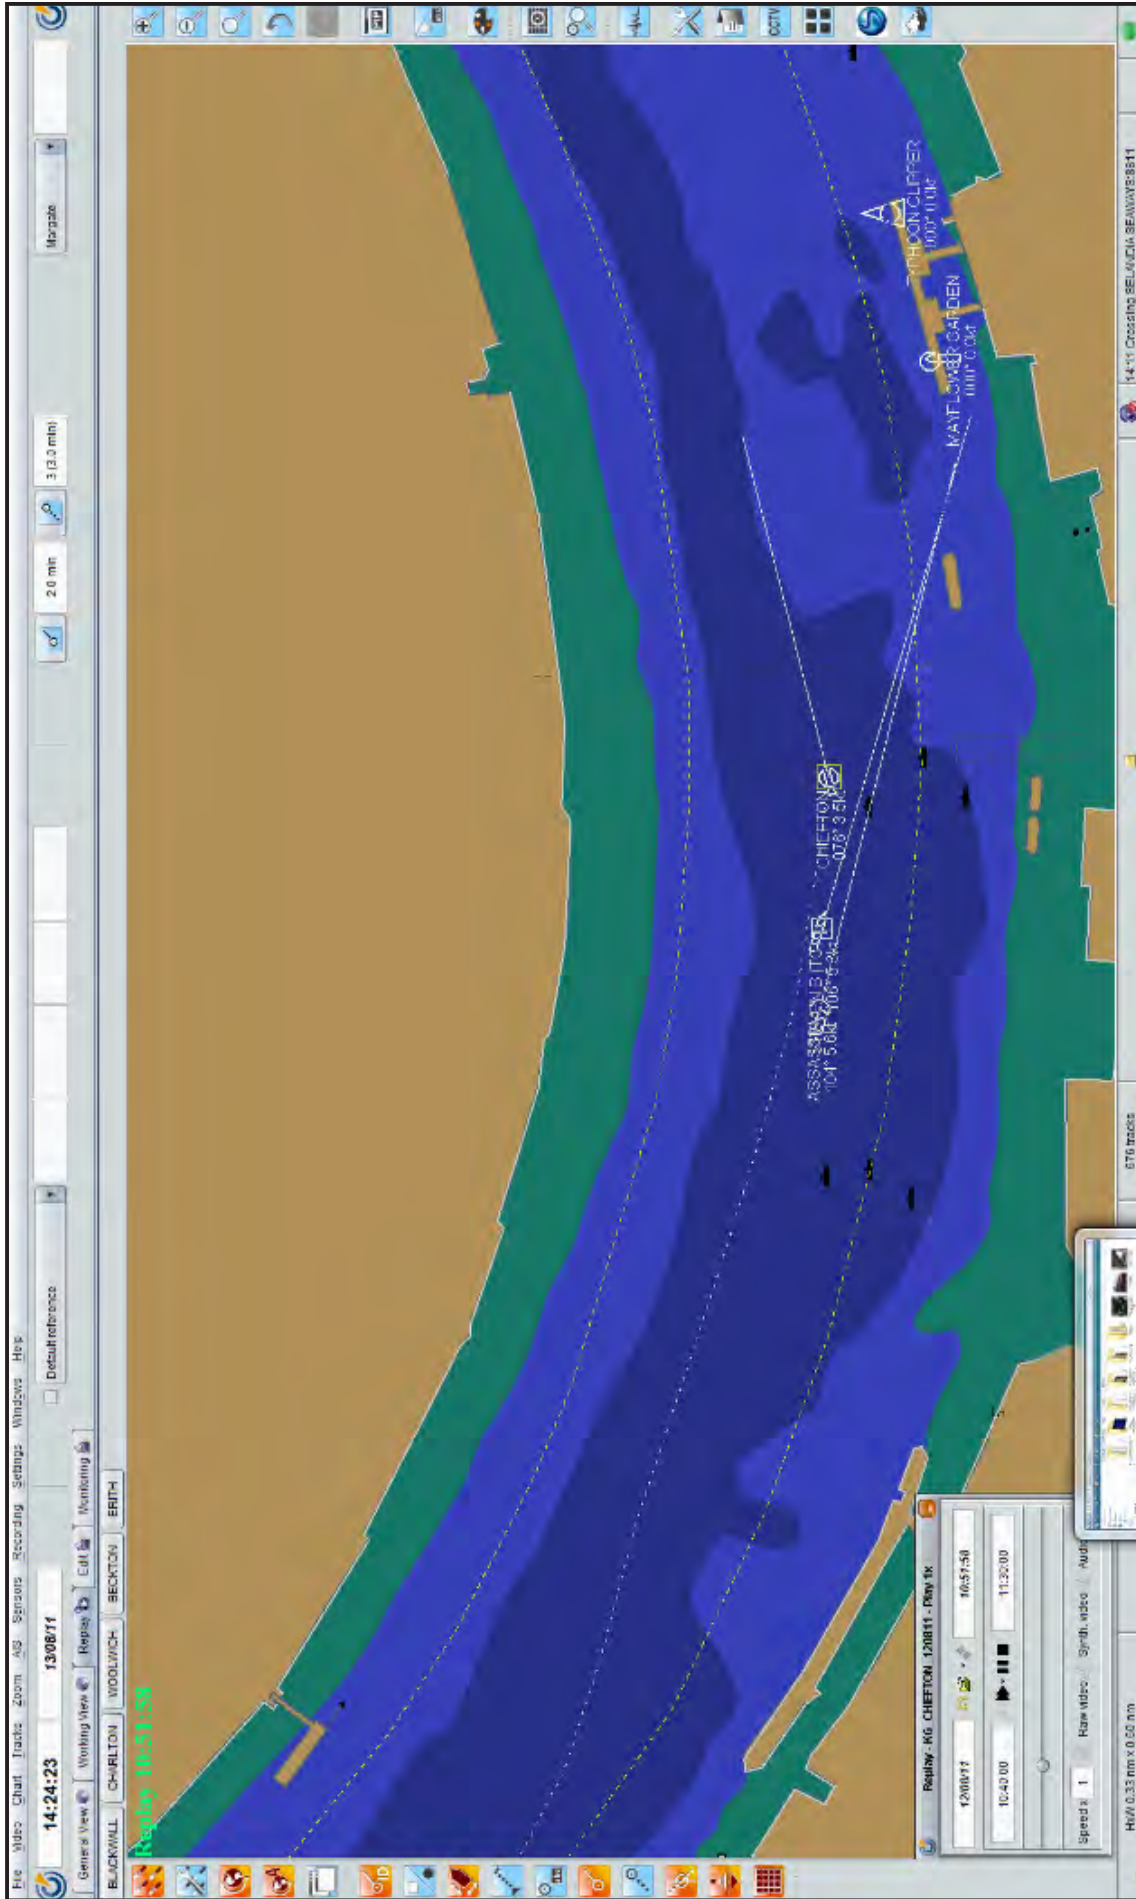
Both *Chiefton's* skipper and pilot 3 were of the view that the difficult bridge transit phase had been completed, and judged the remainder of the passage to be routine. Both would therefore have been experiencing a sense of relief, probably resulting in

Figure 25a: Chiefton's AIS track - approach to the western group of buoys of Greenwich Ship Tier

Figure 25b: Chiefton's AIS track - abeam of the western group of buoys of Greenwich Ship Tier

Figure 25c: Chiefton's AIS track - midway between the western and eastern groups of buoys of Greenwich Ship Tier

Figure 25d: Chiefton's AIS track showing the barge about to make contact with the northernmost buoy of the eastern group of buoys of Greenwich

a reduced level of vigilance. This would have contributed to their loss of situational awareness in terms of position monitoring and of anticipating the effect of the flood tidal stream.

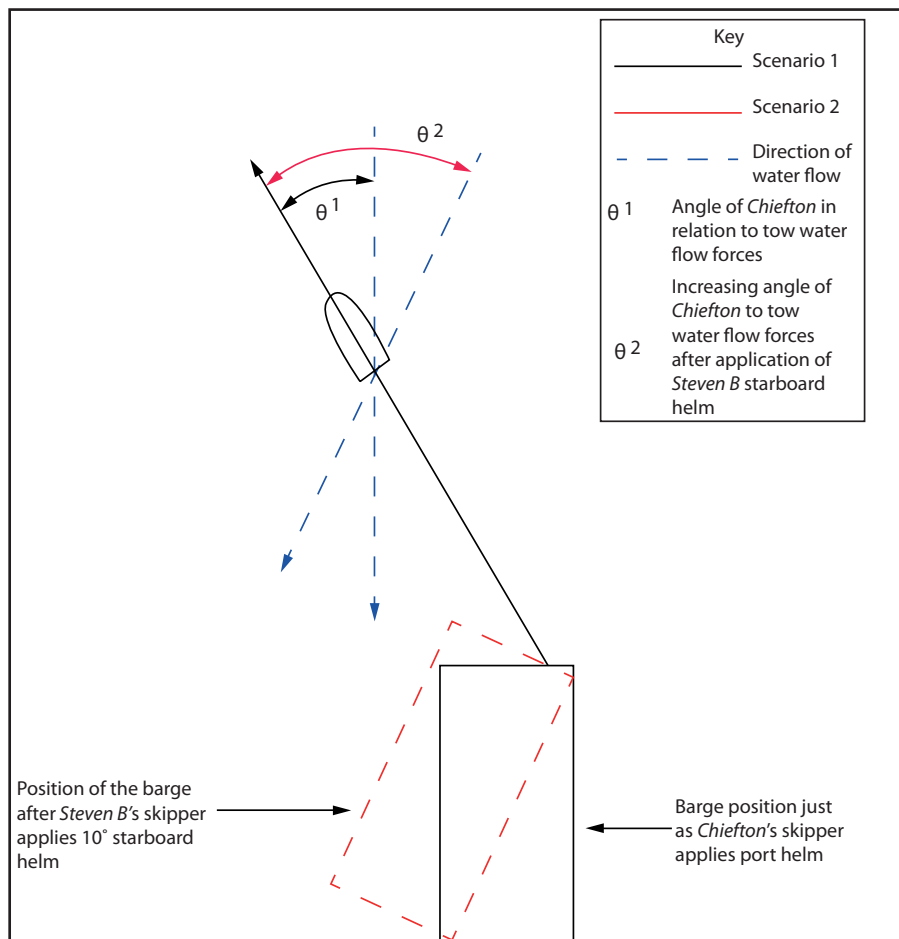
Figure 27: Schematic showing relationship between tug and tow water forces applicable at the time of the accident

This high-risk situation was not properly considered during either the planning or execution of the tow.
