## Grounding of **COASTAL ISLE** Island of Bute 2 July 2012

### SUMMARY

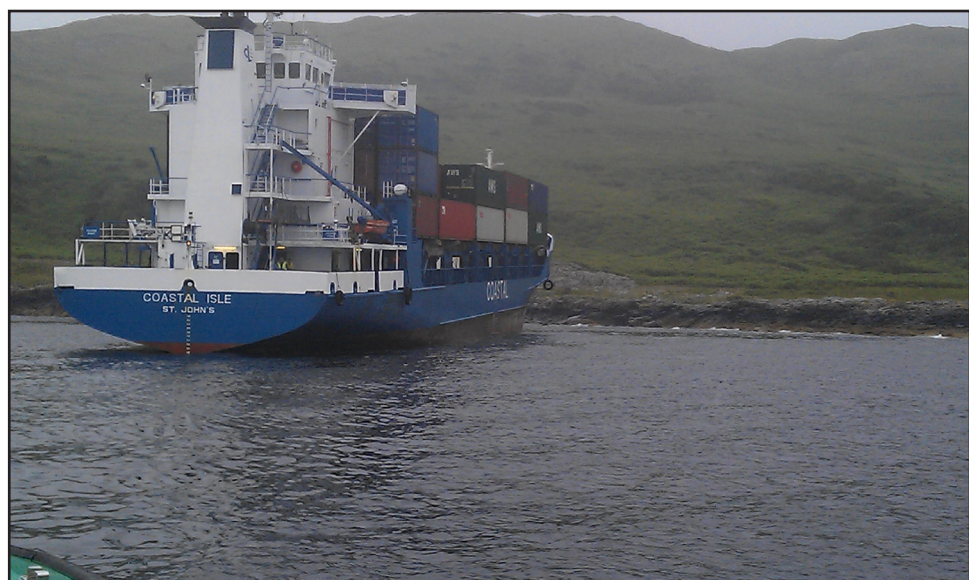
At 0443 on 2 July 2012, while on passage from Belfast to Greenock, the 89m feeder container vessel *Coastal Isle* ran aground on the Island of Bute. The grounding resulted in significant damage to the forward section of the vessel, including minor breaches to the forward ballast tanks. At about 0240 the chief officer, who was on watch at the time, had dismissed the ordinary seaman who was on lookout duties; shortly afterwards he left the bridge himself. The bridge was unmanned from that time until the vessel grounded at 0443 (**Figure 1**). The chief officer was subsequently found in his cabin.

**Figure 1:** *Coastal Isle* aground at the Island of Bute

*Coastal Isle* suffered extensive structural damage and approximately 12 to 13 tonnes of steel had to be renewed. Three ballast tanks, number 1 double bottom tank and the forepeak tank were breached.

Hull damage was extensive along frames 96 to 110 on the port side and from 88 to 115 on the starboard side (the most forward frame of the hull was numbered 130).

*Coastal Isle* ran aground because there was no one on the bridge to correct the vessel's heading when it was set off course by the easterly wind. A lookout, in addition to the watchkeeping officer, was available on the bridge during the hours of darkness. However, the chief officer dismissed the lookout assigned to his watch shortly before leaving the bridge himself.

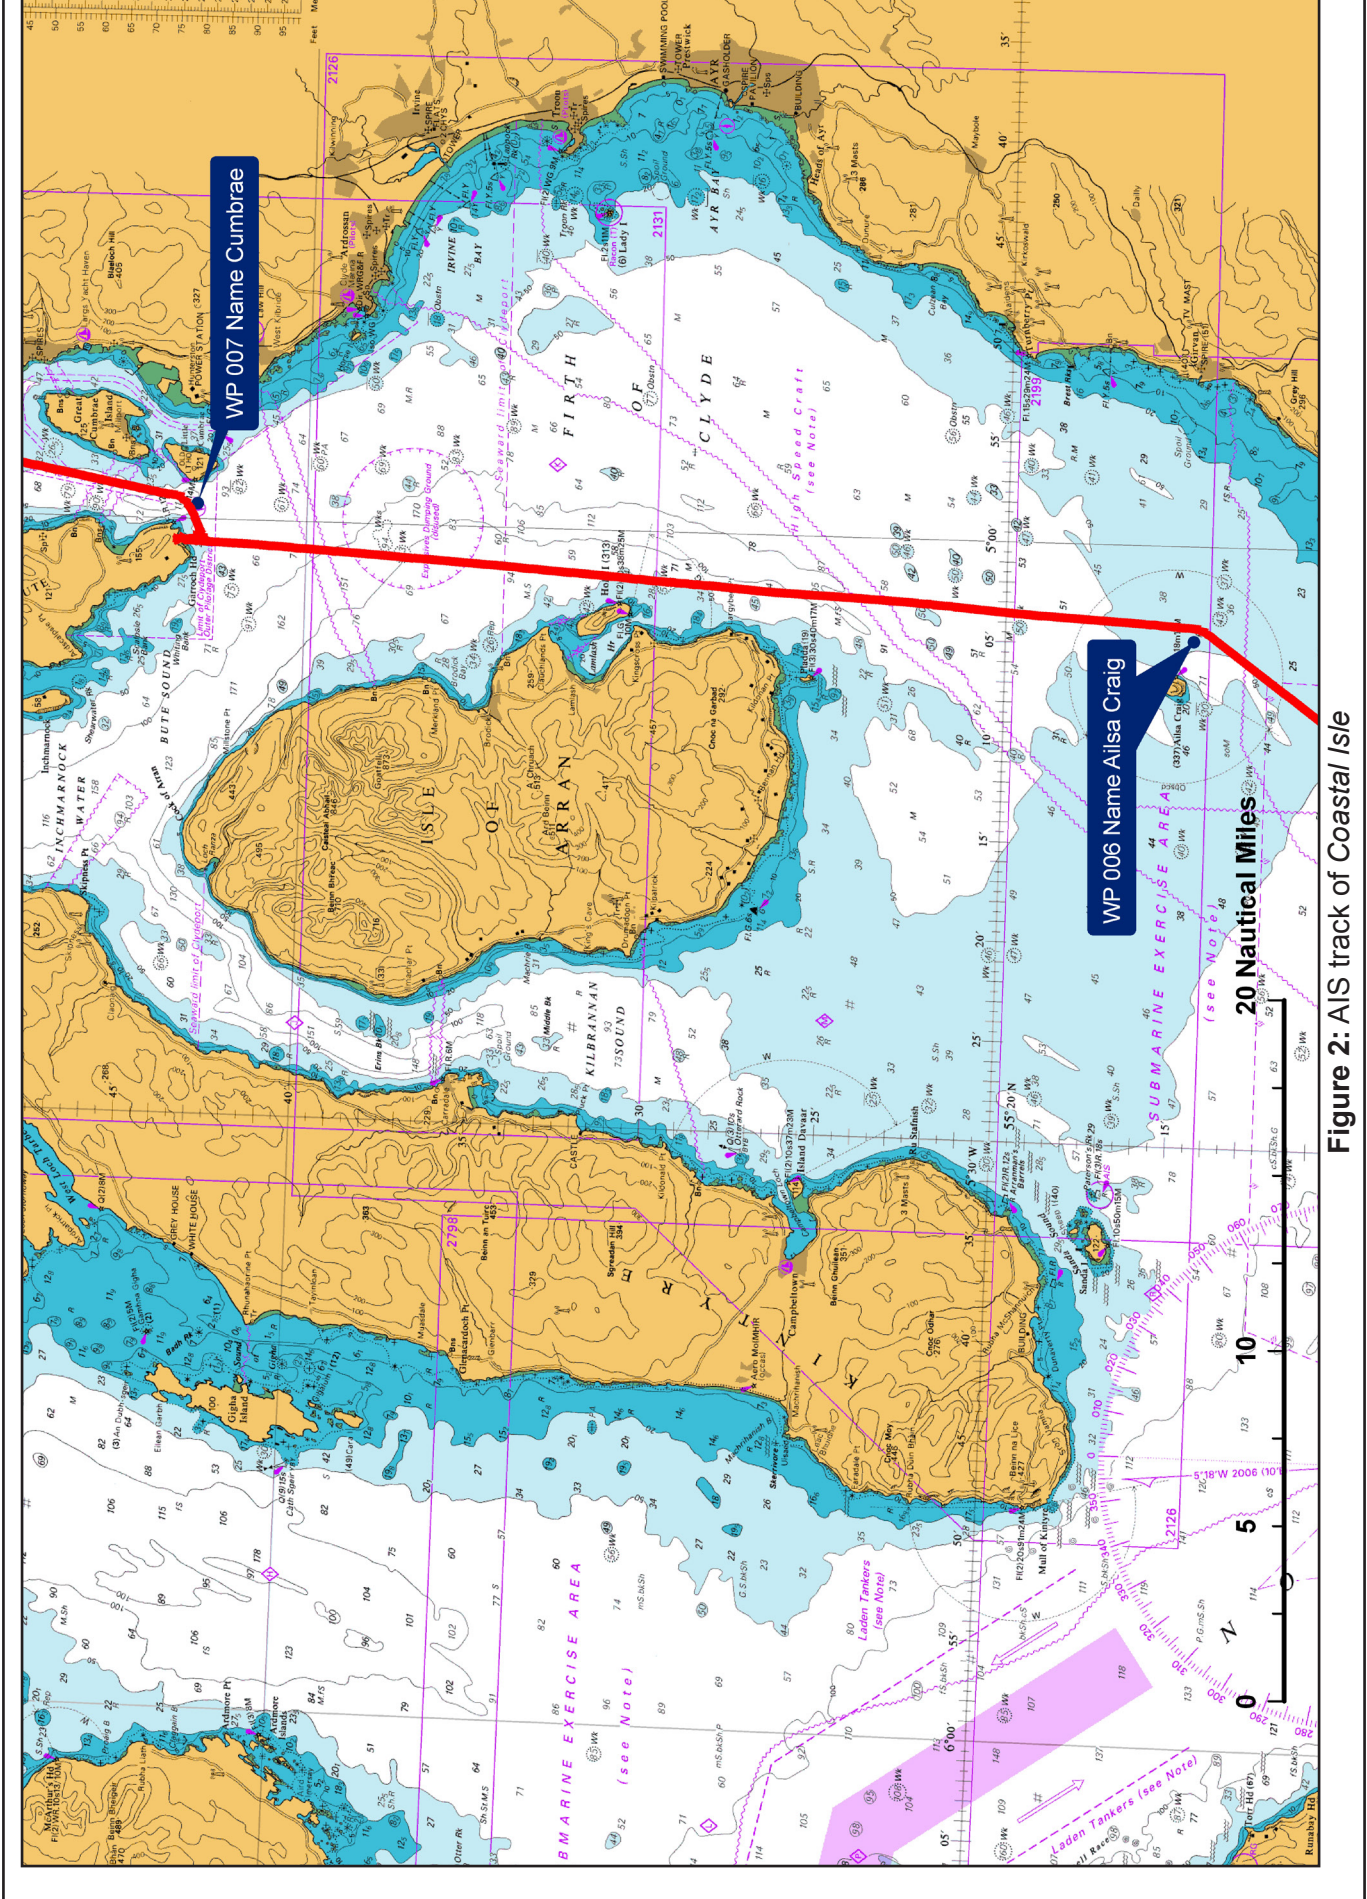
At 0220, when *Coastal Isle* was to the east of Ailsa Craig (**Figure 2**), the chief officer altered the ship's heading to around 006°. The vessel's speed over the ground at the time was around 12 knots. There was no traffic in the area, and the next course alteration point was 30nm away. At approximately 0240, the chief officer dismissed the lookout, who went to his cabin and slept. The chief officer reported that, at some time before 0300, he had started suffering from stomach cramps, and went to his cabin to use the toilet; his cabin was two decks below the bridge and towards the aft end of the accommodation. The nearest toilet to the bridge was only a short flight of stairs away. The chief officer did not recall the lookout or ask any of the other officers to take the watch for him before he left the bridge.

Figure 2: AIS track of Coastal/Isle
