Report on the investigation of the
escape of Vinyl Chloride Monomer onboard

Coral Acropora

Runcorn, Manchester Ship Canal

Report No 4/2005
March 2005

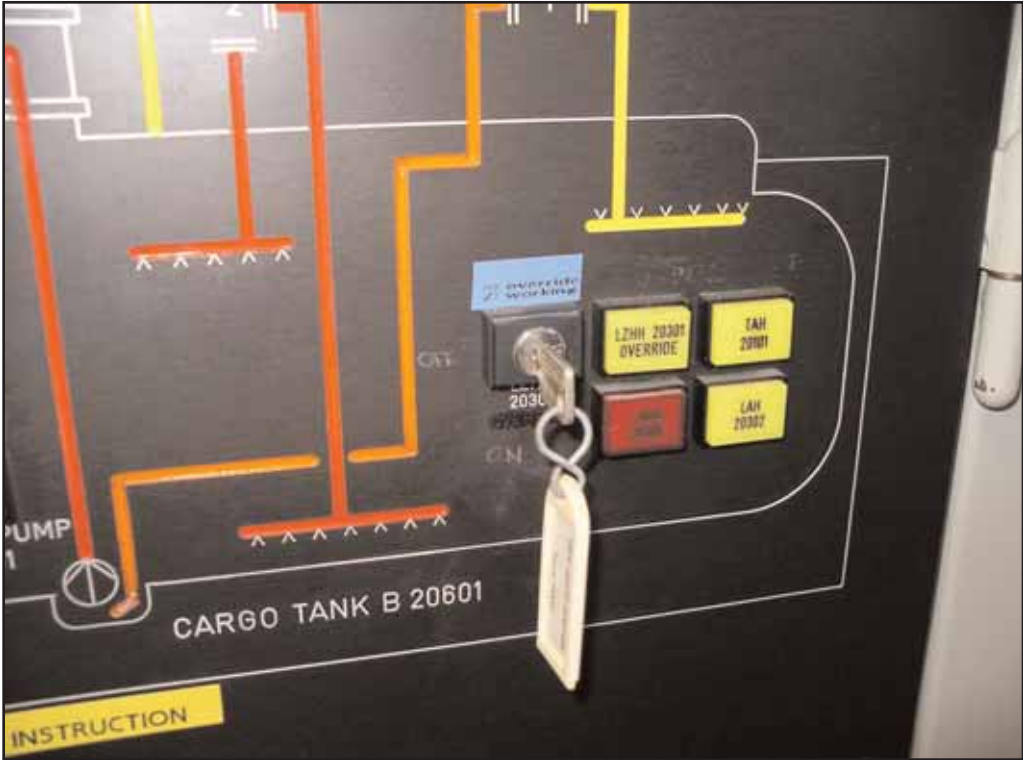
Figure 8

HHLA override key

¹ The MAIB believes this alarm was probably the forward tank 98% HHLA. The pump continued to run and valves remained open because the alarm safety features were overridden.

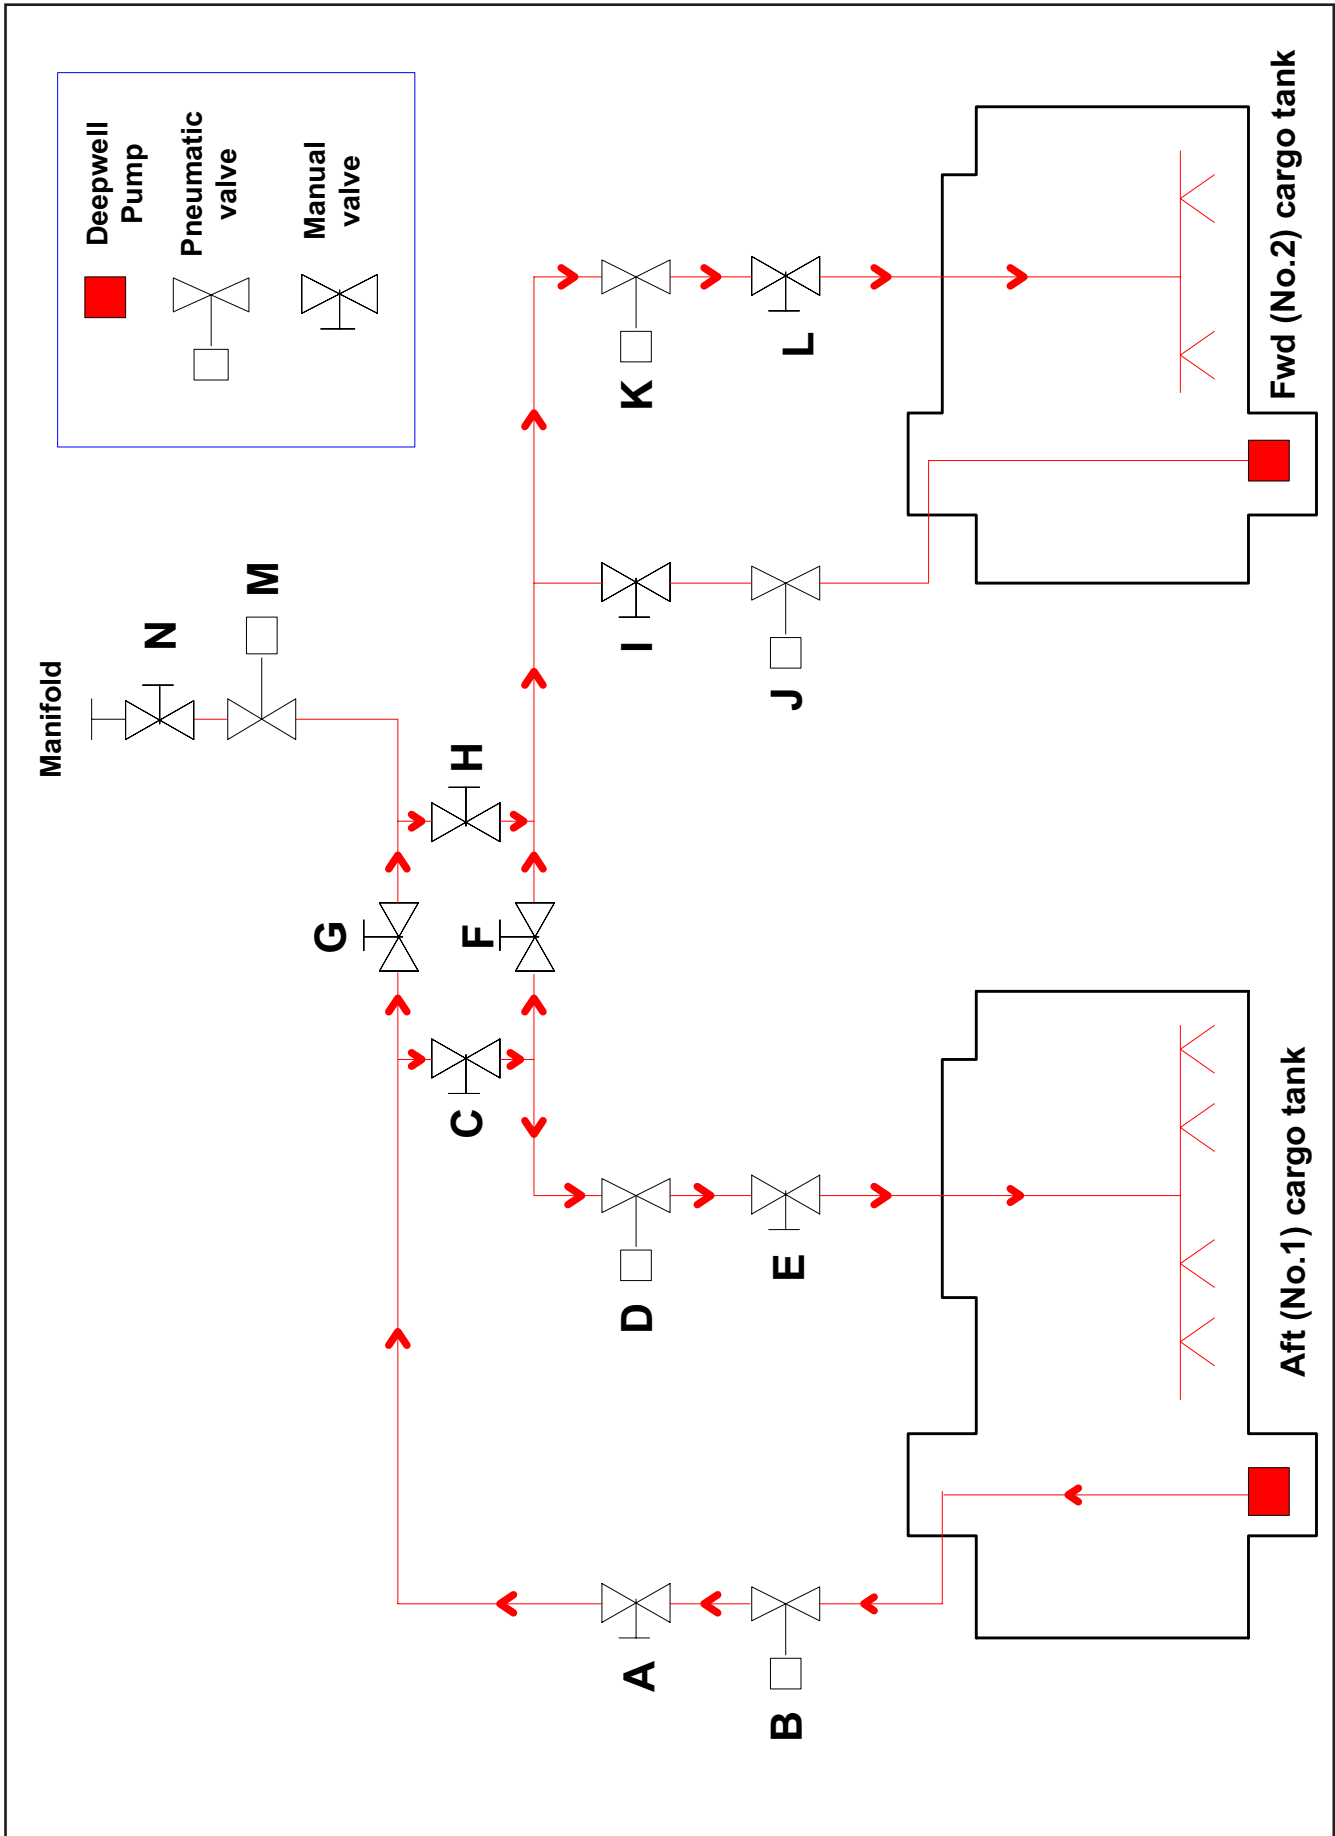
Because other cargo valves were open, unbeknown to the chief officer, the actual cargo flow was as indicated in **Figure 11**.

Relevant valve and piping arrangement - Actual flow

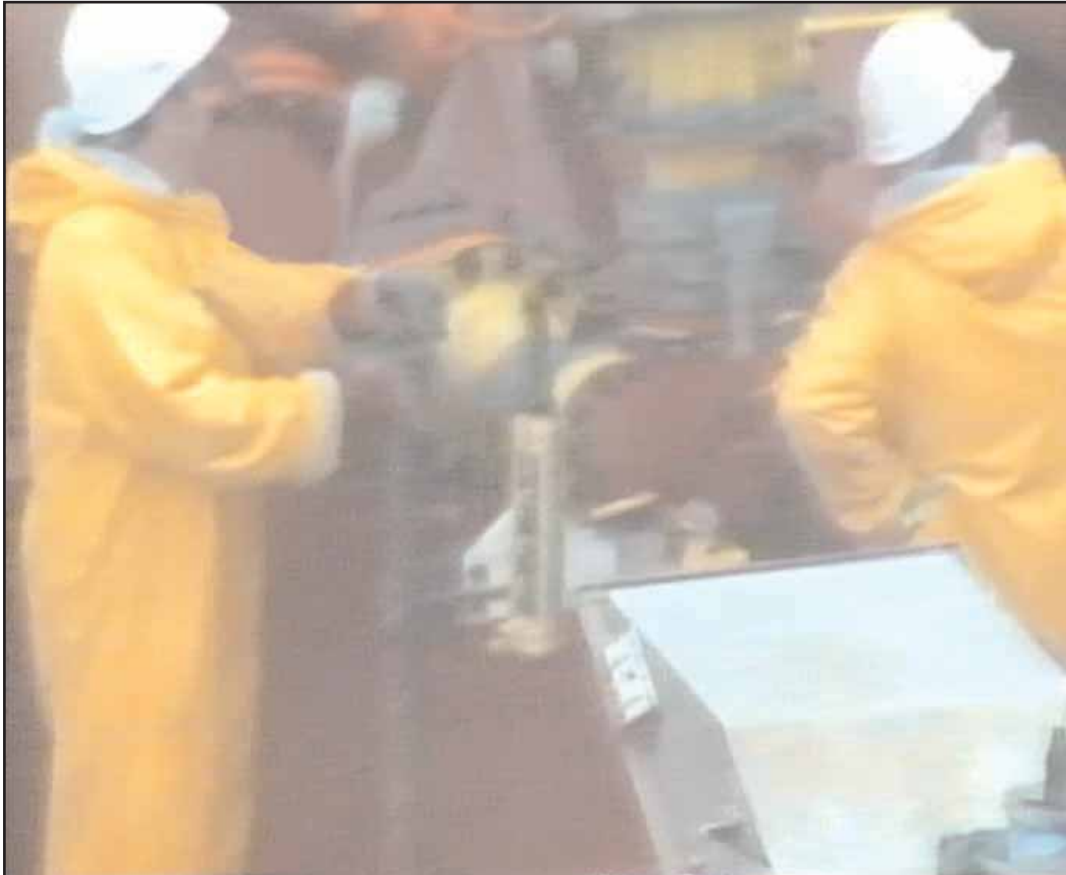
Figure 13

The two shore operators were putting the bolts into the manifold connection when they noticed the vapour cloud approaching (**Figure 13**), and they ran from the manifold area towards the gangway to reach safety. However, they were engulfed by the vapour cloud and had to run clear of the berth in visibility of less than 2 metres. Fortunately, both men managed to get away without becoming overcome by the effects of the gas by running upwind once they were ashore. The vessel was enveloped in the vapour cloud for a period of about 6 minutes (**Figures 14, 15 & 16**) (**Appendix C**).

The moment cargo emitted from the mast riser

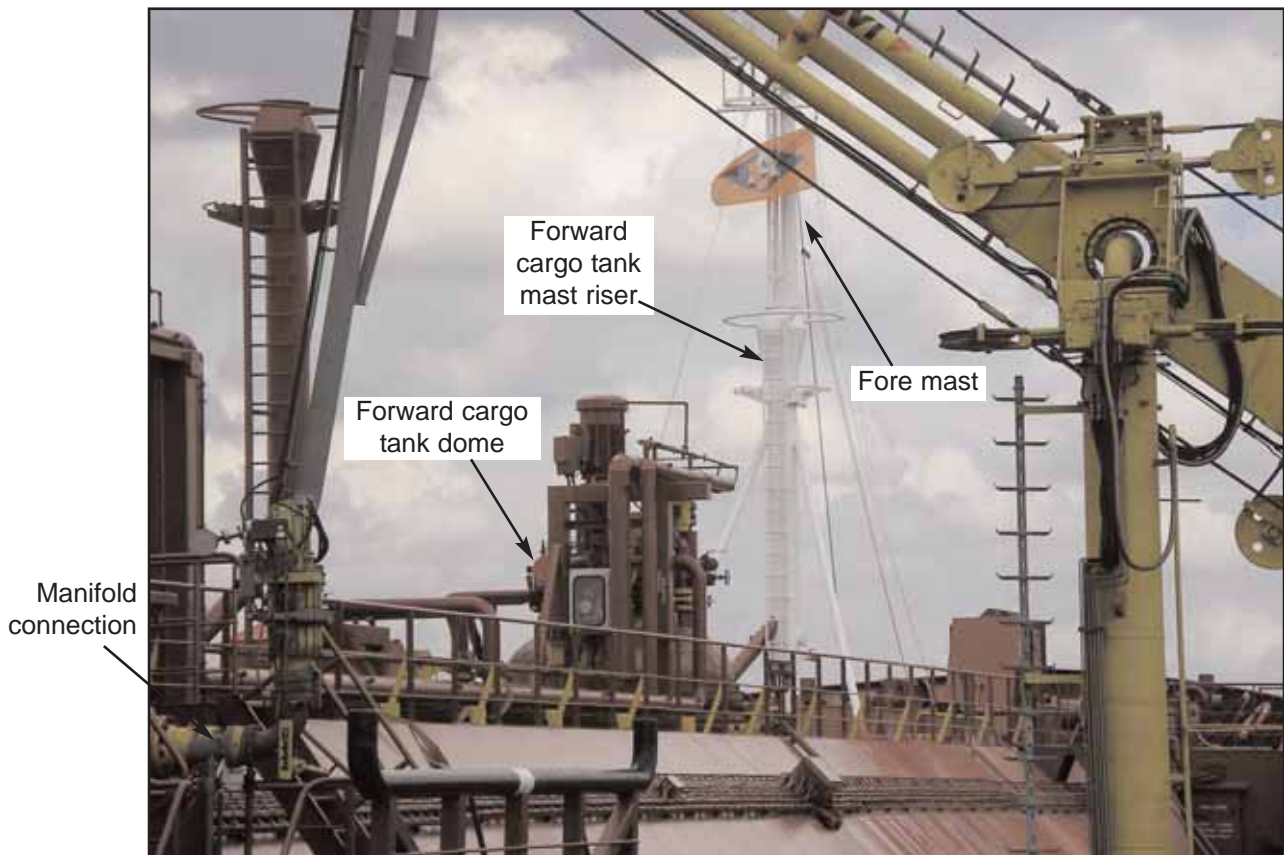
Figure 18

The chief officer noticed that the house flag being flown on the fore mast was frozen, and he deduced that cargo had been released through the forward mast riser (**Figure 18**). He checked the valve positions and began to realise what had happened. The deck was coated in white crystals.

View of mast riser, foremast and forward cargo tank dome

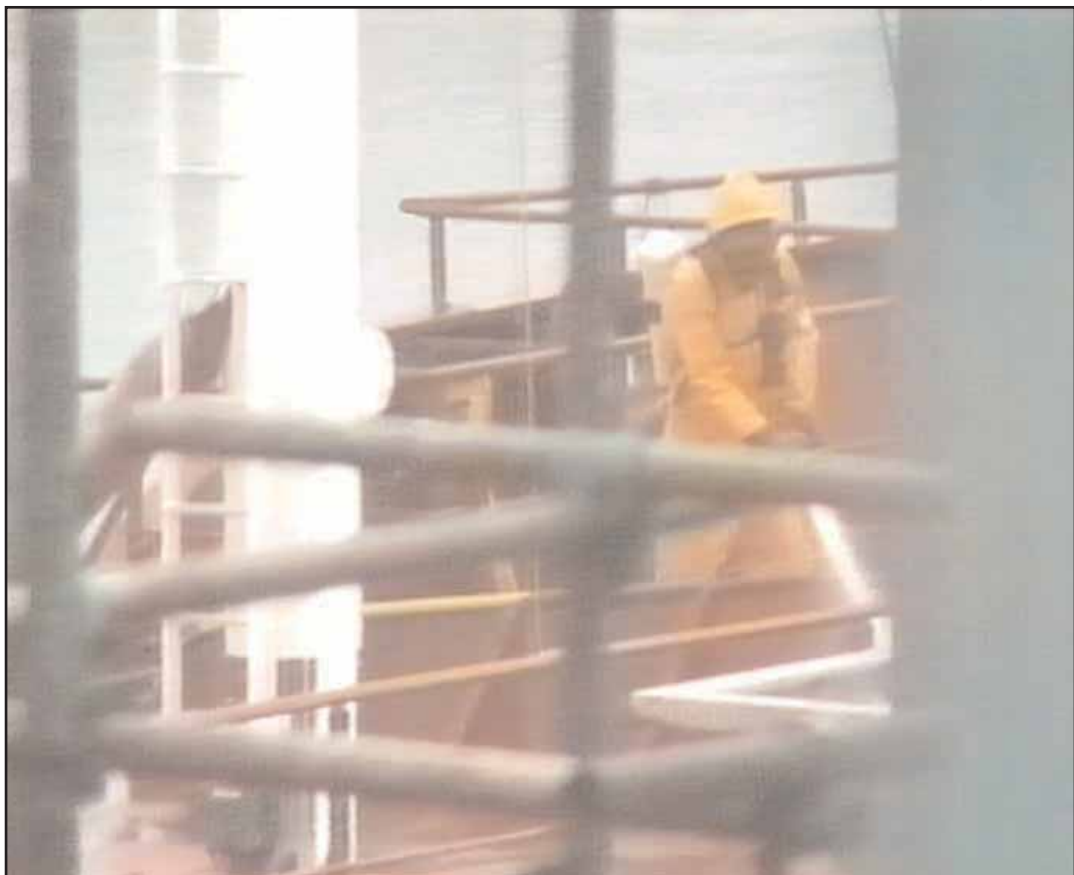
Figure 20

Crewman using water hose on deck

As stated previously, the deck water spray system was not utilised to dilute or disperse the cargo spill. The able seaman used a fire hose in an attempt to dilute the gas and remove "ice crystals" from the deck, to reduce the gas content and stop any damage to the vessel's structure from thermal shock.

As an initial emergency response, the use of a hose to disperse liquid spillage and prevent brittle fractures is completely acceptable. However, care should always be taken once such dangers have been negated, that any residual substance is disposed of safely.

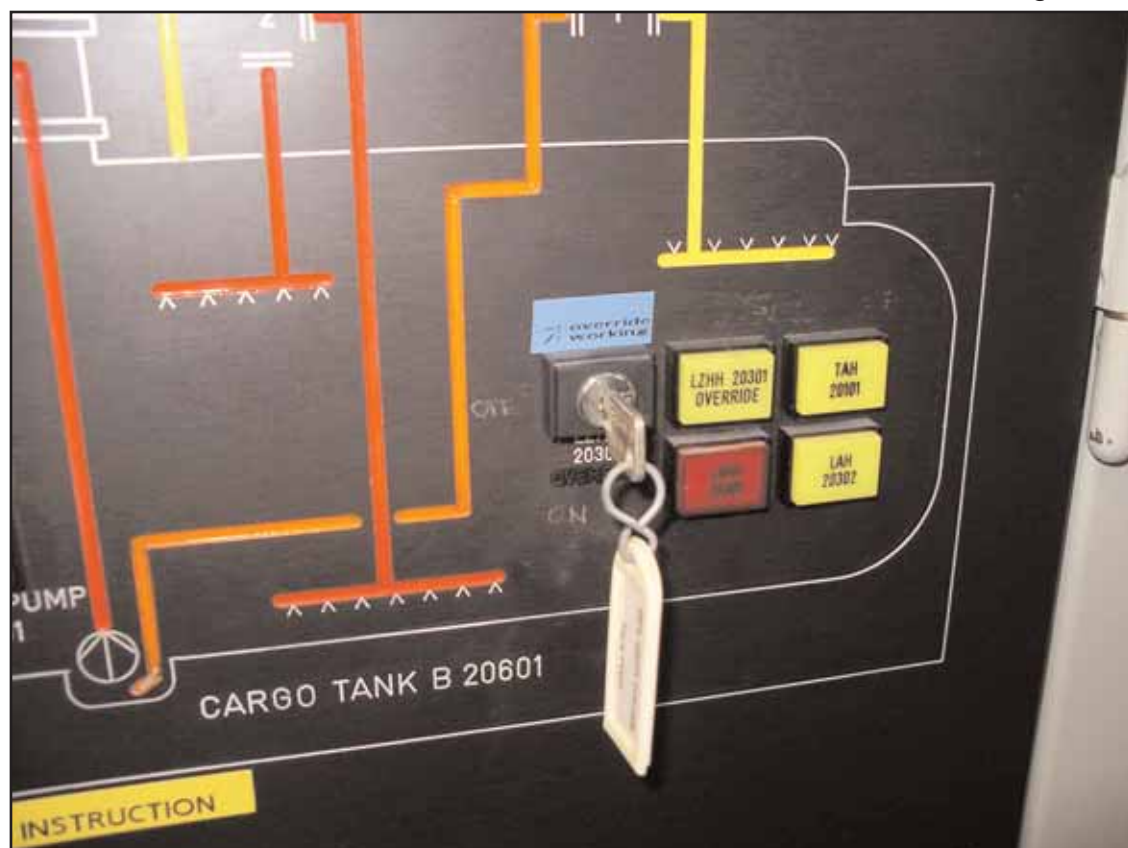
Figure 22

HHLA override switch and key

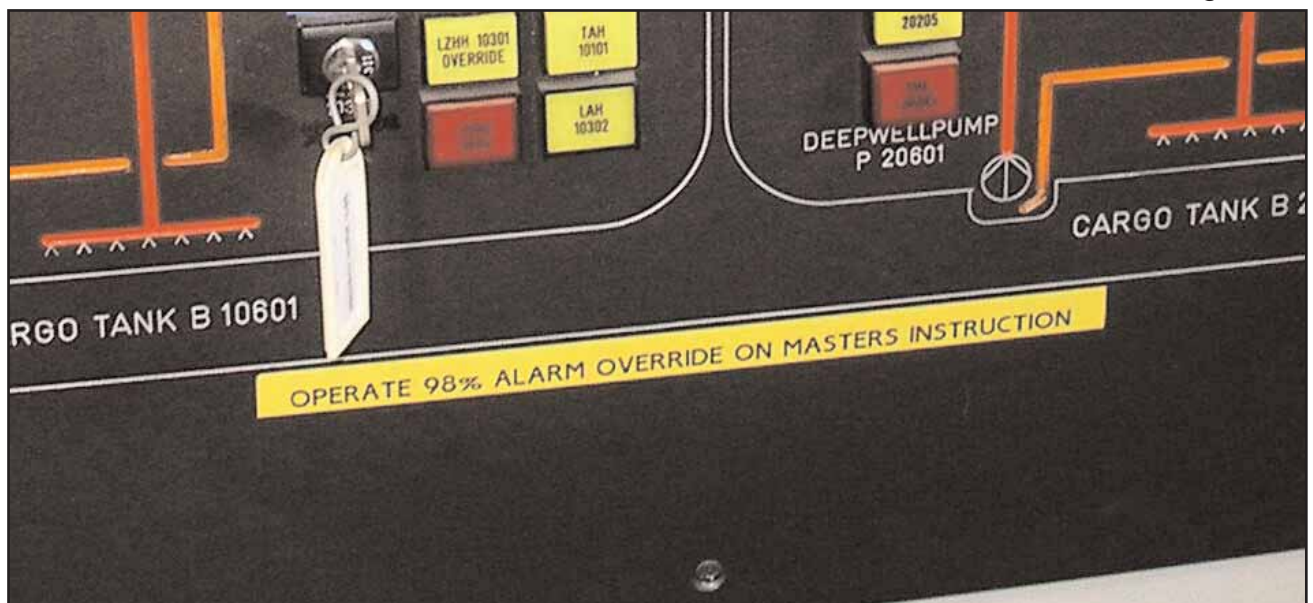
Figure 25

However, no evidence was found to suggest that this was, in fact, the normal operational procedure (**Figure 25**).

The override switch is used throughout loaded passage voyages to stop the cargo system alarming as the vessel moves in a seaway. Further, as previous cargo records show, the cargo tanks were often above, or close to, the 98% alarm level setting, so it appears to have become a matter of common practice to use the override switch during cargo operations.

HHLA override warning instruction

- Avoid transfer cargo to a tank with the 98% alarm / shutdown overridden.*
 - During sampling of VCM cargo a BA set is to be worn all the time in compliance with company's specific instructions on VCM cargoes.*
