Report on the investigation into the grounding,
and subsequent loss, of the ro-ro cargo vessel

Riverdance

Shell Flats – Cleveleys Beach, Lancashire

**Report No 18/2009
September 2009**

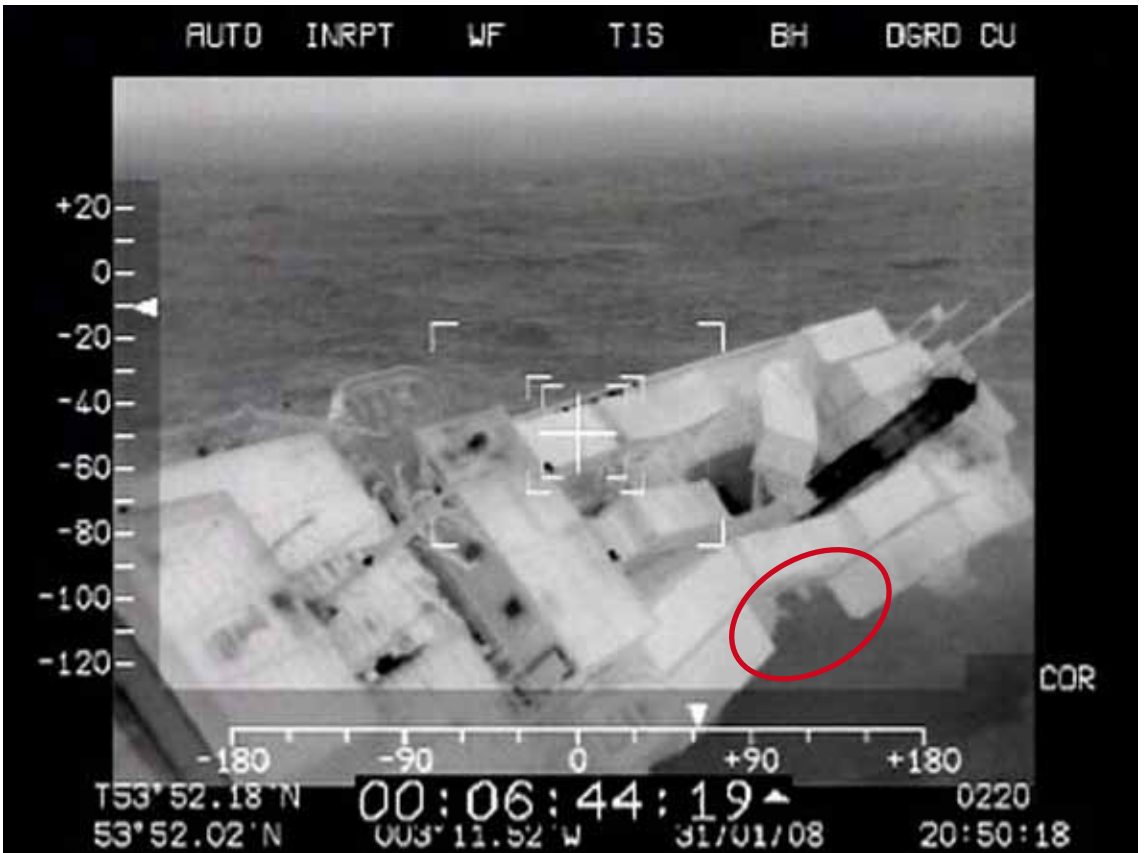
Further reports to Liverpool coastguard followed; at one stage, the list was reported to be as much as 60° to 70°. However, subsequent analysis of the video taken from RAF rescue helicopter, R122, showed *Riverdance* to have a median list of about 35° (although during extreme rolling, angles of 50° were observed) (**Figures 5a and b**).

Video still from R122: Initial encounter with *Riverdance*

Note: seas breaking on the upper deck

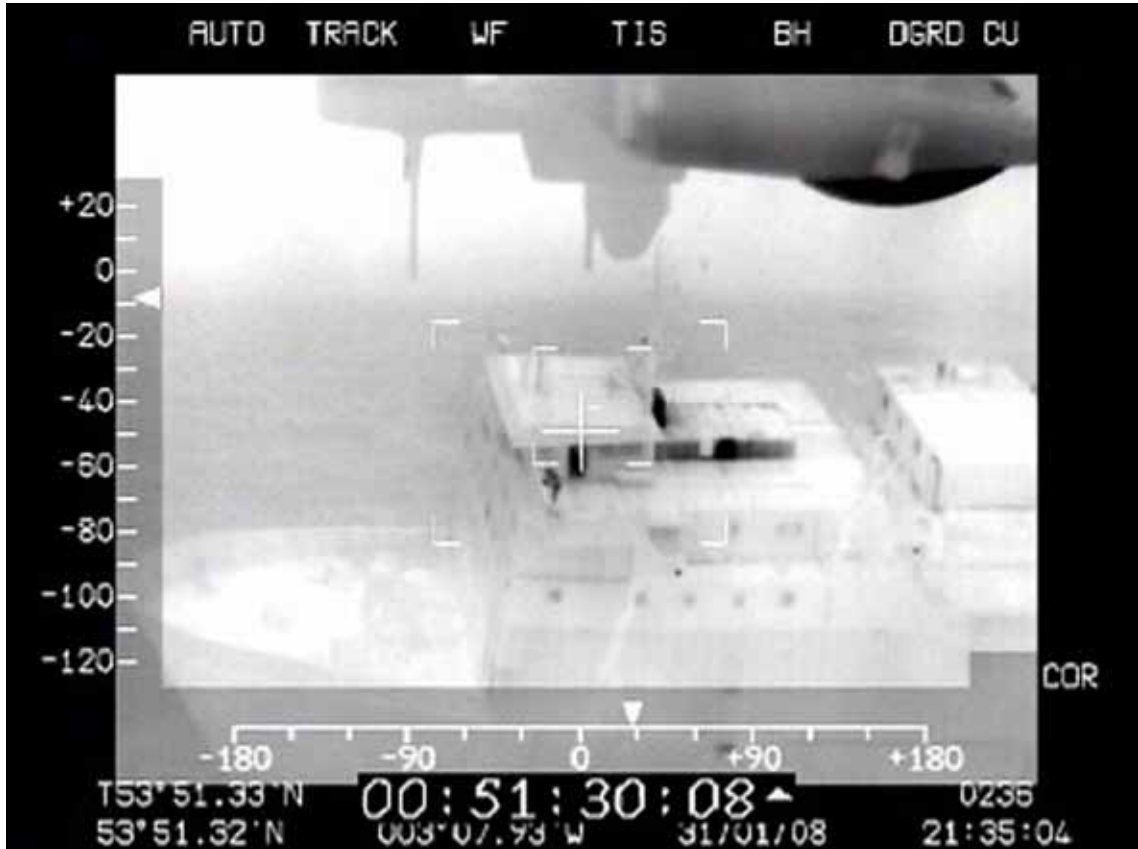
Figure 7a

Just before the engine room was abandoned, one of the volunteers had started the heeling pump, and left it running in an attempt to reduce the port list. Further video taken from rescue helicopter R122 shows the list reduced to about 20° during the next 30 minutes (**Figures 7a and b**).

At 2100 - list approximately 35°

At 2130 - list approximately 20°

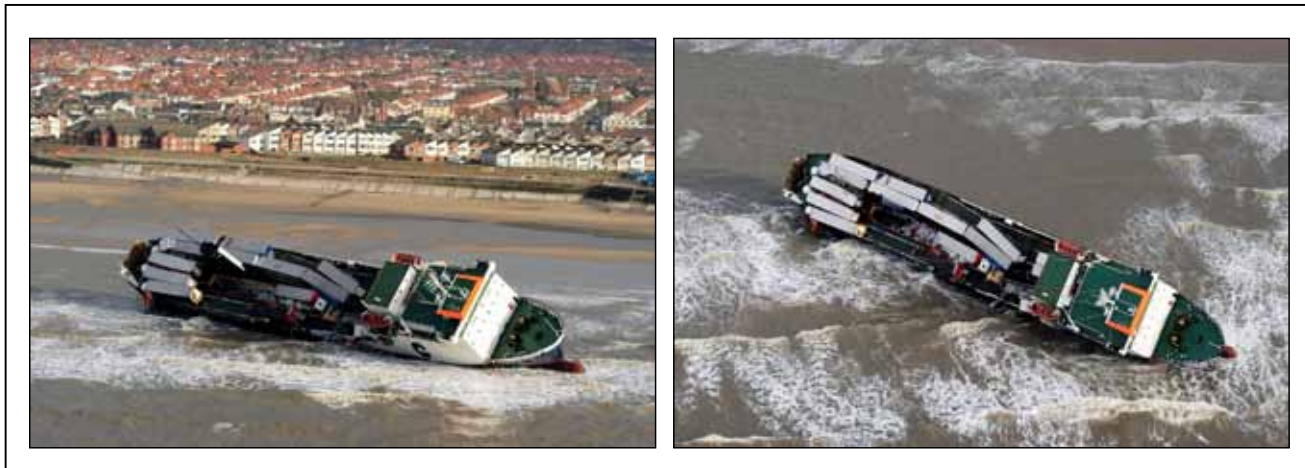
Once the attempts to refloat *Riverdance* were suspended, she began to roll as the waves crashed into her side. Several rolls were felt to starboard, against the wind and sea. These were followed by a lurch and a quick roll, before *Riverdance* settled over on her starboard side at an angle of about 30° (**Figure 9**). Her final grounding position was close to the sewer outfall pipe, which was subsequently found to have suffered slight damage.

Riverdance aground on the morning of 1 February 2008

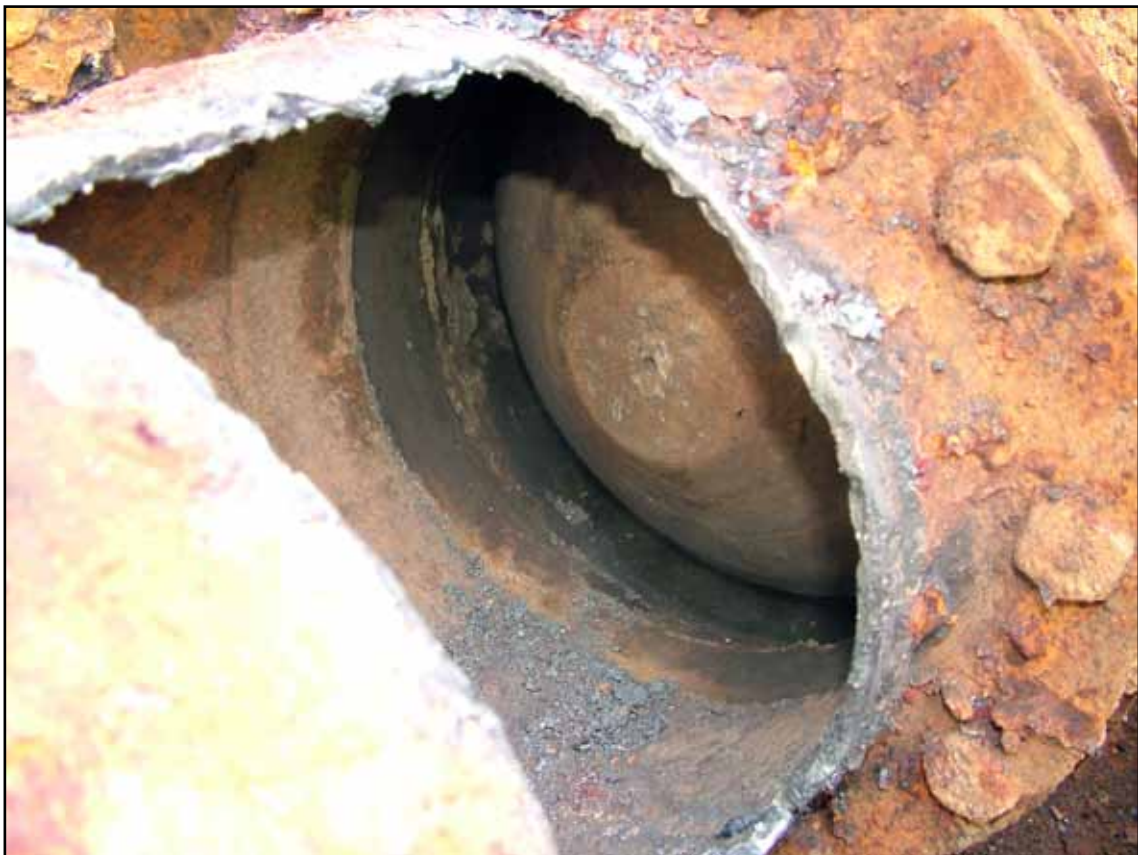
Figure 14a

During the vessel’s demolition process on Cleveleys Beach, some 6 months after the grounding, the non return valves were inspected and both of the upper, discharge side valves were found to be seized in the open position (**Figures 14a and b**).

Port non return valve not sealed

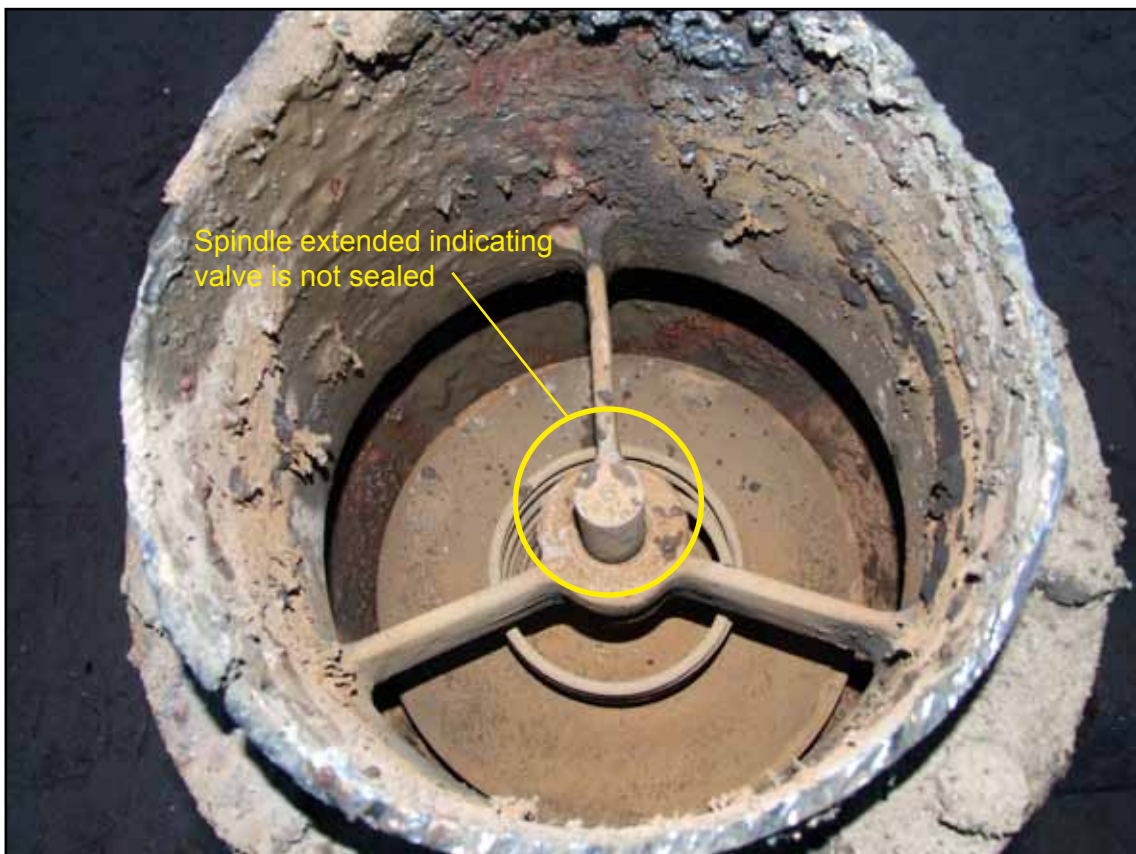
Figure 14b

Starboard non return valve

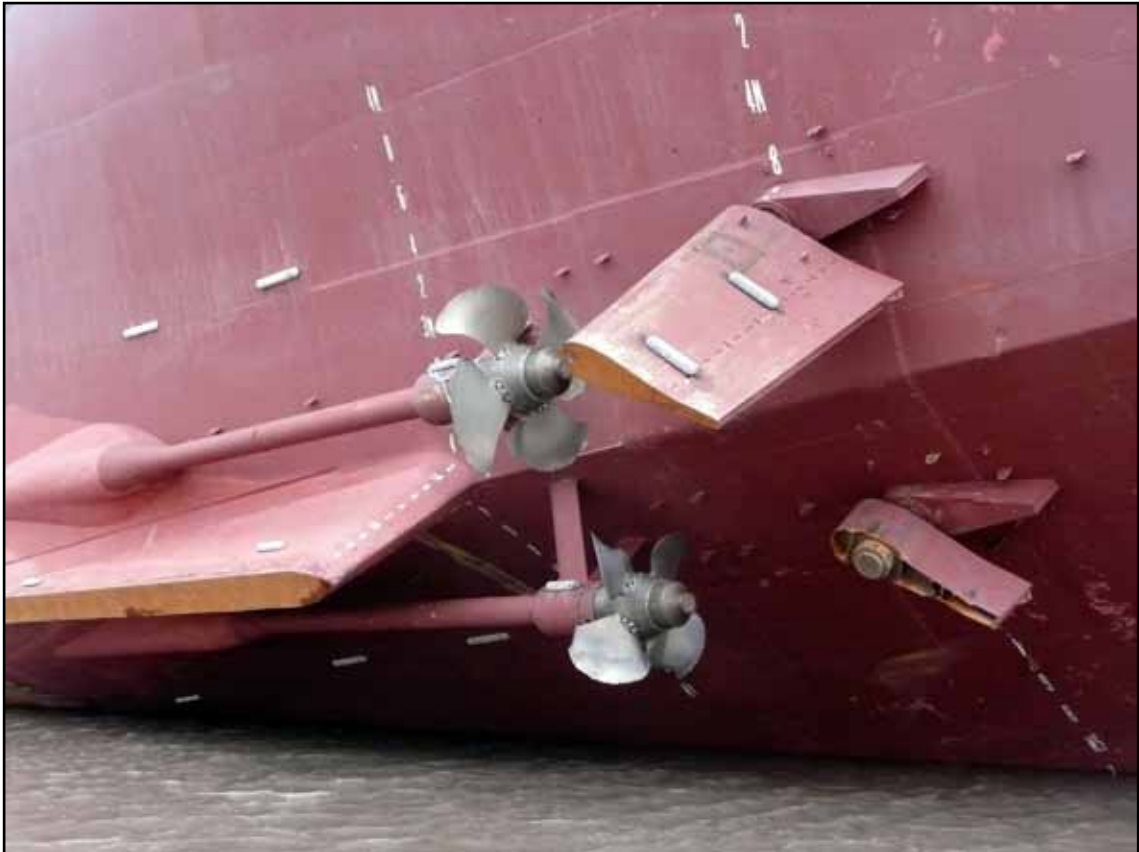
Damage sustained to *Riverdance's* CPP and starboard rudder

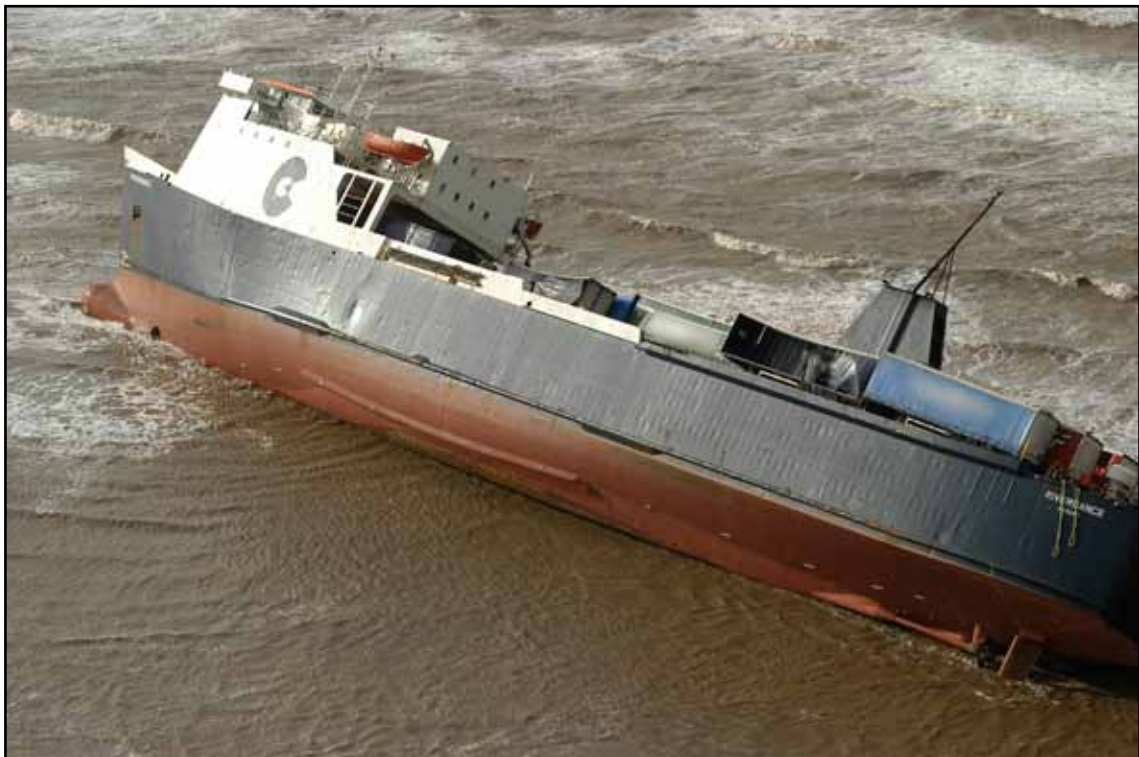
Consequently, when *Riverdance* finally came to rest on the beach at Cleveleys, her hull appeared intact and sound (**Figure 16**). However, the effects of bad weather, during the following days as the vessel lay on the beach, together with the continual pounding and effects of wave action on the hull, eventually laid her open to the sea.

Vessel aground with no apparent damage to ship's port side or hull

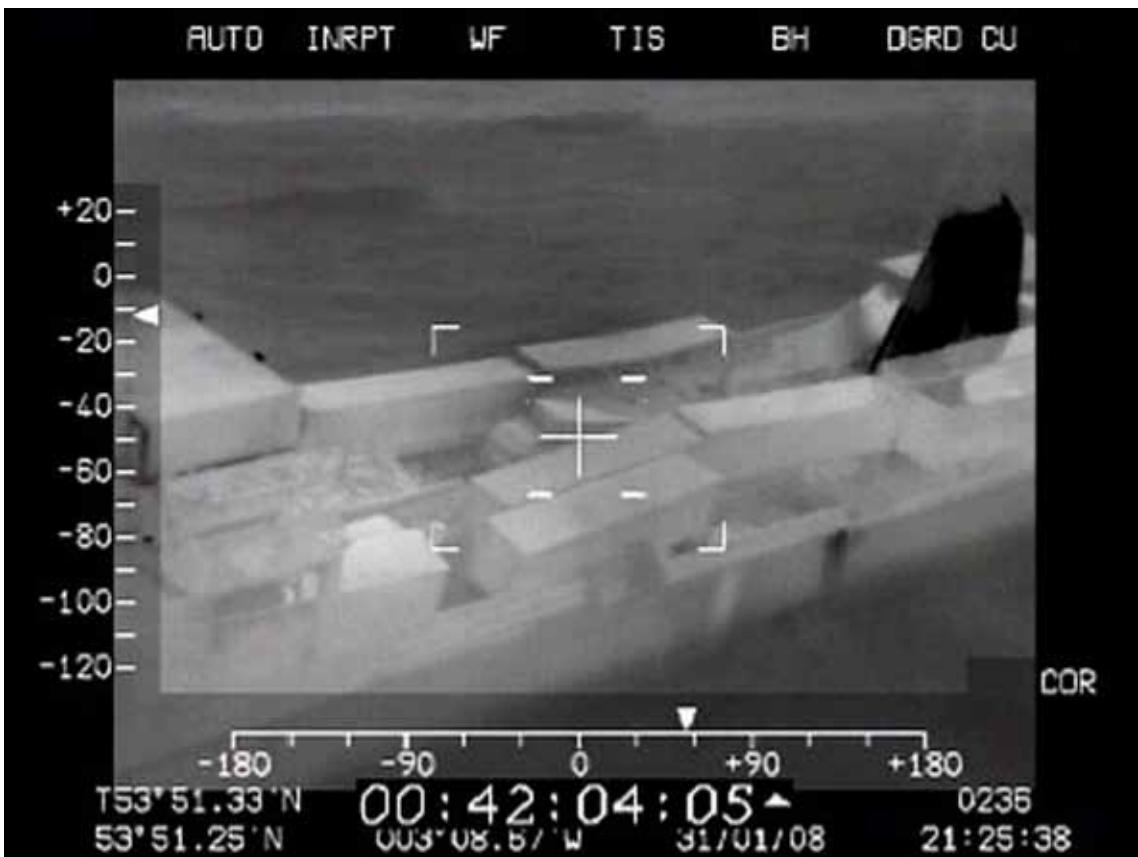
Two stills from RAF video showing majority of trailers still held in, or close to their original position

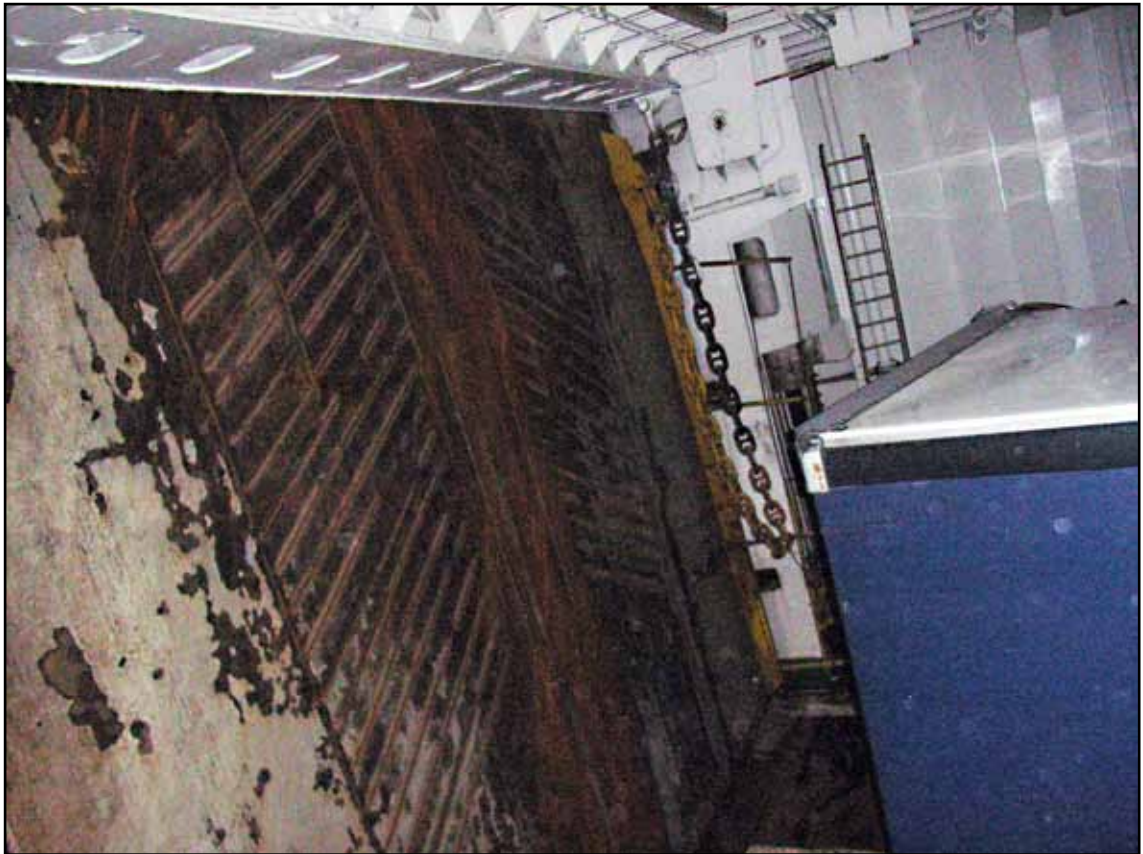
Figure 24a

The few photographs available of the main deck after the final grounding also show little evidence of trailers shifting or of cargo having been lost from the trailers themselves (**Figures 11, 24a and b**). Most show taughtliners still in the stowed positions, with no indication of cargo having broken through the curtain sides.

Taughtliner by the stern ramp on the main deck after grounding still secured and in position

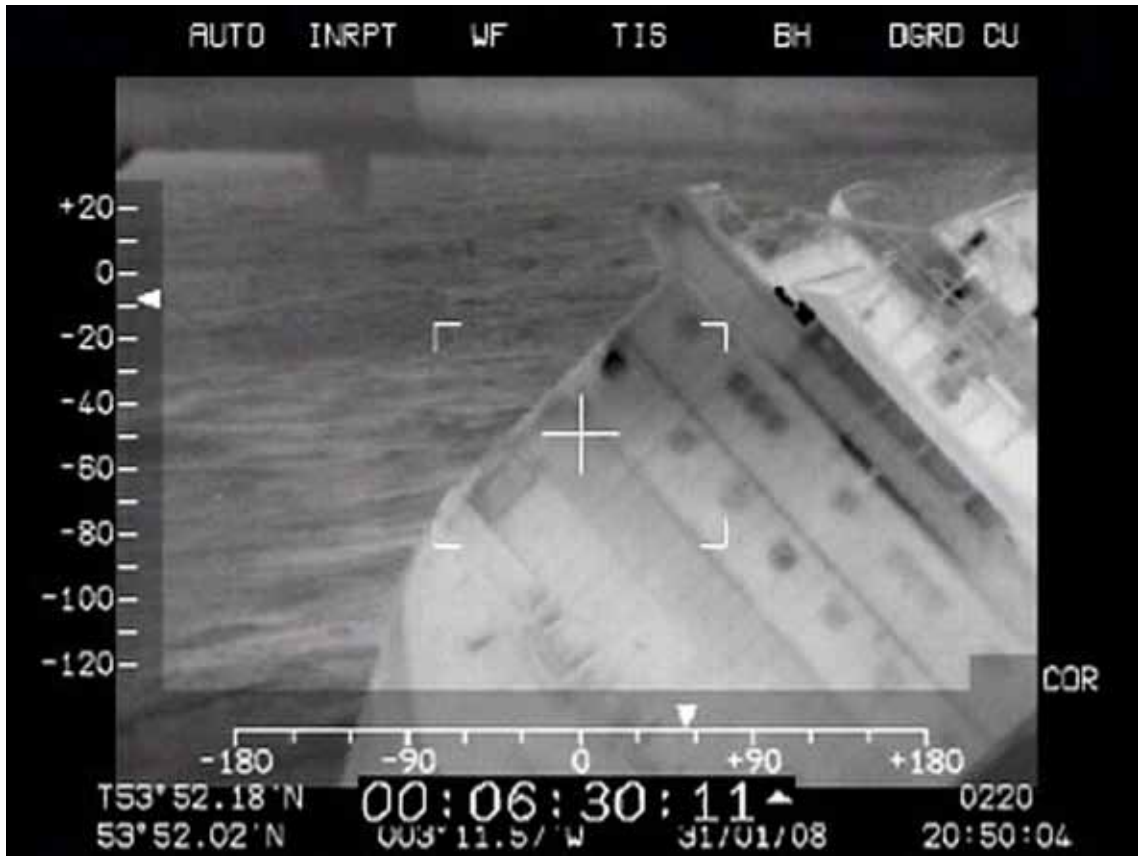
It is not possible to establish with certainty the precise reasons why *Riverdance* experienced the excessive lists on 31 January 2008. However, it is probable that a combination of the scenarios discussed above existed that night. What is known is that the list of 35° experienced on the exit from the sudden turn to starboard is unlikely to have been caused by the effect of cargo shift alone (**Annex 1, Section 3.10.3**).

RAF video showing median list of 30 to 40°

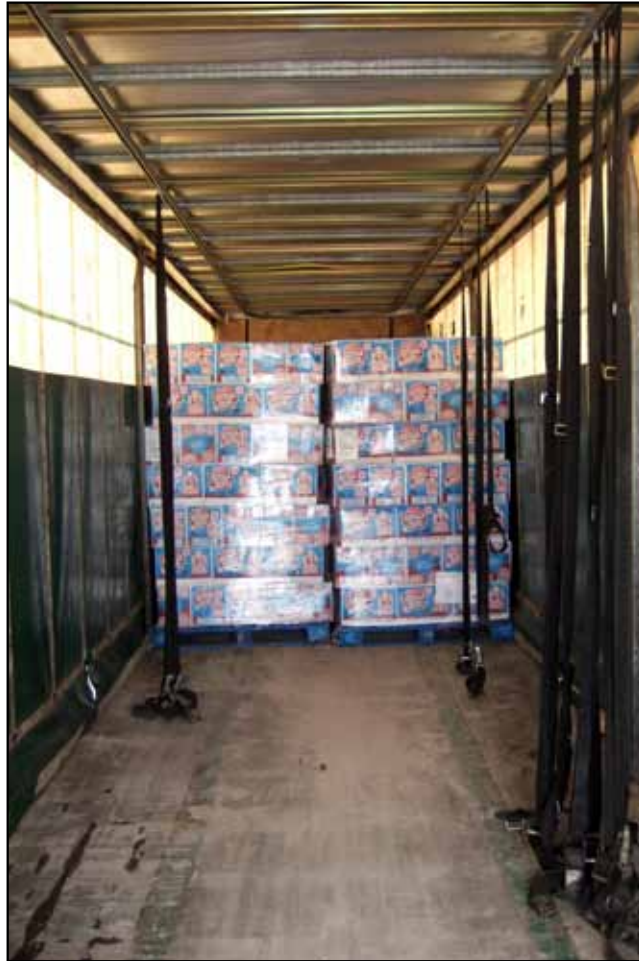
Figure 28

Securing arrangement within a "taughtliner"
Note: cargo is not secured down onto the trailer deck

There is a clear need for further work to be done to ensure that shippers and hauliers recognise the importance of stowing and securing the contents of trailers destined to be transported by sea and adhere to the available guidance on this issue.
