## **SIRENA SEAWAYS**

### **Heavy contact with berth, Harwich International Port**

**22 June 2013**

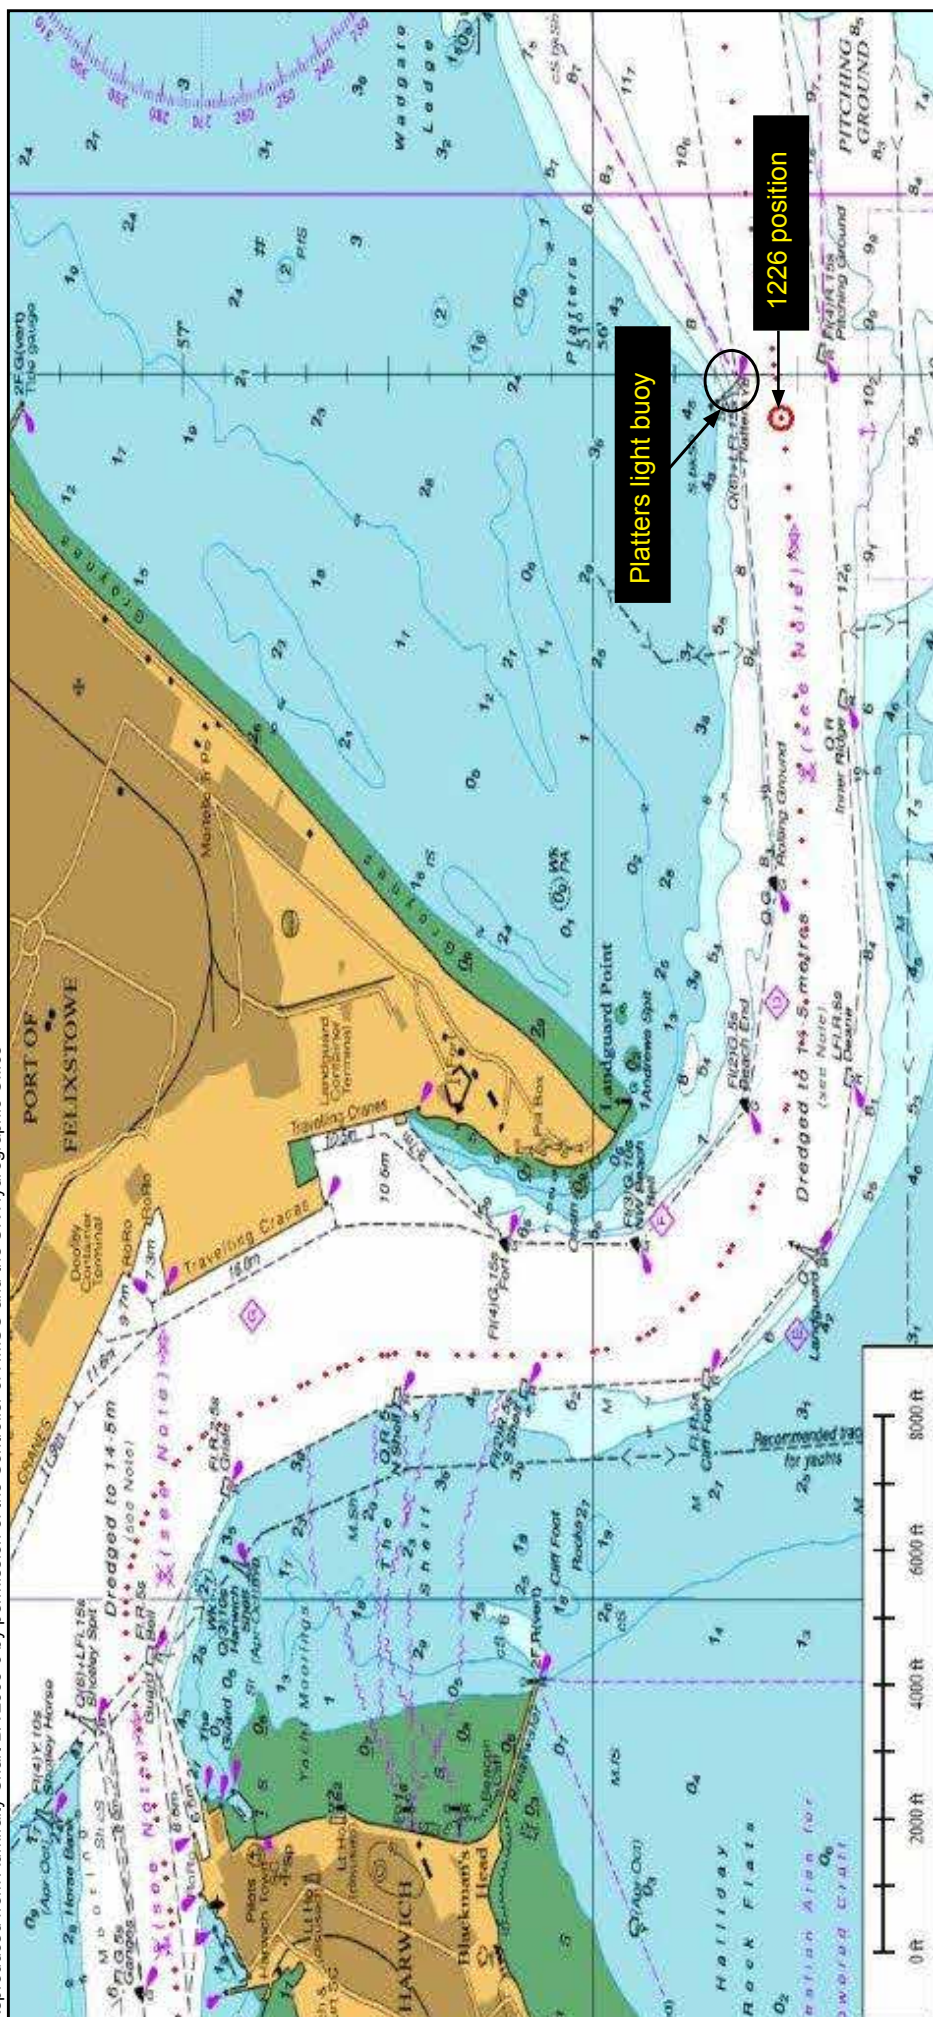
Figure 1: AIS track of Sirena Seaways

At about 1226, as the vessel passed the Platters light buoy (**Figure 1**), the vessel's speed was reduced to 13kts, equivalent to a setting of about 63% on the CPP system. The master noticed that the bridge central console (**Figure 2**) indicator lights had not been returned to full brightness after being dimmed during the hours of darkness. While he rapidly pressed the console 'lights up' button, he complained about it to the chief officer (the OOW<sup>4</sup>) because a similar problem had led to a 'near-miss' incident about 7 months earlier. Less than 10 minutes later, *Sirena Seaways* came abreast of berths 8 and 9 FSR<sup>5</sup> deep water container terminal. As a very large container vessel was alongside, *Sirena Seaways*'s speed was further reduced to 11kts<sup>6</sup> and the master positioned the vessel close to the western side of the fairway.

The senior officers had completed the approach to Harwich many times without any accidents or incidents occurring. Although the vessel's speed was higher than the 8kts specified in Harwich Haven Authority's General Directions, due to the challenging wind conditions and ebb tide, the bridge team was experienced and the vessel was operating within its capabilities.

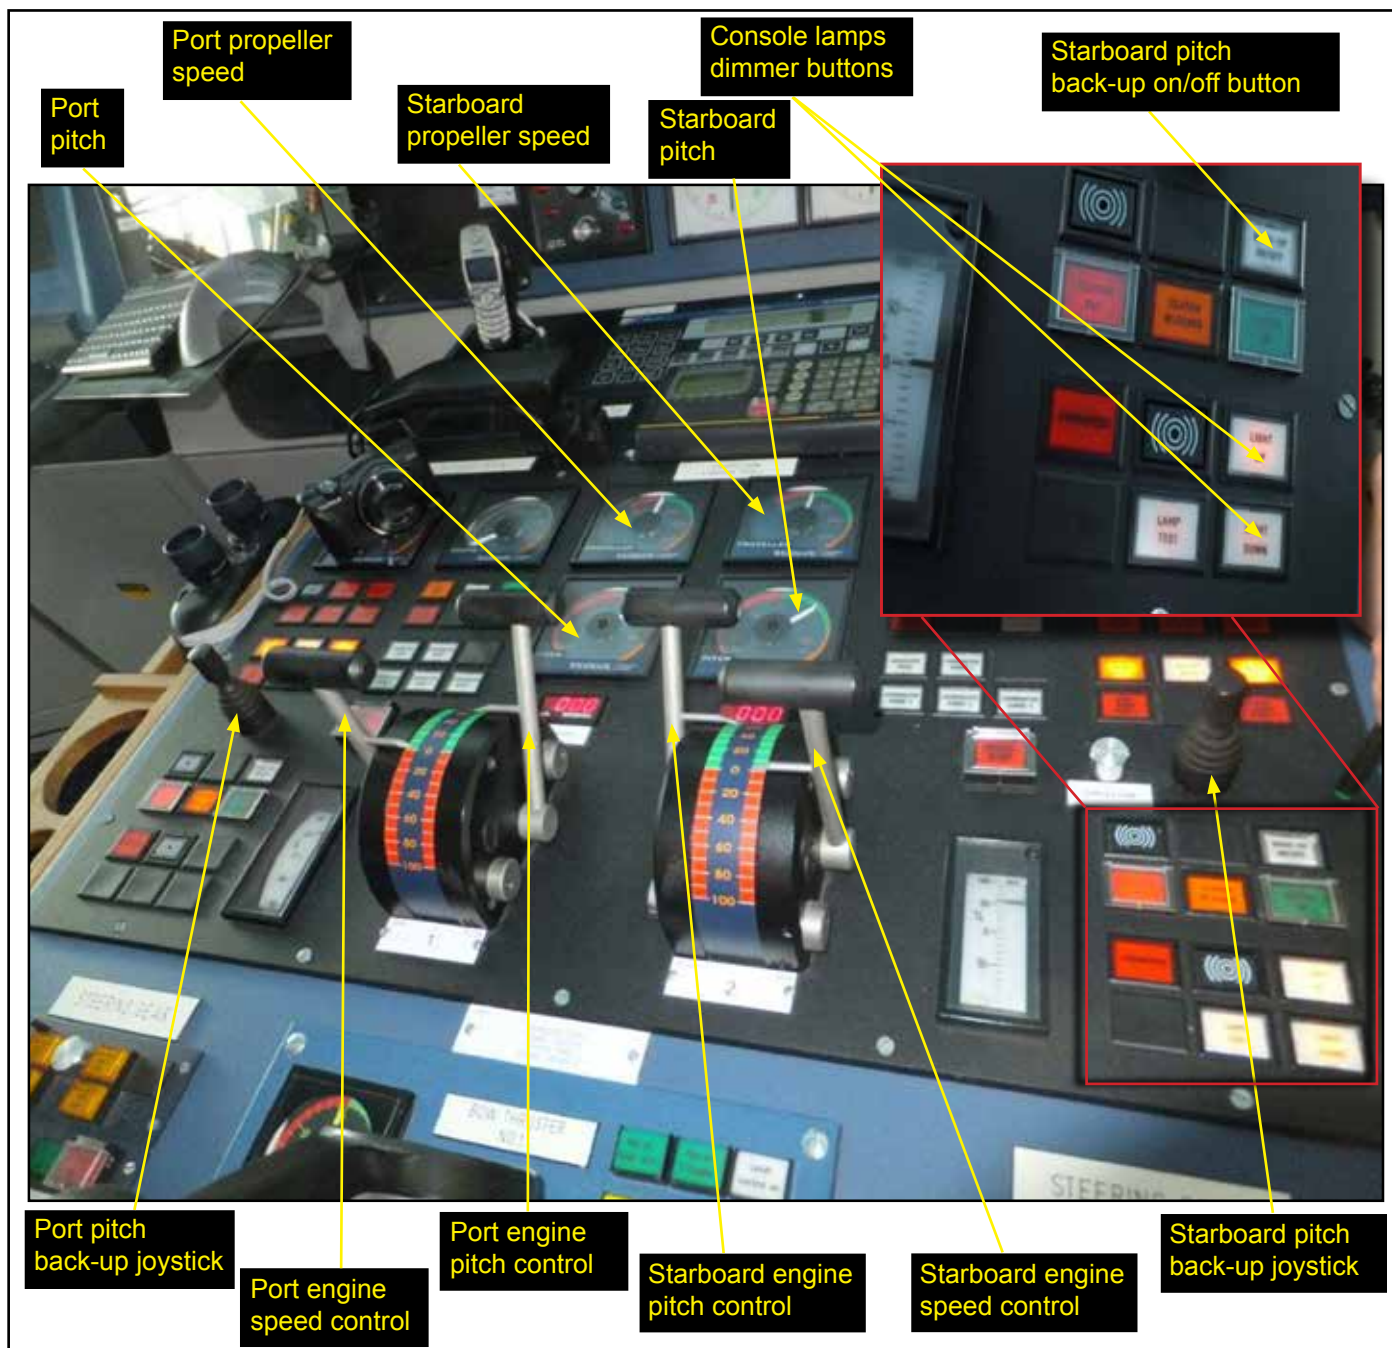
**Figure 2:** Bridge centre console

The electrician found that the starboard CPP back-up control button on the bridge centre console was lit (**Figure 2**). He depressed the button and the light extinguished. He informed the chief engineer, and control of the starboard main engine (SME) was transferred to the ECR. At 1450, the SME was re-started from the ECR and pitch control was tested ahead and astern satisfactorily; control of the SME was then passed back to the bridge.

System records showed that the starboard CPP back-up control button was pressed during the entry into the port. The ship's electrician later deactivated it when he was sent to the bridge while attempts were being made to tow *Sirena Seaways* off the berth. Once activated, the starboard CPP back-up control system bypassed any subsequent attempts to control the starboard CPP with the combinator levers on either the centre or wing consoles. The starboard CPP remained set at its last order, at about 63% ahead.

The starboard CPP back-up control button was positioned closely to the 'lights up' button and it was not fitted with a protective cover. Given the time at which it was activated, it was most likely that it was pressed inadvertently as the brightness of the centre console indicator lamps was increased.

- Carried out an investigation of the accident and circulated the resulting report and recommendations throughout its fleet to share the lessons learned.
- Fitted protective covers to prevent inadvertent operation of the CPP back-up control buttons.
- Ensured that operation of the CPP back-up control system is fully understood by the bridge officers and included its periodic testing in the planned maintenance system.
- Raised awareness within the company of the importance of good bridge procedures and the potential for complacency to develop.
- Ensured that propulsion transfers between control stations are positively cross-checked and pitch control checks are conducted.
- Carried out a review and update of its pre-arrival and pre-departure checklists and procedures.
- Modified the bridge wing console indicator lamps to improve clarity
- Conducted an ISM audit of the vessel.

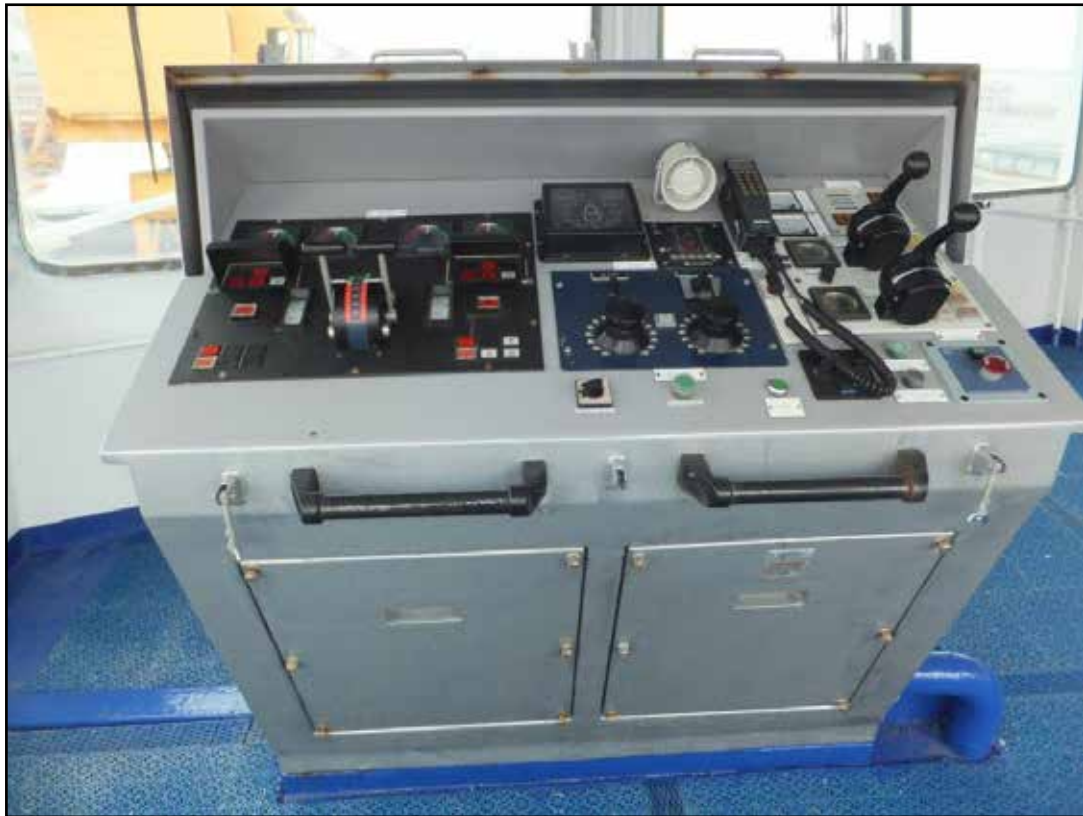
**Figure 3:** Port bridge wing console

At about 1251, the master went to the port bridge wing console (**Figure 3**) and took control of both the CPPs, the bow thrusters (BTs) and the helm from the central console. The port and starboard CPP indicator lamps and a bright white lamp adjacent to the CPP combinator levers illuminated to indicate that the port wing console had control of the propulsion. The master then informed the chief officer and helmsman that he had transferred control of the vessel to the port bridge wing. The sun was shining through the bridge windows and the master did not notice any other indicator lights on the port bridge wing console. Subsequent tests showed that a faint red light on the bridge wing console glowed when the starboard CPP back-up control system was engaged (**Figure 4**).

- The design of the propulsion control indicators on the bridge wing consoles, and the subsequent modification, allowed both the in-command lights and the back-up lights to be lit simultaneously even though the back-up system was in control.

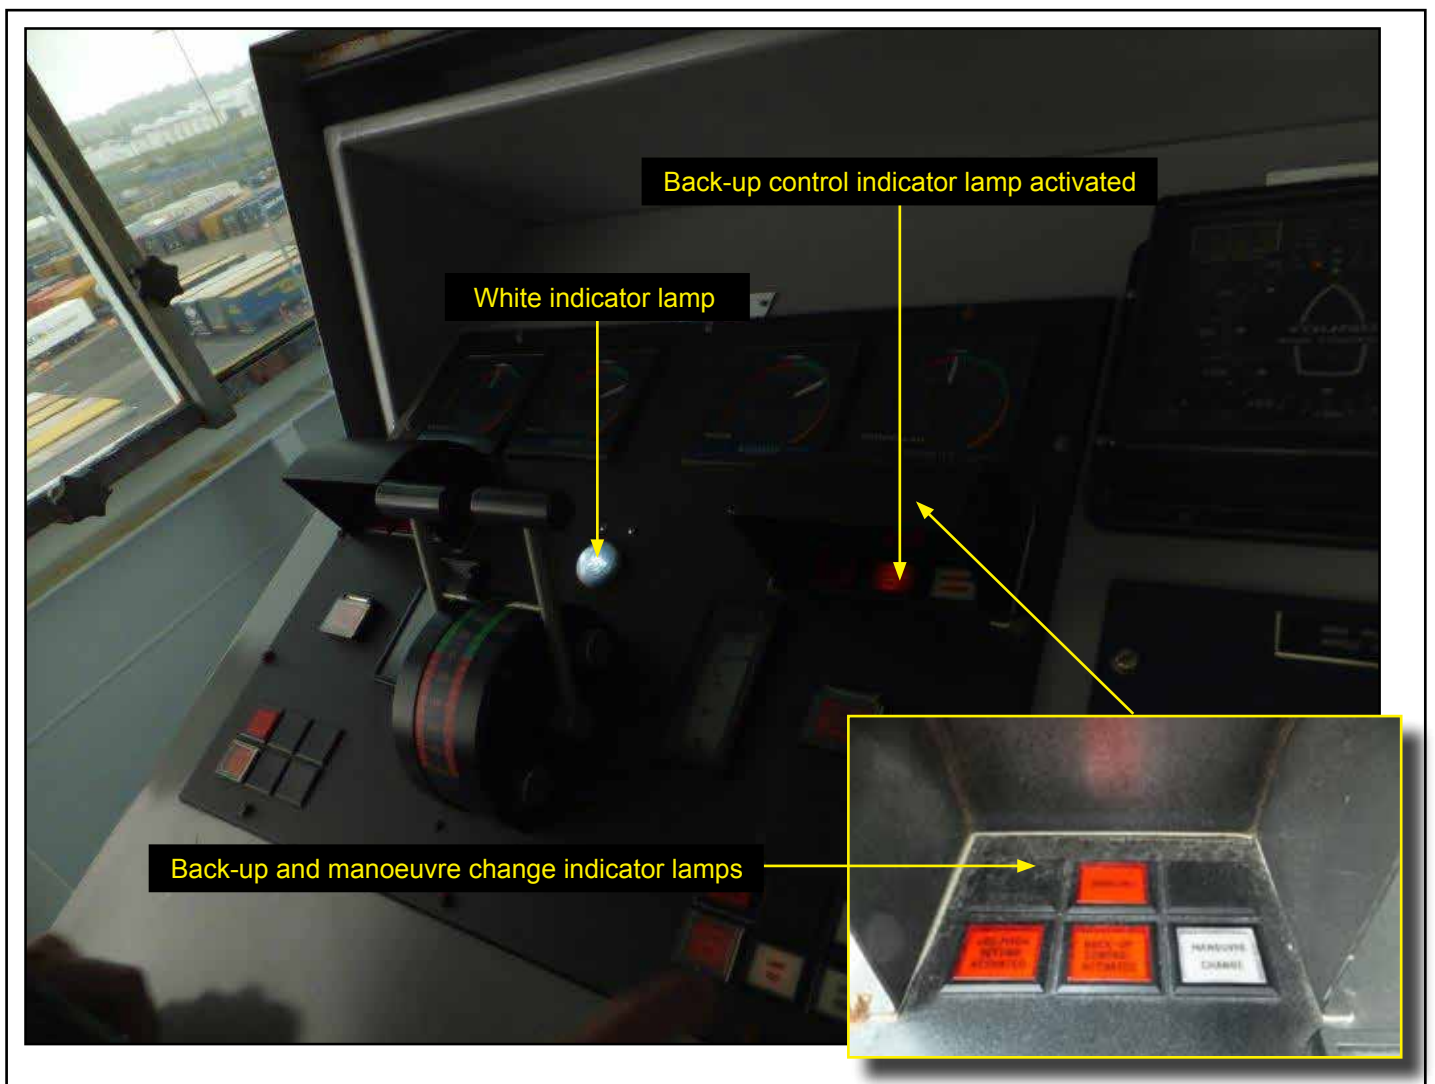
**Figure 4:** Comparative brightness of bridge wing console indicator lights

The transfer of pitch control from the bridge centre to a bridge wing console was achieved by operating the 'manoeuvre change' button at the wing console (**Figure 4**). The combinator lever was then adjusted to match the pitch setting on the centre console combinator. Once the two combinator levers were aligned, the computer transferred control and the wing console 'manoeuvre change' lamp was lit. This occurred regardless of whether the back-up system was engaged or not, and so could present a false impression that control of the CPP had been passed to the wing console.

This mistake was partly disguised by the modifications carried out after the accident in Esbjerg in 2008, which were intended to prevent misunderstandings over which console had control of the propulsion systems. However, the new bright white 'in-command' lamp simply affirmed that combinator lever control had been passed between consoles; it did not confirm that the combinator levers actually had control of the CPP, and it was lit regardless of whether the back-up control system was active.

Both the original design and the subsequent modification on the bridge wing consoles provided a false sense of security to the operator. This was made more likely in bright sunlight when it was harder to see the glow of the back-up control lamp on the bridge wing console. The only method of checking CPP control was to monitor the indicators to see that the power output from each shaft corresponded with the order given.

- The glow from the back-up indicator lamp on the bridge wing console was insufficient for it to be noticed by the bridge team.
- The design of the bridge consoles pre-dated changes in SOLAS Chapter V which required improved ergonomics on bridge control systems.

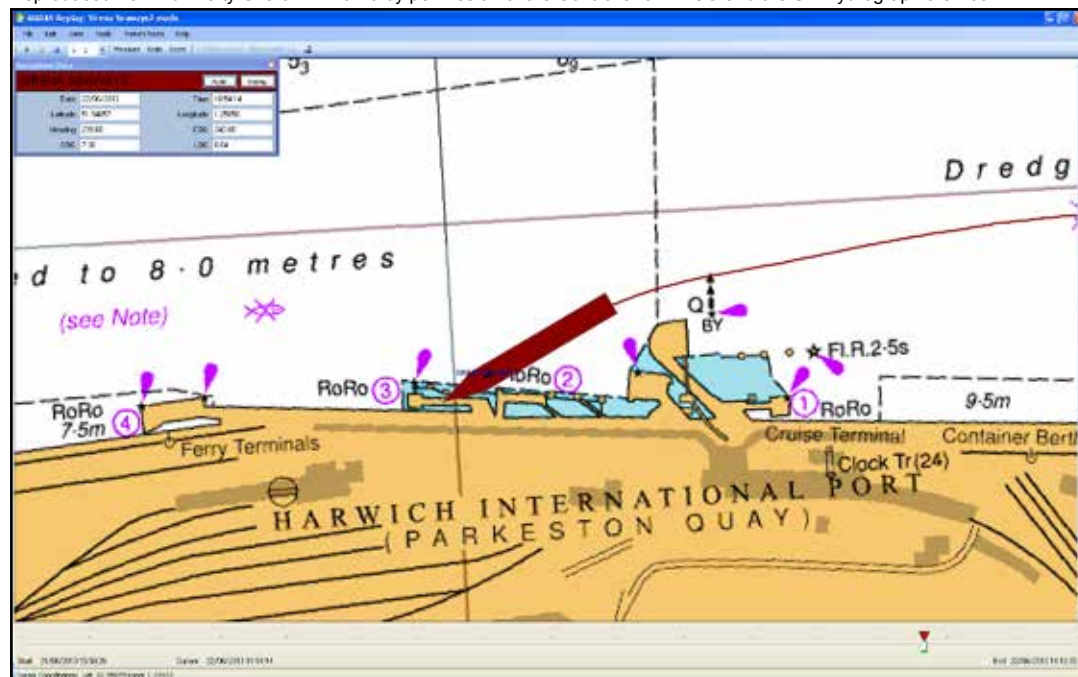
Figure 5: Vessel contact with berth 3

At 1254, at a speed of about 7.5kts, *Sirena Seaways* made heavy contact with berth No.3. The vessel hit and rode over one mooring tower, causing an adjoining walkway to collapse. Another mooring tower was pushed over and the vehicle loading linkspan was lifted off its supports as *Sirena Seaways* carried on until its bow made heavy contact with the concrete berth (**Figure 5**). The linkspan's western end was pushed on to the quay (**Figure 6**) while the eastern end collapsed into the water, where it came to rest on *Sirena Seaways's* bulbous bow. Almost immediately, the bilge alarms for No 2 BT space sounded, and the chief engineer stopped the BT remotely from the ECR.

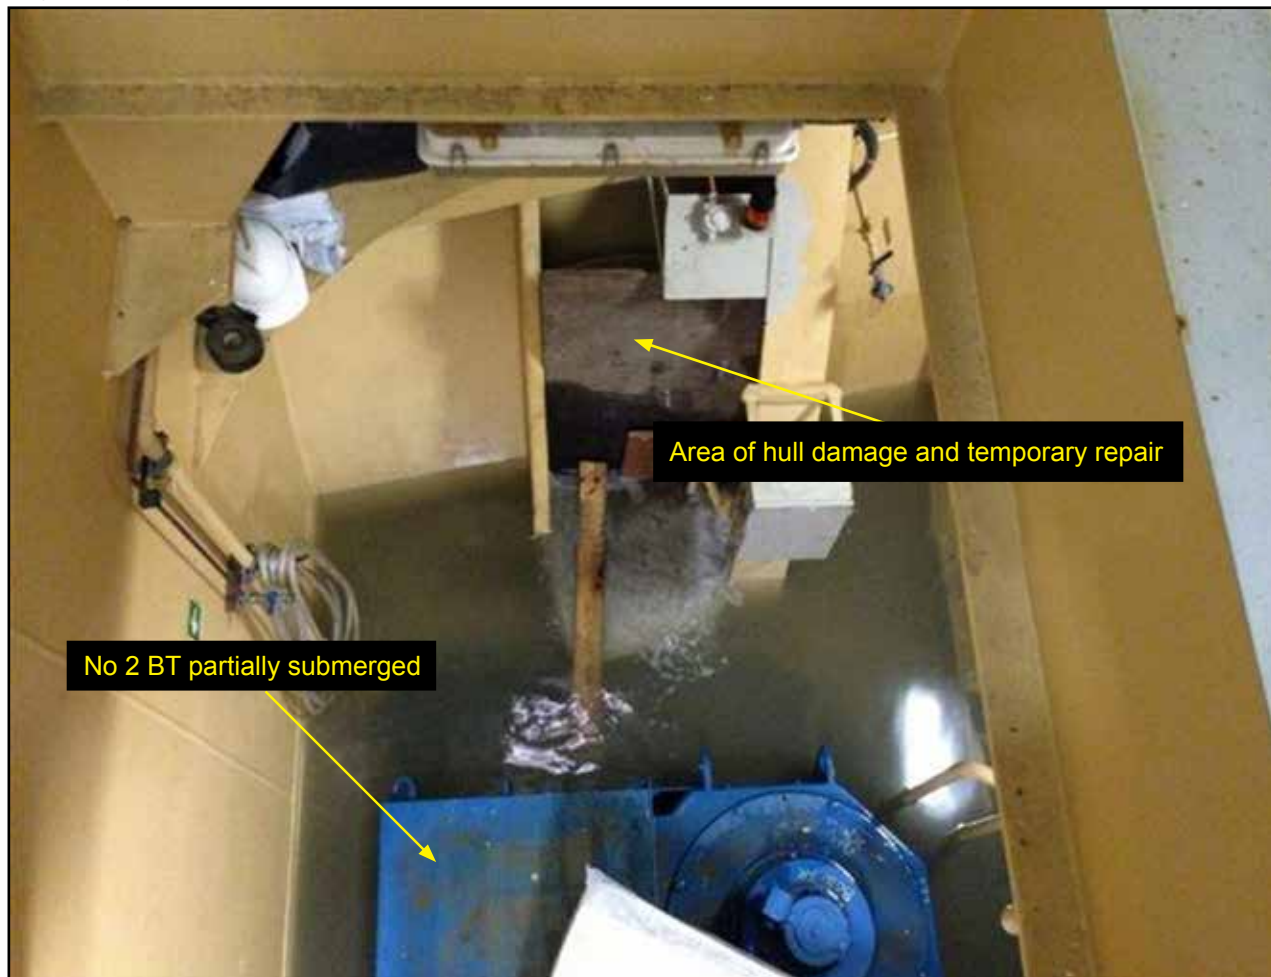
**Figure 7:** No 2 bow thruster partially submerged

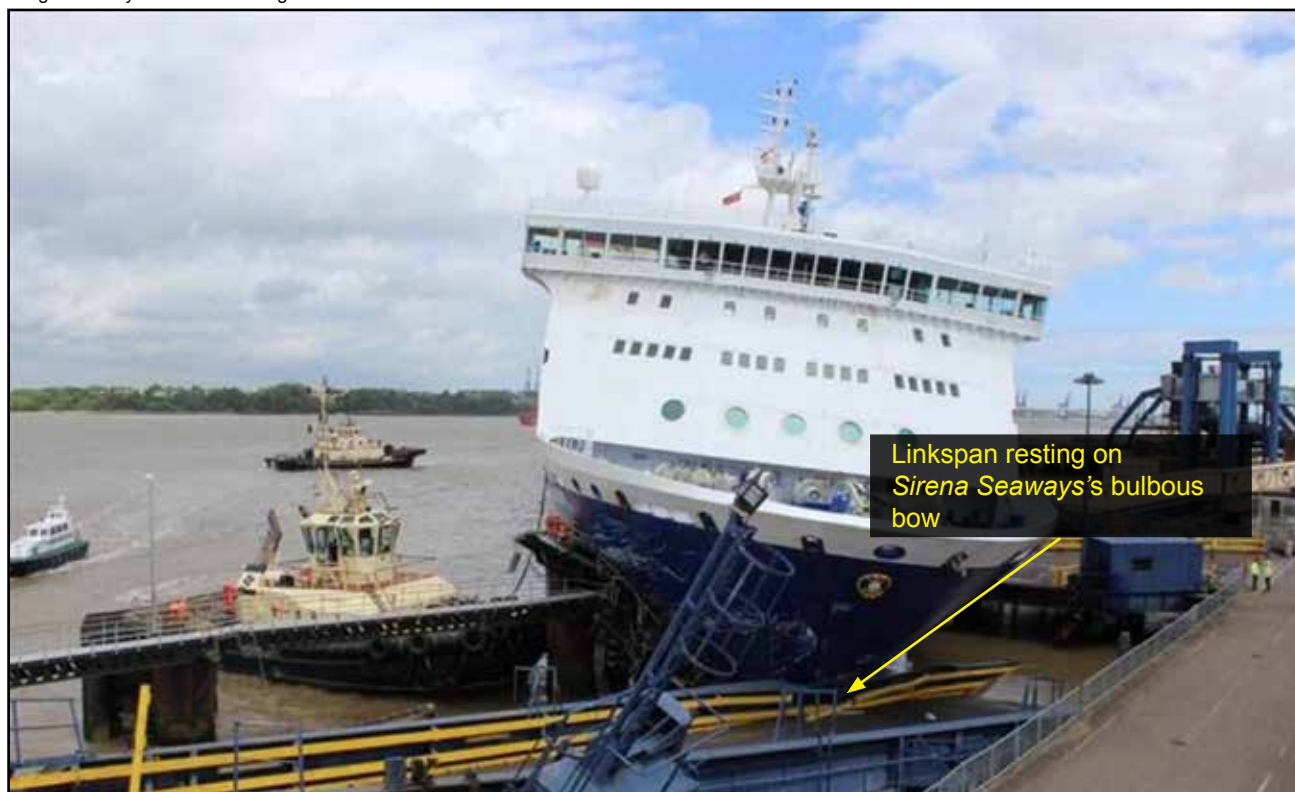
**Figure 8:** Aftermath of contact with berth

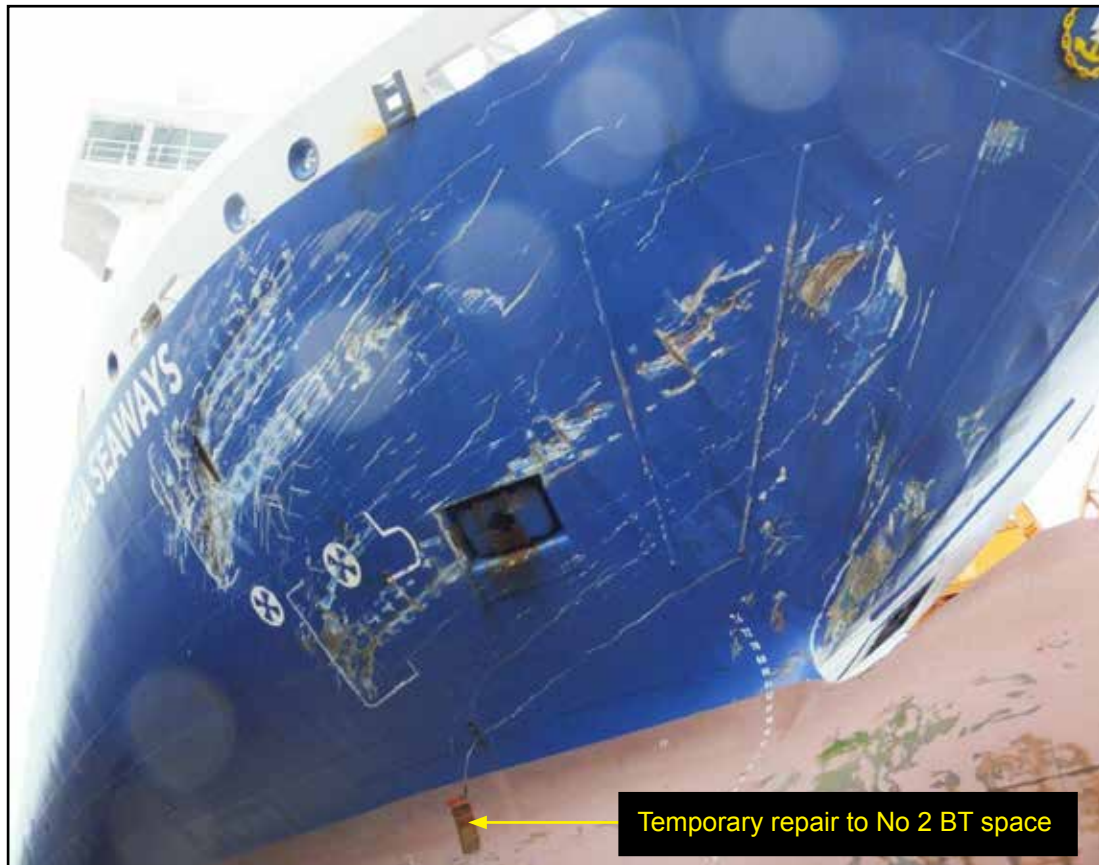
**Figure 9a:** Starboard bow damage

- No warning was given to the passengers and crew (other than the mooring teams) prior to the impact with the linkspan.
- The impact caused multiple hull penetrations, including some below the waterline, and demolished much of the infrastructure at berth 3, Harwich International Port.

*Sirena Seaways* was moved to No 2 berth, and at 1610 the passengers and vehicles commenced disembarking across the stern ramp. At the first opportunity, the police boarded the vessel and breathalysed the master. The result was negative. The following day, *Sirena Seaways* moved across the river to the port of Felixstowe, where temporary repairs were undertaken before the vessel sailed to Bremerhaven for repair (**Figures 9a and 9b**).

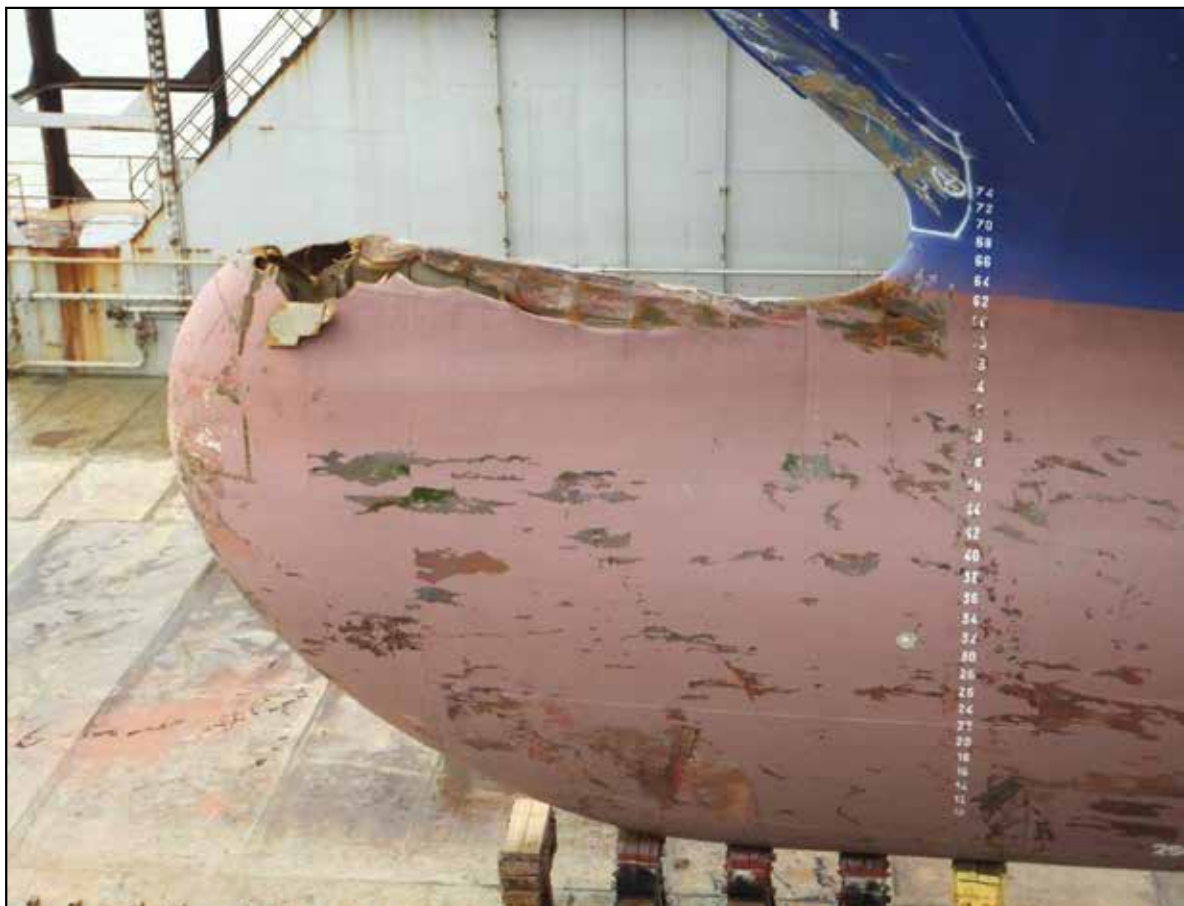
**Figure 9b:** Damage to upper section of bulbous bow
