Report on the investigation into  
the structural failure and foundering  
of the general cargo ship

***Swanland***

Irish Sea

27 November 2011

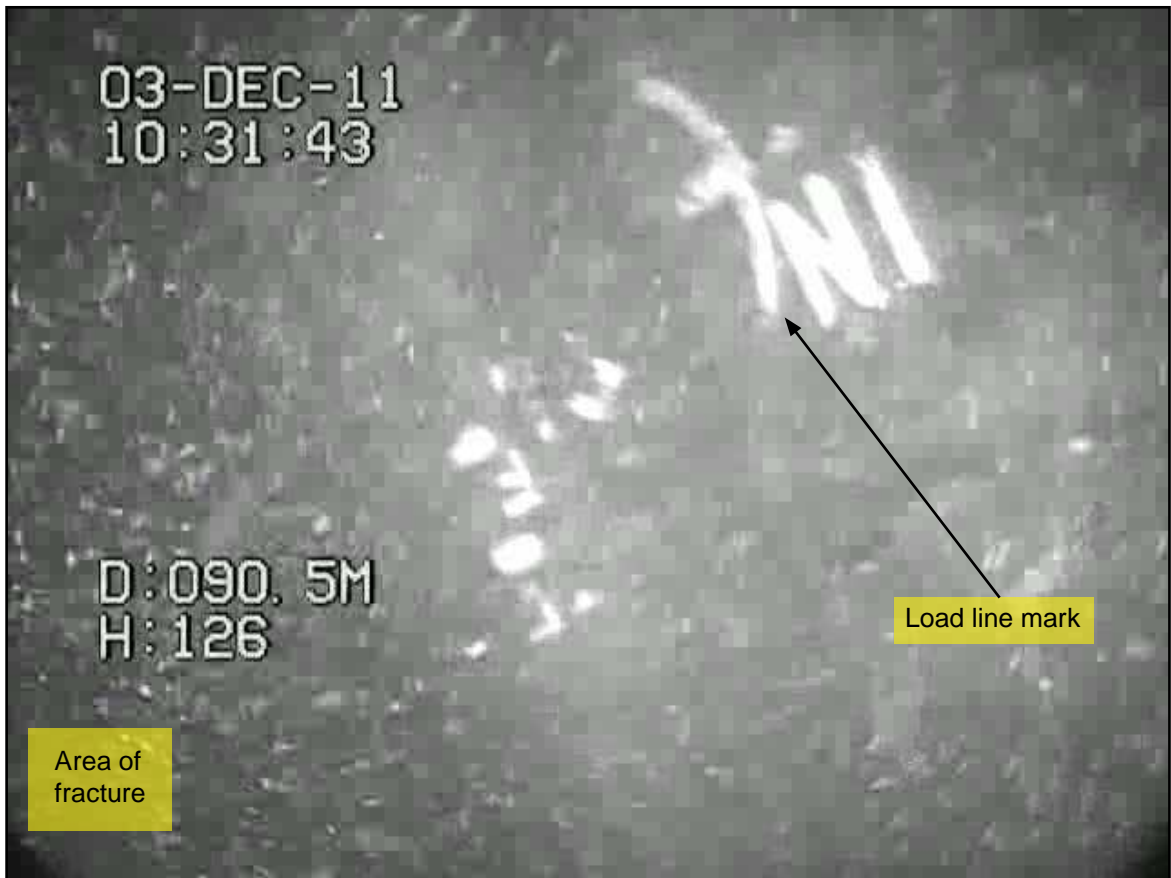
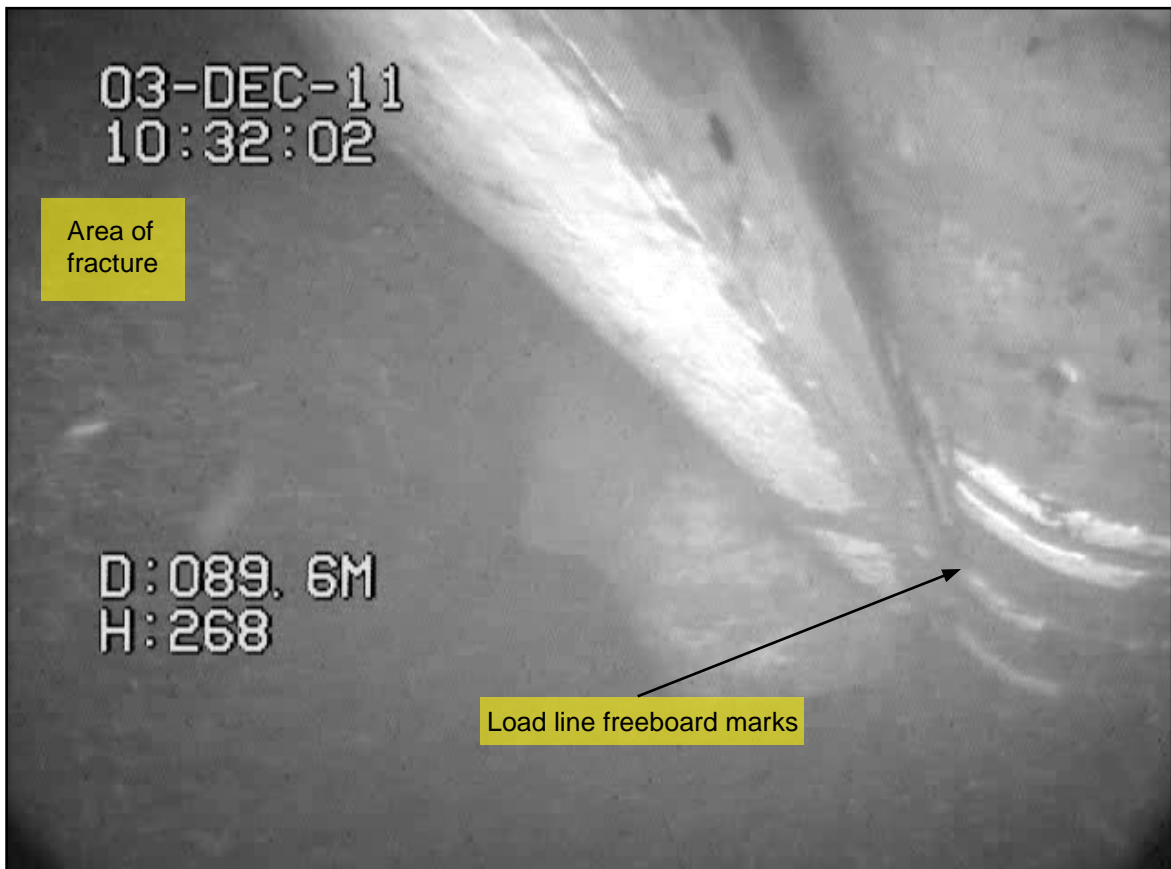
**Figures 13a and 13b:** Stills from MiniROV footage showing the structural failure on starboard side in way of the load line mark (external)

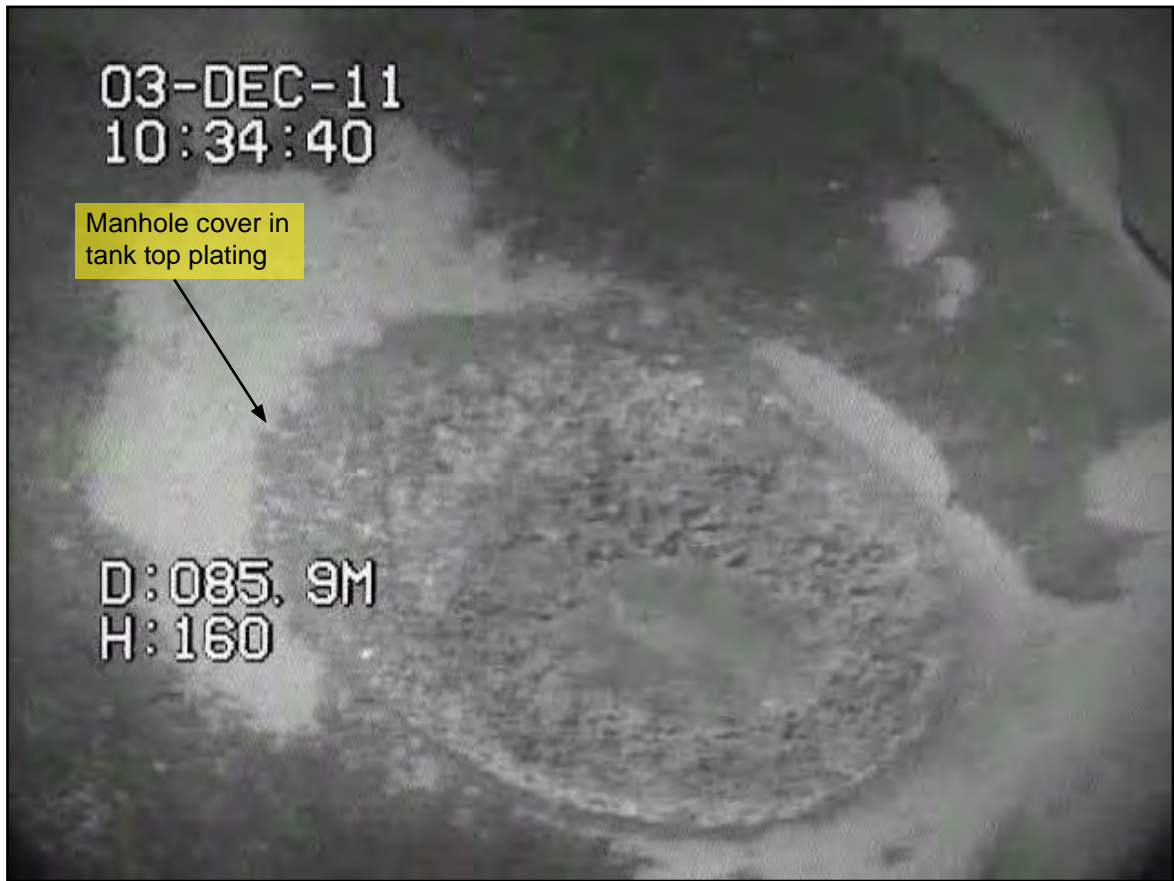
**Figures 14a and 14b:** Stills from MiniROV showing tank top plating inside the cargo hold

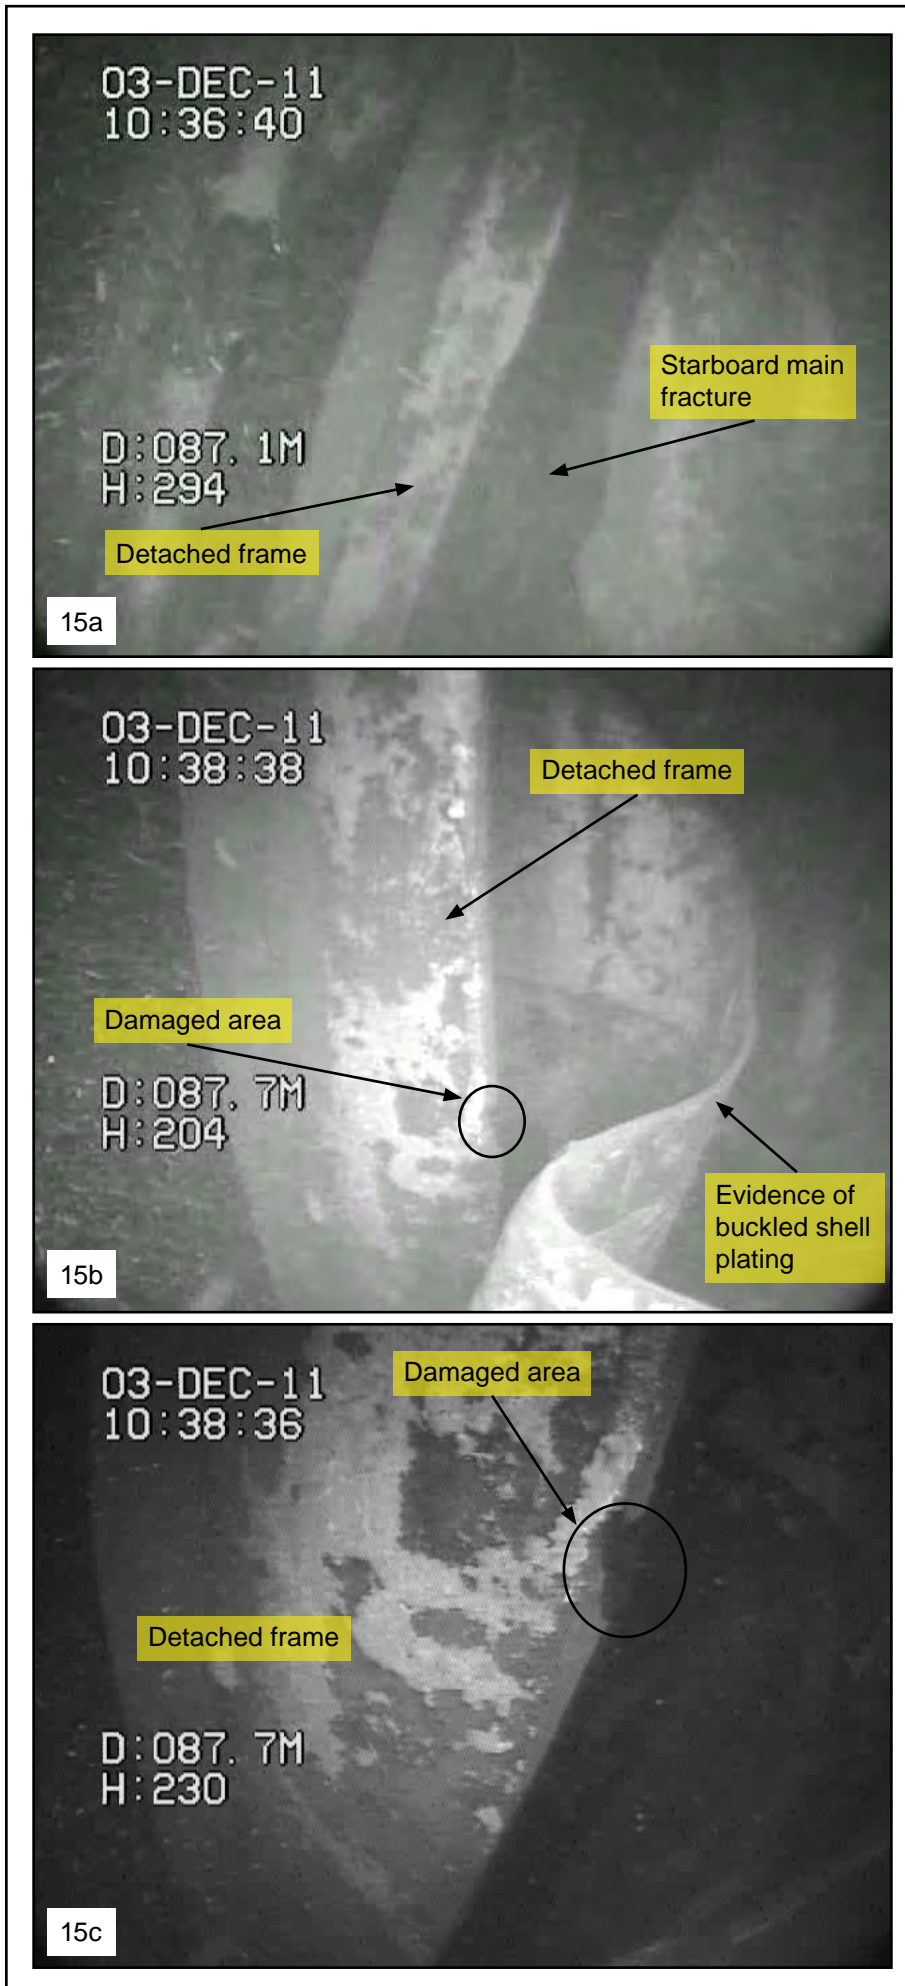
Figures 15a, 15b and 15c: Stills from MiniROV showing the structural failure on starboard side (from inside cargo hold)

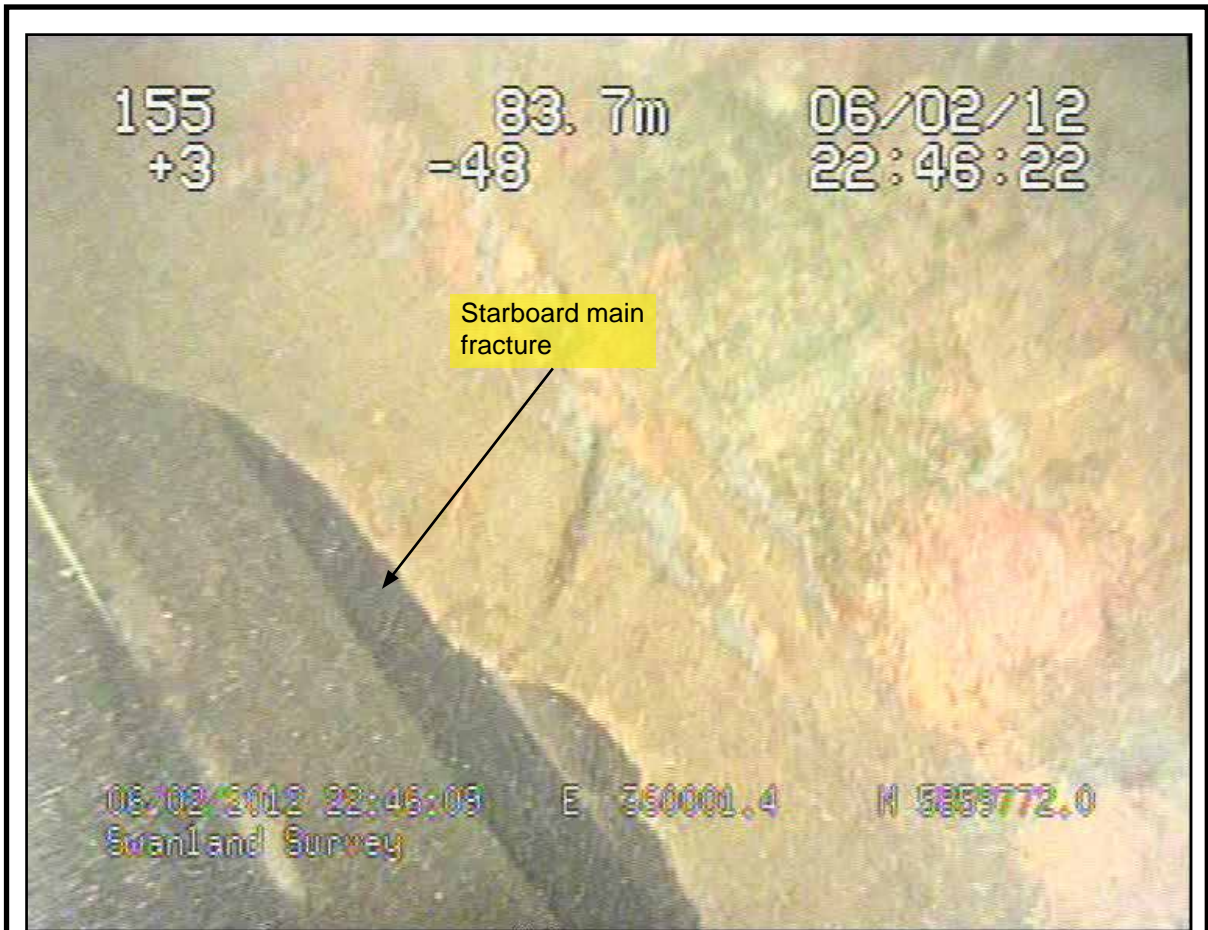
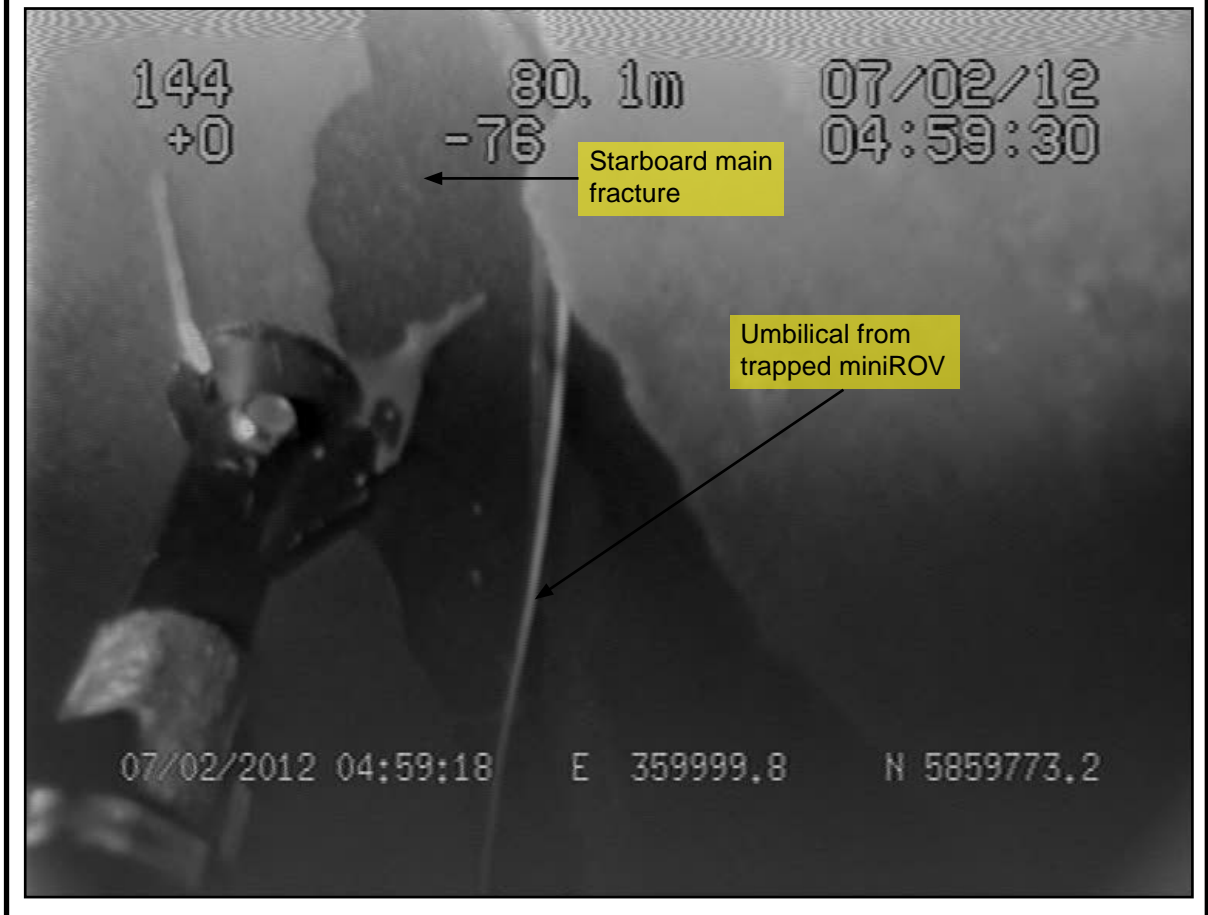
**Figures 18a and 18b:** Stills from ROV footage showing damage close to the starboard load line mark

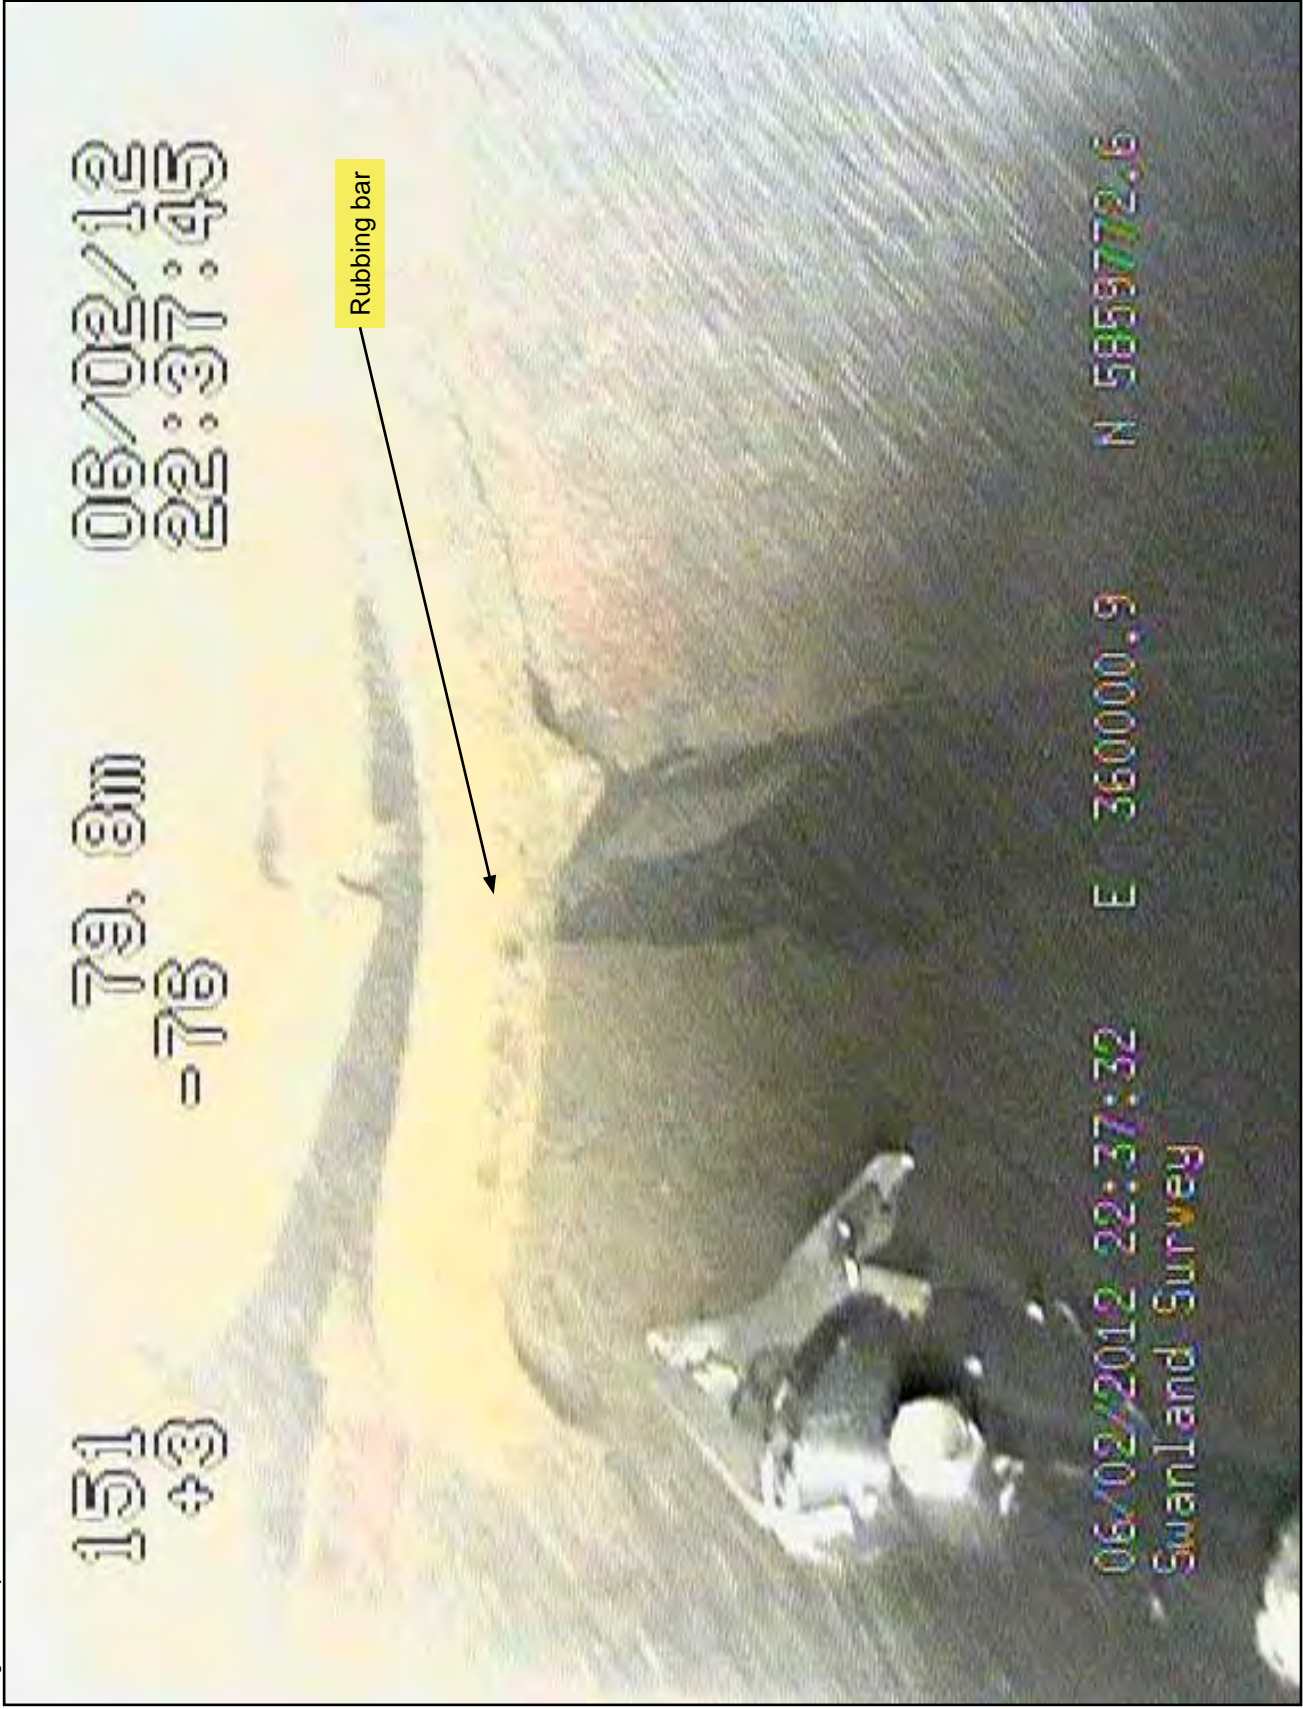
**Figure 20:** Still from ROV footage showing 'V' shaped fracture in way of the rubbing bar above the starboard bilge keel

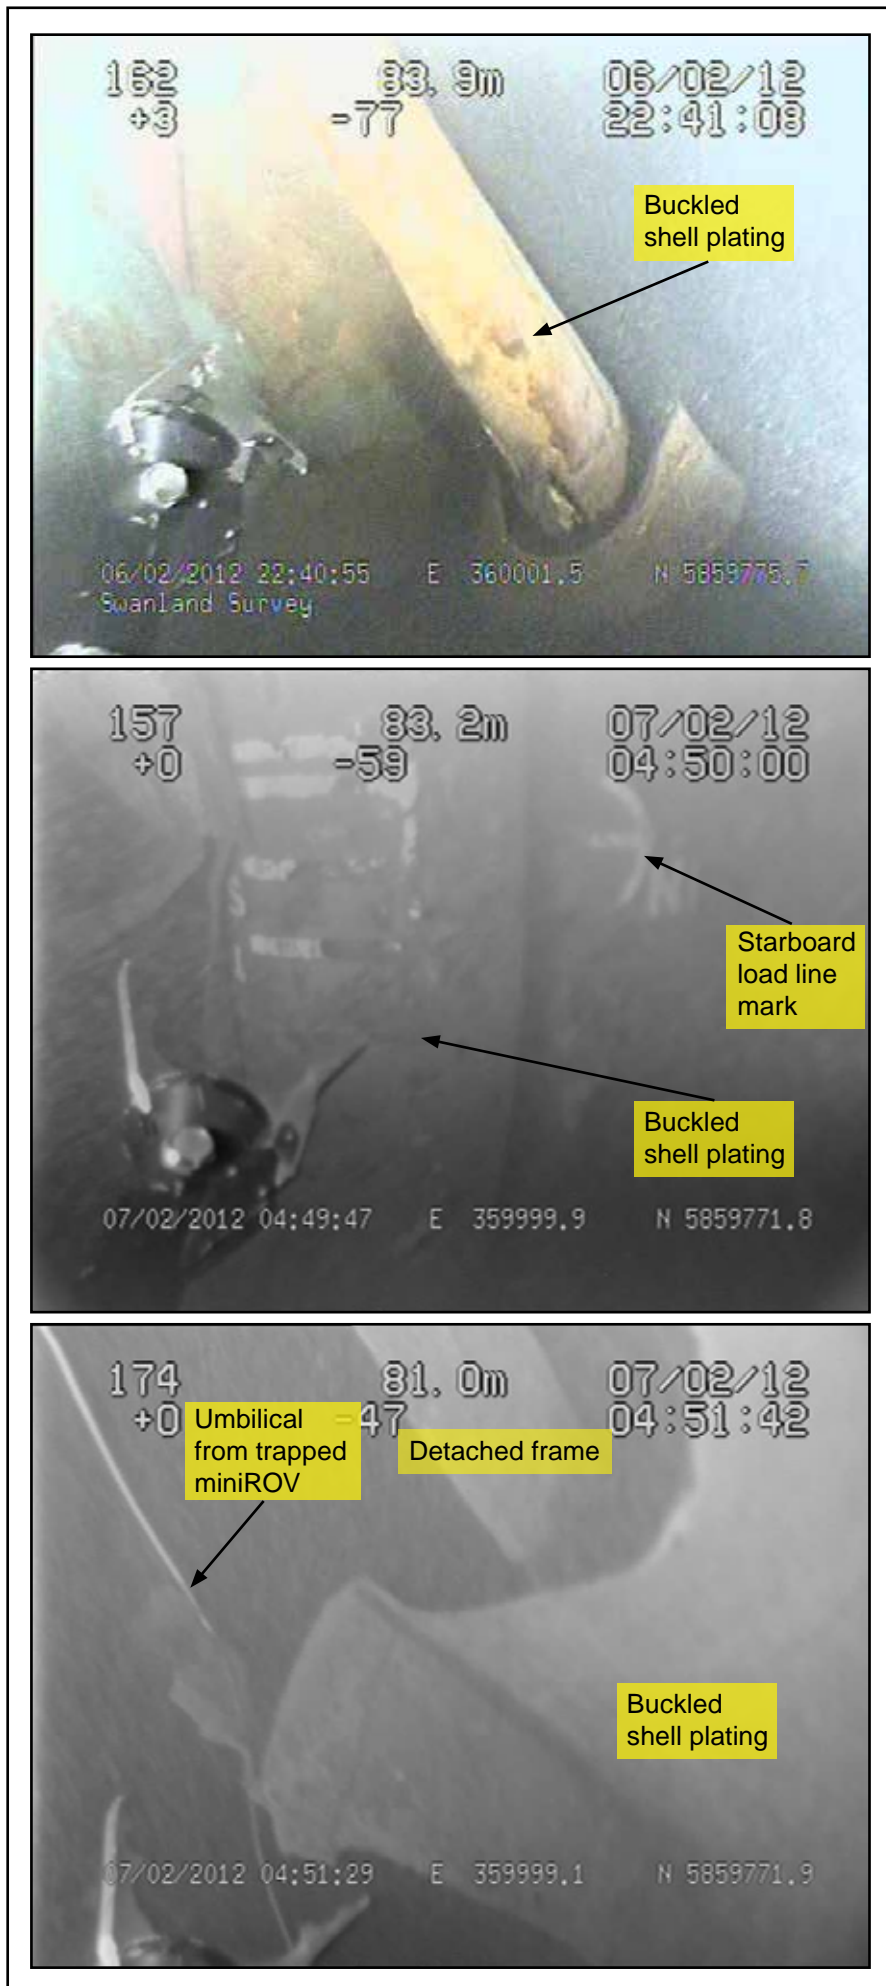
Figures 21a, 21b and 21c: Stills from ROV footage showing folding and buckling close to the starboard load line mark

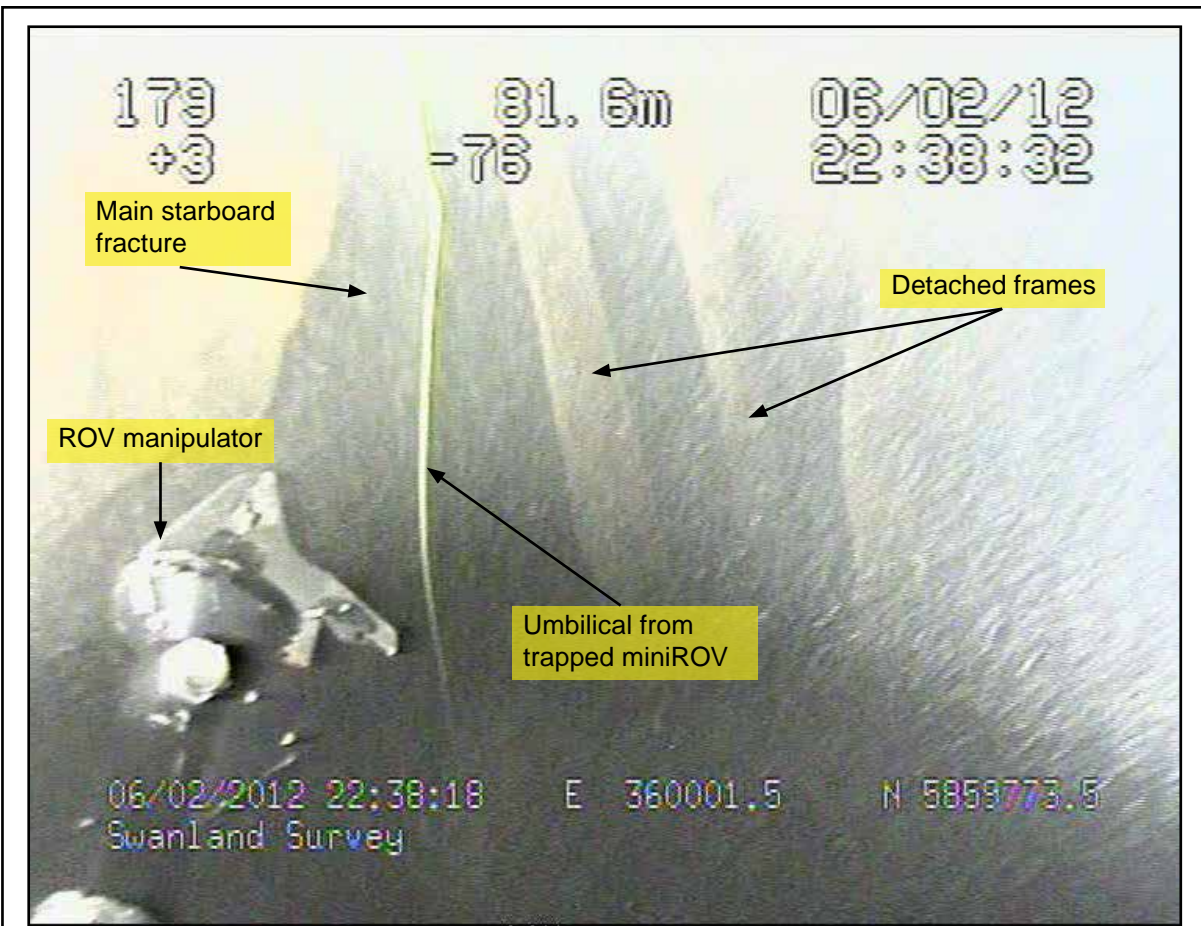
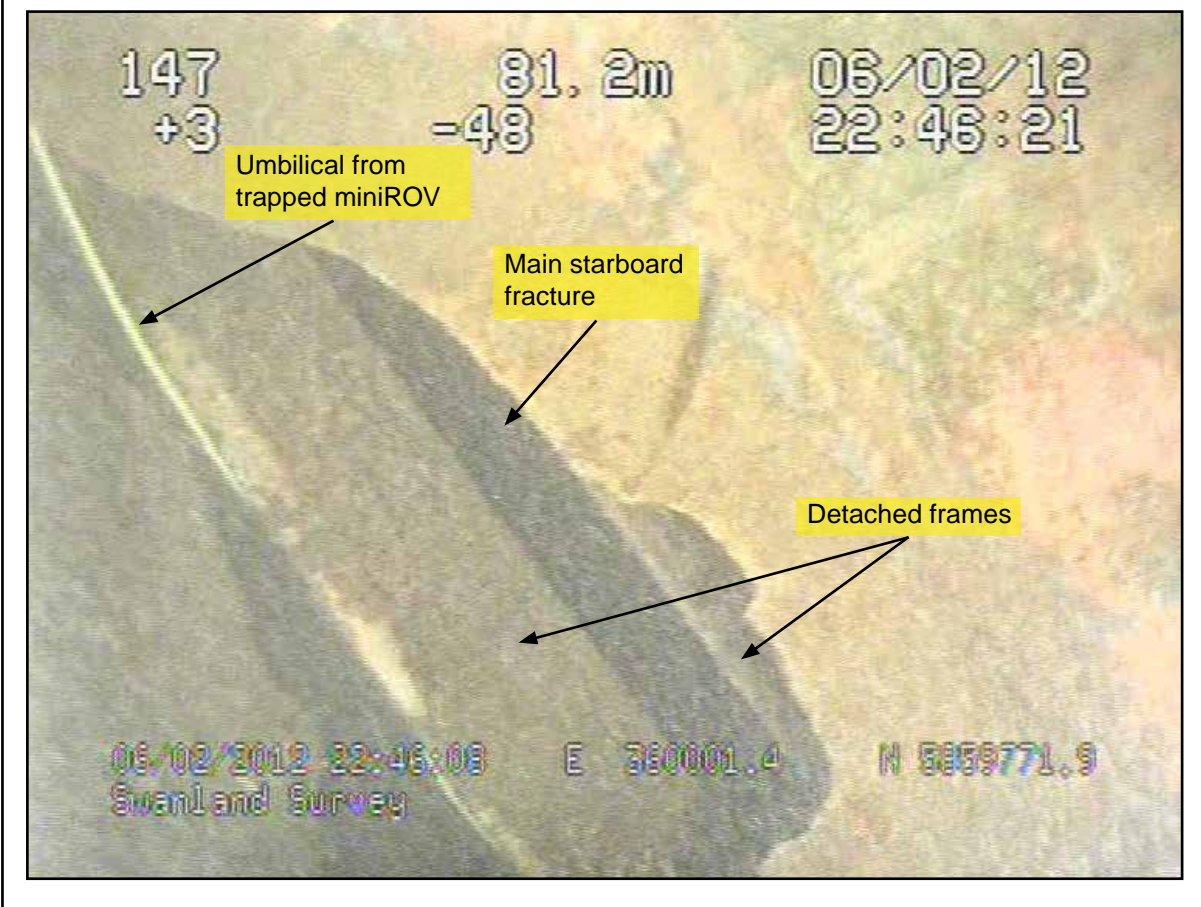
**Figures 22a and 22b:** Stills from ROV footage showing evidence of detached frames in way of main starboard fracture

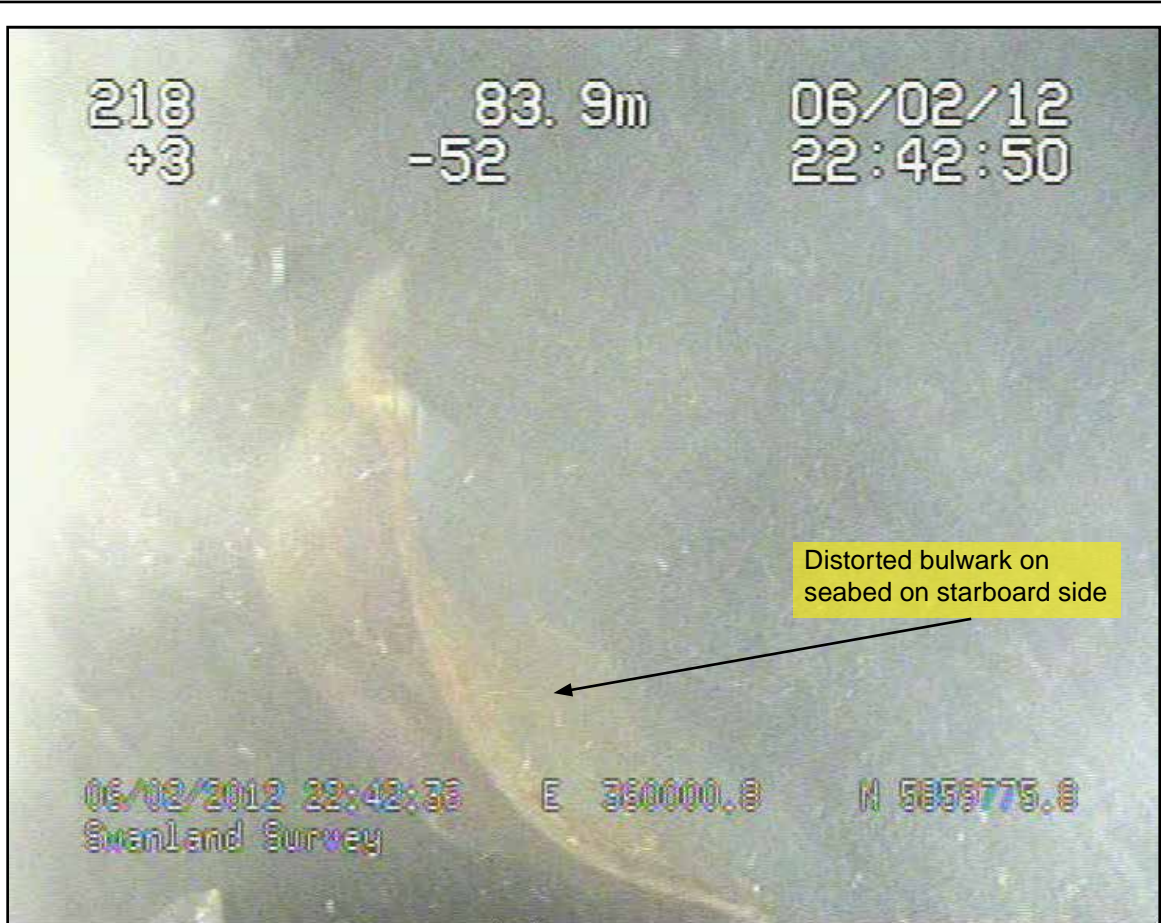
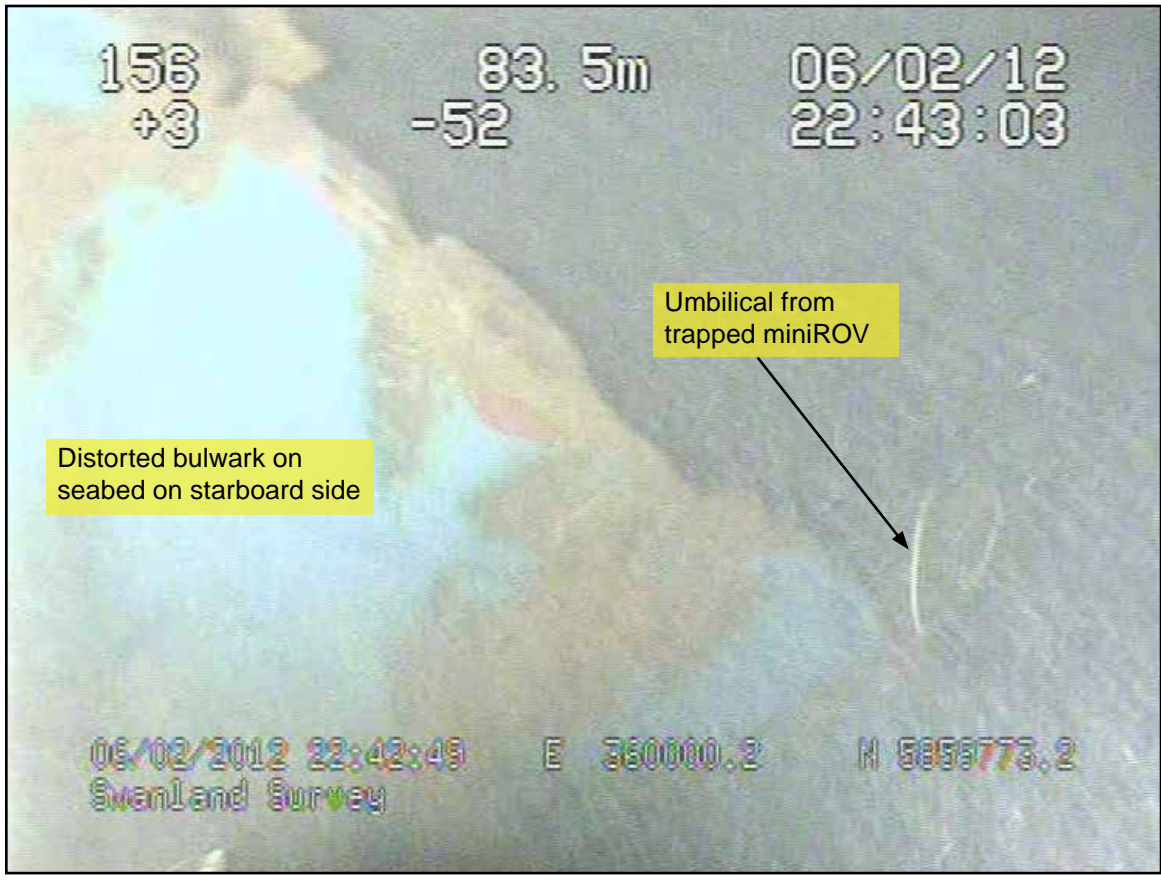
Figures 23a and 23b: Stills from ROV footage showing distorted bulwark on starboard side

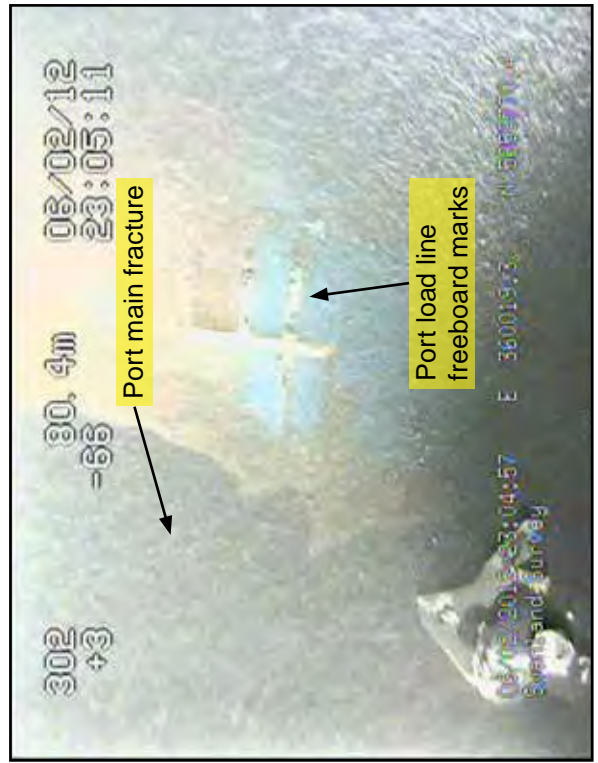
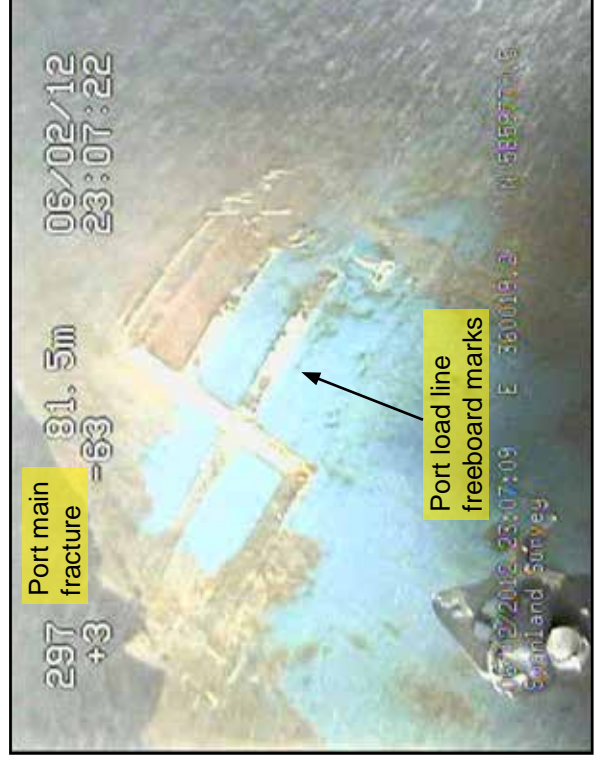
Figures 24a, 24b, 24c and 24d: Stills from ROV footage showing damage near to the port load line mark

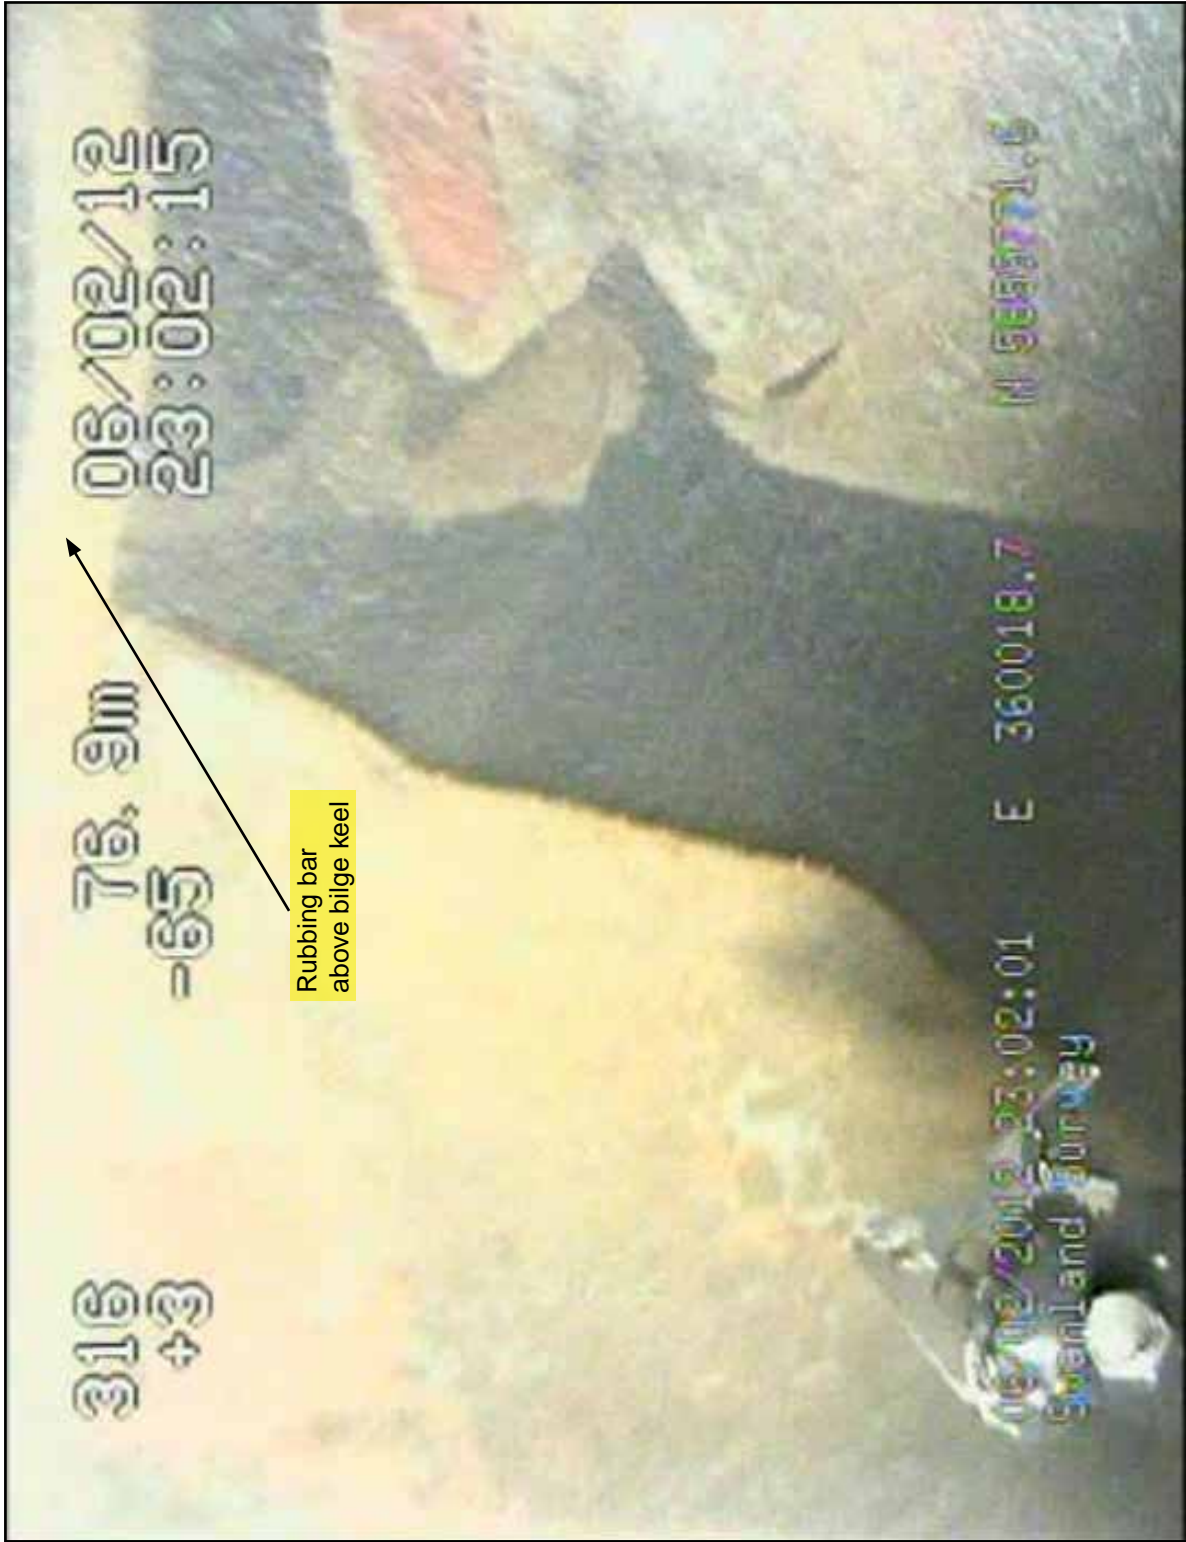
Figure 25: Still from ROV footage showing 'V' shaped fracture in way of the rubbing bar above the port bilge keel

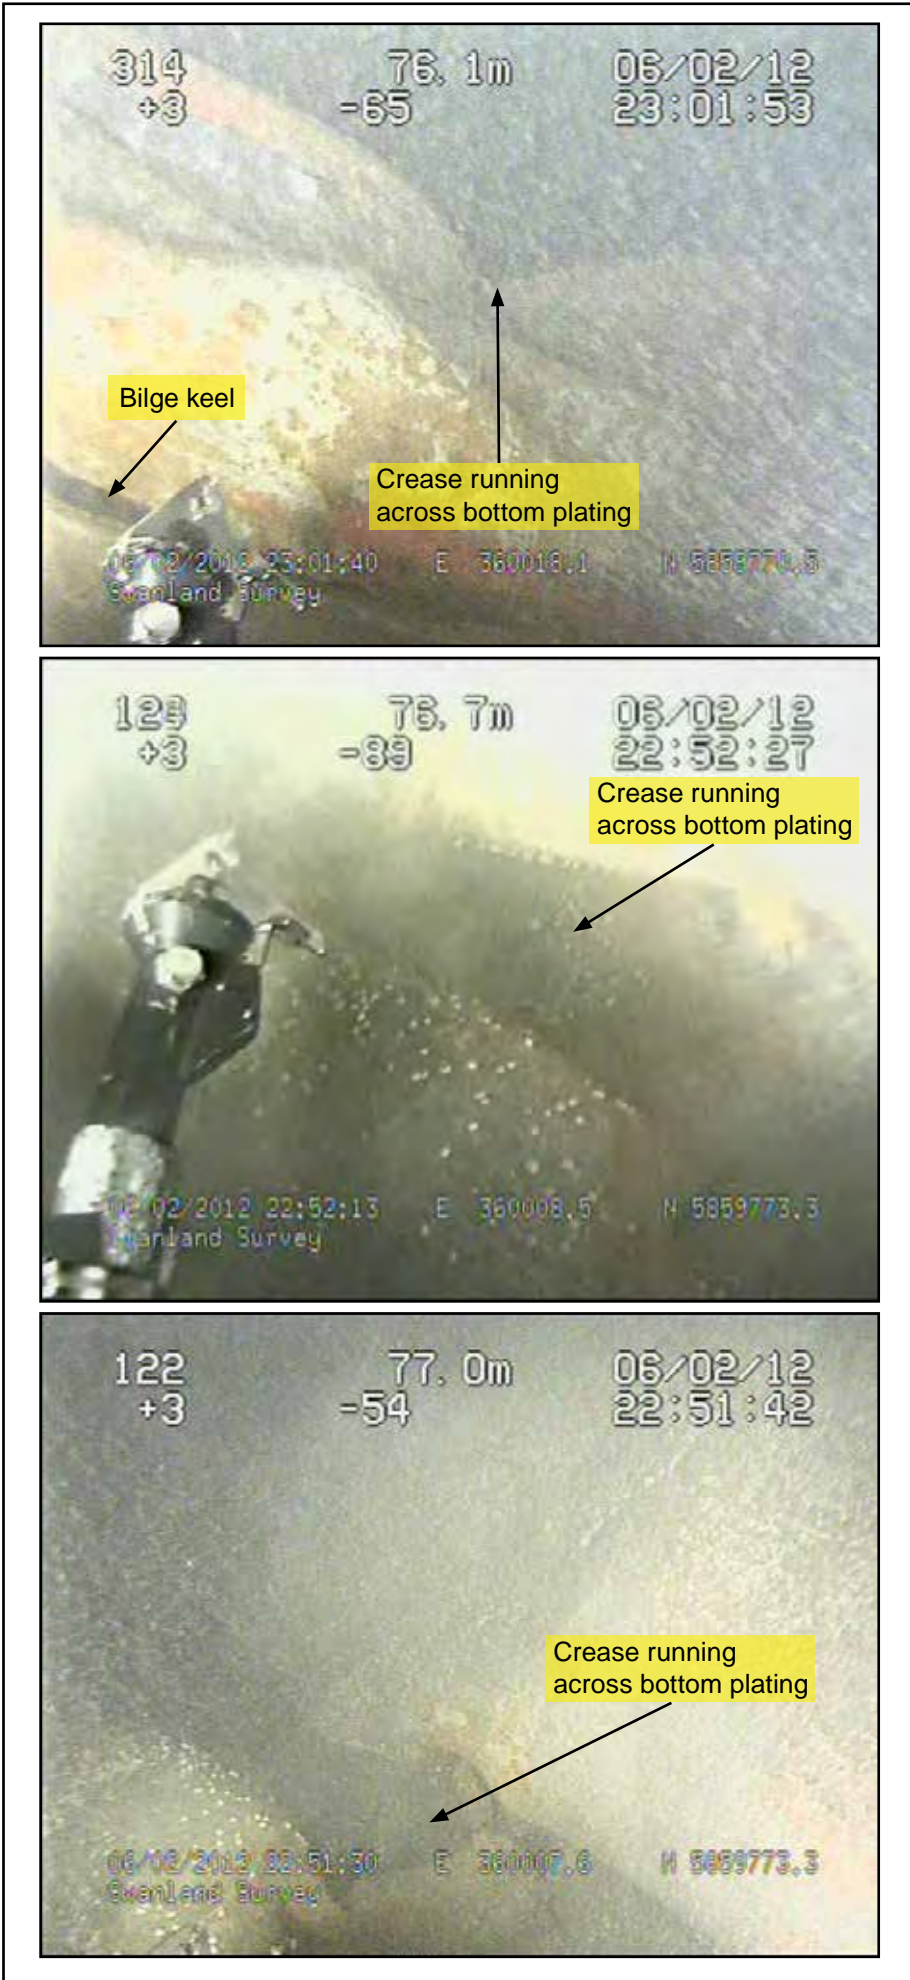
Figures 26a and 26b: Stills from ROV footage showing crease running across *Swanland's* bottom between the side fractures

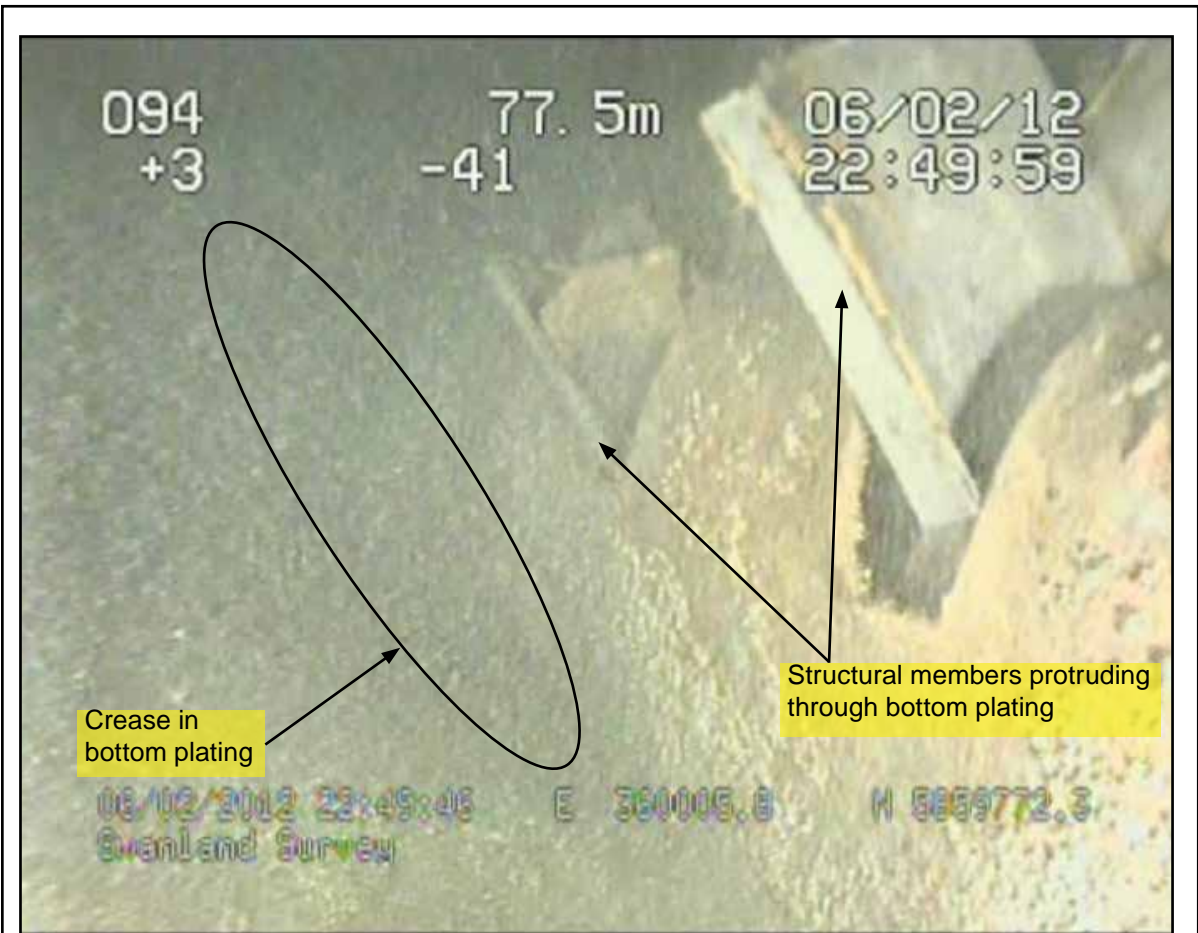
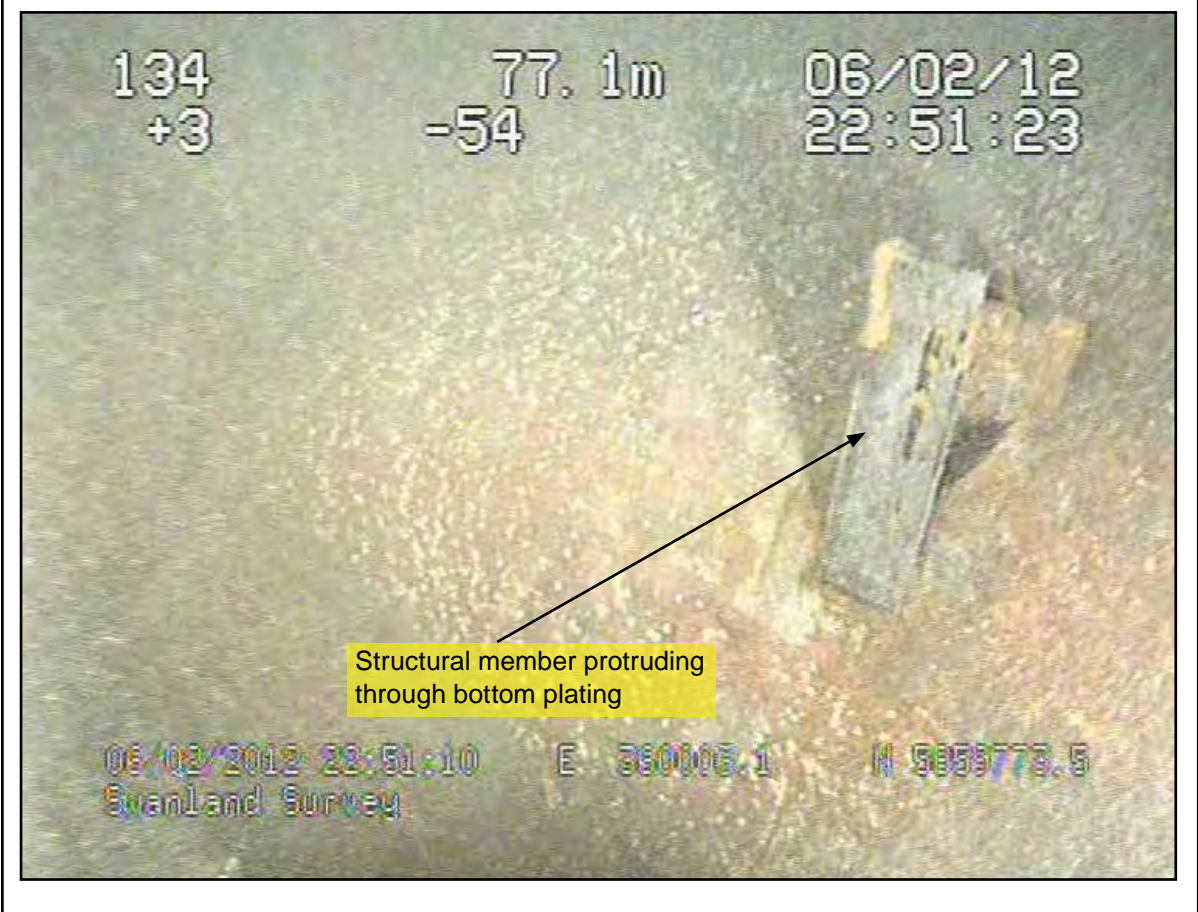
**Figures 27a and 27b:** Stills from ROV footage showing structural members protruding through *Swanland's* bottom plating
