Report on the investigation into  
the structural failure and foundering  
of the general cargo ship

***Swanland***

Irish Sea

27 November 2011

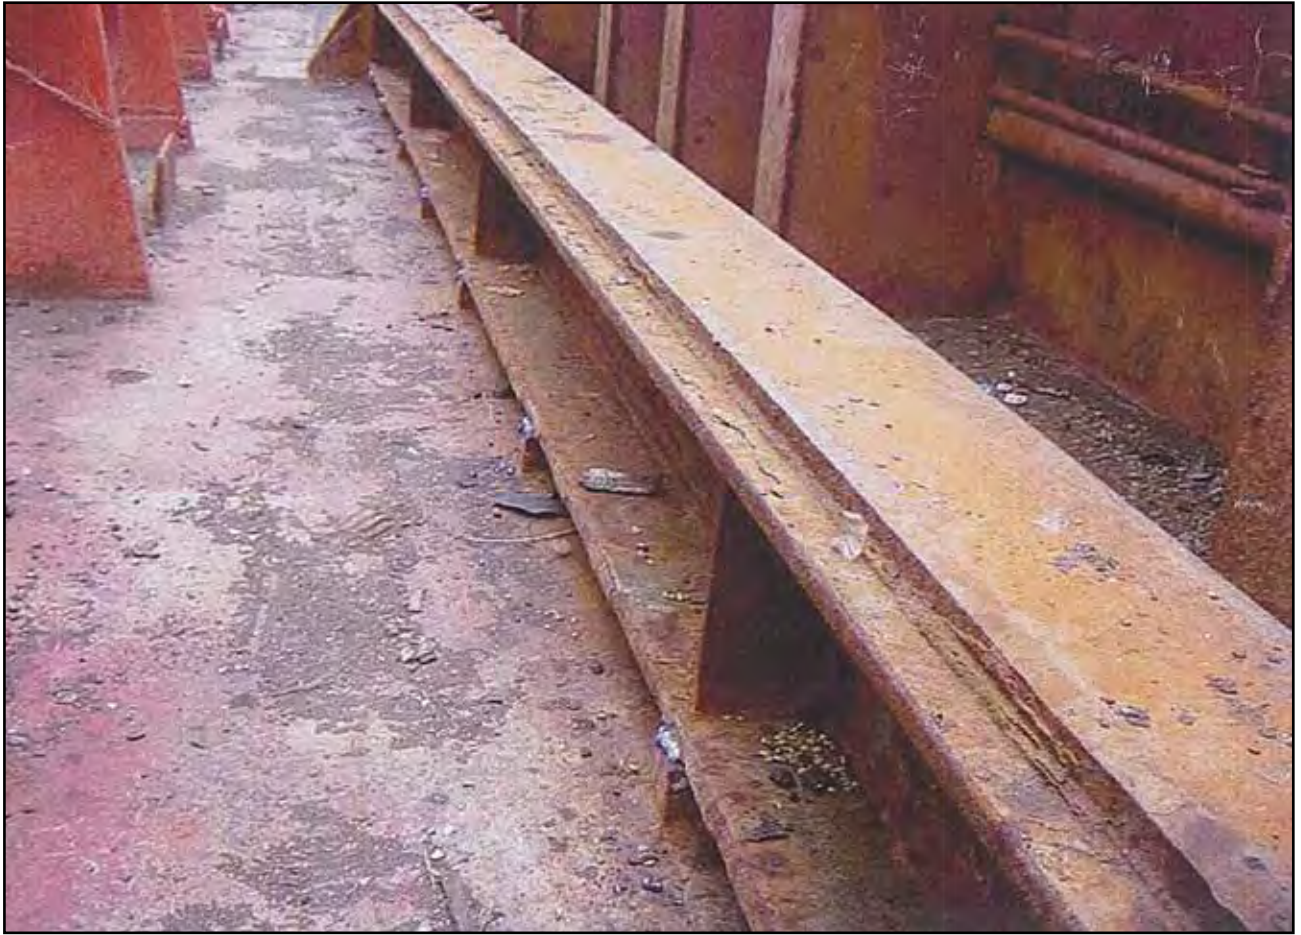
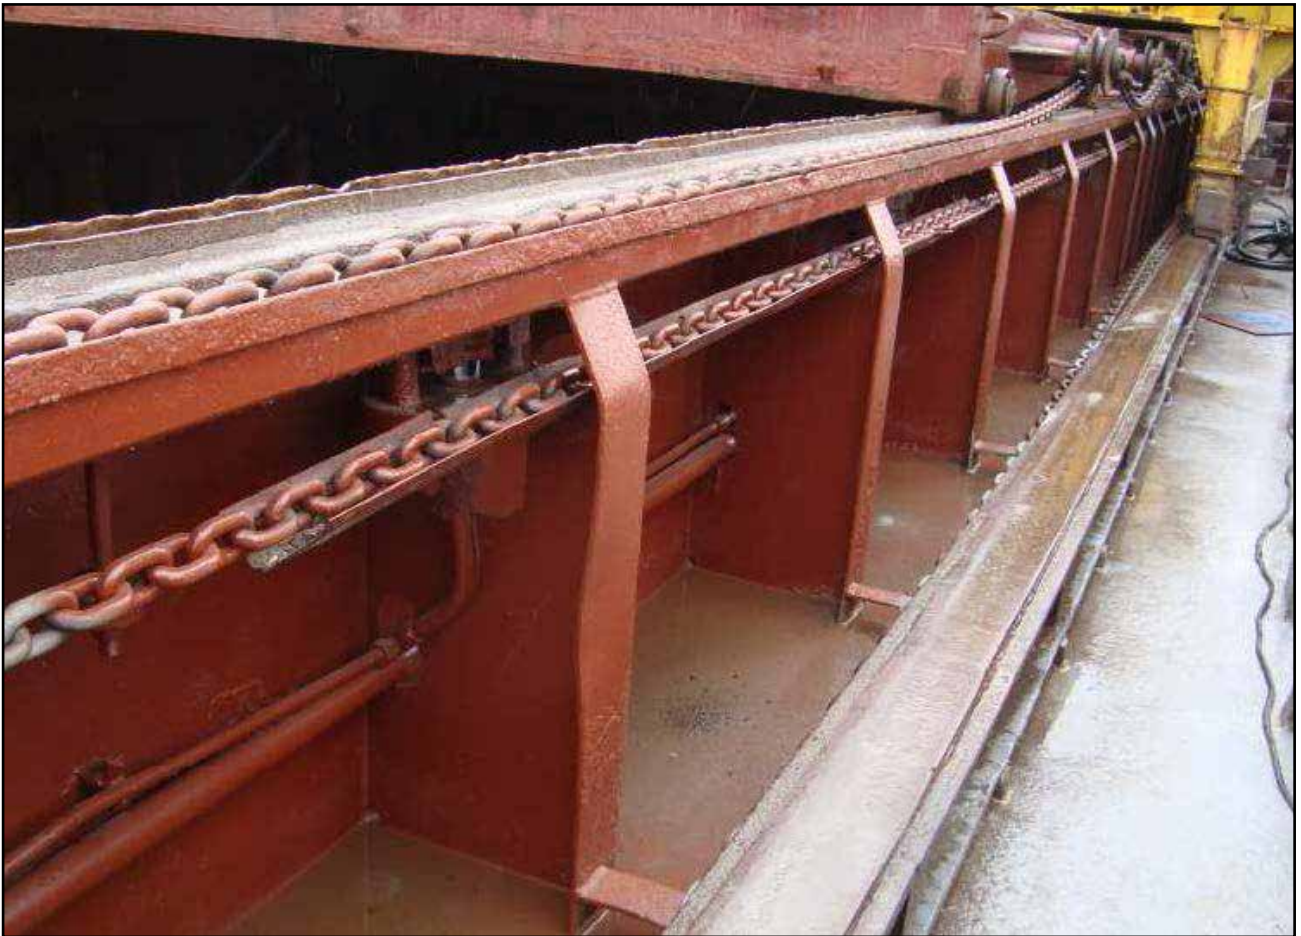
As part of its analysis (**Annex D**), Braemar commented that the addition of the self-discharging equipment would have had an overall beneficial effect on the structural capacity of *Swanland*, given the alterations to the transverse frames. However, Braemar also noted that the installation of the rails either side of the hatch coamings would have created a water 'trap' area where corrosion would have been more likely to develop, as shown at **Figures 39a** and **39b**.

**Figures 39a and 39b:** Water trap area between excavator carriage rail and cargo hold hatch coaming on *Swanland*

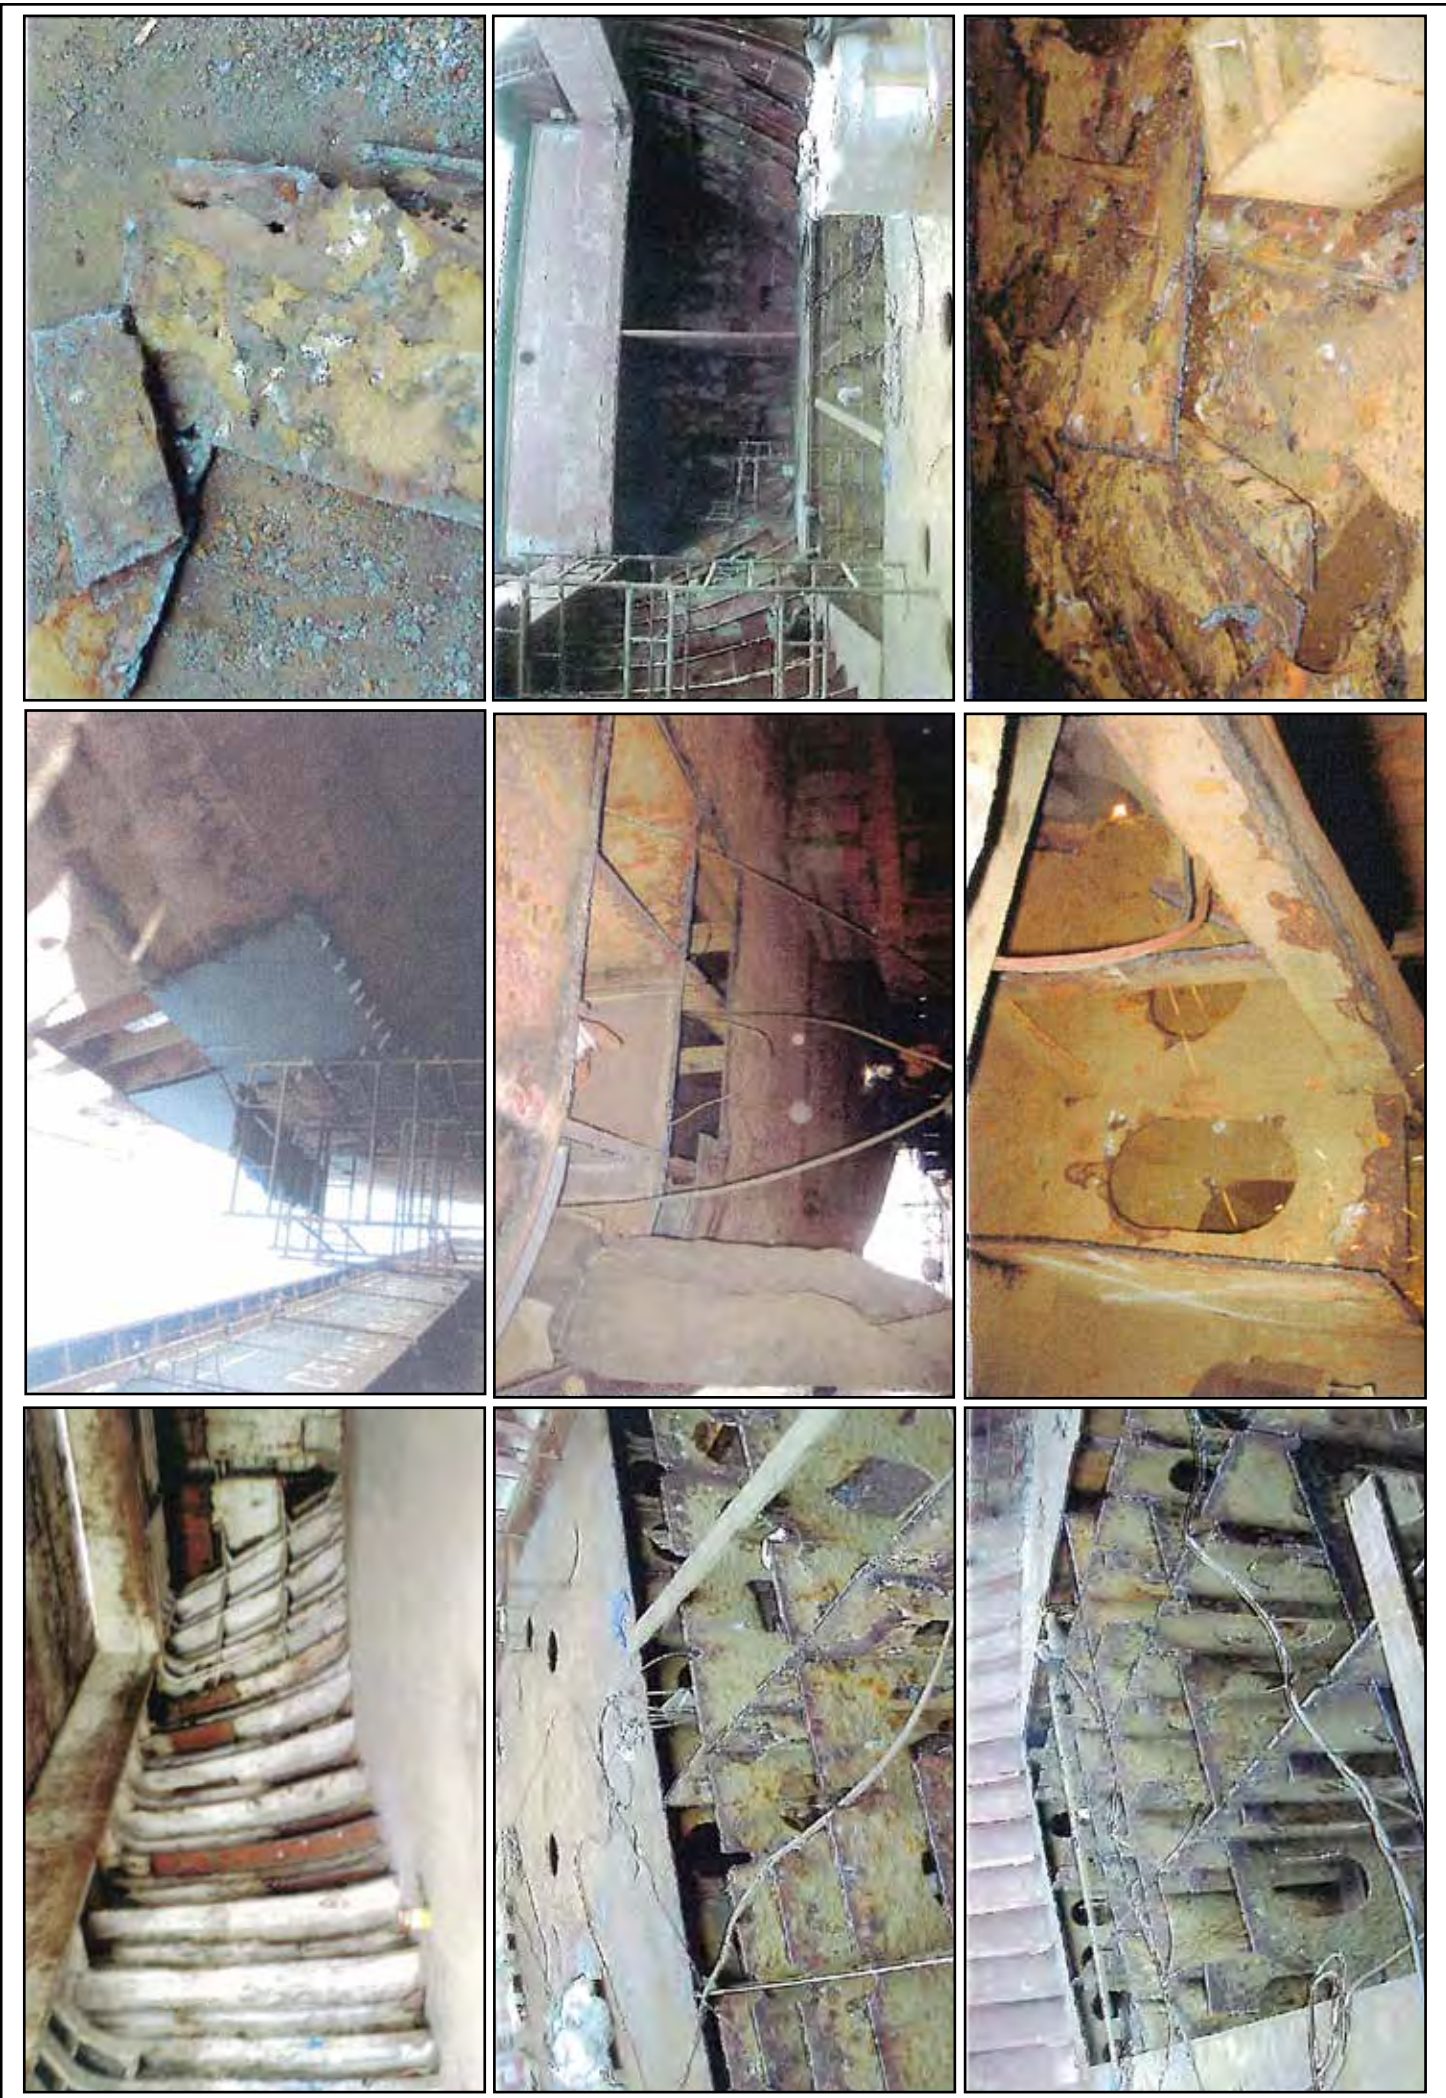
Figure 40: Repair work underway in Liepaja in 2006

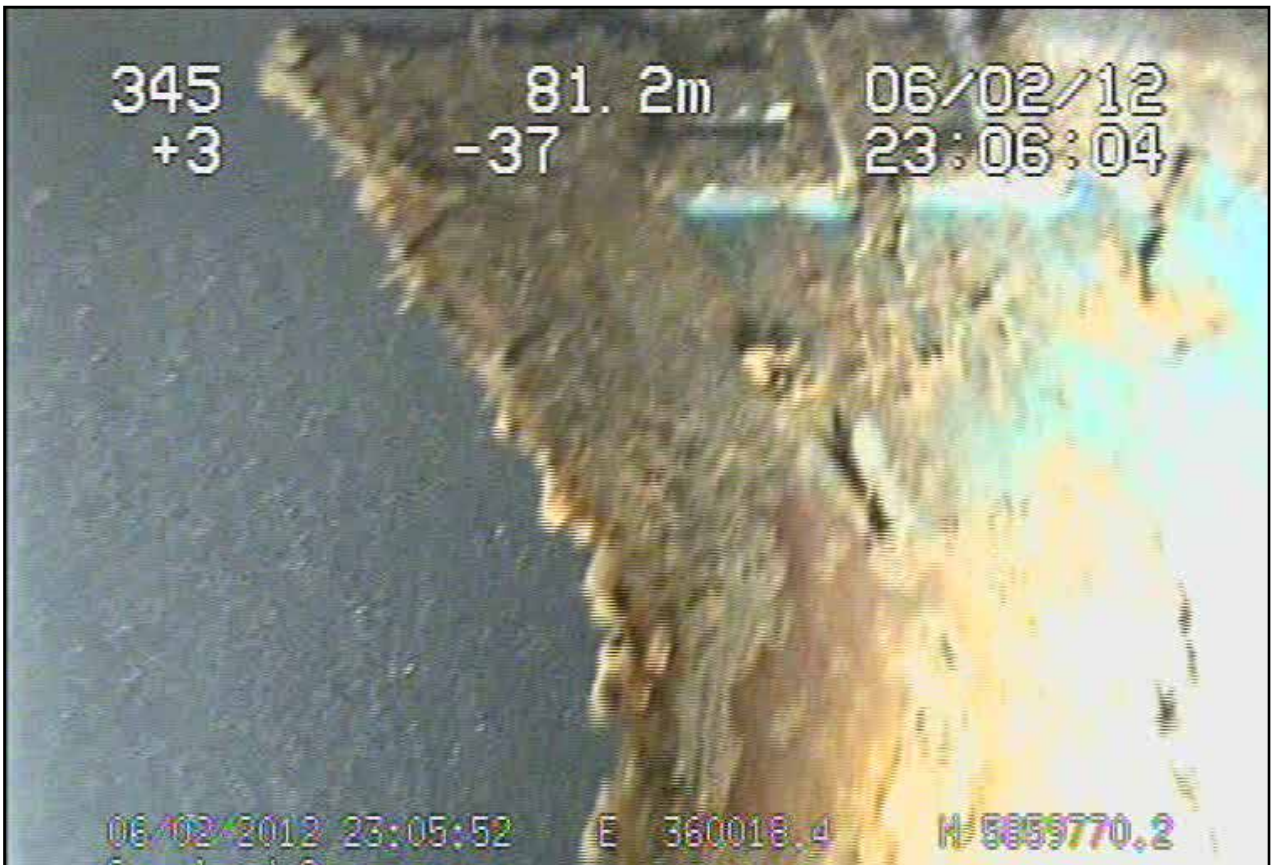
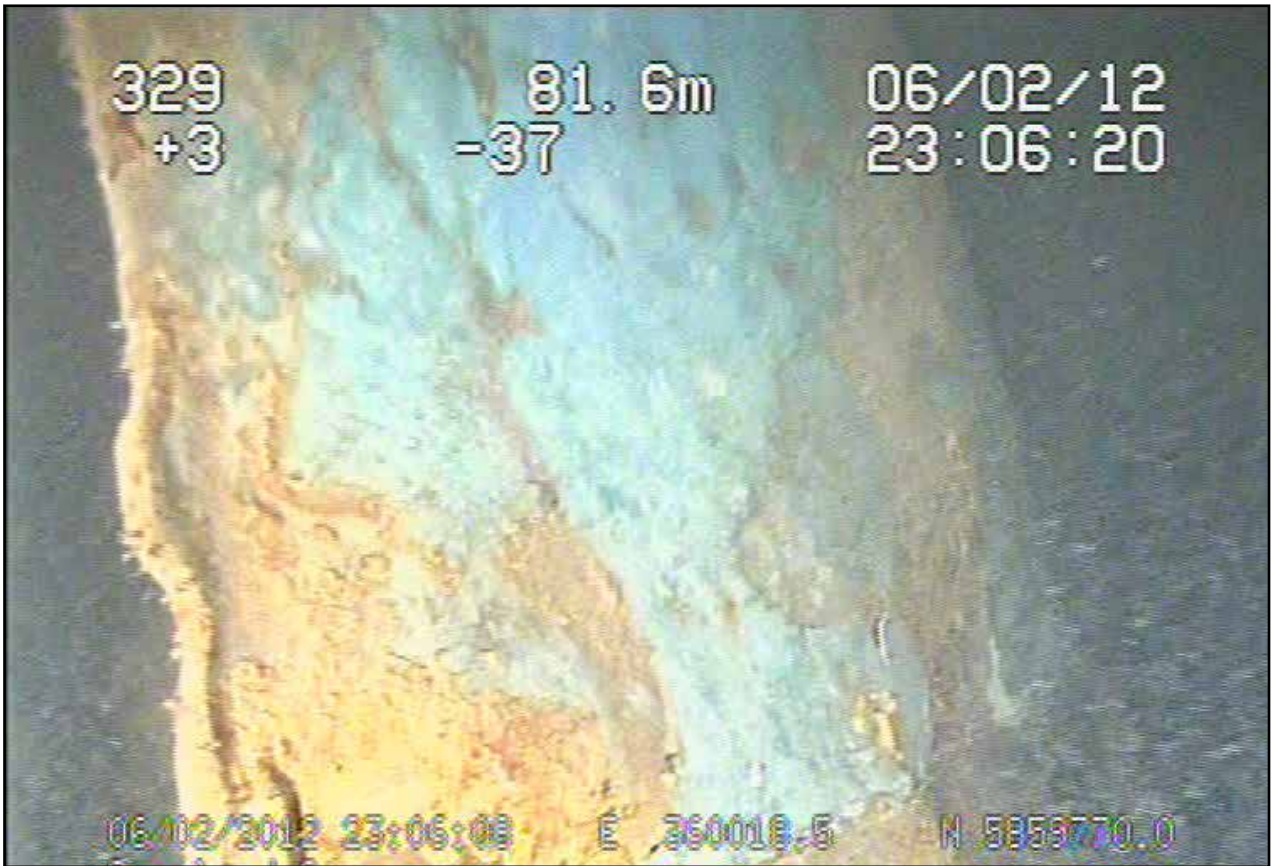
**Figures 68a and 68b:** Stills from ROV footage representative of best imagery obtained of main fracture surface

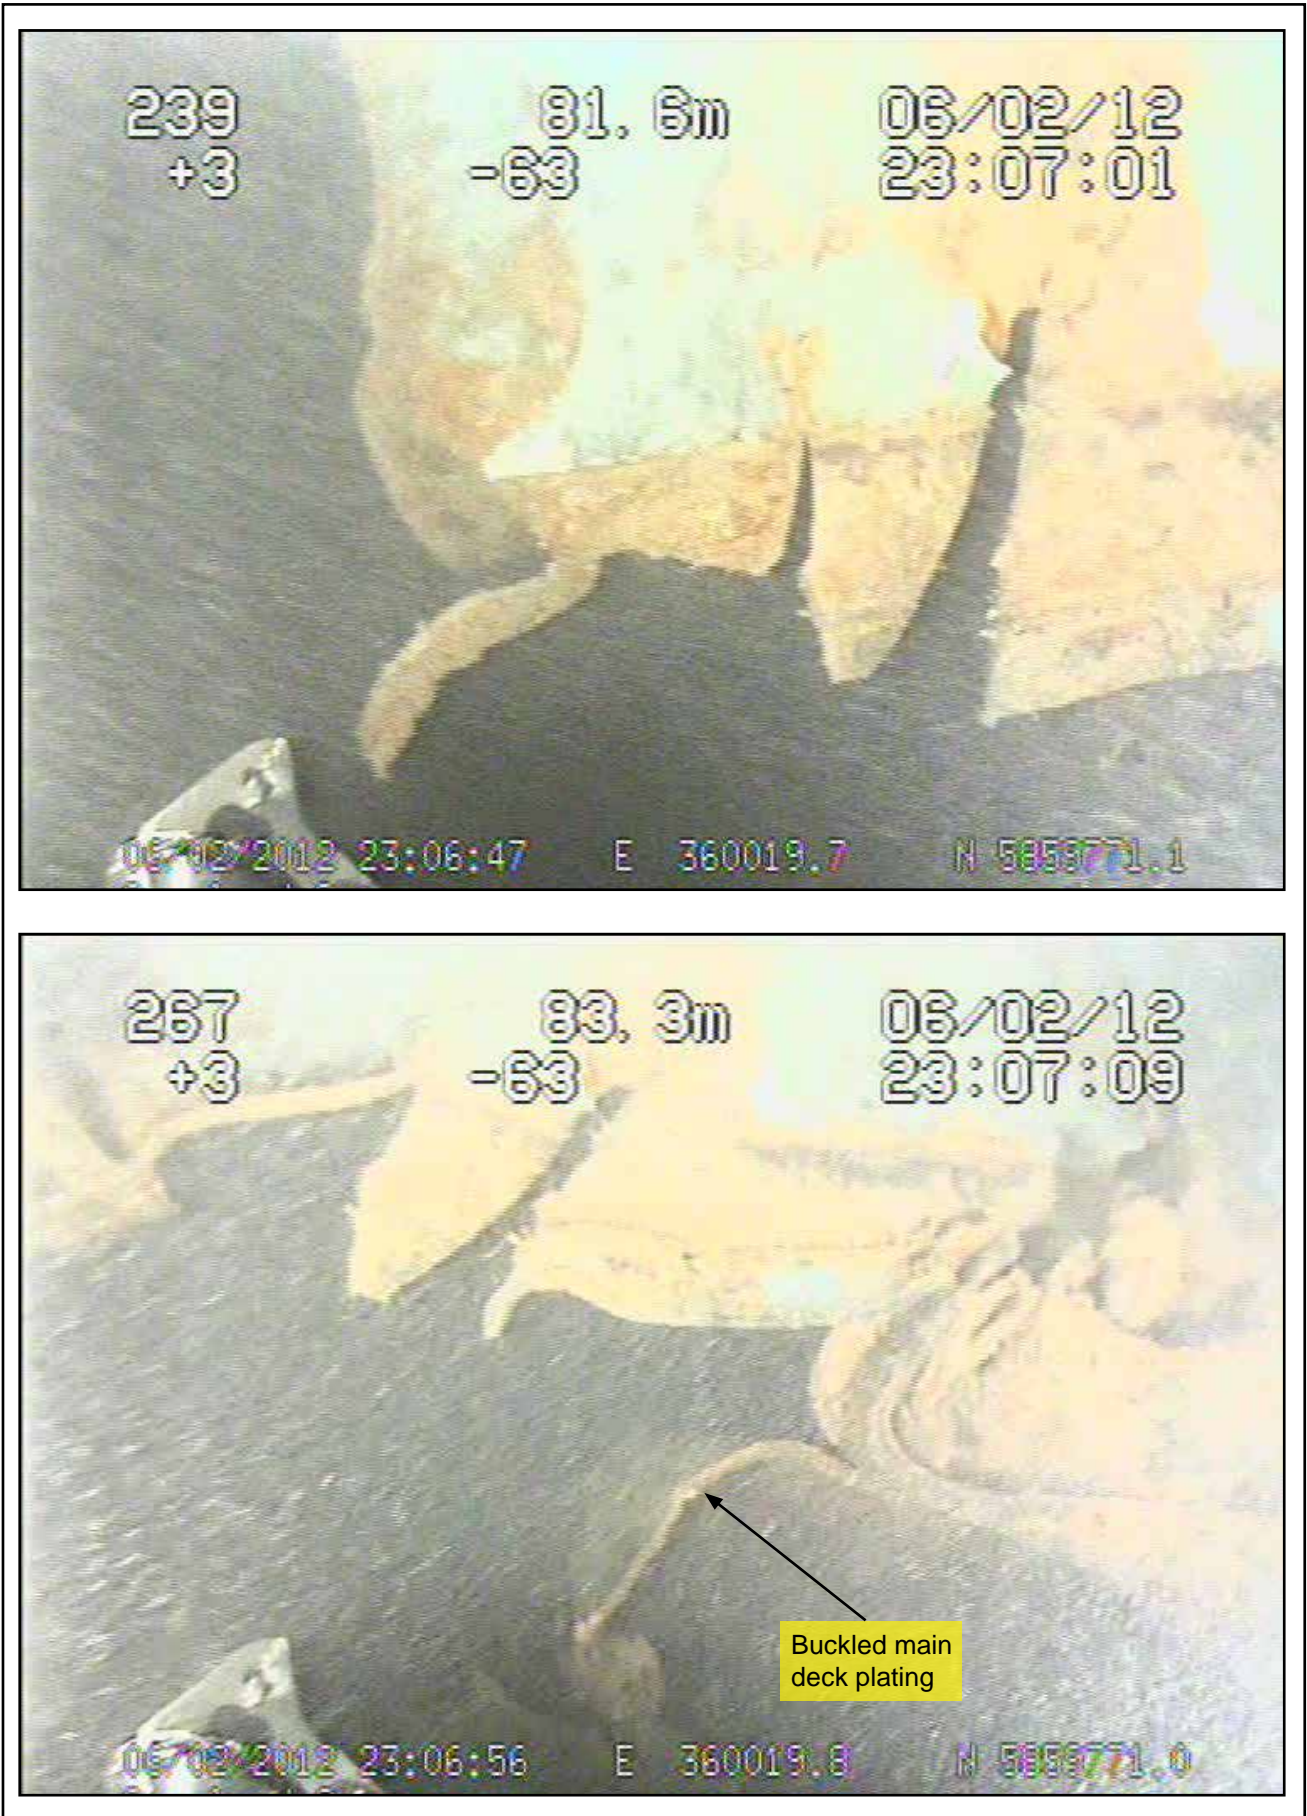
**Figures 69a and 69b:** Stills from ROV footage showing signs of ductile failure in the upper structure in way of the main fracture path

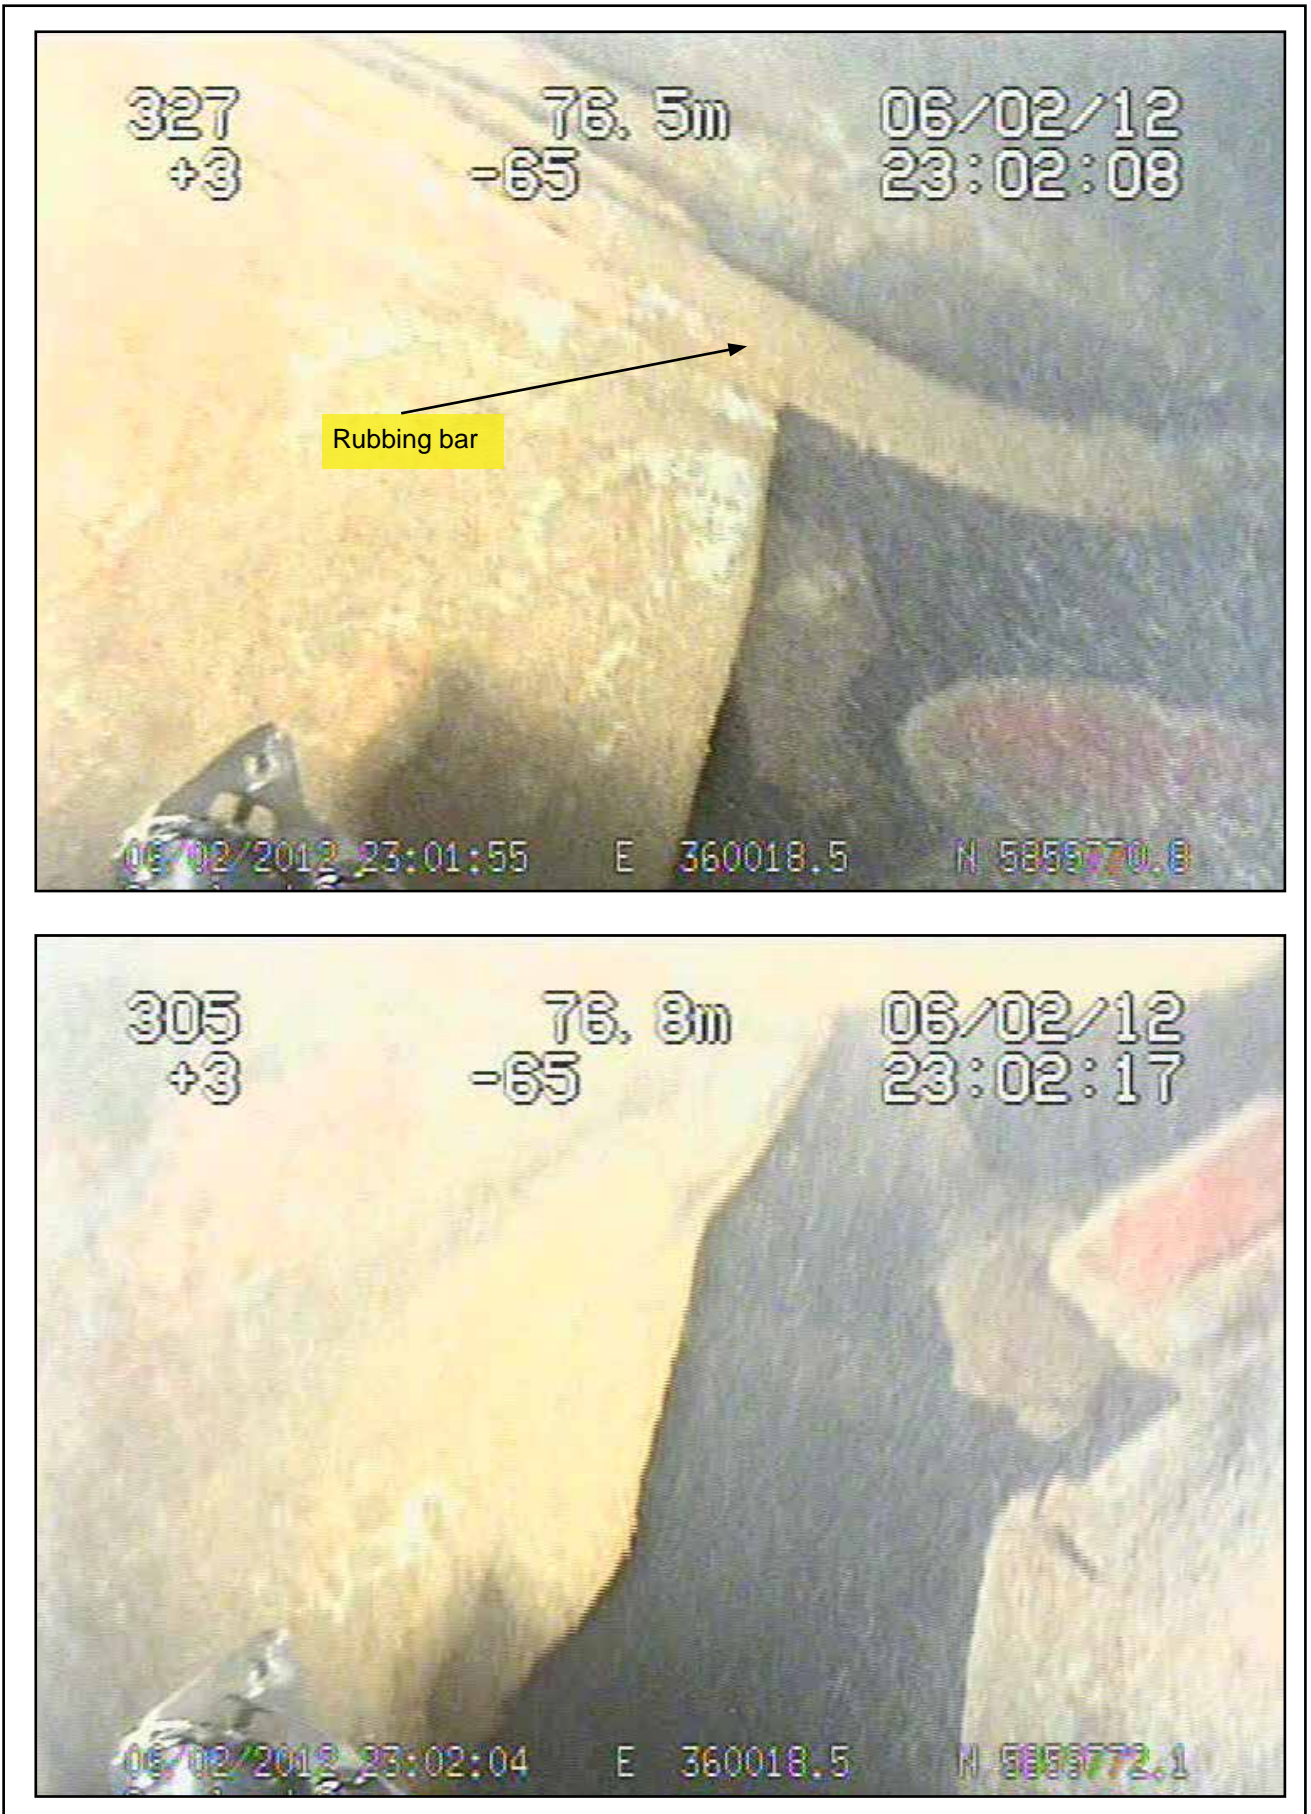
**Figures 70a and 70b:** Stills from ROV footage showing signs of brittle failure in the lower structure in way of the main fracture path

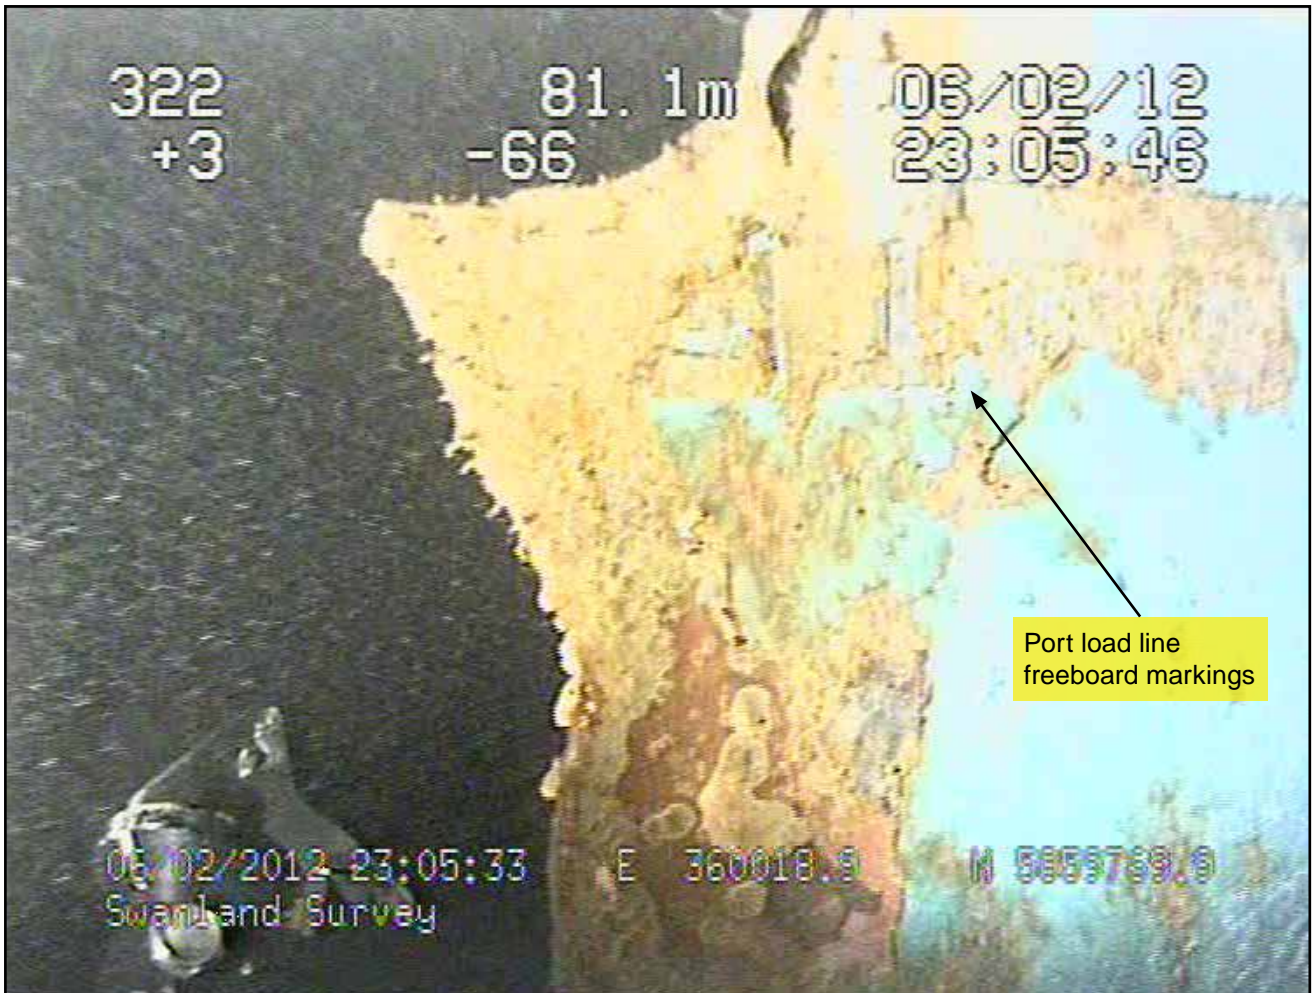
Due to the limited capabilities of the ROVs employed for the underwater survey, it was not possible to obtain any metallurgical samples or measurements, which could have been helpful in substantiating the condition of the structure in way of the failure paths. Although some areas of the shell plating appeared to be relatively thin, it was not possible to quantify to what extent this might have contributed to the failure. The apparent detachment of paint in a number of areas in way of the main fracture path (**Figure 71**) reflects the high stresses that were needed to exceed the steel's ultimate tensile strength (UTS)<sup>63</sup> and therefore to cause the shell plating to fracture.

**Figure 71:** Still from ROV footage showing evidence of paint detachment in way of the main fracture path

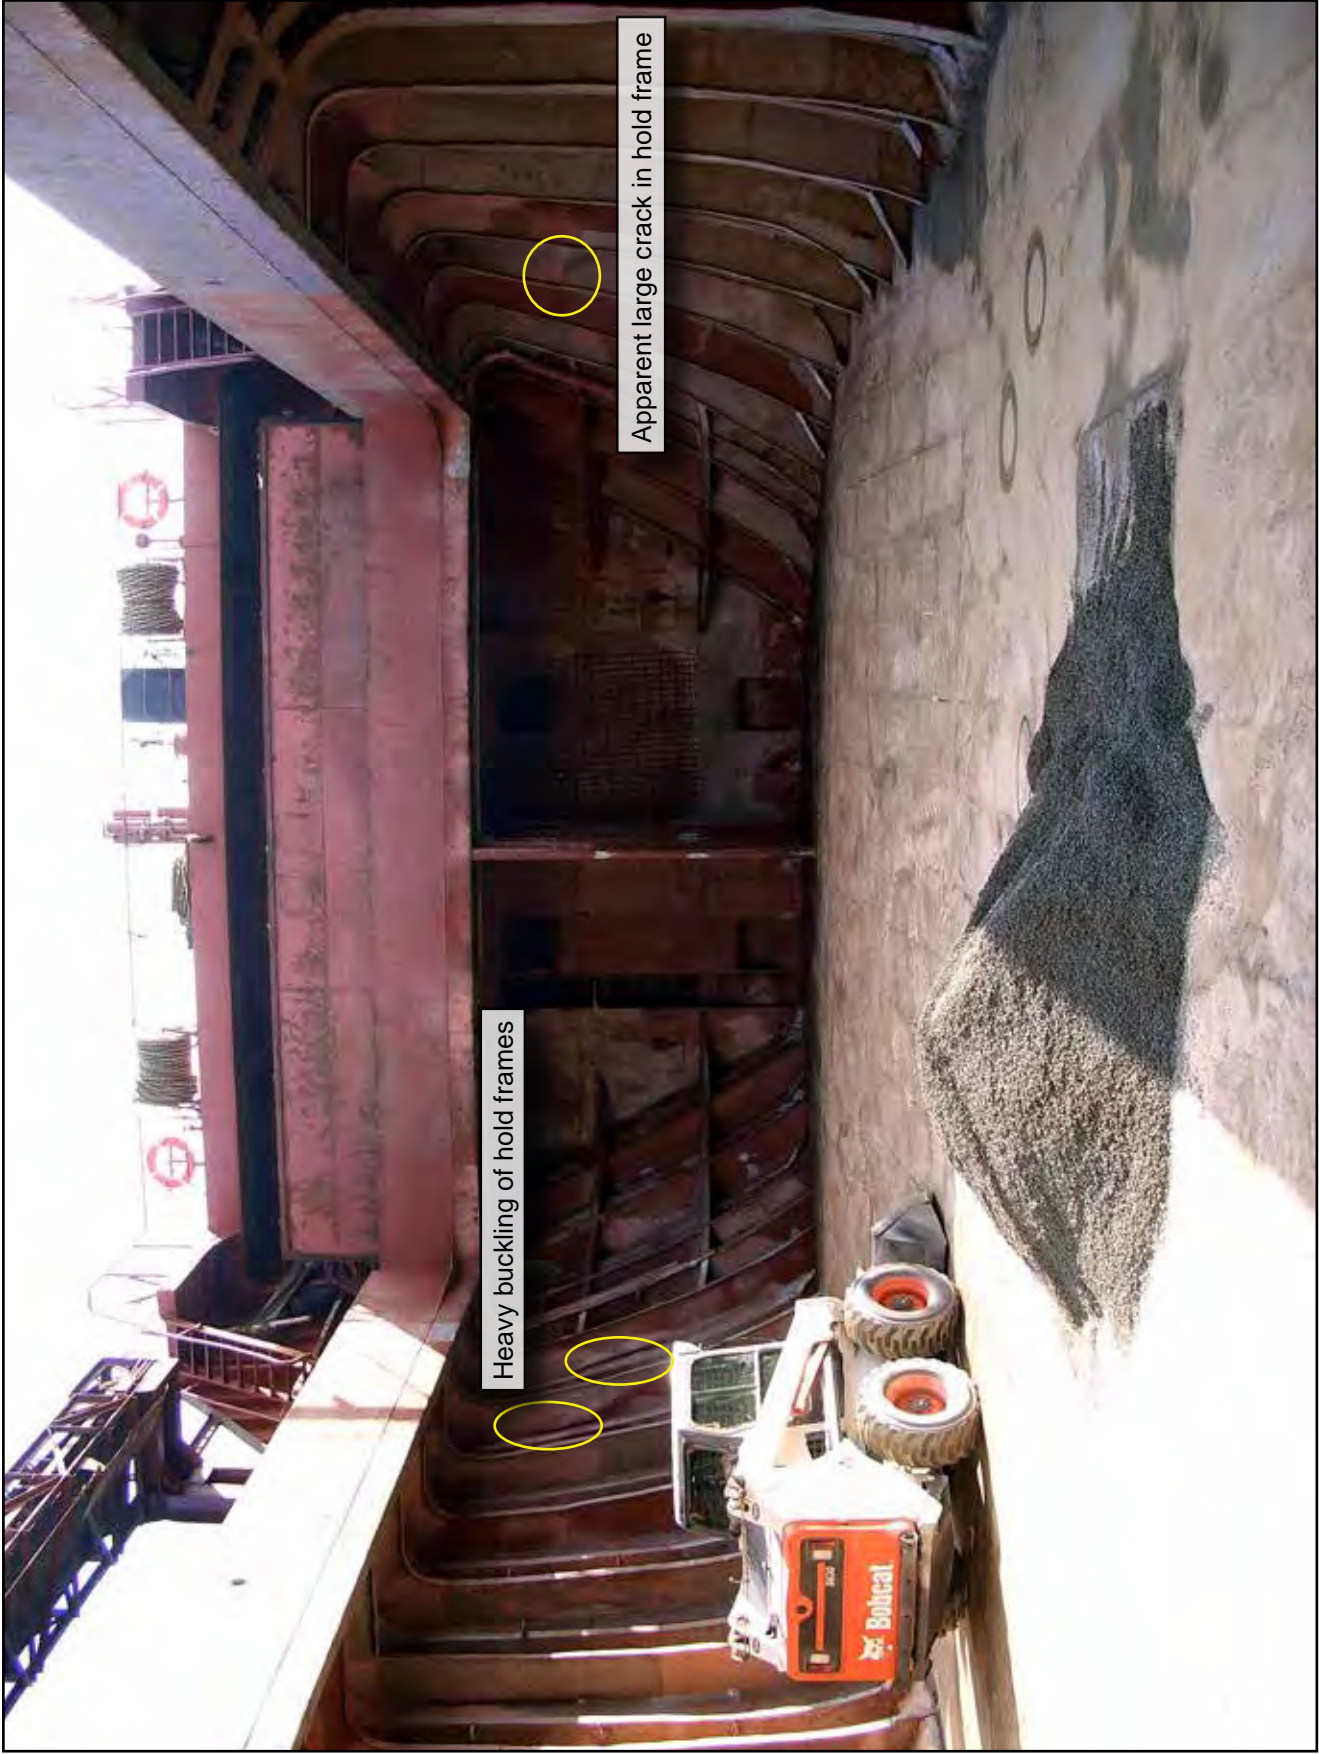
It is apparent that following an intensive period of carrying salt cargoes in late 2010, the condition of the hold necessitated its pressure washing and painting in July 2011. However, as can be seen in **Figures 75a, b, c, d, e and f** the hold coating appeared to be in a poor condition. Closer examination of these photographs appears to show that in addition to mechanical damage, there were areas of coating loss, instances of frame detachment, substantial cracks in some frames, and areas of significant pitting and general corrosion. It also appears that scale (much of it heavy) had simply been painted over.

Figures 75a: Photograph of Swanland's hold in September 2011 showing apparent structural defects

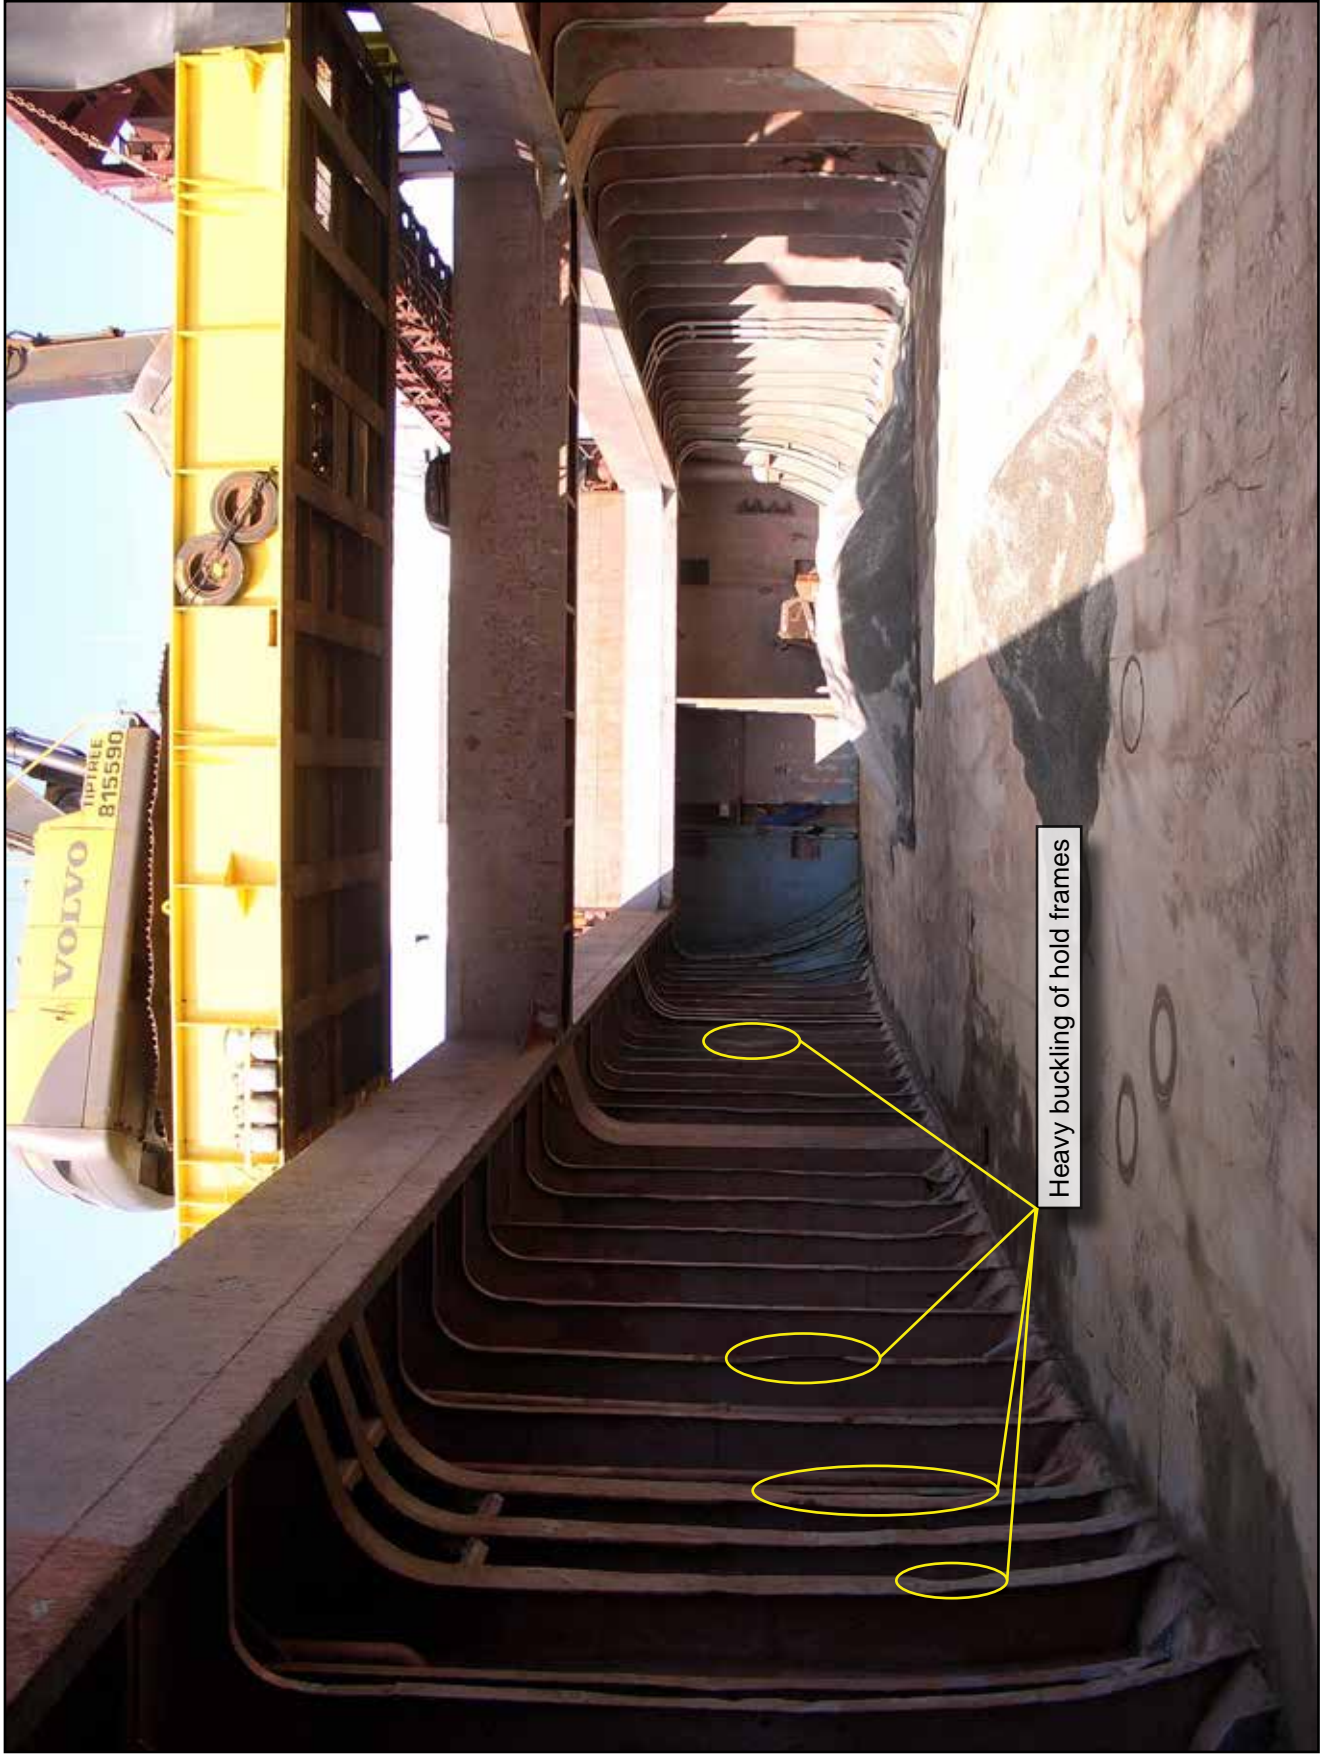
**Figures 75b:** Photograph of Swanland's hold in September 2011 showing apparent structural defects

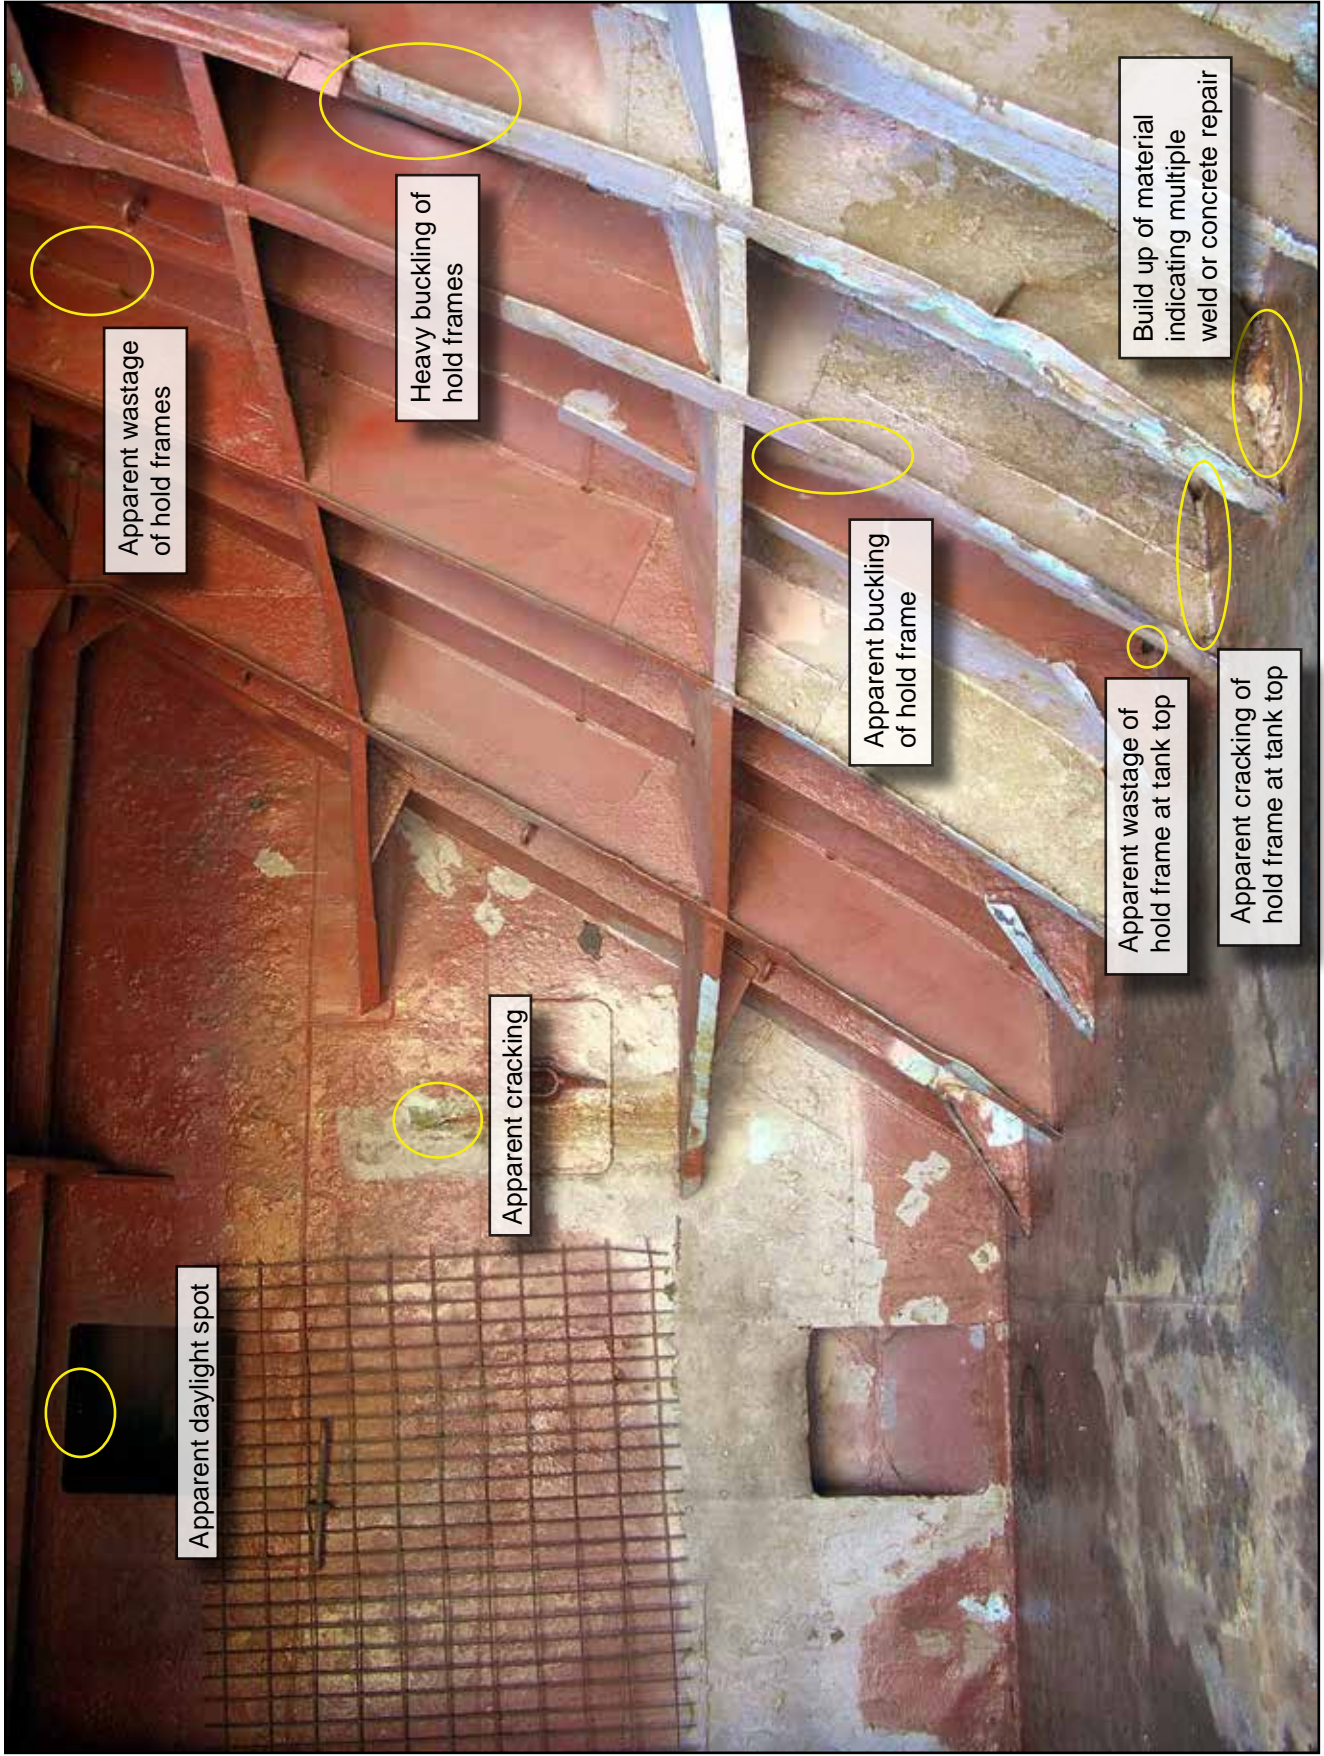
**Figures 75c:** Photograph of Swanland's hold in September 2011 showing apparent structural defects
