Report on the investigation into  
the structural failure and foundering  
of the general cargo ship

***Swanland***

Irish Sea

27 November 2011

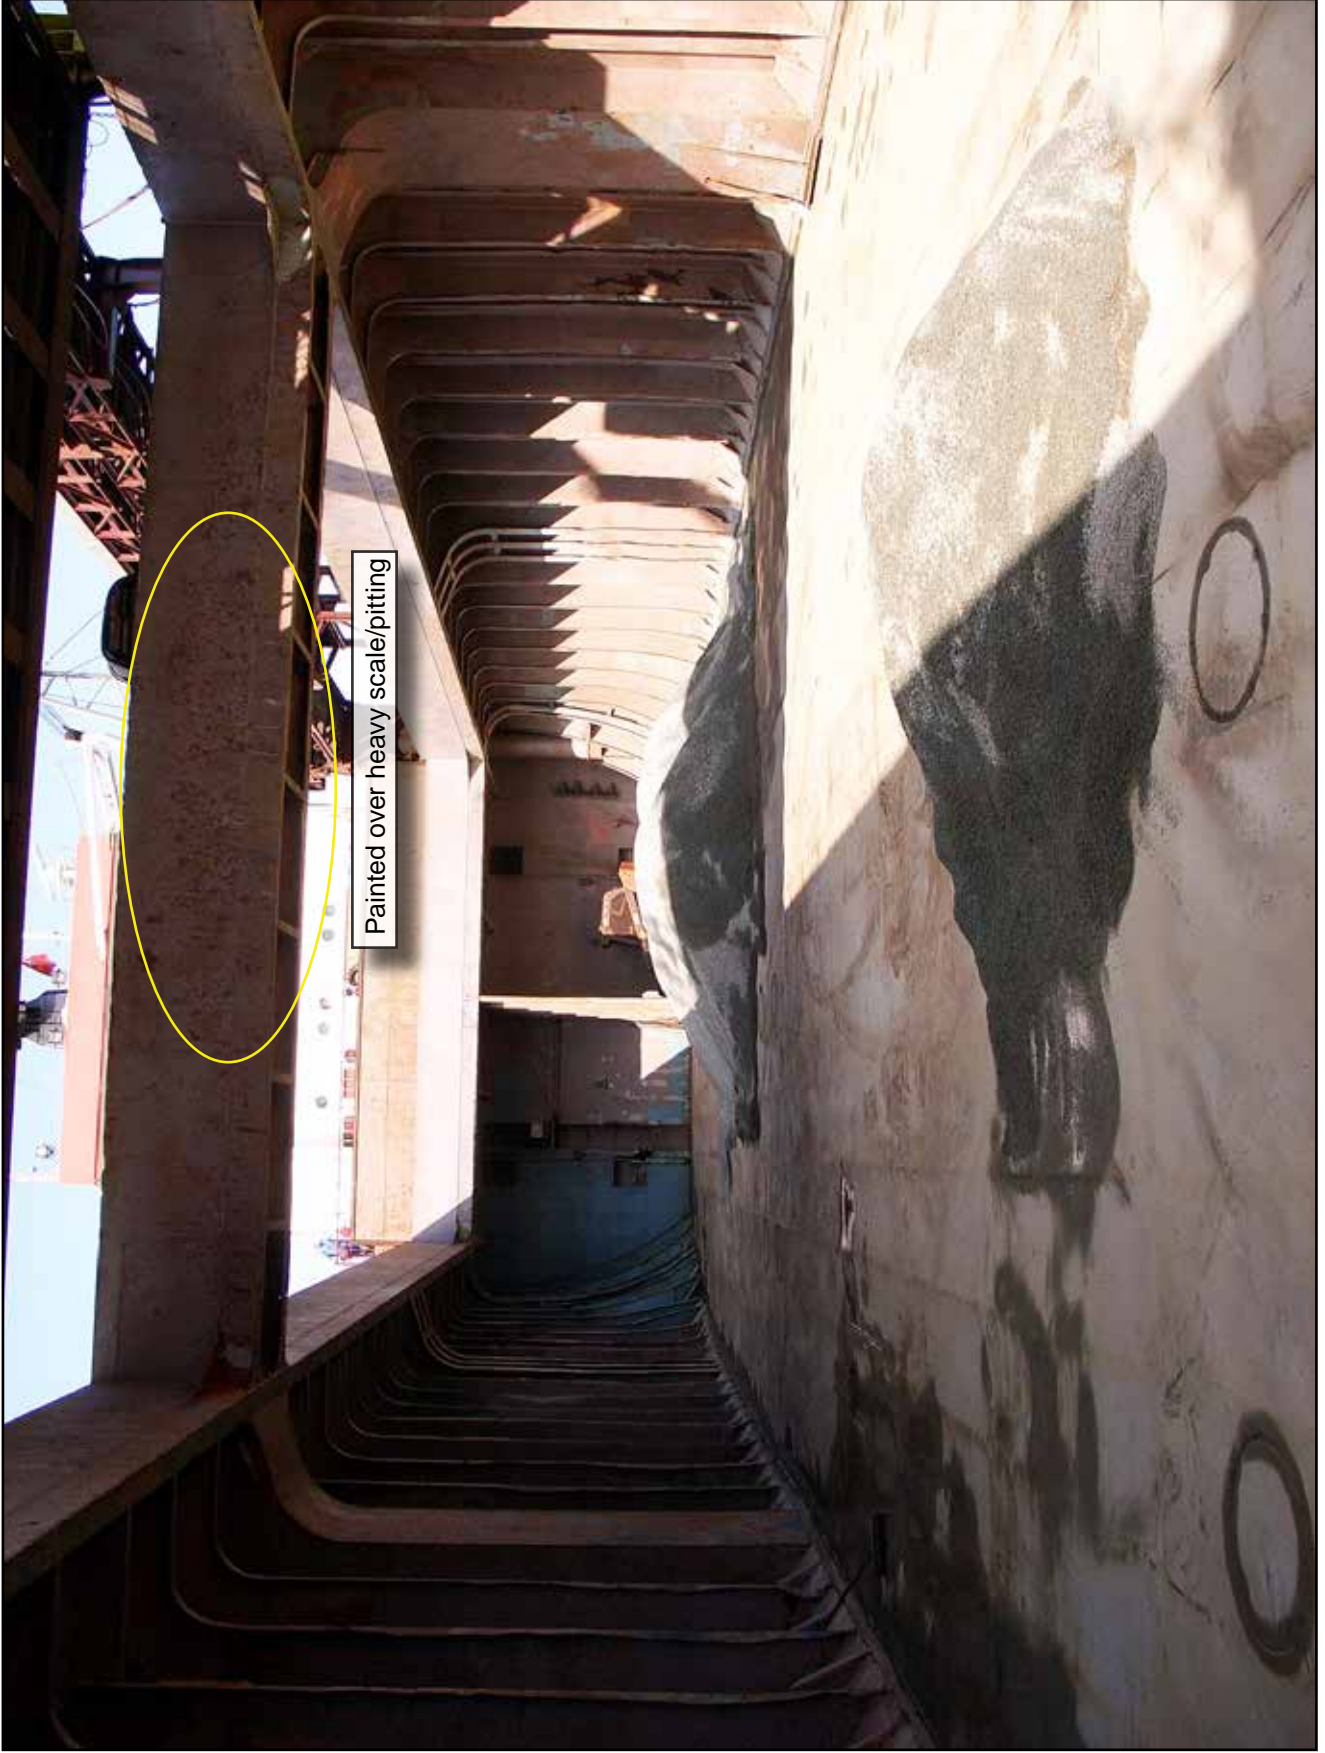
Figures 75d: Photograph of Swanland's hold in September 2011 showing apparent structural defects

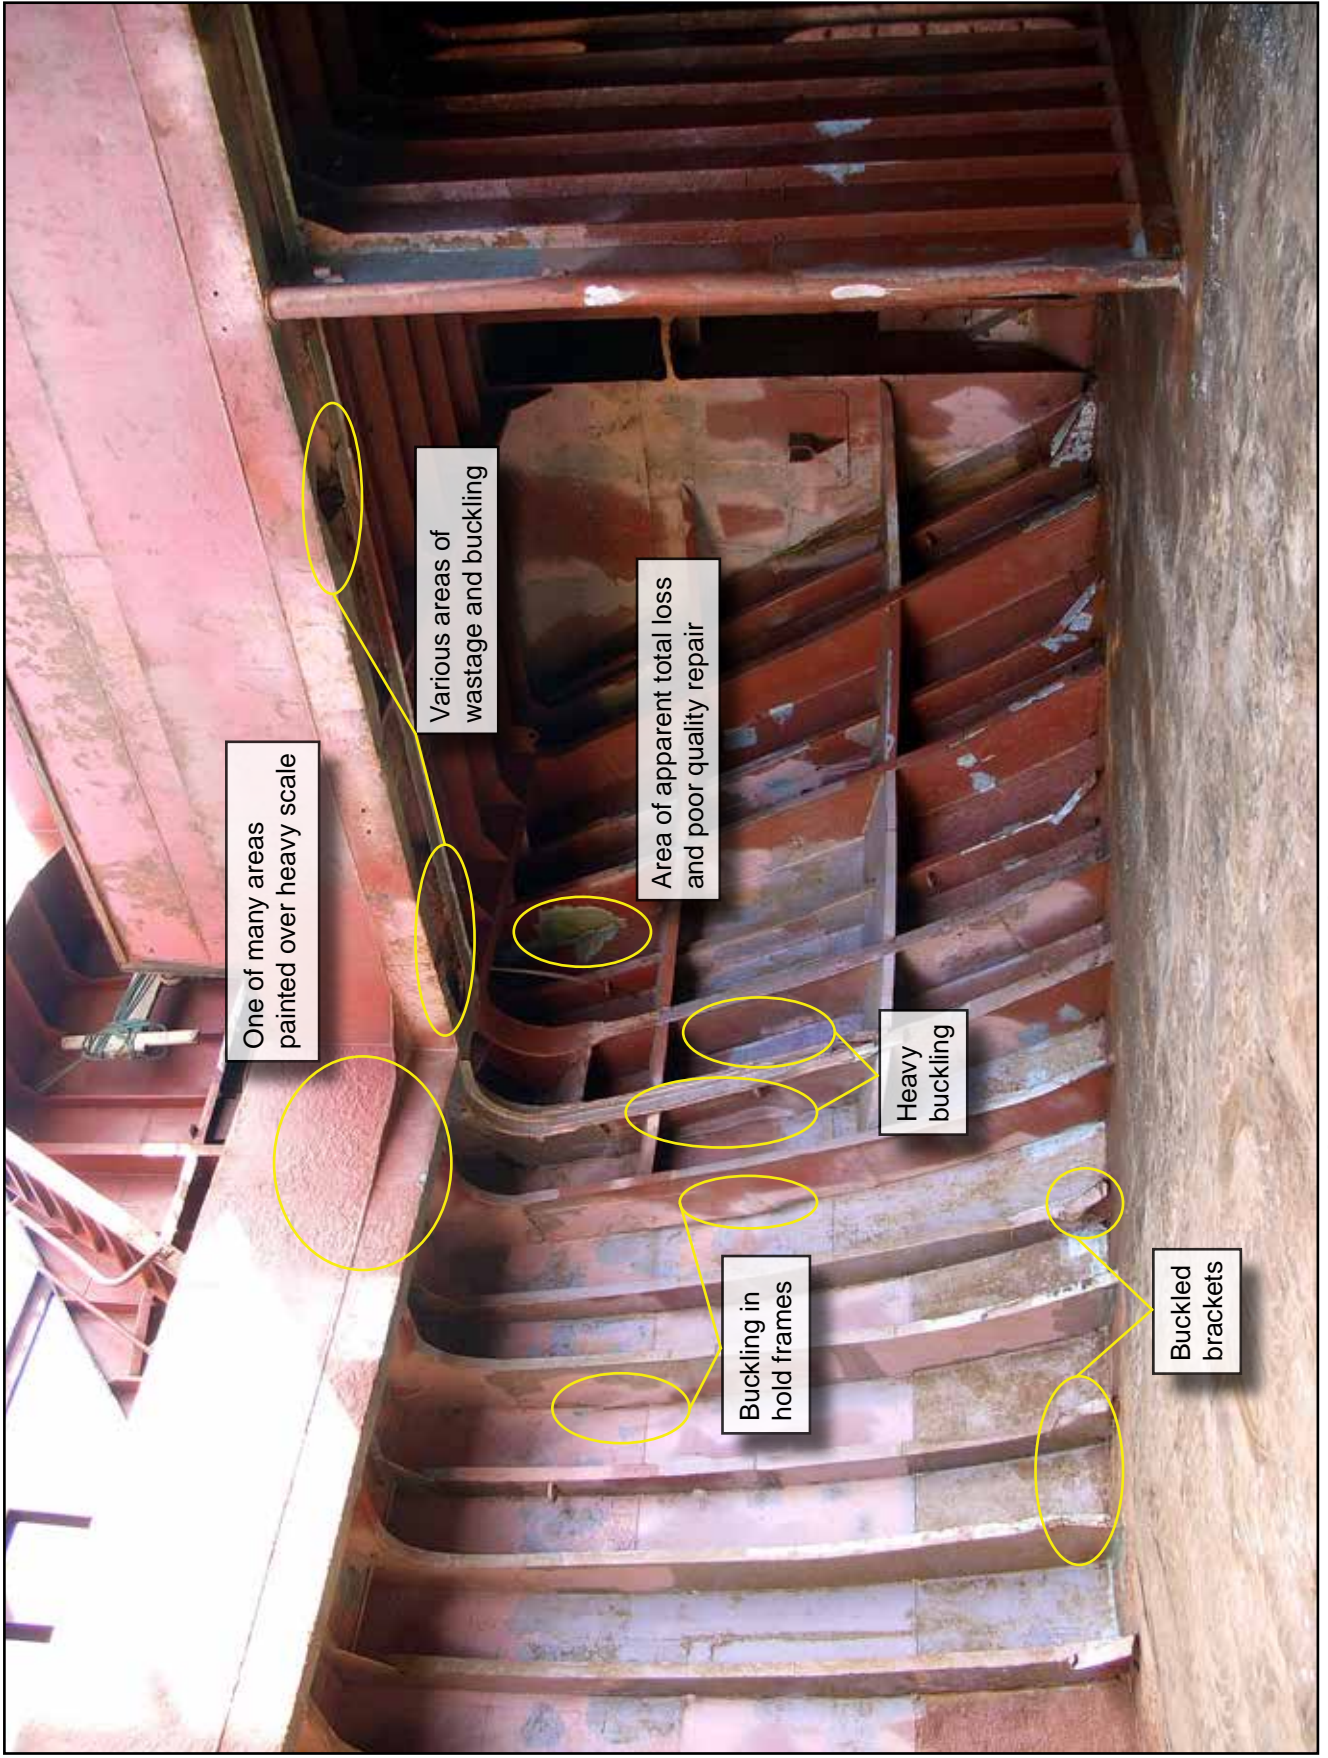
Figures 75e: Photograph of Swanland's hold in September 2011 showing apparent structural defects

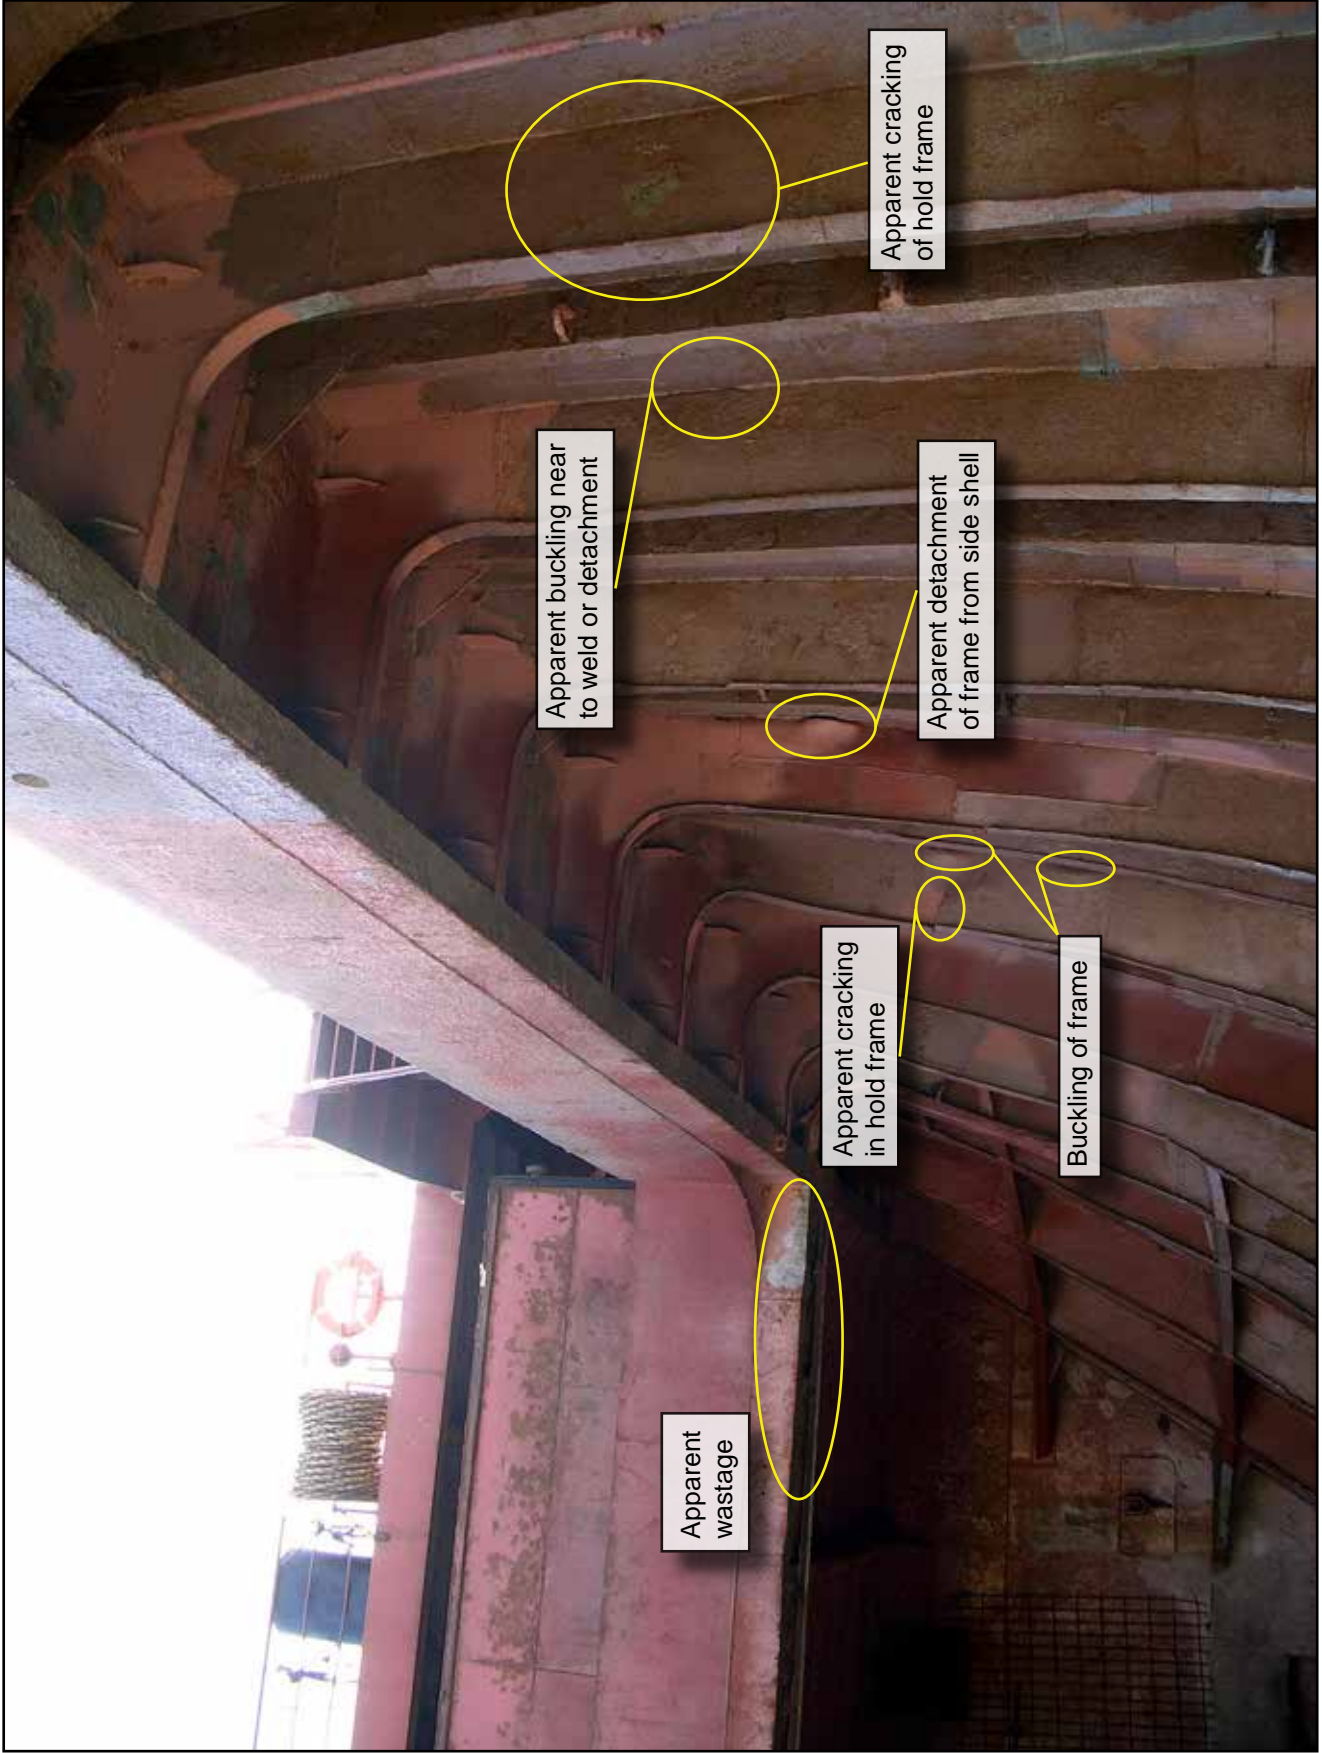
Figures 75f: Photograph of Swanland's hold in September 2011 showing apparent structural defects
