Report of the Inspector's Investigation

into the loss of the fishing vessel

***BLUE HOOKER PW250***

with two lives on 12 November 1998

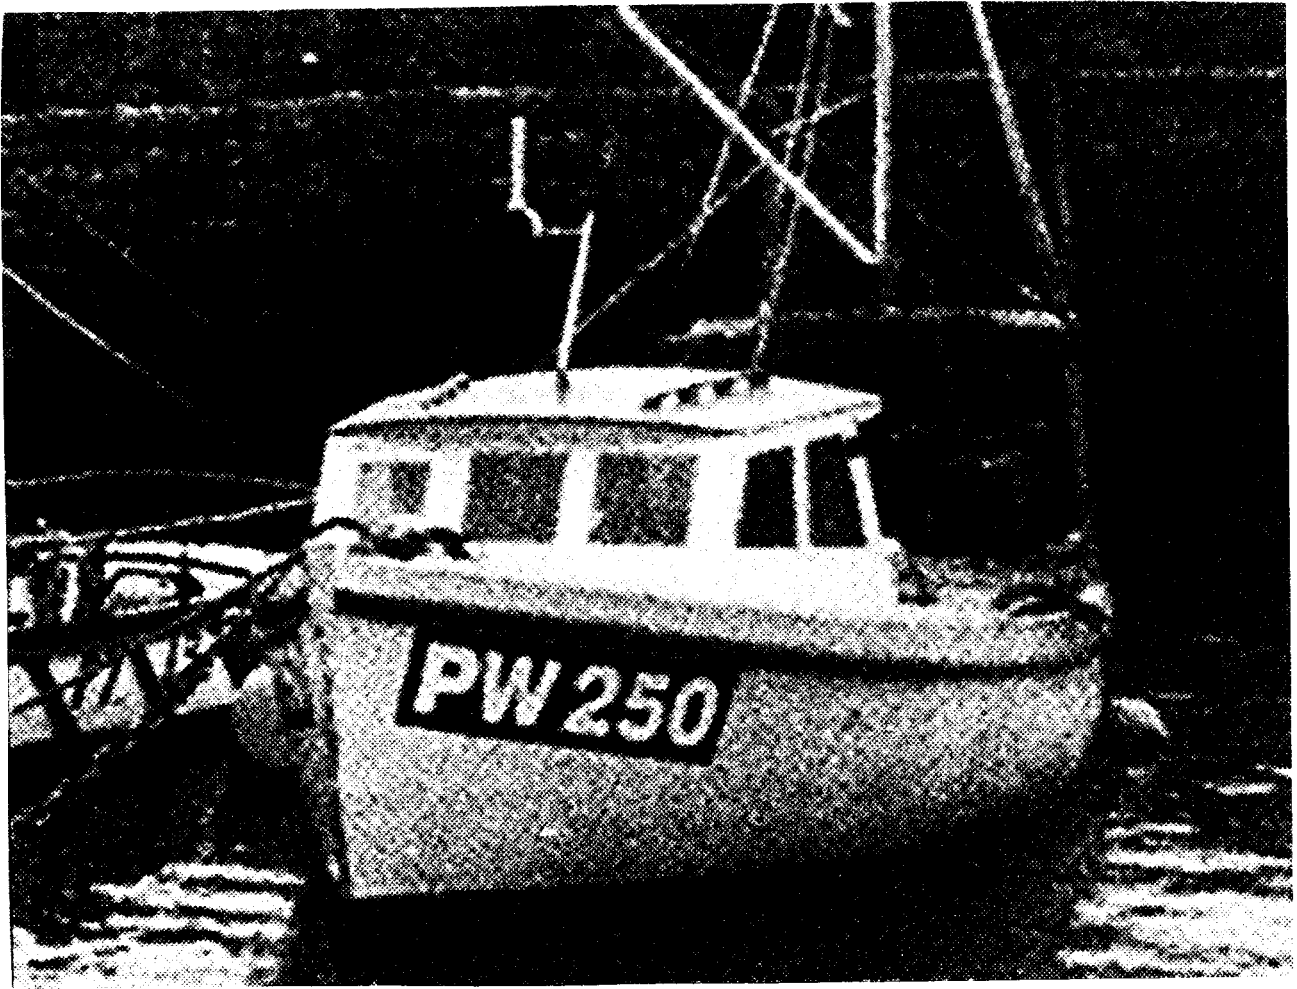
Figure 1

*fv Blue Hooker* moored in Clovelly Harbour

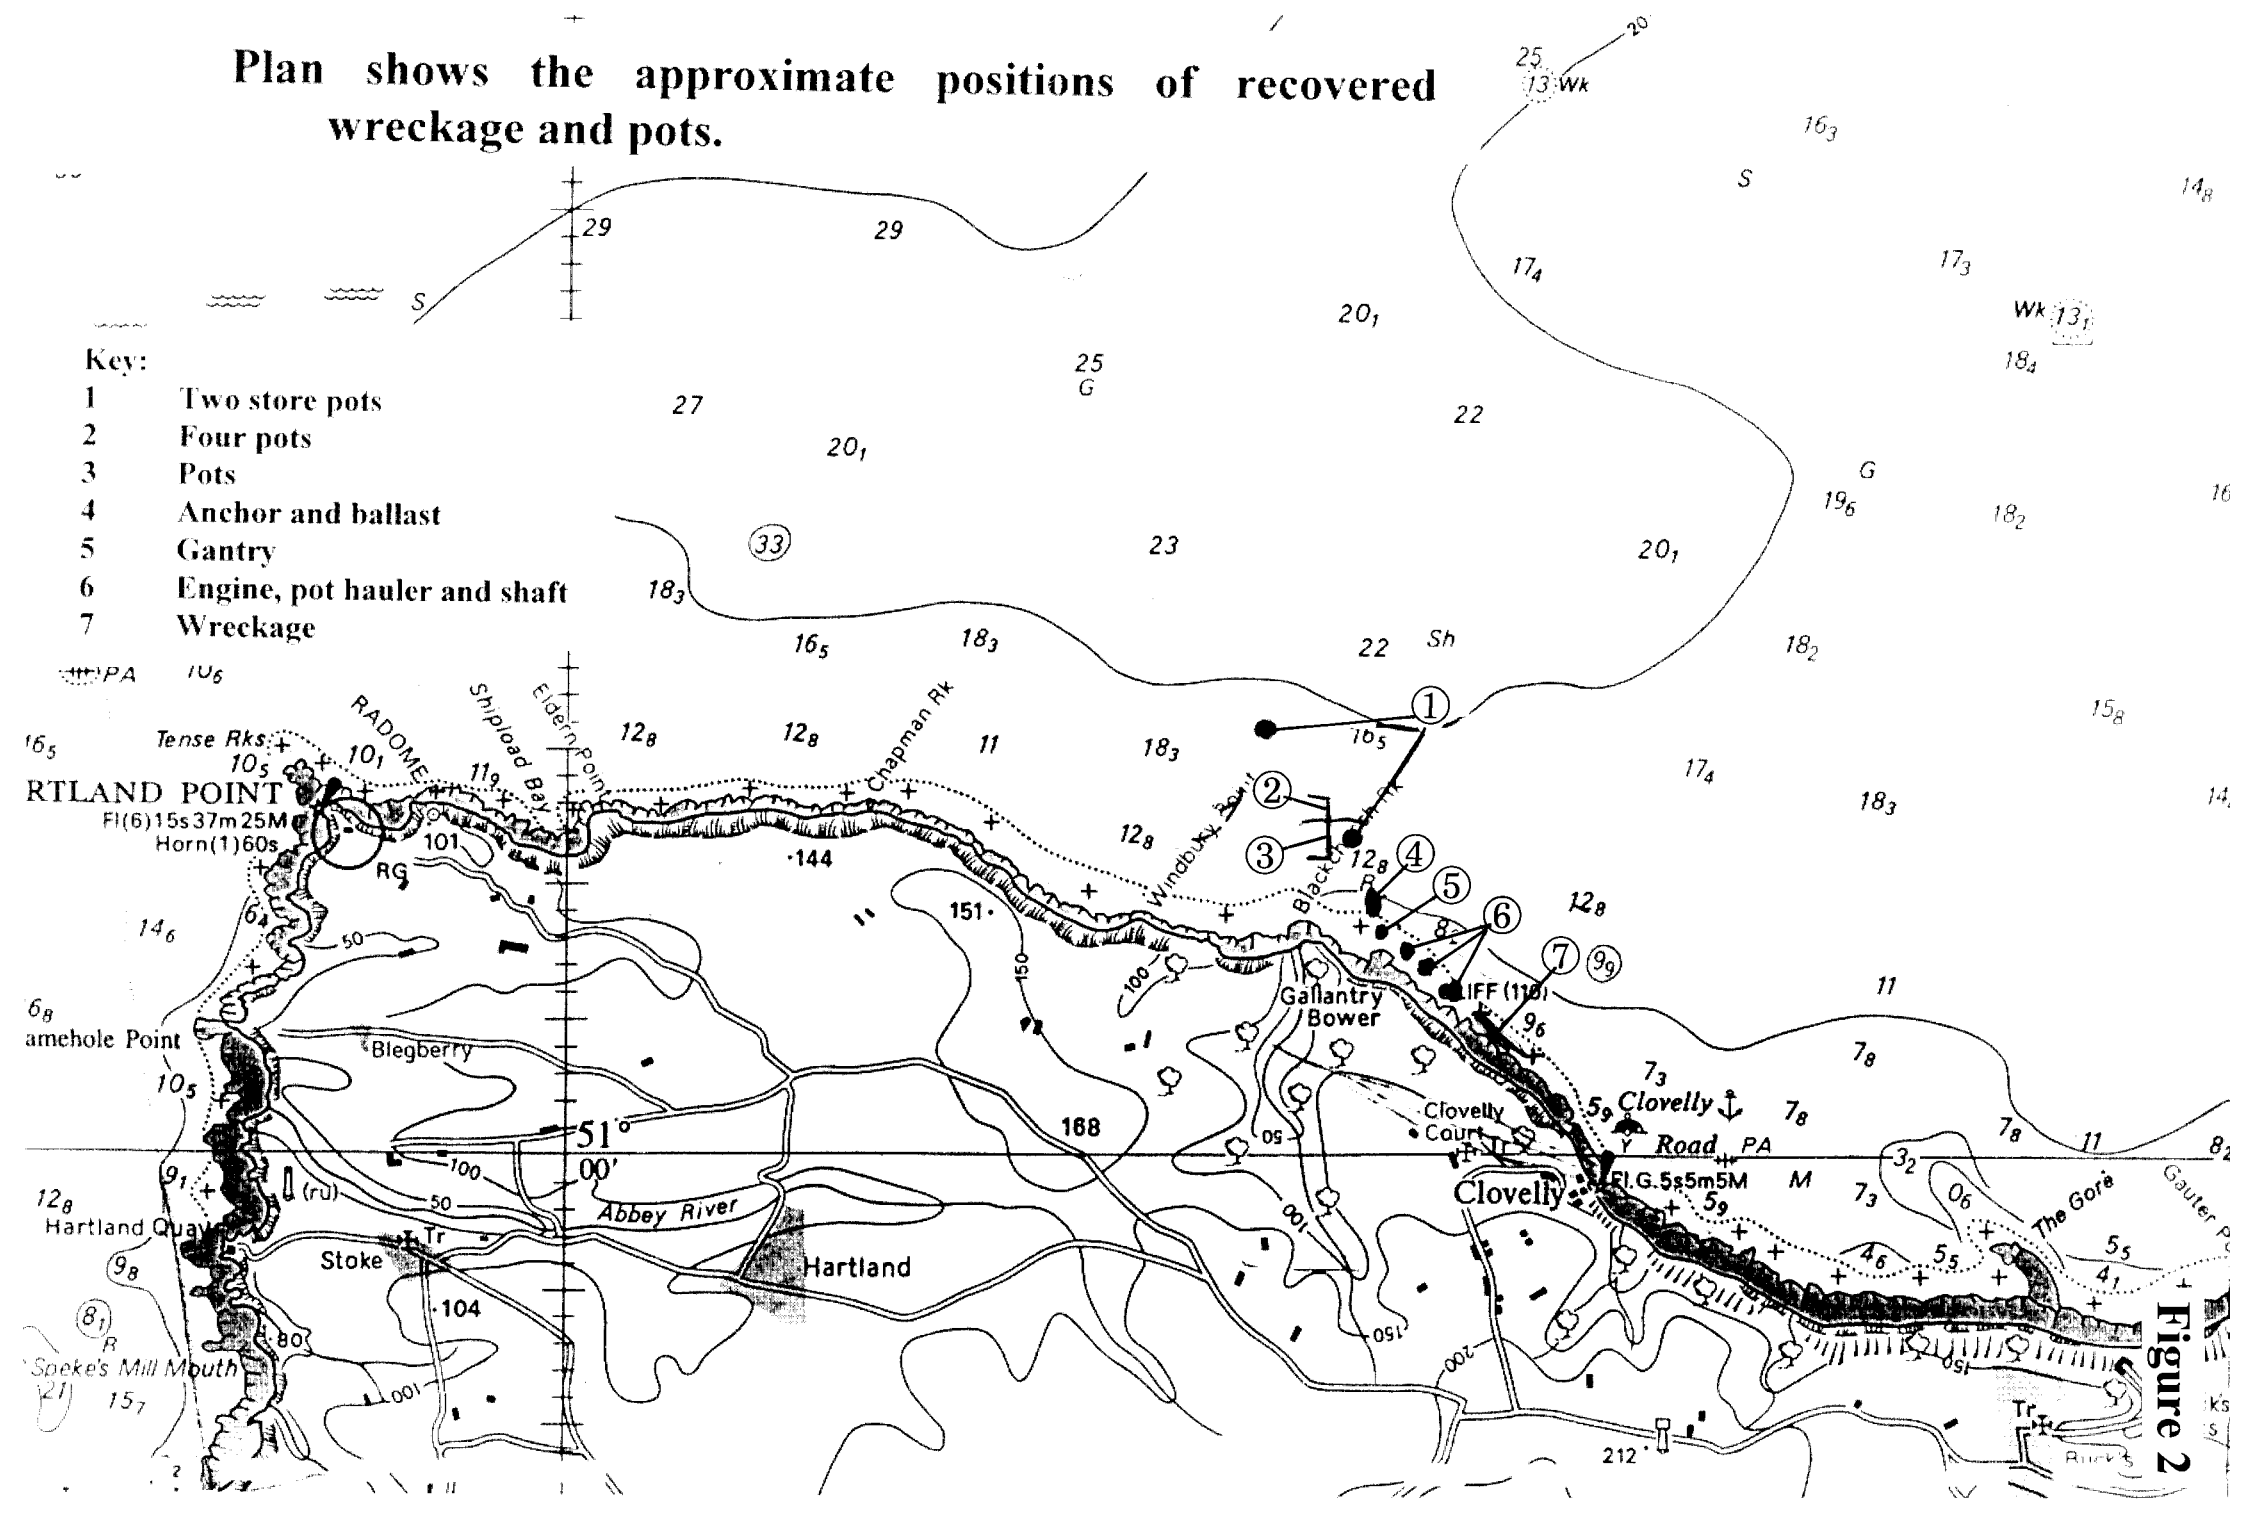
Figure 2

# Plan shows the approximate positions of recovered wreckage and pots.

At low water the vessel's ballast, anchor, gantry, damaged wooden structure, engine, shaft, propeller (with net wrapped around it) and hauler were seen along the shoreline (**Figure 2**). The VHF radio, switched to channel 16, was recovered.

Most probably the engine was still operating at that stage and the crew endeavoured steer towards the coast or Clovelly. Further flooding probably occurred. At some stage it is believed that the skipper removed his boots and oilskin jacket, before attempting to swim ashore; suggested by normal RNLI safety training. It is thought that the vessel actually capsized close to the shore because some of the vessel's ballast weights were found at low water (**Figure 2**).

As the vessel went further inshore she must have hit rocks because the wreckage, especially the wood wreckage, was completely broken up and found along the shore line. The main engine and the hauler were still connected by hydraulic piping, but separated from the wood structure which was found between the low and high water marks. There was no rope in the hauler. The propeller and shaft, though buckled and damaged, were one unit. Entangled in the propeller was fine netting which indicates that the propeller was still turning when the vessel capsized. The gantry, which was fitted at the after end of the vessel, was also entangled with netting.

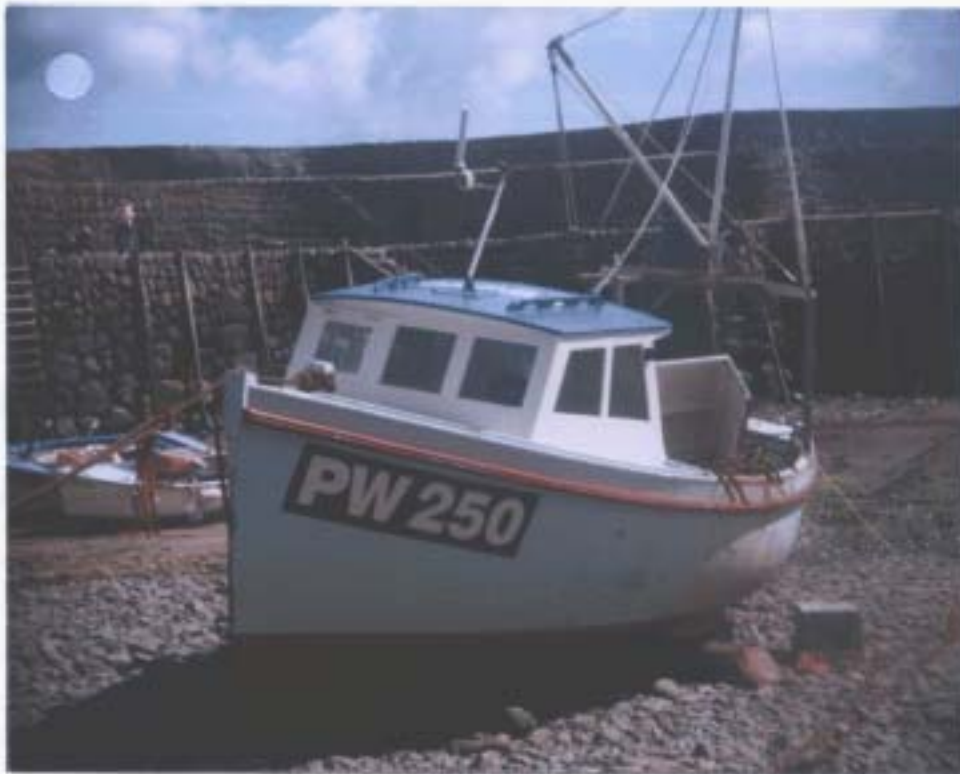
**Figure 3**

*Blue Hooker* was built as a fishing vessel by Pearn's of Looe, Cornwall, in 1974. Mr M J Gist purchased the vessel in 1995, and operated her as a potter. The vessel was surveyed for insurance purposes in June 1998, by an experienced marine surveyor who found her to be in "sound seaworthy condition" (**Figure 3**).

*Blue Hooker* during the survey in June 1998  
Photograph courtesy of Mr A L Hinks
