Report on the investigation of
the contact of the oil tanker

Apollo

with the quayside at
Northfleet Hope Container Terminal
Tilbury, River Thames
on 25 July 2013

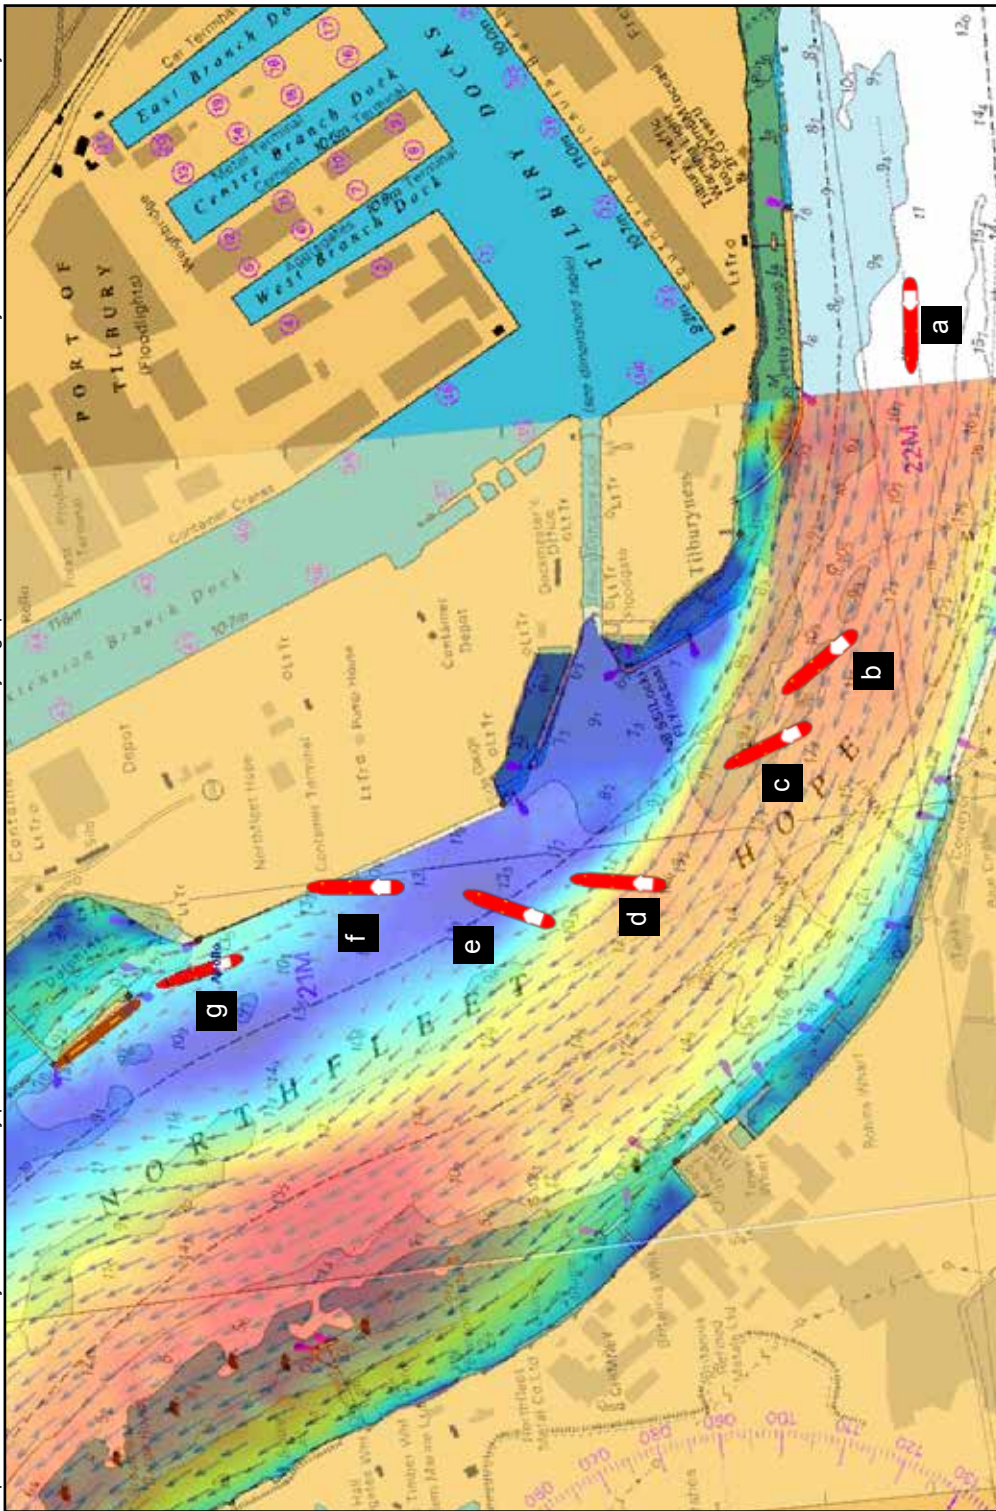
Figures 3 a-g: Apollo's manoeuvre around Tilburyness (showing tidal stream arrows for time of accident)

At 0213 *Apollo* was approaching Tilburyness (**Figure 3a**) when the pilot ordered the helm to starboard 15°; within 30 seconds the vessel's rate of turn⁴ (ROT) became 25°/min to starboard.

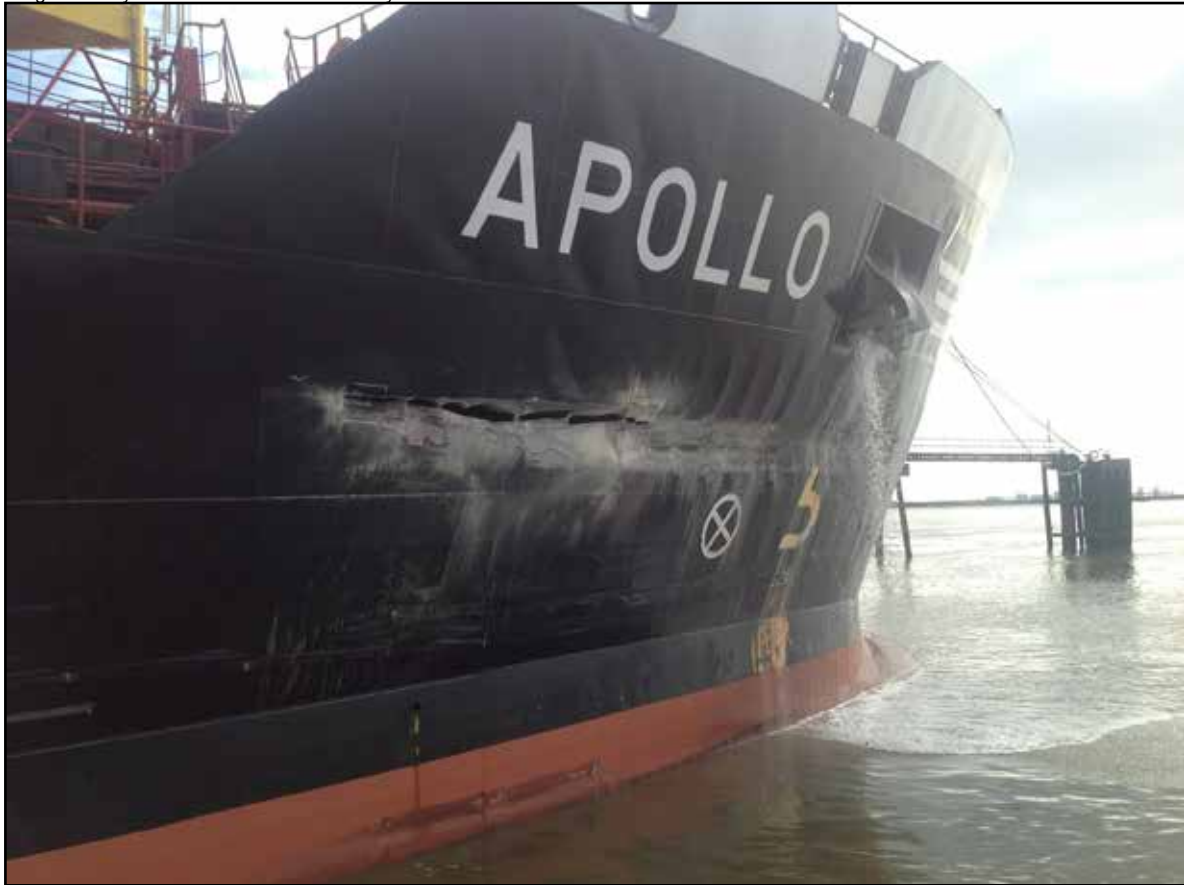
Figure 4: *Apollo* - damage to shell plating

It was found that the shell plating had been holed in way of number 1 starboard water ballast tank, above the waterline, and that the plating was indented in way of the starboard forepeak tank (Figure 4). The shell plating was also found to have been indented above and below the waterline in the area of the starboard shoulder, aft.

Following discharge of *Apollo*'s cargo of 21,730 tonnes of gas oil, temporary repairs were undertaken which were approved by the vessel's classification society, Germanischer Lloyd (GL). A GL surveyor issued a Condition of Class (**Annex D**), which allowed the vessel to proceed to Rotterdam on 27 July 2013 for permanent repairs. The vessel resumed trading on 18 August 2013.

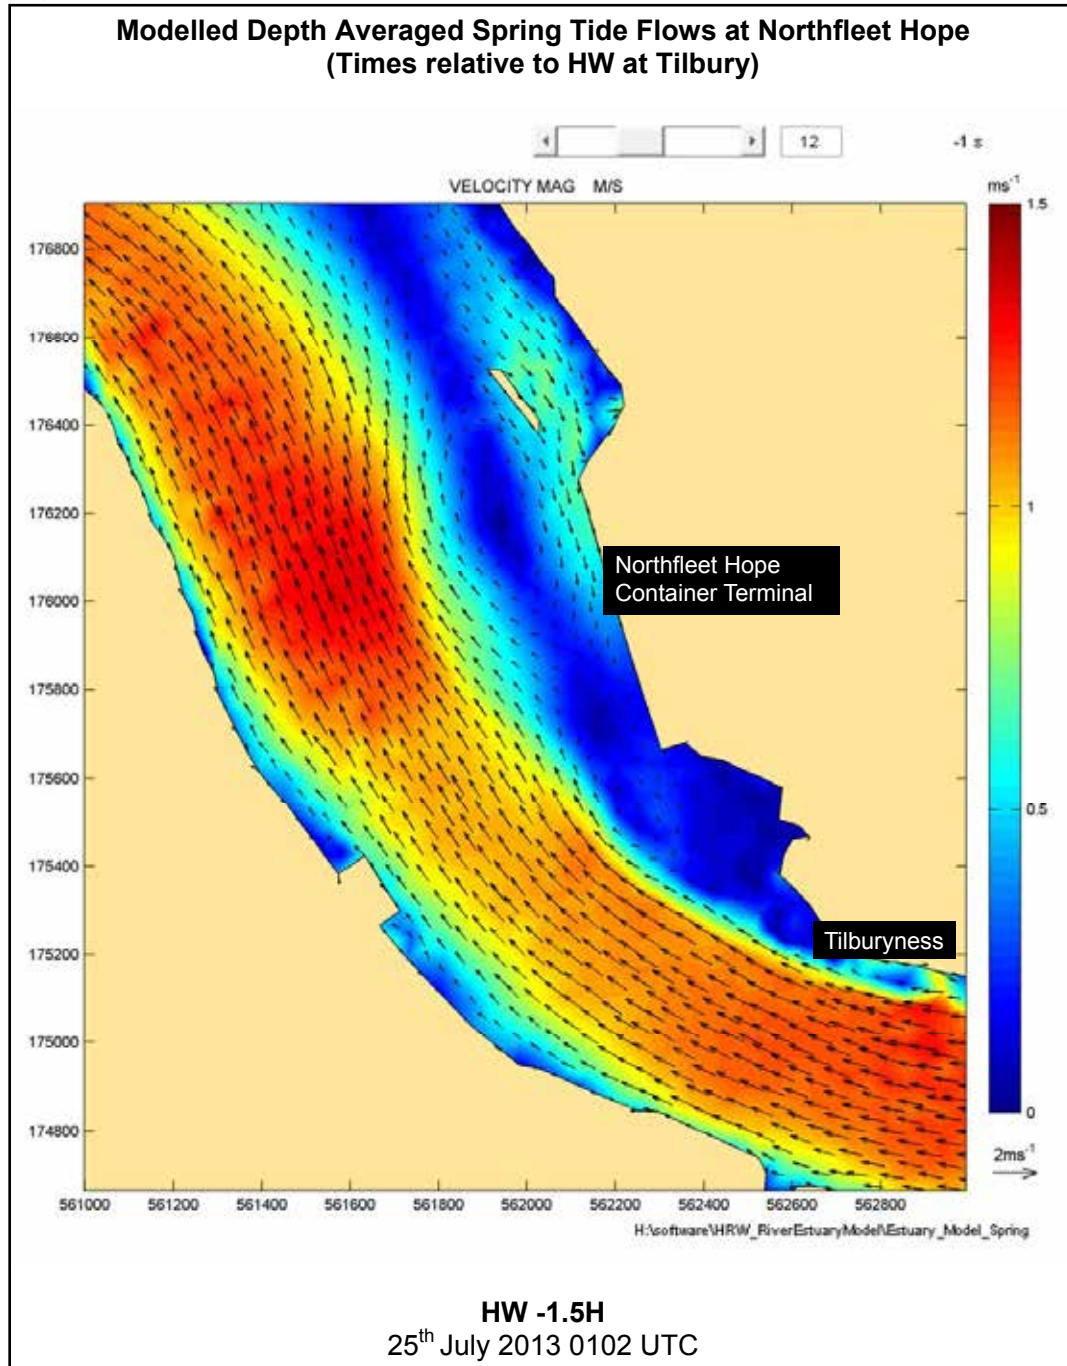
Figure 6: Tidal stream diagram, Tilburyness

The PLA's tidal stream diagram for 1 hour before high water (**Figure 6**) predicted a flood⁵ tidal rate of about 3kn around Tilburyness (coloured: dark red), and showed the extent of the *down drain* (blue) off the container terminal.

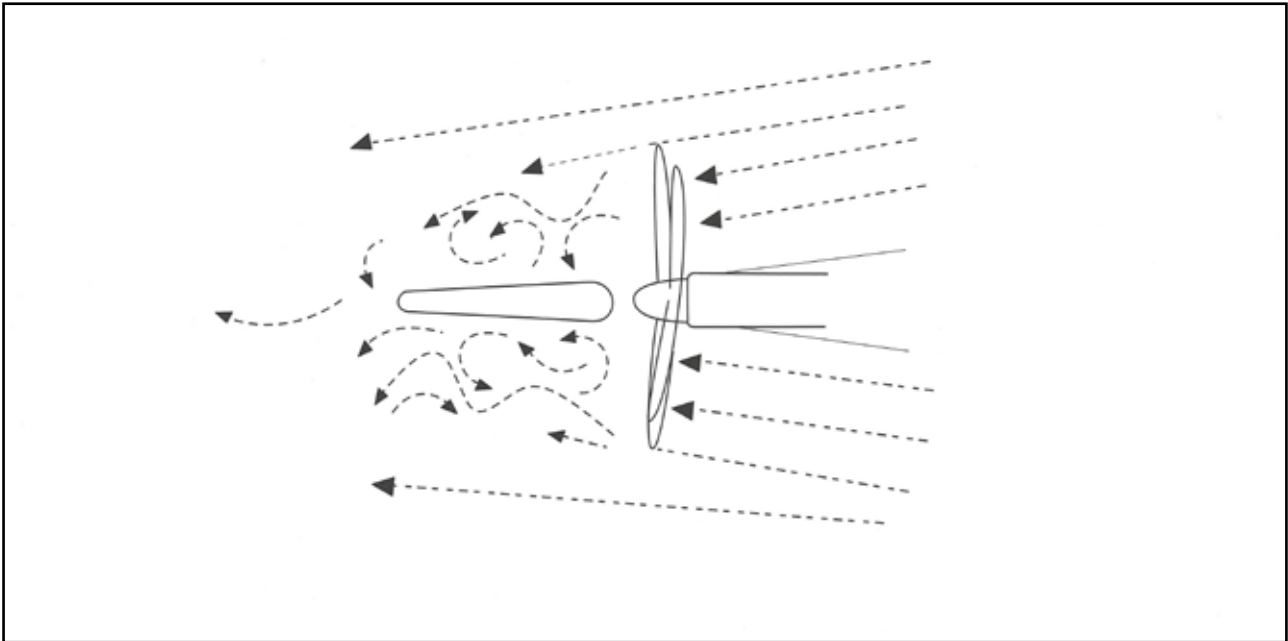
Figure 8: Manoeuvring with a controllable pitch propeller

Apollo hit the quayside as a result of loss of control caused by the Class 3 pilot ordering what he believed to be an FPP to stop while rounding Tilburyness, to reduce the vessel's speed in anticipation of the need to secure two tugs required for the berthing operation. The effect of putting the CPP system to stop was an uncontrollable increase in the vessel's rate of turn that could not be corrected quickly enough to prevent the accident.
