Report of the investigation of
the grounding of
Aqua-boy
Sound of Mull
11 November 2006

Marine Accident Investigation Branch
Carlton House
Carlton Place
Southampton
United Kingdom
SO15 2DZ

Report No 14/2007
July 2007

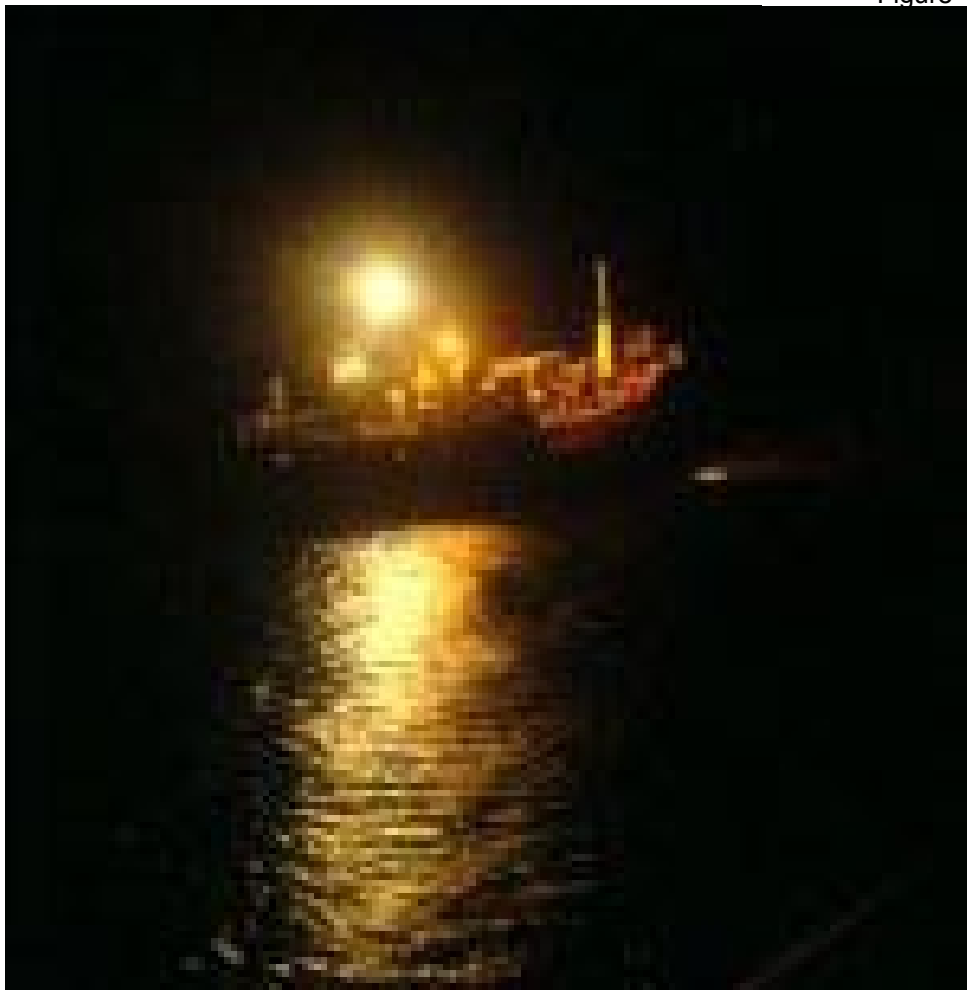
Figure 4

Ronja Commander arrived on scene at about 0400, and *Skán Viking* was released. *Ronja Commander* made her first attempt to tow *Aqua-boy* off at 0408. This failed when again the towline broke. A second unsuccessful attempt was made at 0414. Further attempts were then postponed until the tide had risen. LW had been at 0314, and the vessel was not expected to float until 0600 at the earliest (**Figure 4**).

Photograph taken on scene by RNLI crewman

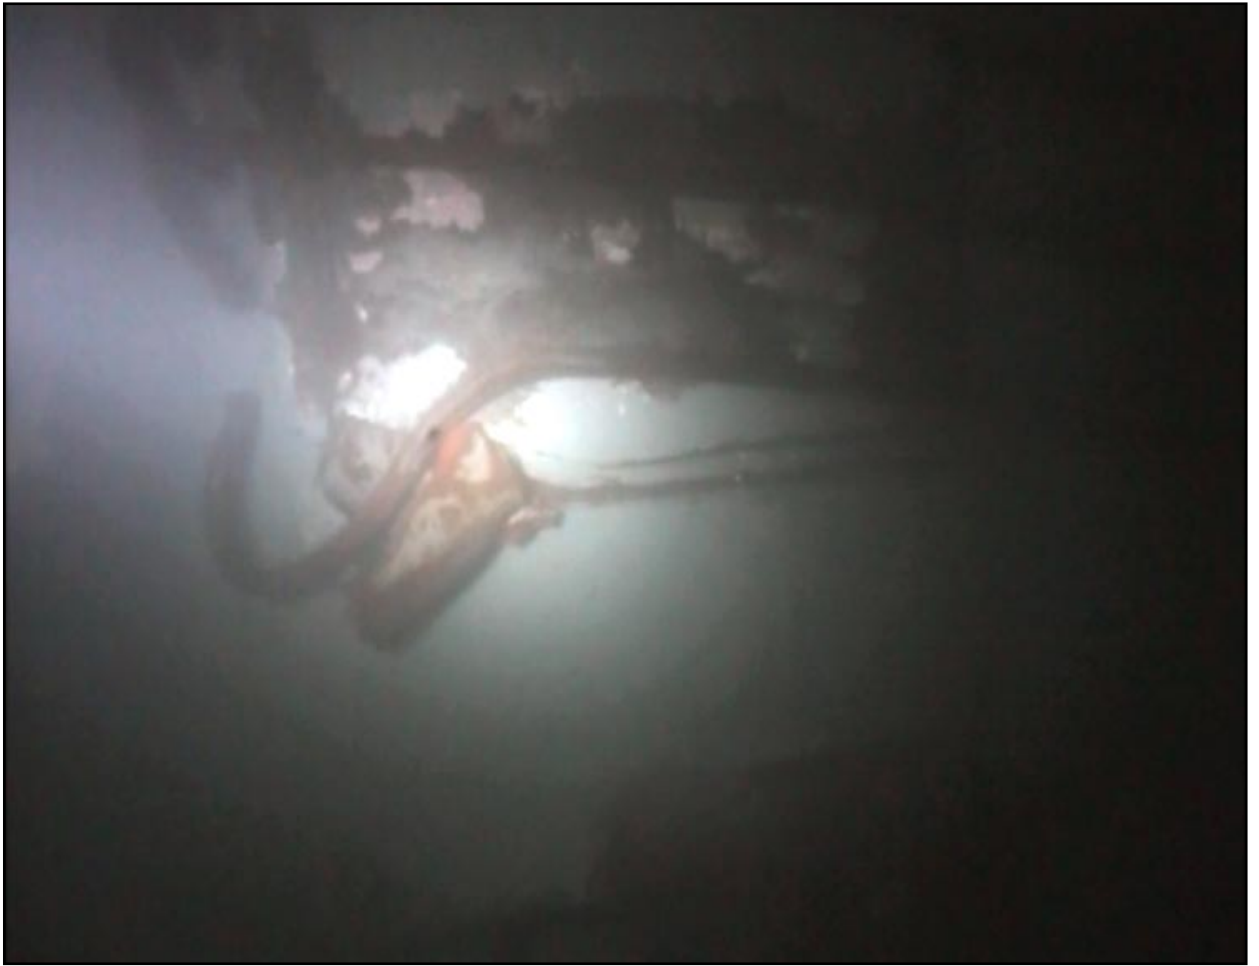
Figure 5a

The resulting damage was restricted to the forward third of the vessel, and consisted of some deep scoring and denting to the hull. In addition, the hull was split in two places. Each split was about 10cm long and both splits were in the vicinity of the bow thruster tunnel, one to port and the other to starboard (**Figures 5a, 5b, 5c**).

Damage to sea valve protection cage

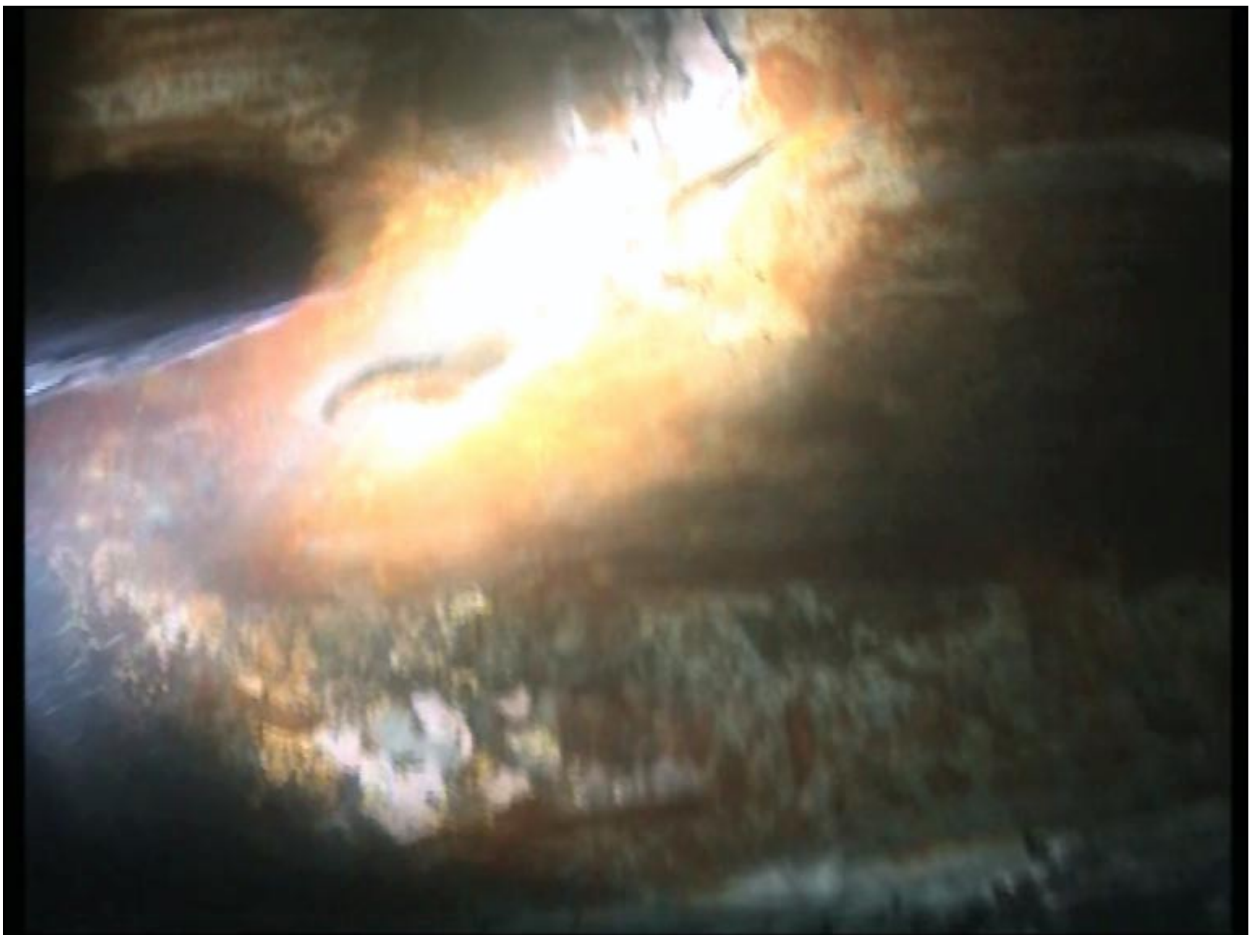
Figure 5b

Although the splits in the hull were small, they were below water level and allowed free flooding of the forward ballast tank. Since this had been partly full before the grounding, there was little change to the vessel's draught when she refloated.

Split in port side of hull

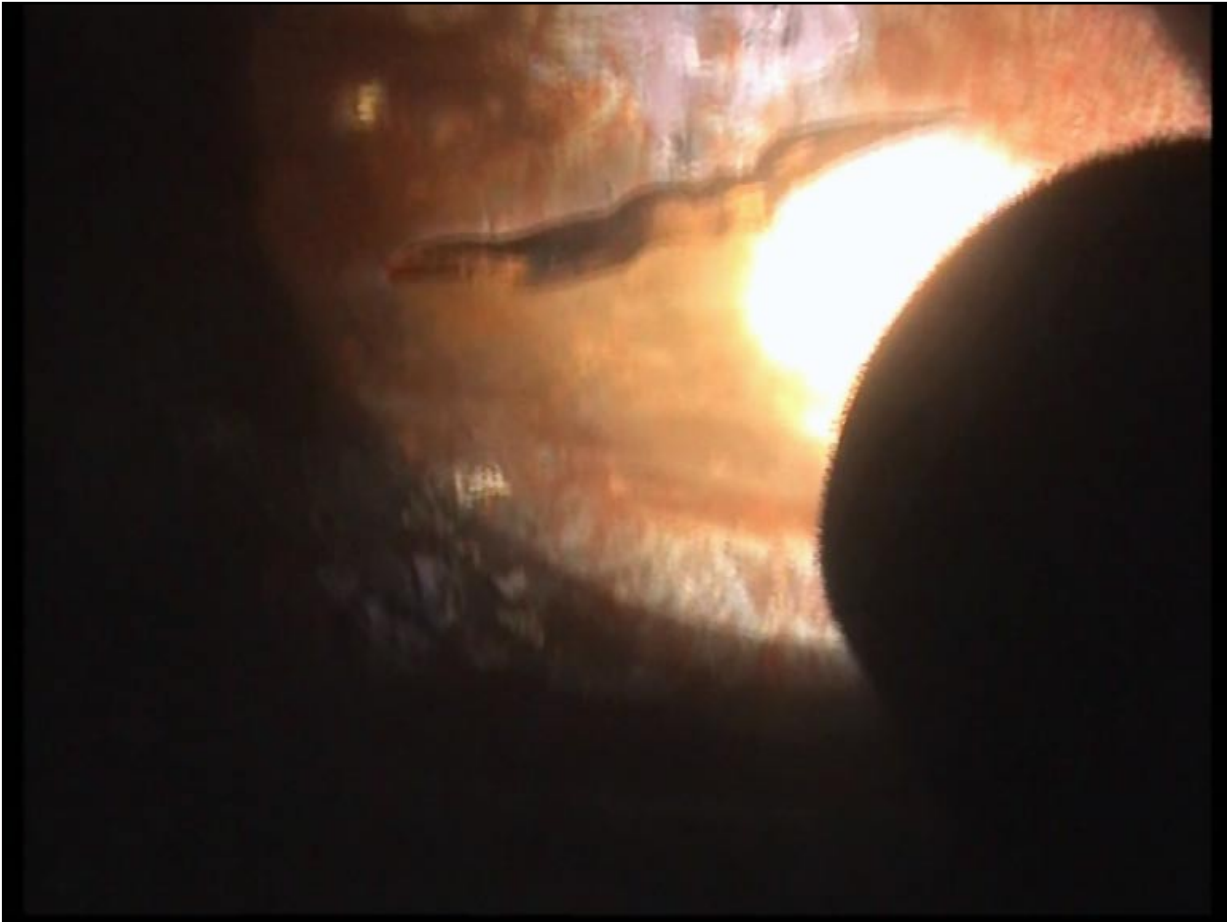
Split in starboard side of hull

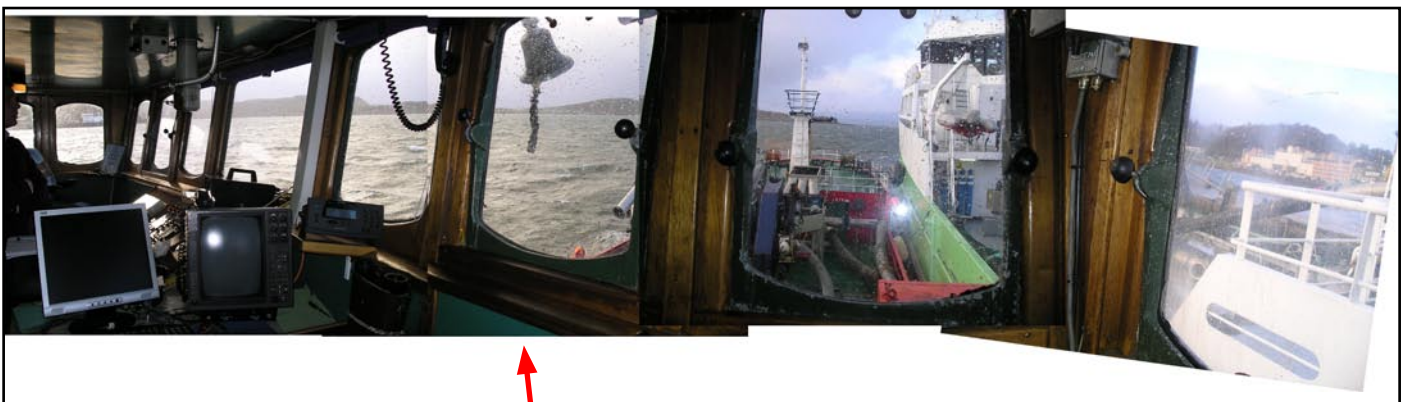
Figure 6

At either end of the console housing the navigation and fish monitoring equipment was a watchkeeper's chair. The steering and engine controls, ECDIS, radar and other navigation electronics were all within reach and view of a person sitting in the starboard chair. However, the chair was fitted close to the bridge front and, in order to fit the footrest in the space available, it had been fixed permanently facing about 45° to port (**Figure 6**). This meant that if the watchkeeper wished to look to starboard, he had to look over his right shoulder (**Figure 7a**). In addition, the view looking ahead from the starboard watchkeeper's chair was partially obscured by the frame of the bridge windows.

View straight ahead from chair

Composite photograph illustrating view from starboard chair

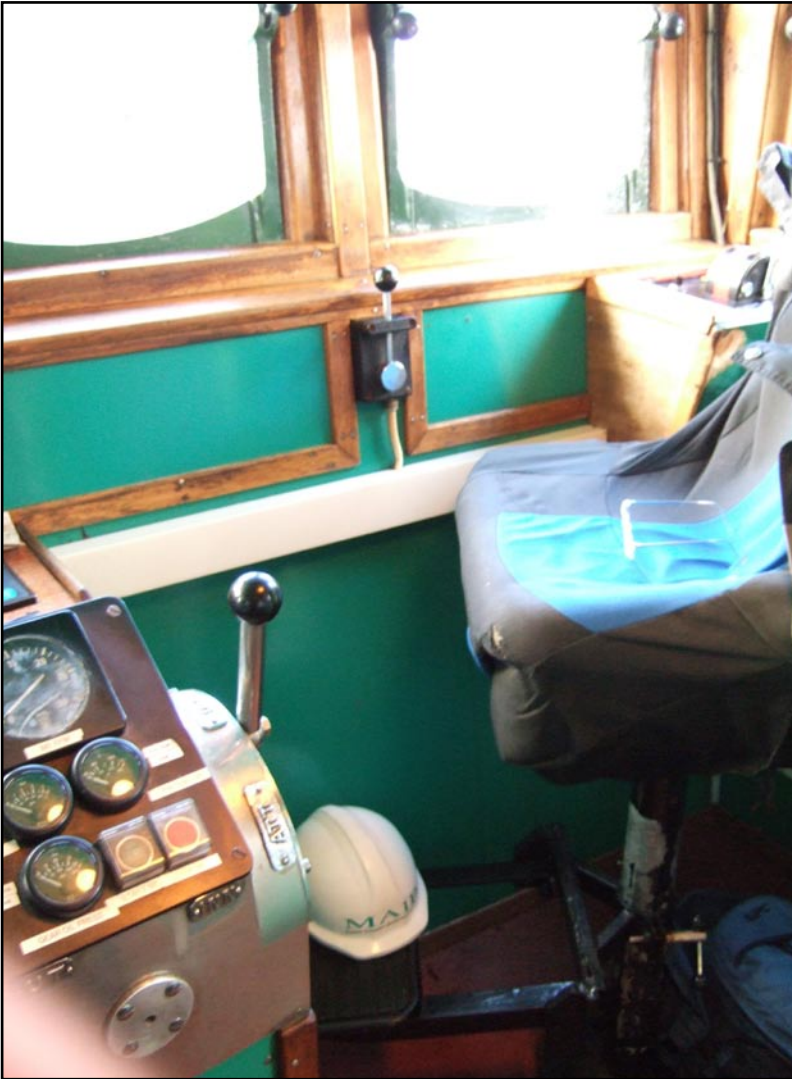
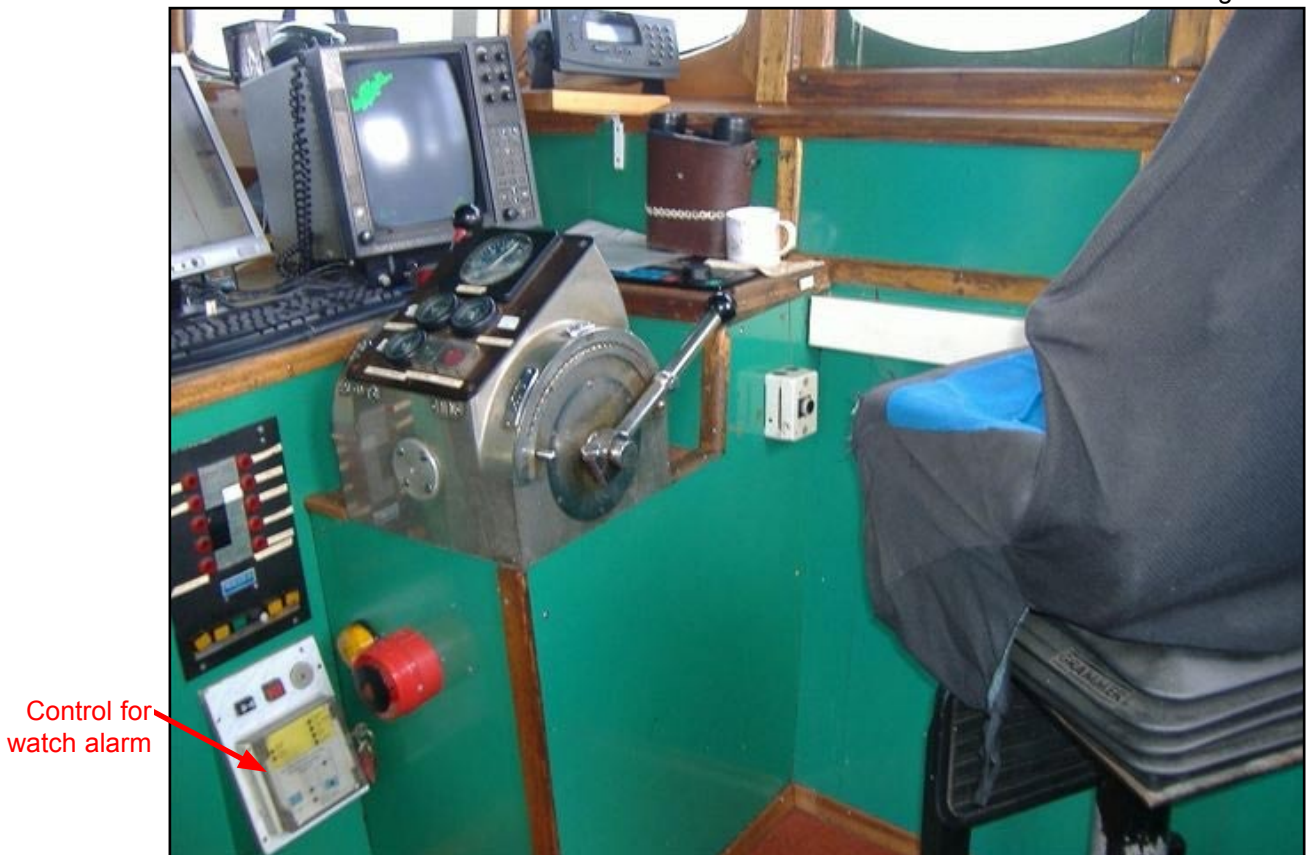
Around the starboard watchkeeper's chair were fitted a radar, ECDIS, the AIS receiver which was linked to the ECDIS, the steering, engine and bow thruster controls and a VHF radio handset (**Figures 7a, 7b**). The operation of each piece of equipment could be carried out without the watchkeeper moving from the chair. This operating position occupied a little under half of the available space at the front of the bridge. The rest of the space was taken up with the console containing the equipment for monitoring the condition of the fish and the second watchkeeper's chair on the port side of the bridge.

A watch alarm was fitted. This consisted of a motion sensor directed at the starboard watchkeeper's chair. Any movement within the viewing arc of the sensor would reset the timer and the alarm would not sound. The control panel was situated to port and within reach of the starboard watchkeeper's chair. The alarm system was turned off at the time of the accident.

The starboard watchkeeper's chair

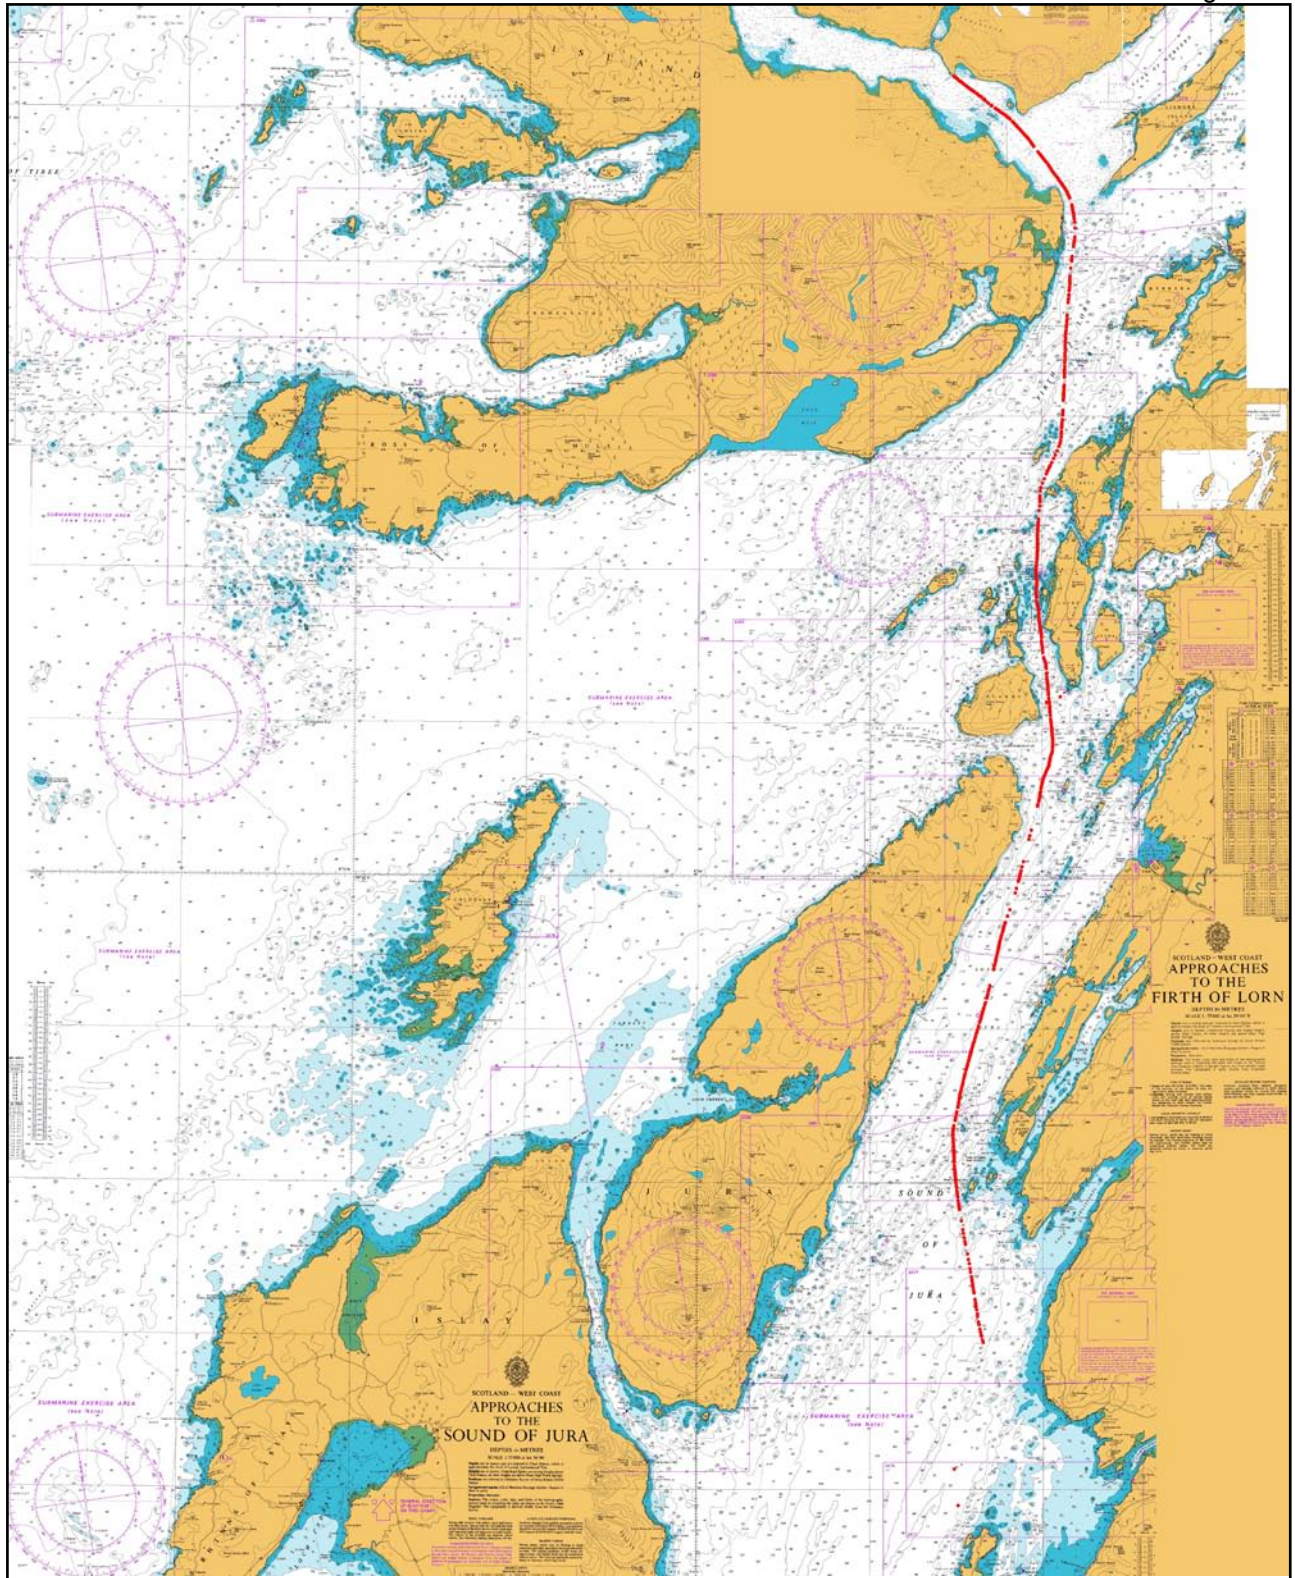
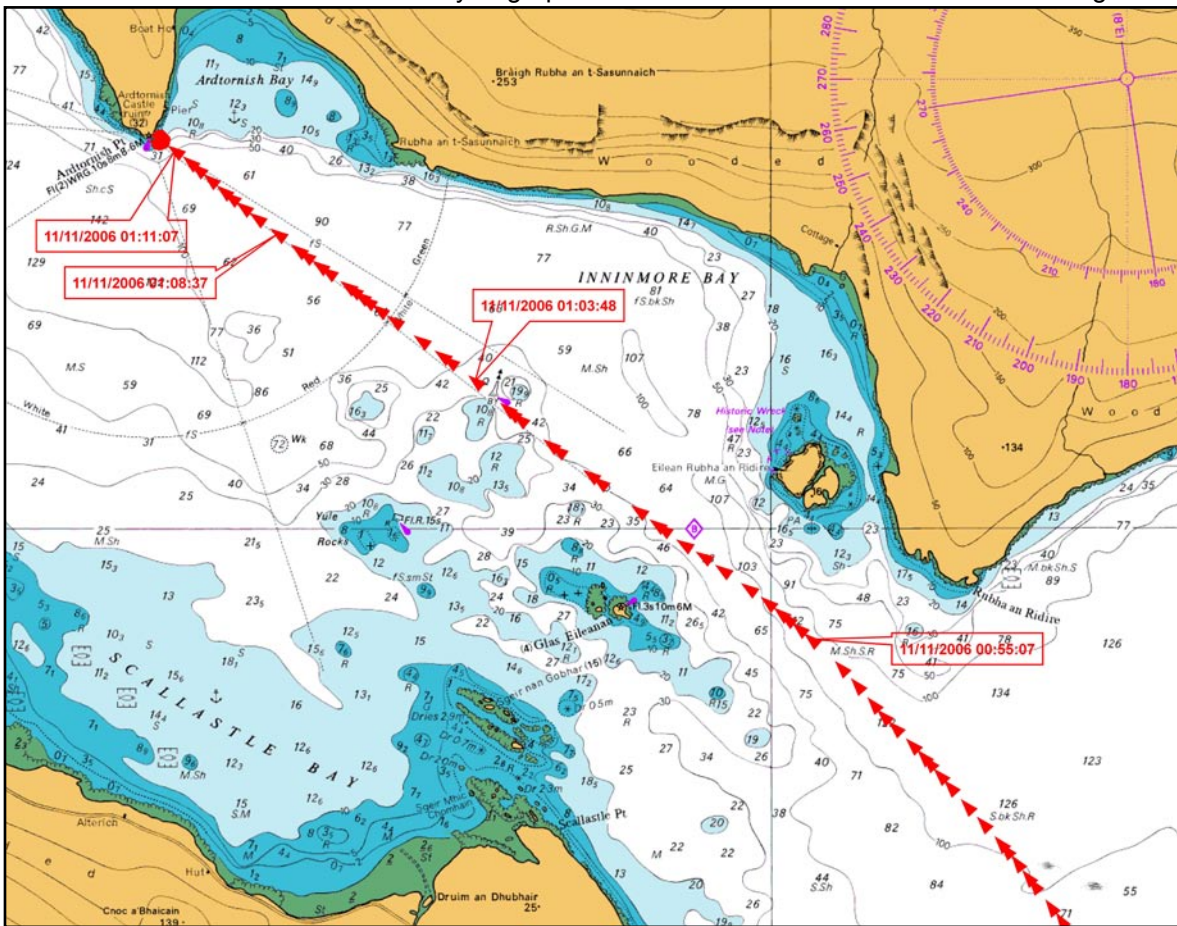
AIS data recorded by the MCA was obtained by the MAIB, and the position and time data from this was entered into a Geographic Information System (GIS). This was then superimposed over charts of the area, and used to recreate the movements of *Aqua-boy* (**Figures 8a, 8b**). From this data, a more precise time for the grounding was obtained – 0112.

Both sets of data indicate that the vessel passed very close to the Inninmore Bay Buoy, some 10 minutes before the grounding. The condition of the buoy was checked by the Northern Lighthouse Board in the week following the grounding, but no damage was found.

AIS data showing voyage from Gigha

AIS data showing voyage through the Sound of Mull

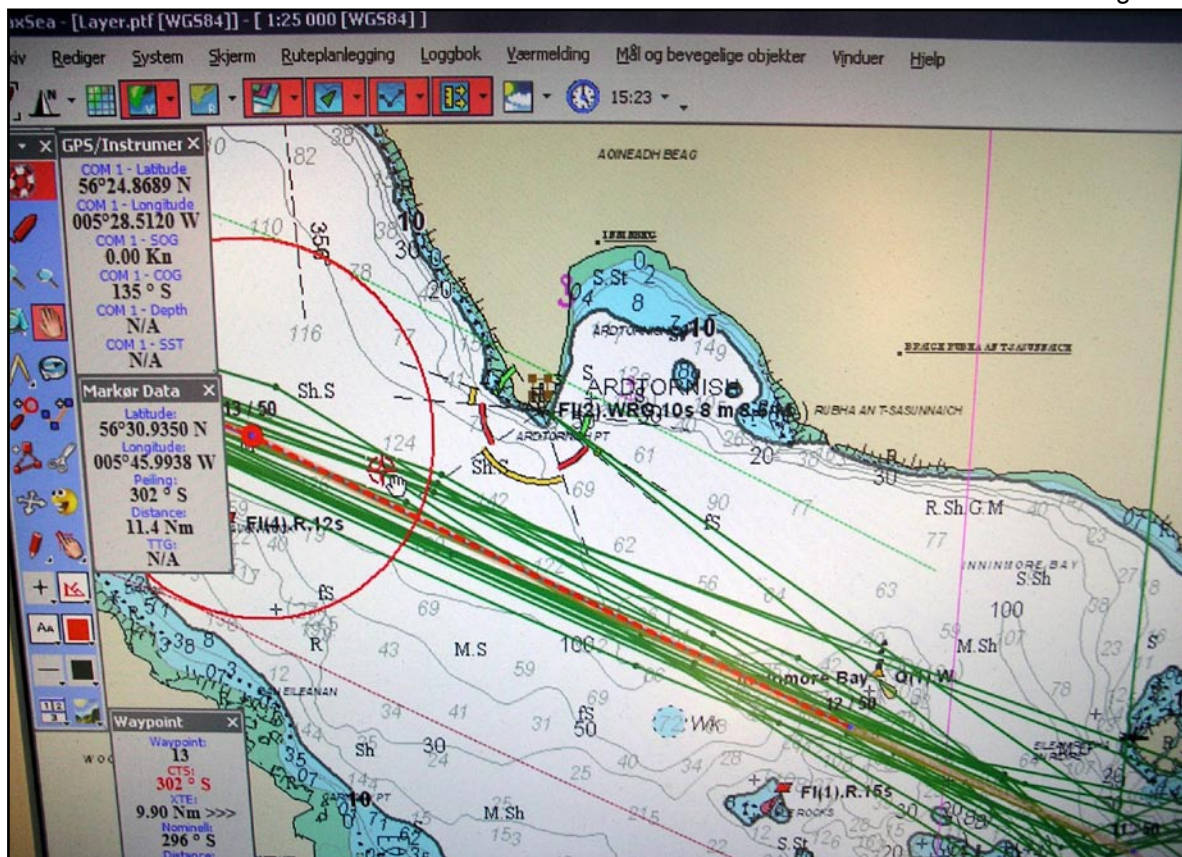
Figure 9

Aqua-boy was not required to be fitted with, and did not have a Voyage Data Recorder. However, position and time data was recovered from the logbook facility of the ECDIS. The logbook stored the position, course and speed of the vessel at 90 minute intervals, and also recorded the times that the vessel passed its waypoints (**Figure 9**). It was possible to display the approximate past track of the vessel from this logged data as a series of lines joining the stored positions.

ECDIS logbook
