Report on the investigation of
the capsizing of the fishing vessel

Aquila

with the loss of three lives
Bo Faskadale Reef, Ardnamurchan
on 20 July 2009

Report No 5/2010
April 2010

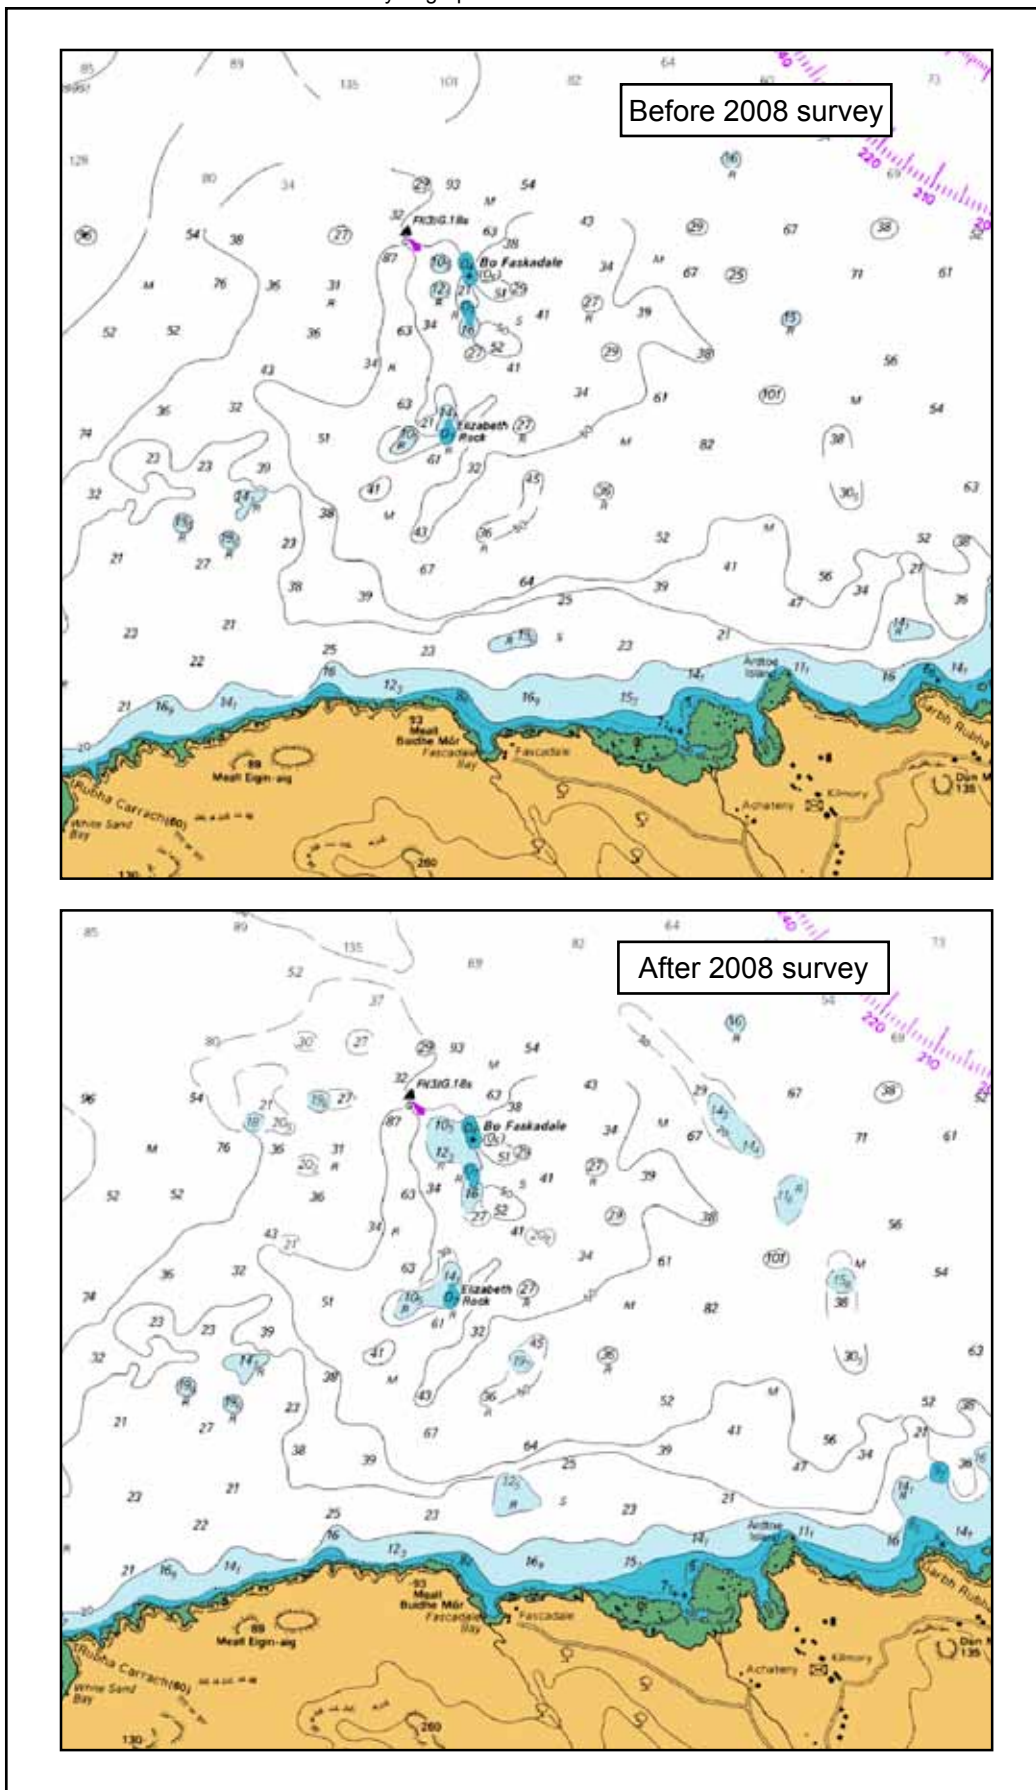
A hydrographic survey of the reef and surrounding area, using modern technology, was undertaken by the MCA in December 2008. The previous survey of this area had been undertaken in 1862 using a hand leadline only. As a result of the significant differences discovered in depths between the two surveys, a new edition of the chart of the area was published, as a matter of urgency, by the UK Hydrographic Office (UKHO) in January 2009 (**Figure 11**).

The electronic chart system in use on *Aquila* at the time of the accident had not been updated with the latest chart edition.

BA chart 2207 (showing depths before and after the MCA's survey, December 2008)

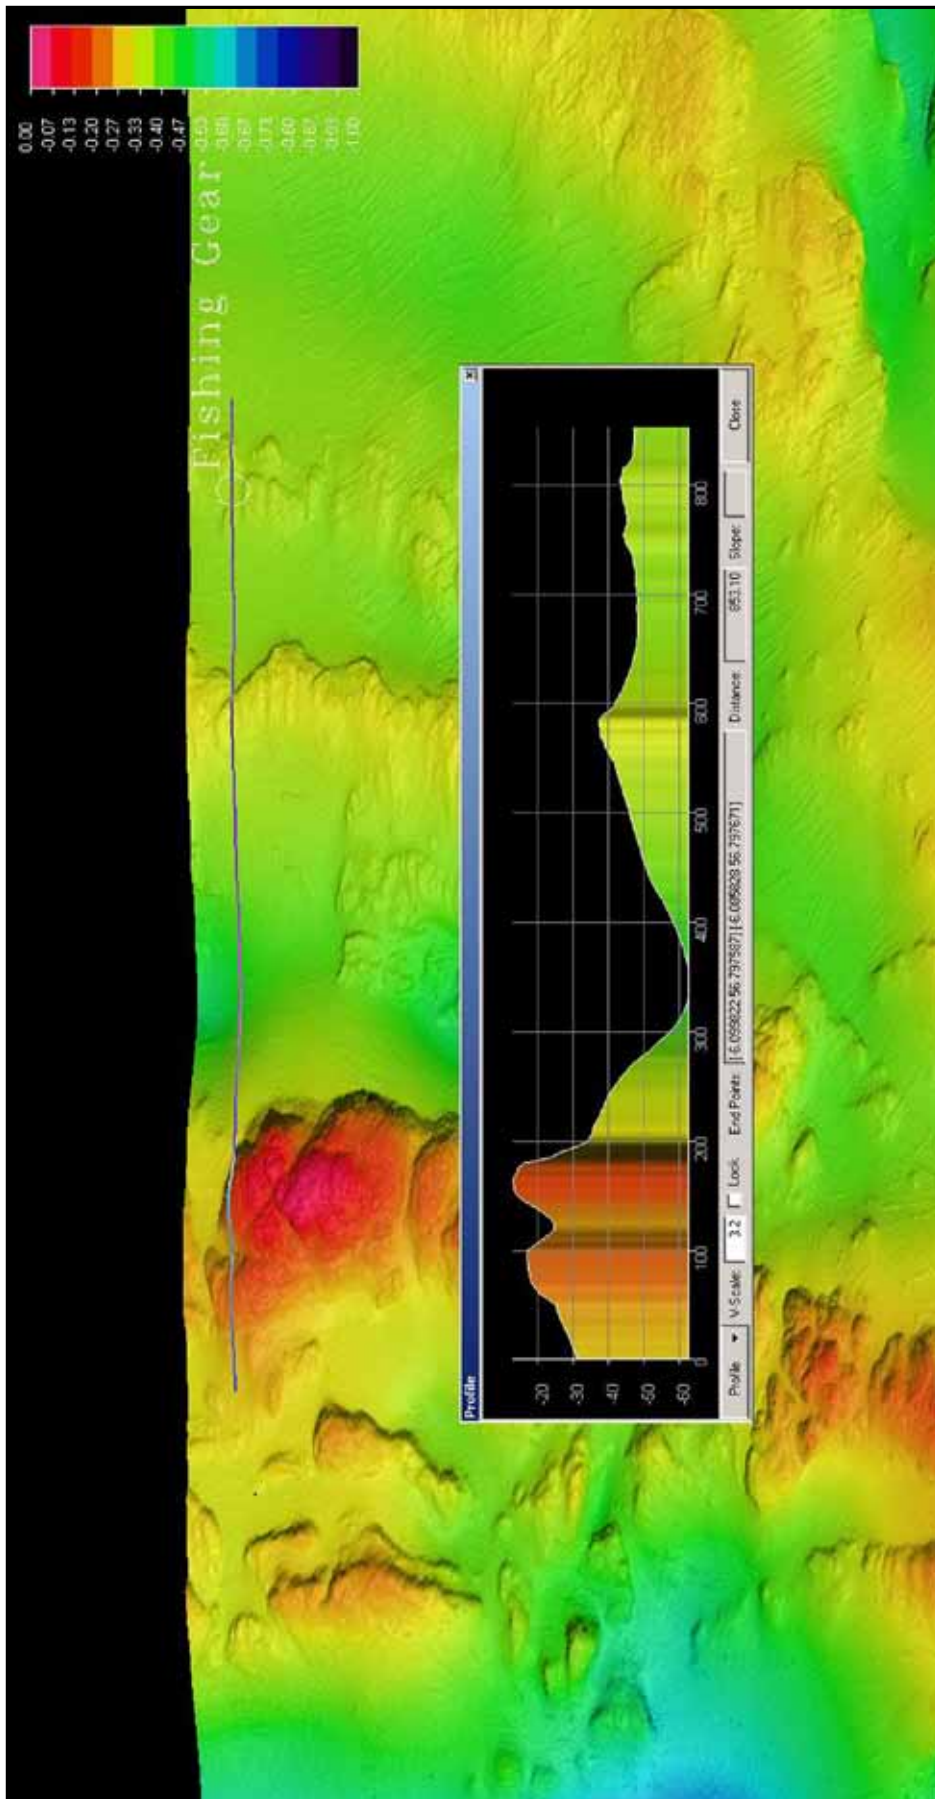
The position of the accident, and *Aquila*’s probable course at the time of the accident, were superimposed onto the latest seabed survey information obtained from the MCA (**Figure 12**). Analysis of this information showed that, while dredging, several metres of the trawl warp would have been in contact with the seabed before it became snagged.

Seabed profile showing track of fishing gear
