Report on the investigation of

a fatal accident on board

Arco Adur

**Report No 23/2003
September 2003**

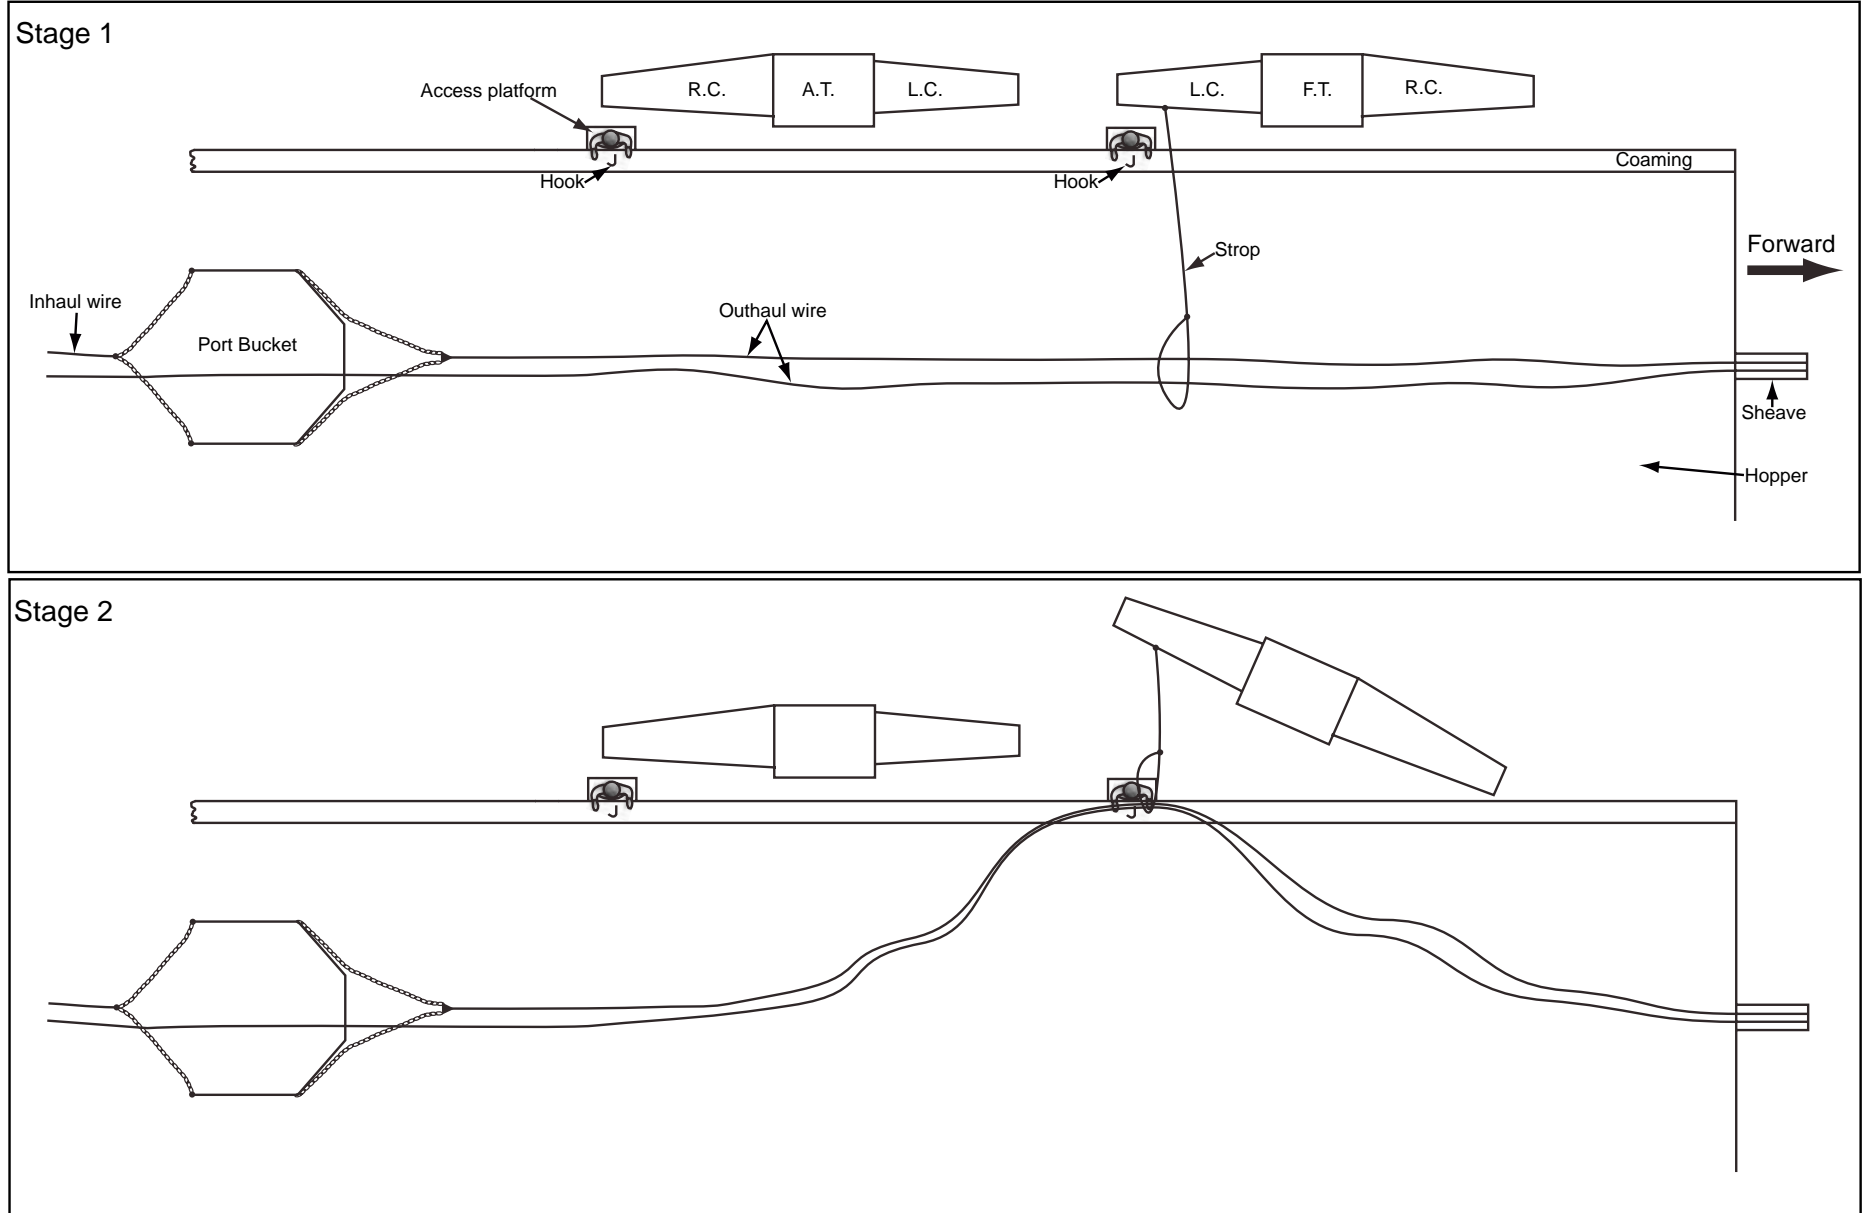
Figure 2a

Meanwhile, in preparation for loading, the AB on the forecastle had made his way aft to the port main deck, and was in the process of hanging-off the port drag scraper bucket outhaul wires to the port coaming of the cargo hopper. This involved lowering a strop with a grapple attached into the cargo hopper, to hook on to the outhaul wires. This strop was then attached to the loading chute of the forward loading tower. The tower was used to assist in lifting and swinging the wires away from the hold. Moving the wires clear of the hold prevented them being damaged by aggregate during the loading operation, and also prevented the aft tower loading chute from fouling the wires **(Figures 2a, 2b, and 3)**.

Port drag scraper bucket Outhaul wire hanging-off operation

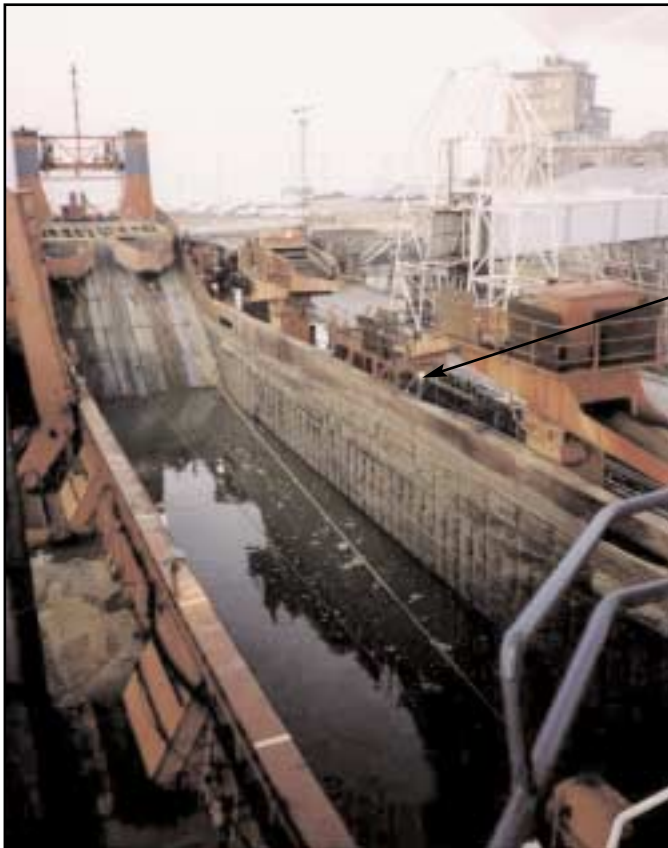
Photograph 2

View from bridge loading console

Aft loading tower

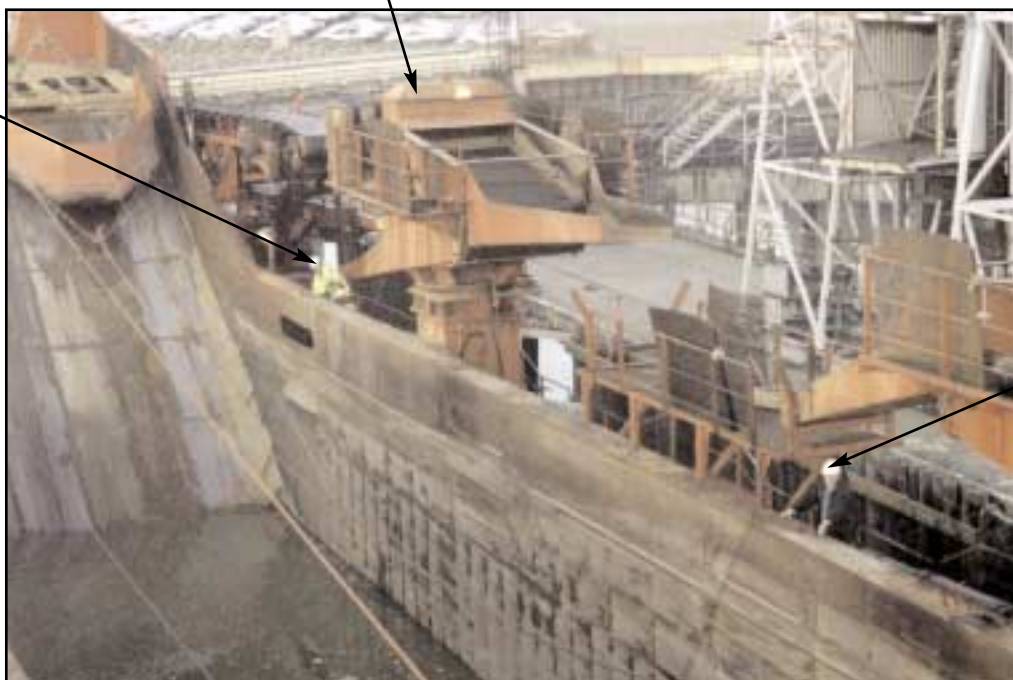
Photograph 3

The second mate, realising that Sid Mattingley had been standing on a platform between the aft tower reject chute and the coaming (**Photograph 3**), immediately swung the aft tower in the opposite direction.

Position of bosun

Enlarged view of crew positions immediately before the accident

1. A fleet-wide risk assessment of shipboard activities was instigated.
2. The operation which caused the accident was stopped, and the bucket wire access platforms moved so as to keep crew members clear of danger, regardless of the operation of the loading towers.

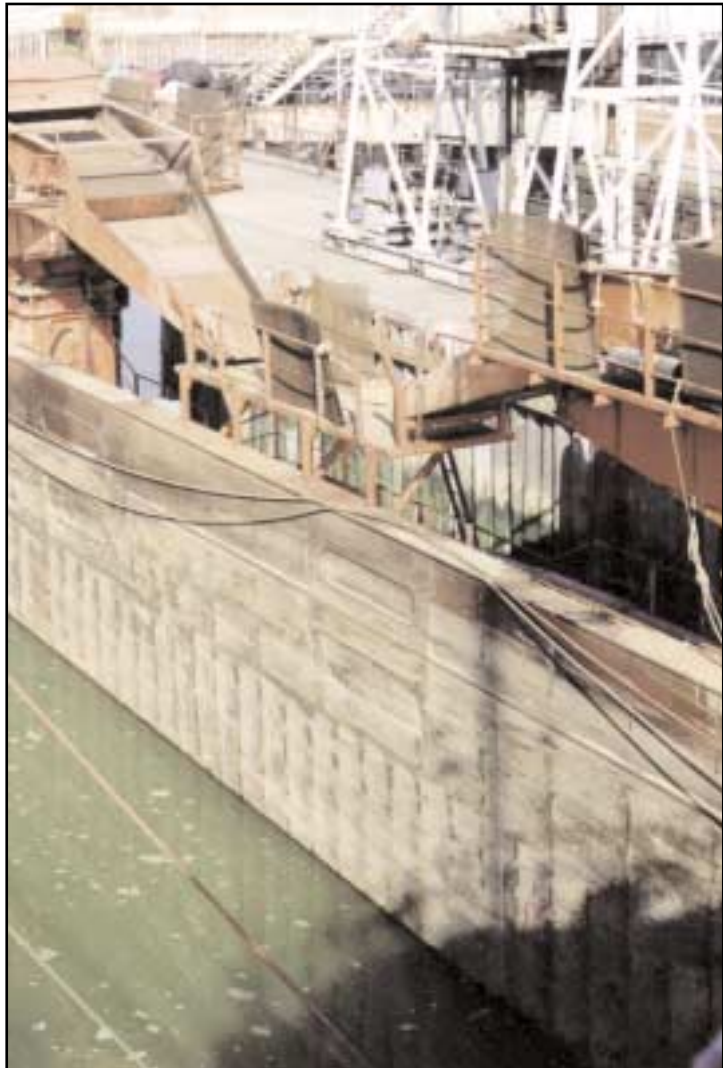
Photograph 11

View from bridge loading console of outhaul wire retained behind forward hook

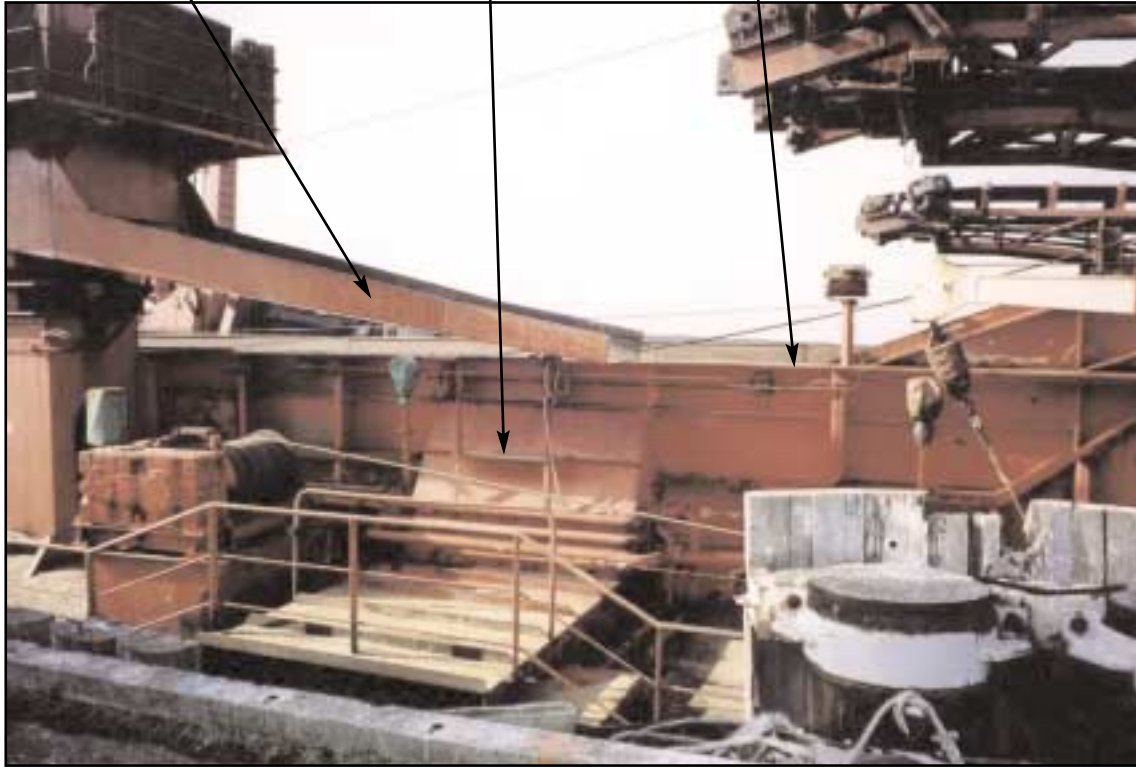
View of aft tower reject chute and platform
