Report on the investigation of the collision between

Audacity

Leonis

Report No 2/2008
January 2008

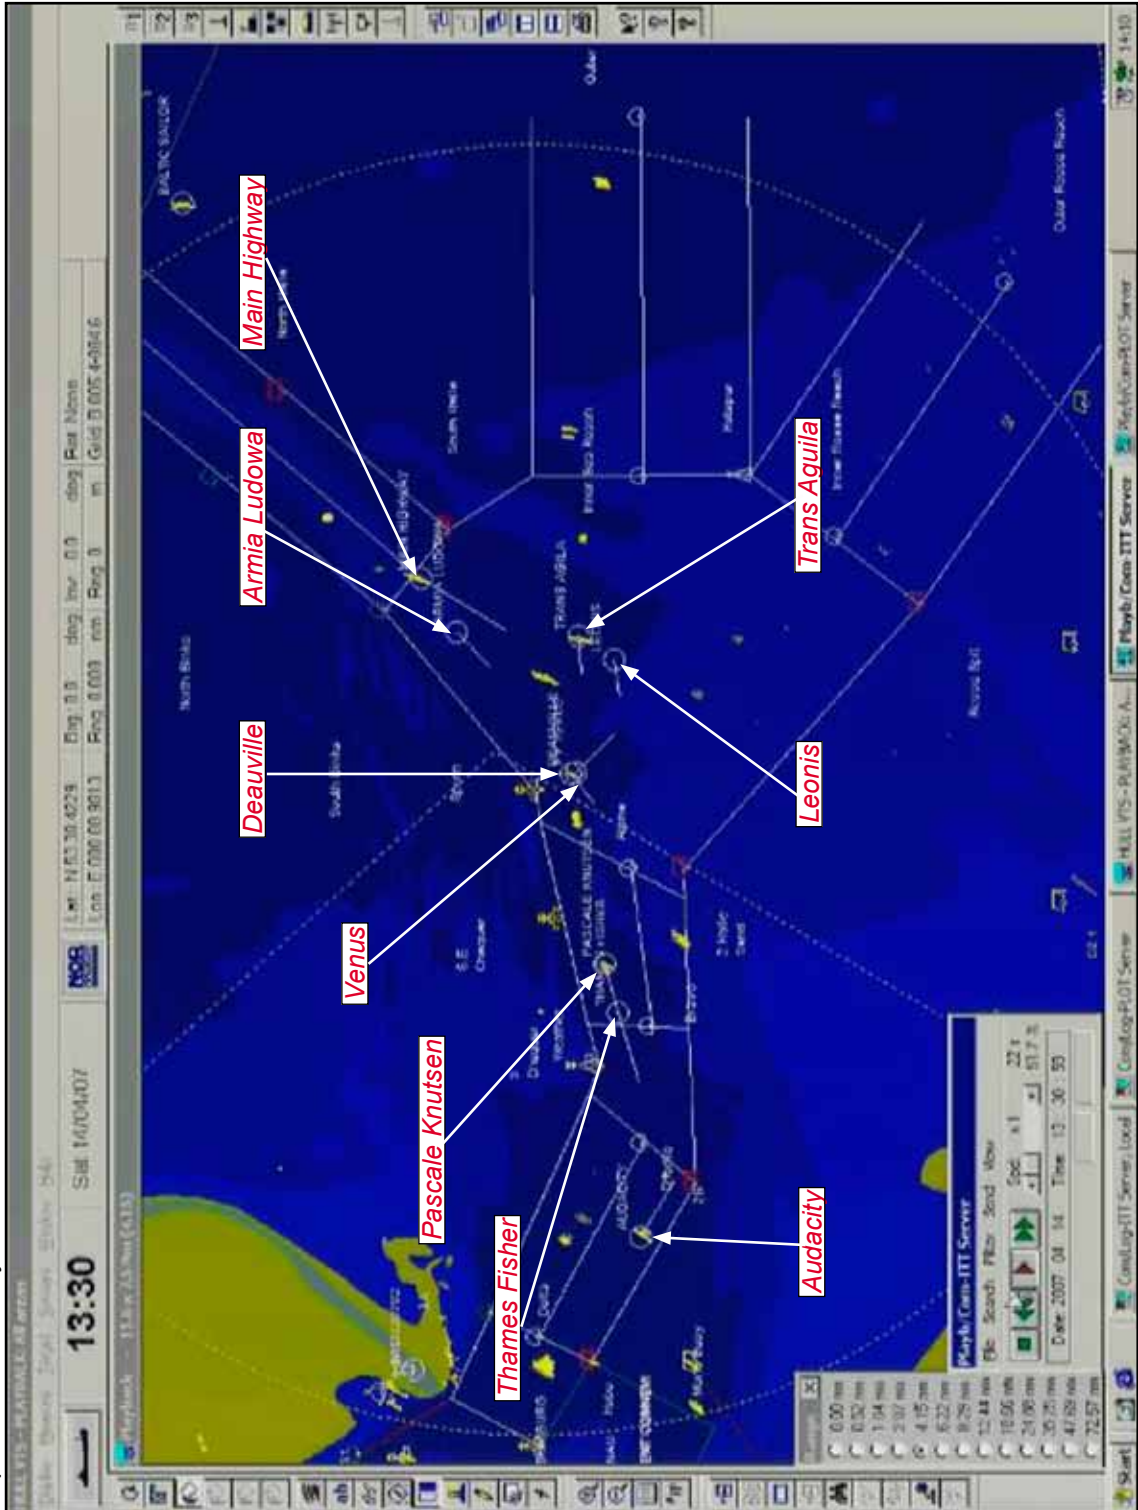
Figure 1

The positions of these vessels at 1330 are shown on a chartlet of the VTS area (**Figure 1**). The turn allocated to each vessel to embark a pilot was determined both by time of arrival and the vessel's final destination. As can be seen at **Figure 1**, at 1330 *Armia Ludowa* and *Trans Aquila* are further from the pilot boarding area than *Leonis*, however they were scheduled to embark a pilot before *Leonis* due to the latter's shorter river transit.

VTS Humber screen shot at 13:30

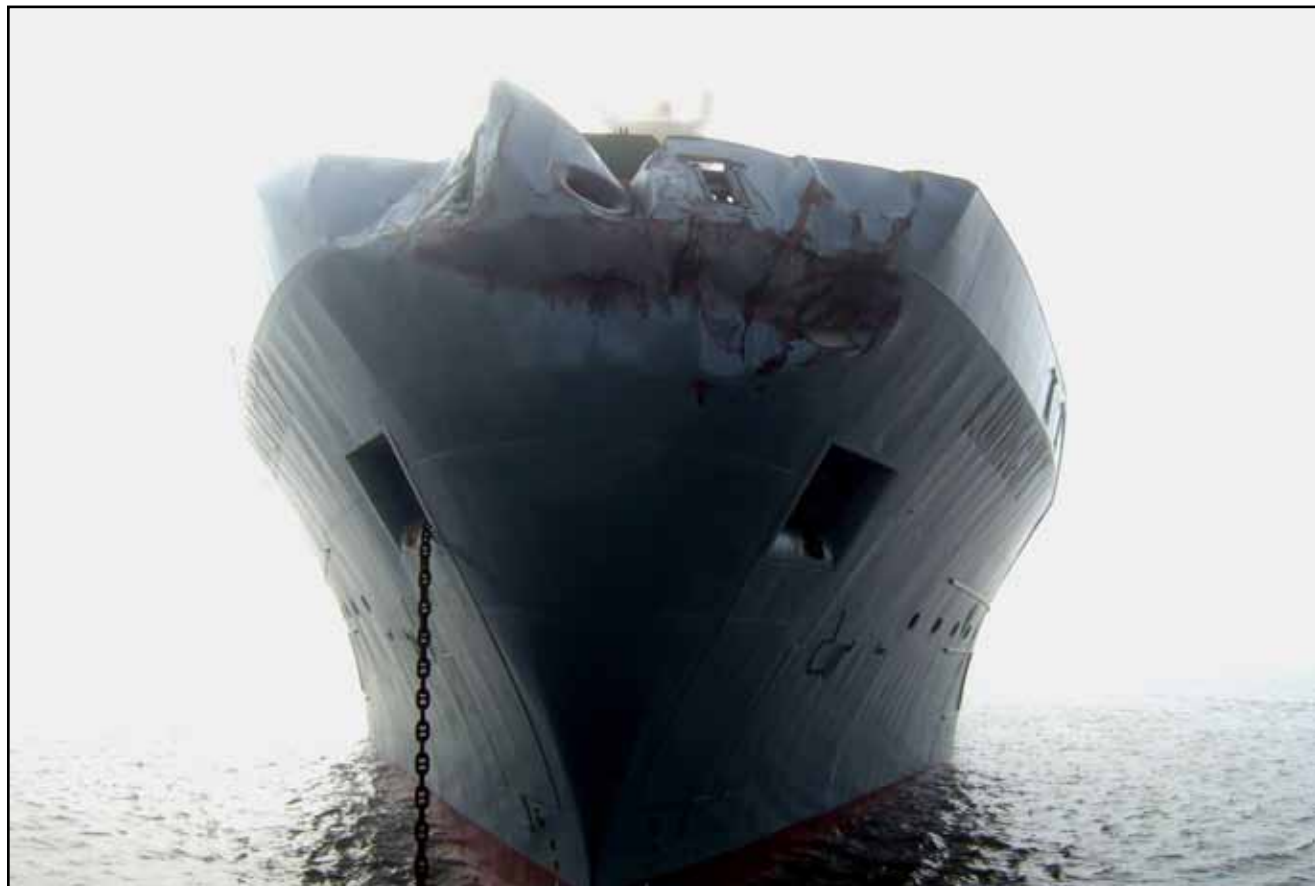
Accident details	
Time and date	: 1351 Local Time (UTC +1) on 14 April 2007
Location of incident	: Precautionary area approaching Spurn Point
Injuries/fatalities	: No injuries or fatalities
Damage	: Both vessels suffered significant bow damage.

Damage to the bow of *Audacity*

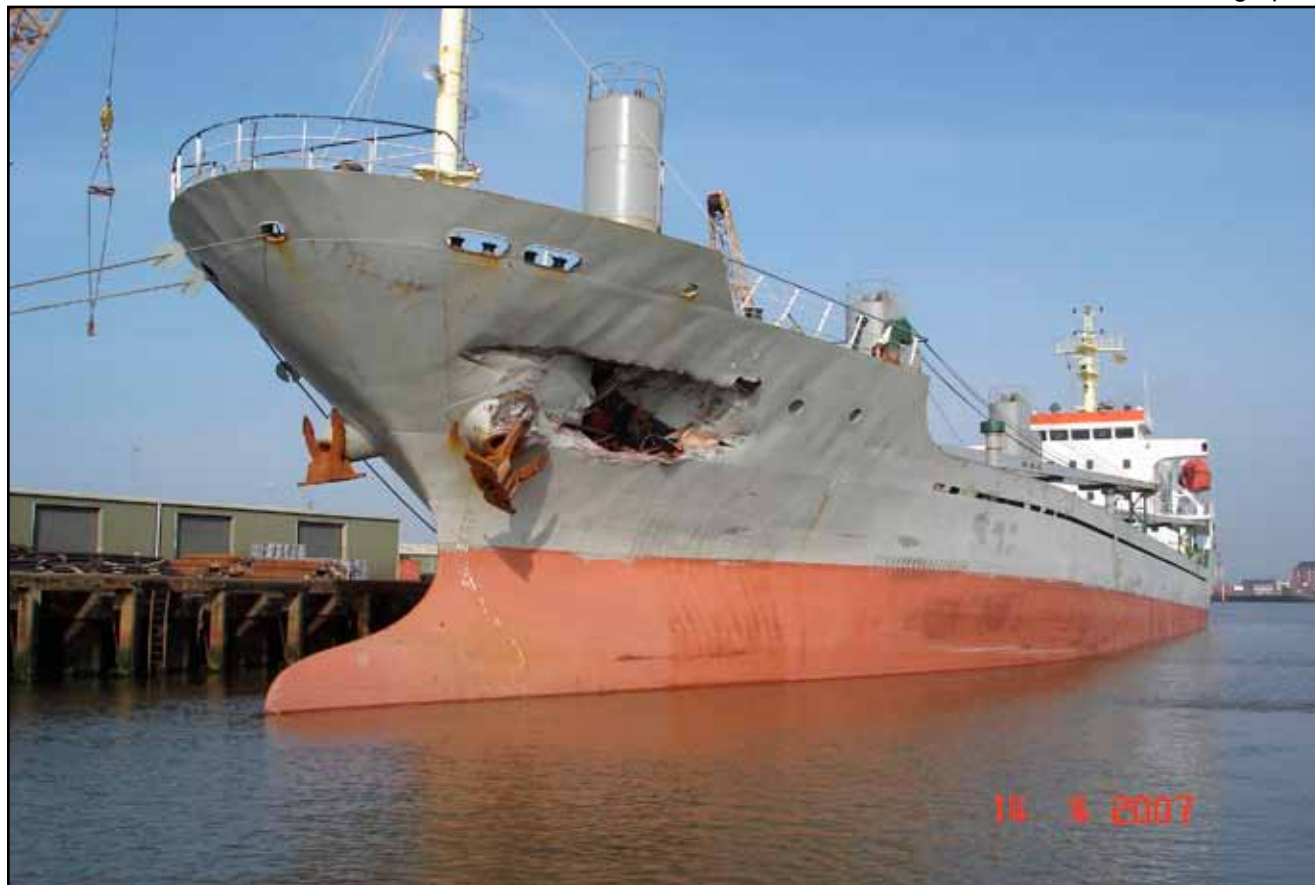
Damage to *Leonis*

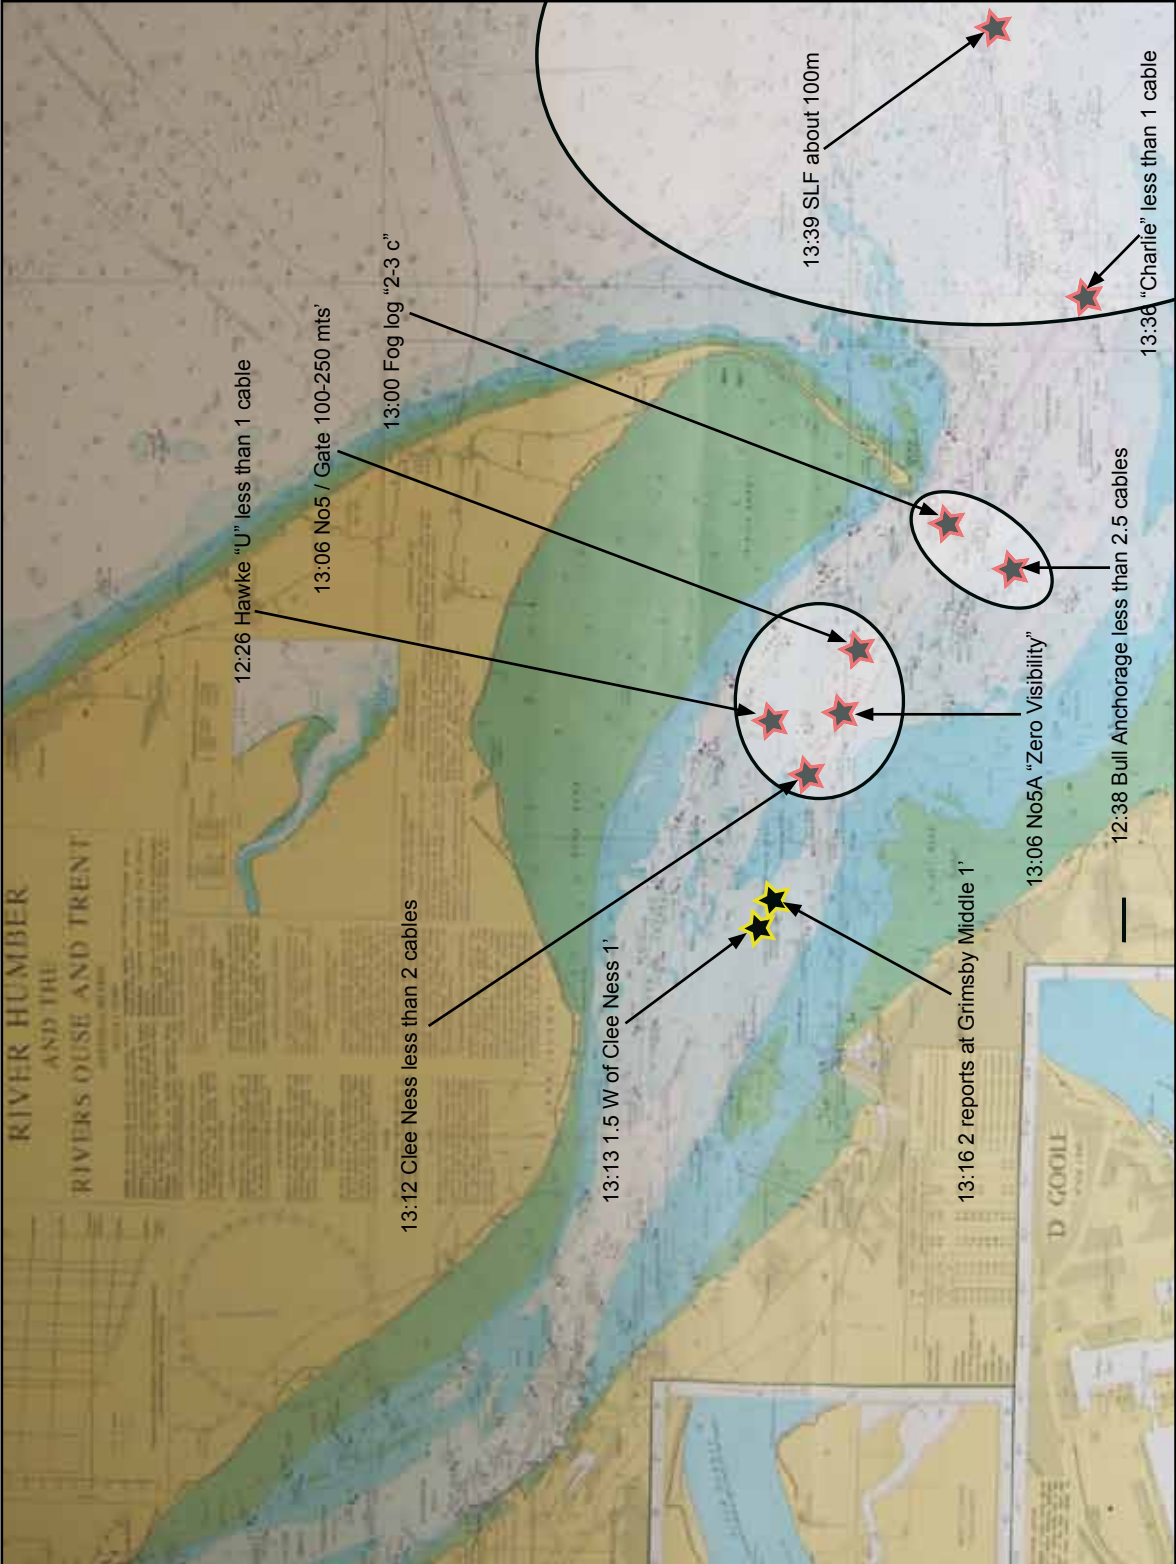
Figure 2

Estimated visibility within the Humber Estuary

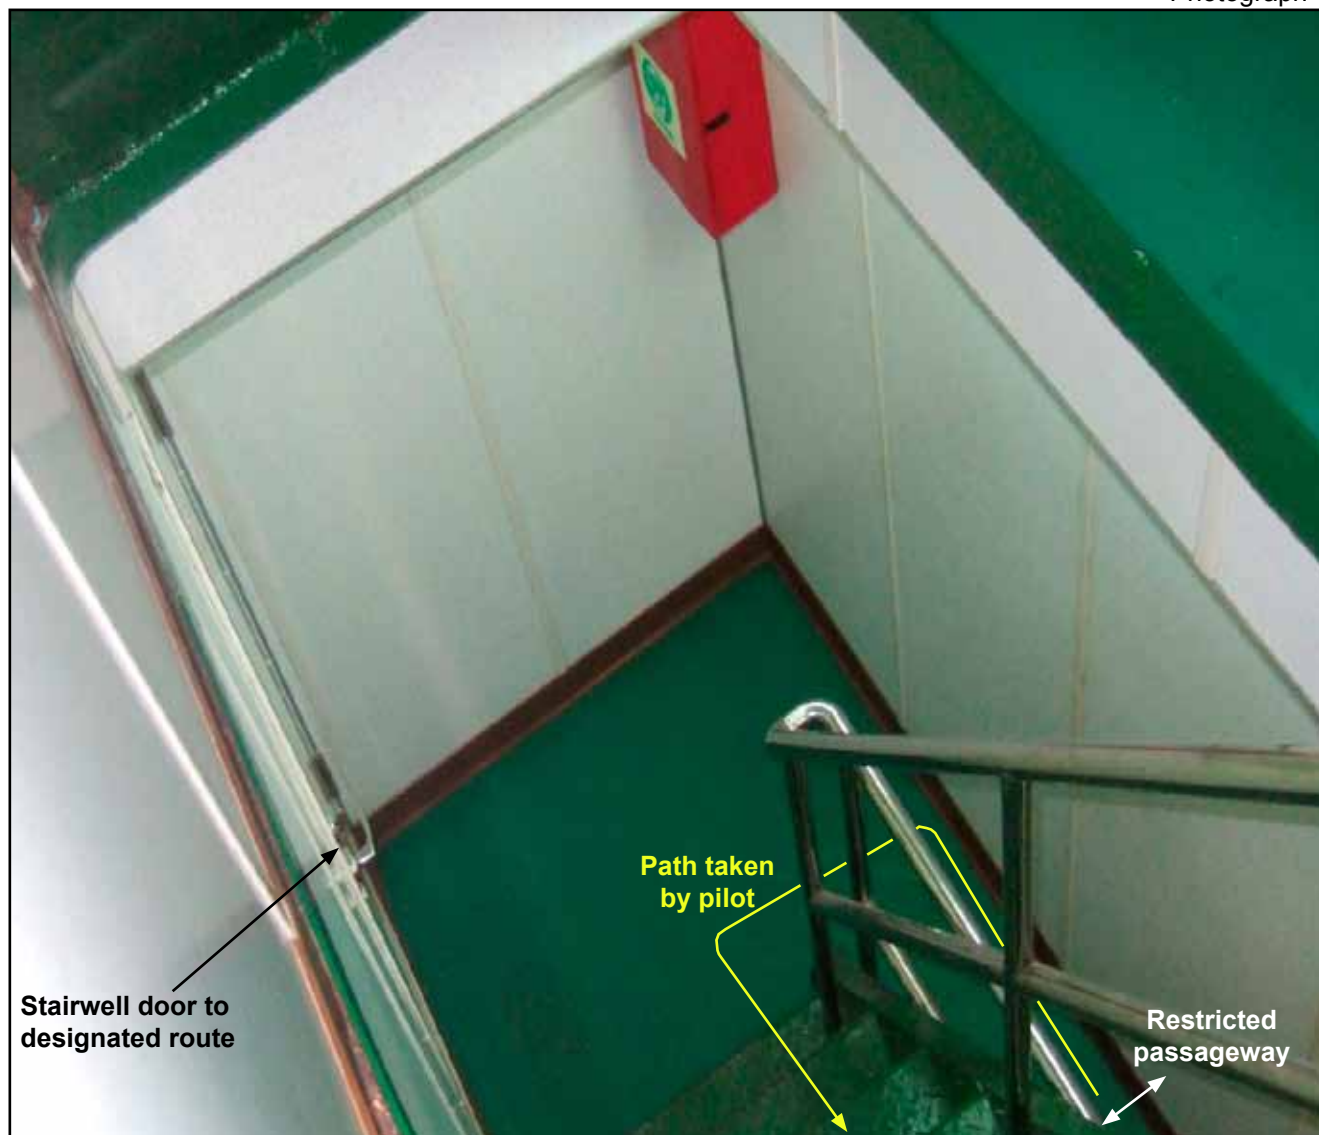
The pilot was taken from the main deck into the accommodation and up the stairs, via an enclosed stairwell, to the bridge. The pilot's progress was impeded because the design of the stairwell allowed just enough space for a slim and unencumbered person to pass between the stair railings and the bulkhead. In fact, this was not the most efficient way of using the stairs. There was a door at the head and foot of each flight of steps; and the correct way to use these should have been to enter the stairwell at the door at the base of the stairs, climb to the next deck, exit the stairwell into the adjacent alleyway, and re-enter at the foot of the next flight of stairs (**Photograph 6**).

Internal stairs within *Leonis*

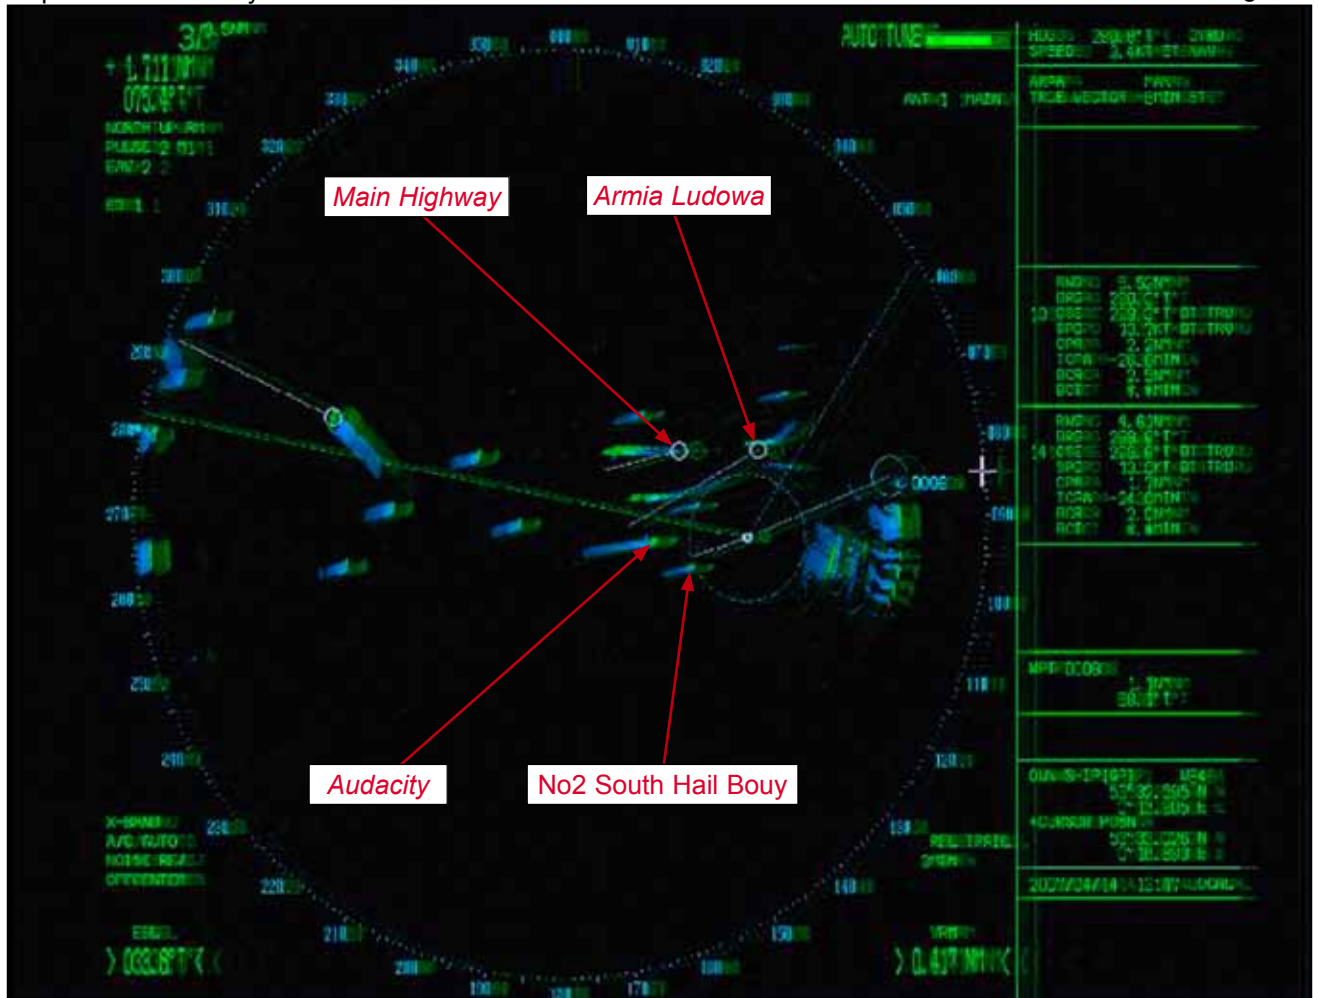
Due to the limited amount of time between the pilot becoming aware of the presence of *Audacity* and when he began to manoeuvre the vessel, it is unlikely that a proper assessment of the risk of collision was made.

Leonis' radar at 13:47 - time the pilot reaches the bridge

There was no effective ARPA plot made of *Audacity*: when the radar target was acquired there was no time for a reliable vector to be calculated before the collision occurred.
