Report on the investigation of the
foundering of the fishing vessel

Blue Sinata

in Weymouth Bay
on 8 September 2005
with the loss of one life

**Report No 7/2006
March 2006**

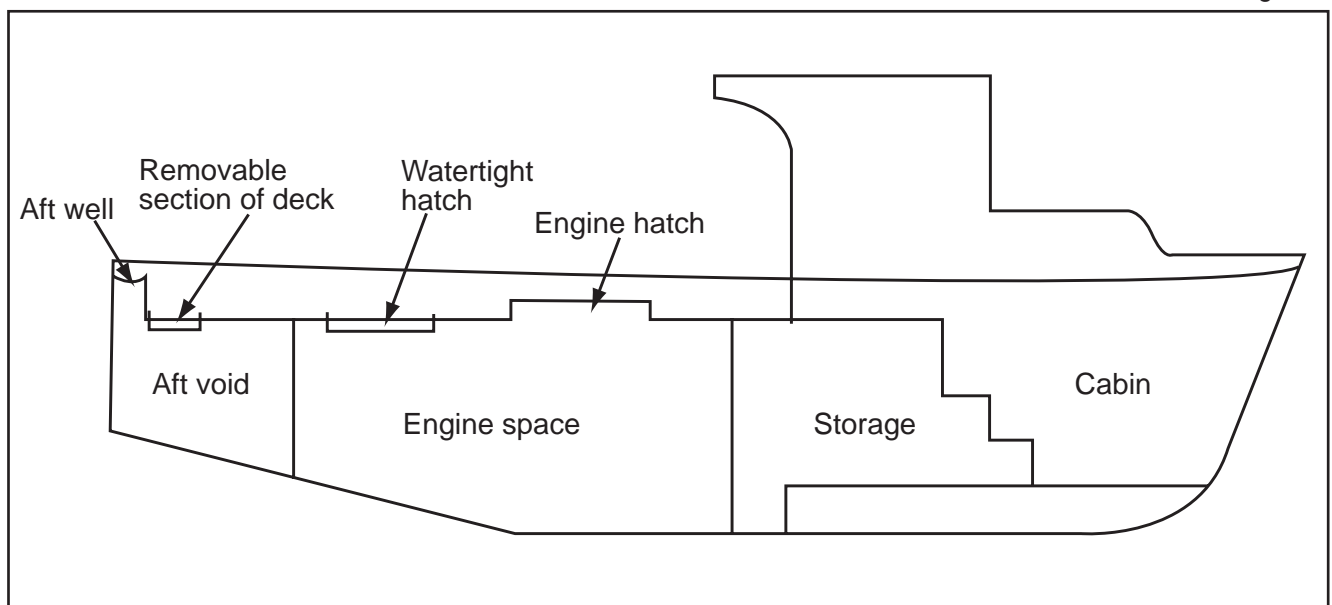
Figure 2

A GRP moulding formed the top of the cabin structure forward, having an escape hatch in its roof. This hatch could not be secured closed. Aft of the cabin was the wheelhouse, constructed of GRP and wood. An open working deck extended from the wheelhouse to the stern.

The plywood deck was bonded into the hull around its edges and covered with a layer of GRP. Layers of rubber sheeting covered most of the deck to provide a non-slip working surface. The bulwarks extended 600mm above the deck. Two freeing-ports, each 260mm wide by 55mm high, were cut in the bulwarks at the stern (**Figure 3**).

Adjacent to the transom stern, was an opening in the centre of the deck with a 450mm high coaming. The top of the coaming had a loose GRP cover which had no securing arrangements. The well formed by the coaming led down into the aft void. Immediately forward of the coaming was a rectangular, flush section of the deck that could be lifted for better access to the aft void. This piece of deck had no securing arrangements, but was a close fit in its aperture (**Figure 2**).

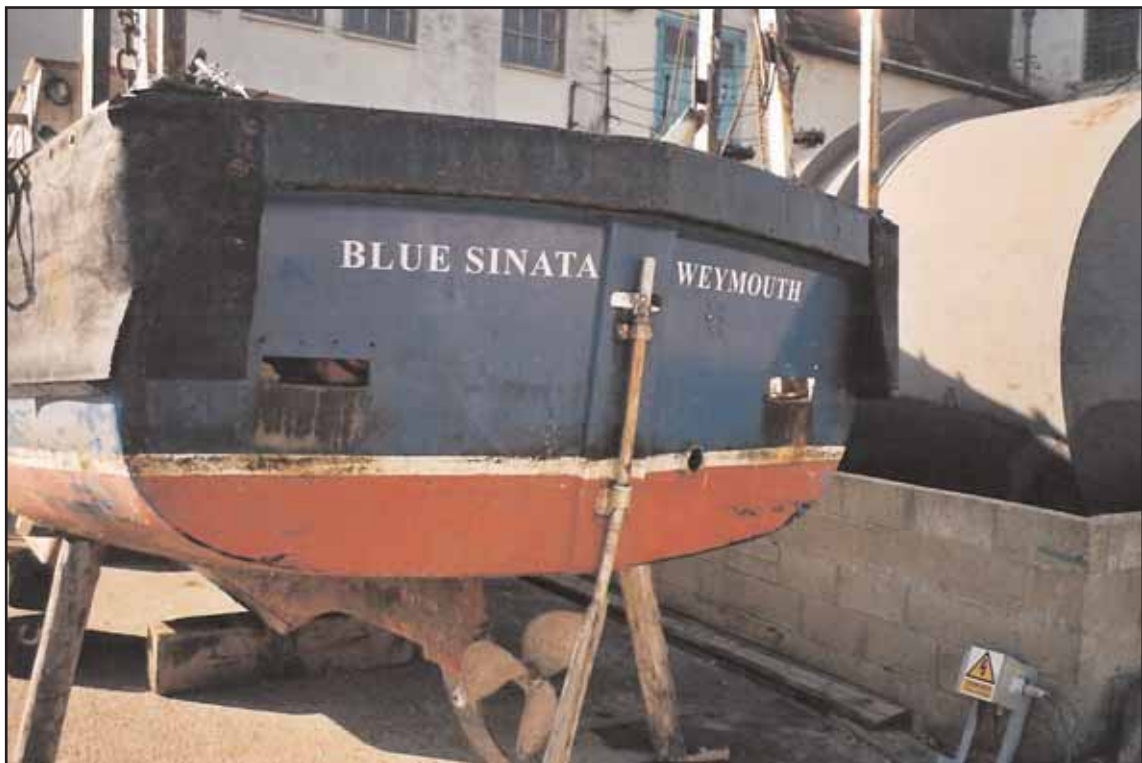
Figure 3

Stern showing freeing ports

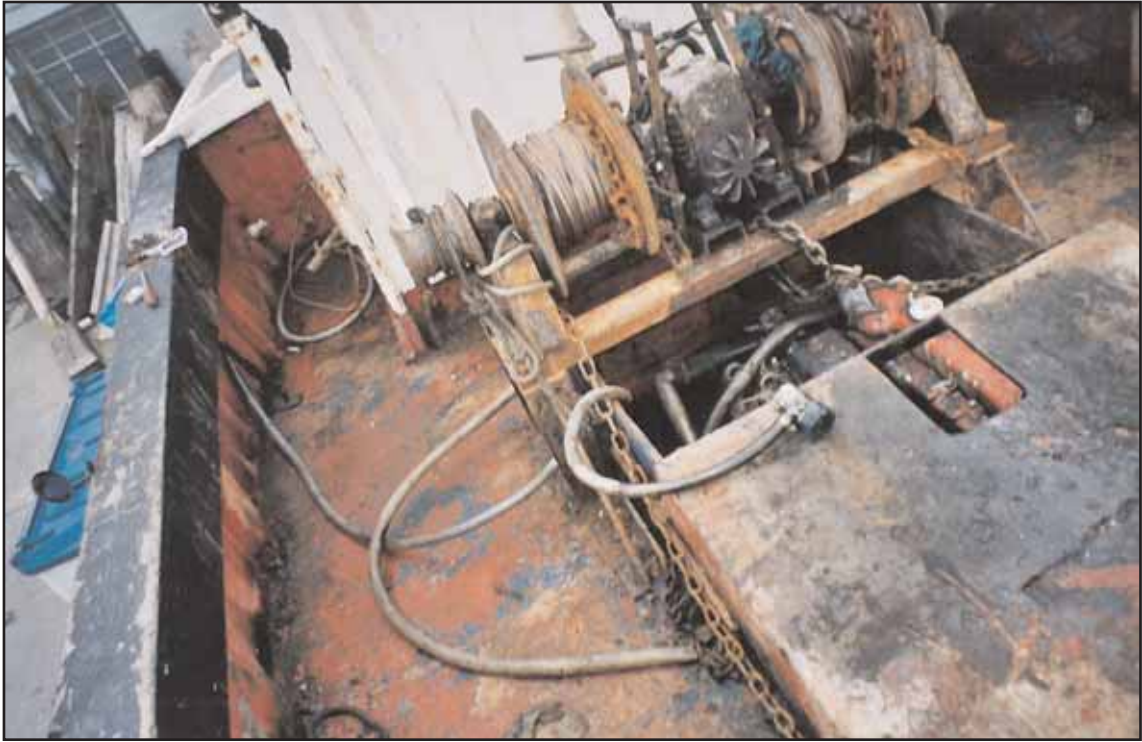
Engine hatch and coaming penetrations

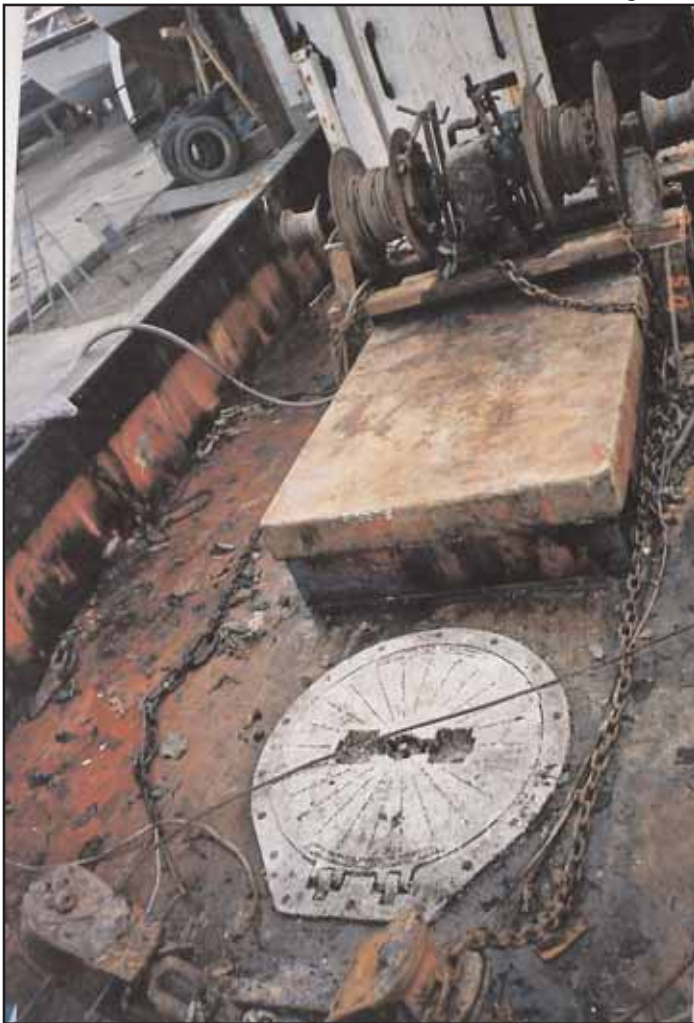
Figure 5

Circular watertight hatch and engine hatch

The circular hatch in the deck was fully open. The engine hatch cover was displaced aft by a few centimetres from the closed position. The GRP cover to the aft well was missing.

The mechanism for securing the circular hatch, fitted to its underside, was in place but its operating handle was missing.

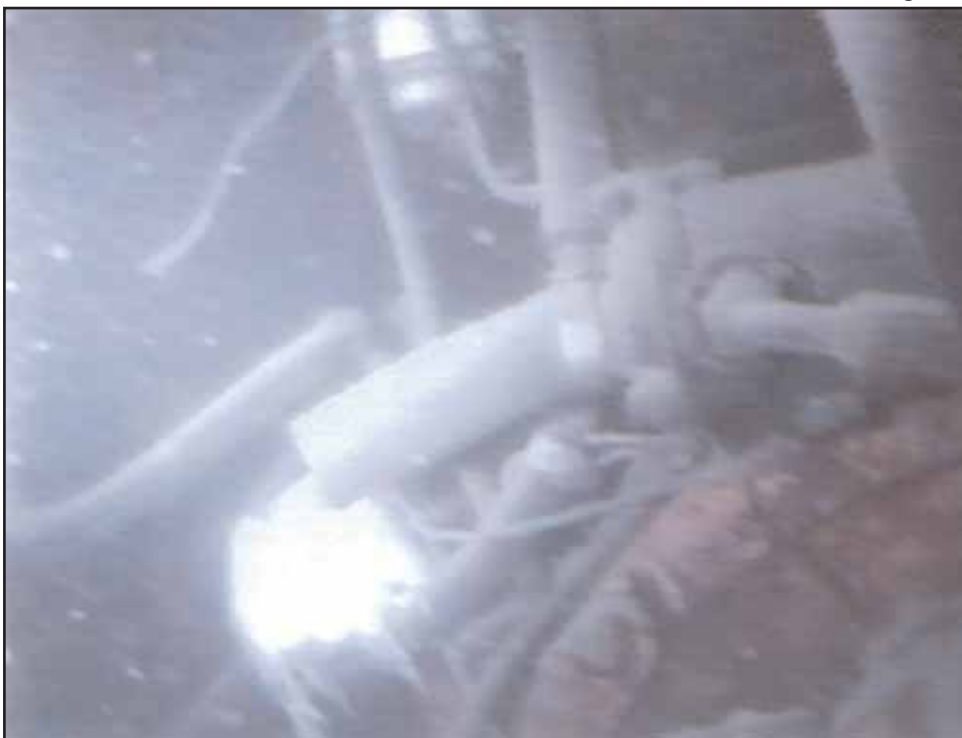
Figure 8

Cut hose in engine sea water system at gearbox oil cooler

With the vessel floating at a freeboard aft of 230mm, assessed as being the Weymouth departure condition, no water leaked into the hull through the cut water pipe in the engine's seawater system at the outlet of the gearbox oil cooler.

However, as weights were added to represent the weight of water in the circular tanks on deck, the freeboard reduced sufficiently for water to leak into the hull through this pipe. The rate of ingress increased as weights were added. This check was made with the sea inlet valve closed as far as possible.

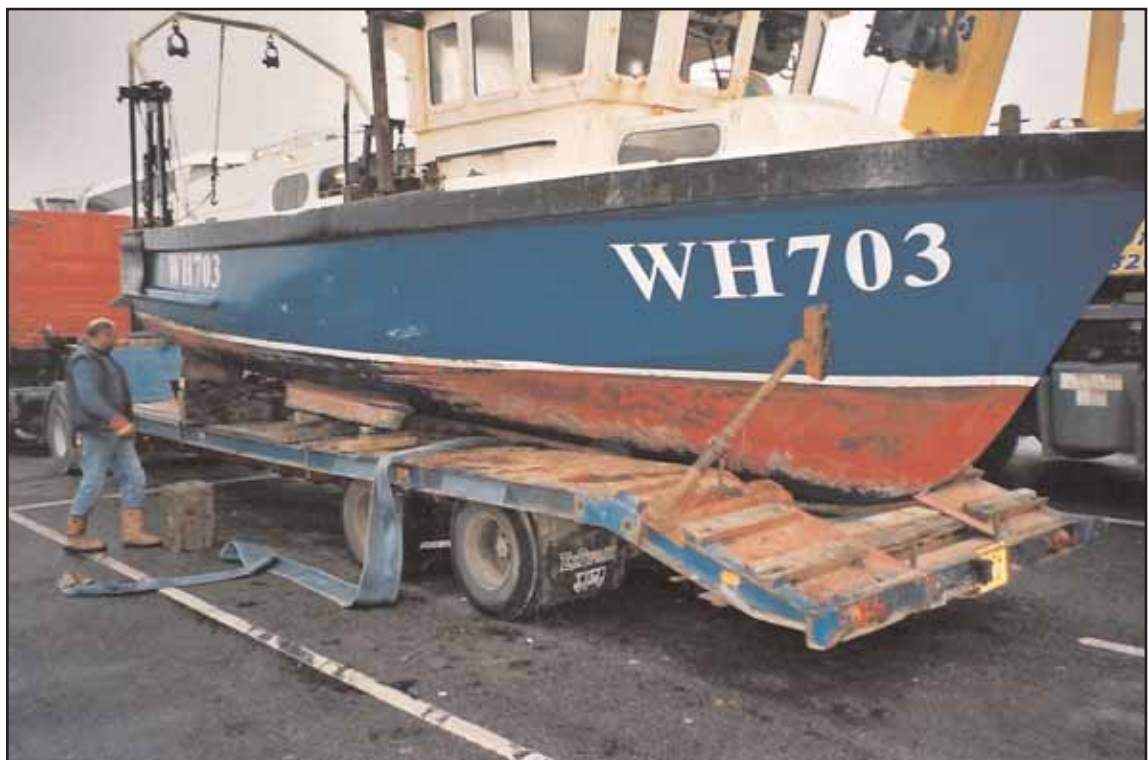
Figure 9

Blue Sinata after recovery

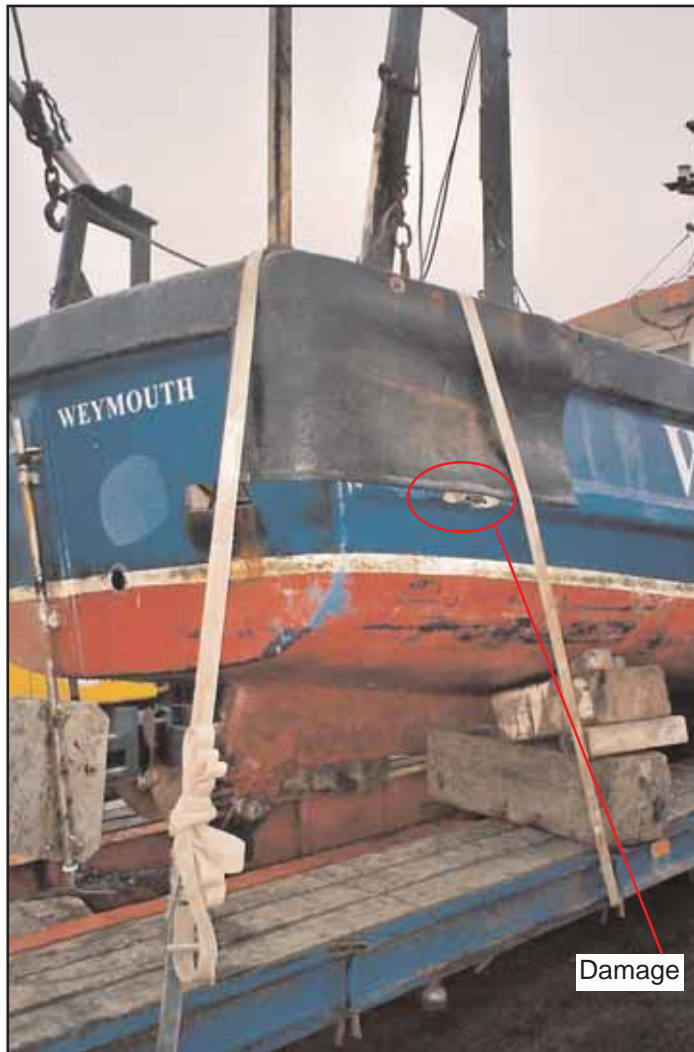
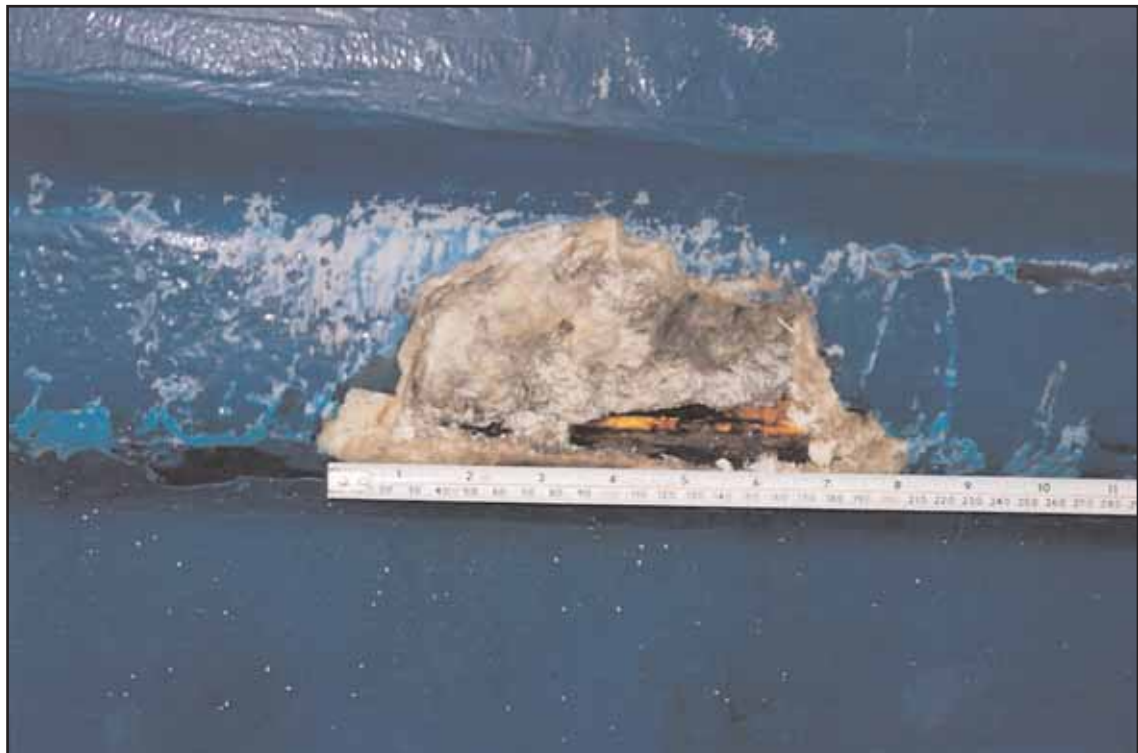
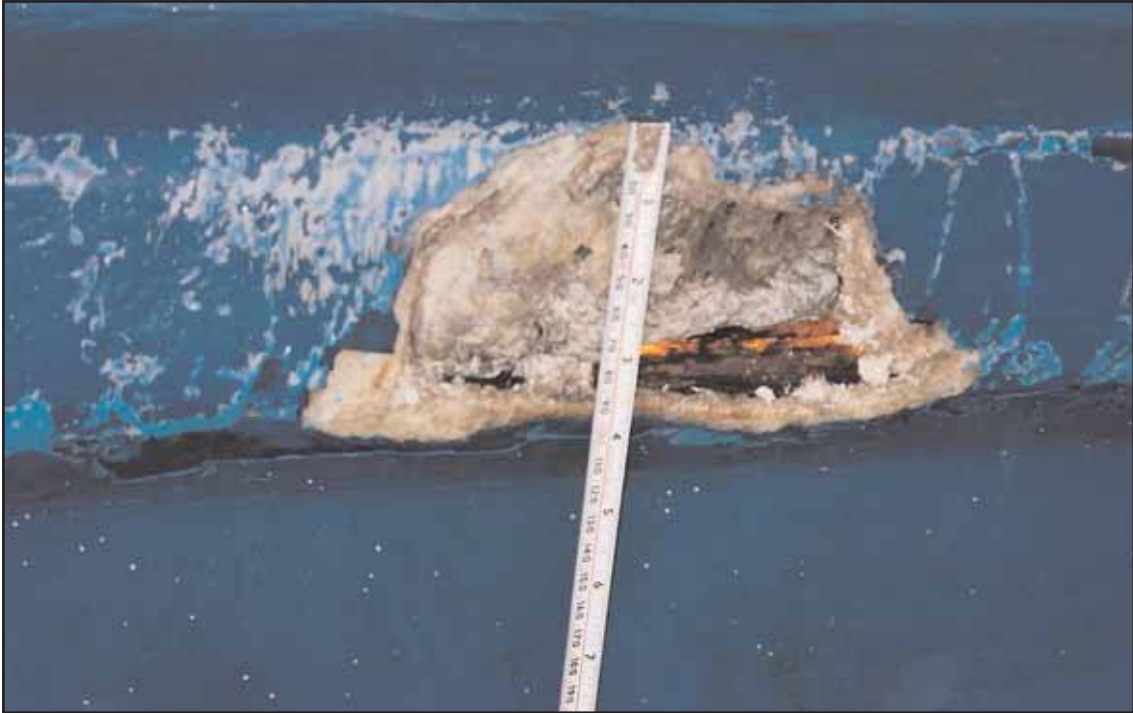
On the starboard quarter of the hull, level with the deck edge and largely covered by a protective rubber sheet, was an area of damage (**Figure 10**). The damage was centred on a moulded GRP rubbing strip running along the hull at deck level and had dimensions of 180mm long x 90mm high (**Figures 11 & 12**). After lifting the rubber sheet, a hose test was performed on this damage (**Figure 13**).

Damaged area

In view of the limited freeboard measured during the tests, the damage to the starboard quarter at deck level is significant. This damage, coupled with the poor freeboard which brought the damage close to sea level, produced a potential flooding mechanism, as demonstrated by the hose tests. However, the event that caused this damage, and its timing, are uncertain.

The underwater survey of the wreck showed the starboard trawl door sitting on the seabed, leaning against the starboard quarter and its protective rubber matting. As the vessel struck the seabed, it is possible that the door caught the edge of the moulded rubbing strip on the hull, causing the damage seen. One factor against this theory is that the door was leaning against the protective rubber mat, with the mat between it and the hull, rather than behind the mat as might otherwise be expected.

An event during the previous charter trip on 31 August 2005 also had the potential to cause this damage. On the first haul of that trip the two trawl doors came up at the starboard side after the fishing gear became twisted and tangled. This made control of the doors difficult, and it was noticed that they swung against the starboard side of the vessel. The intensity of impact is not certain and no damage was noticed at the time; nor, apparently, was any looked for. However, if the damage was caused that day, at the end of the first tow, it is unclear why no flooding occurred later in the day's work.

Whenever this damage was caused, the protective rubber mats on the vessel's two aft quarters effectively shielded the damage from a casual observer. It was necessary to lift the mat aside to see the damage clearly. An observer on the deck of the vessel, and thus looking from above, would be unable to see this damage with the mat in its normal position. An observer on a pontoon or quay adjacent to her berth would be in a similar position. Thus, unless he was deliberately looking for damage in this area of his vessel, the skipper was unlikely to have noticed its presence.

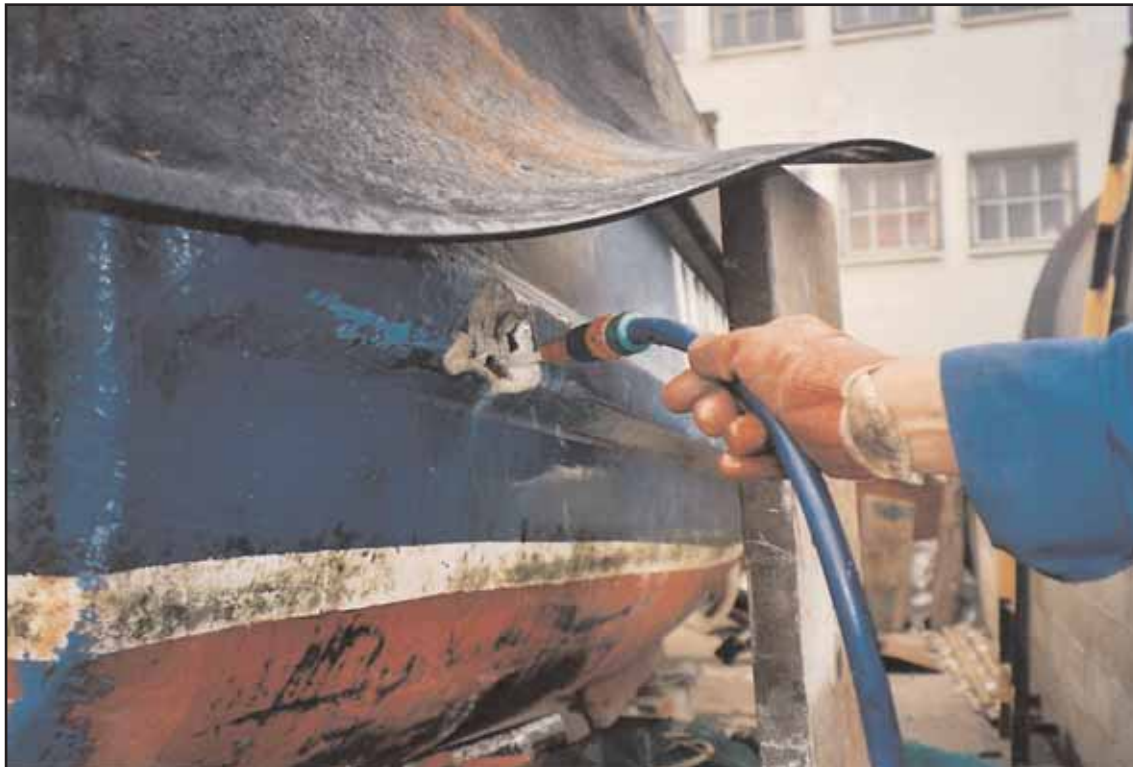
Figure 13

Hose test on damage

With a hose directed forwards and playing on the damage, water entered the engine space. A small quantity of water also migrated forward, within the moulded rubbing strip, to exit outboard at a small penetration.

When the hose was directed aft, or square on to the damage, water entered the void space at the stern.

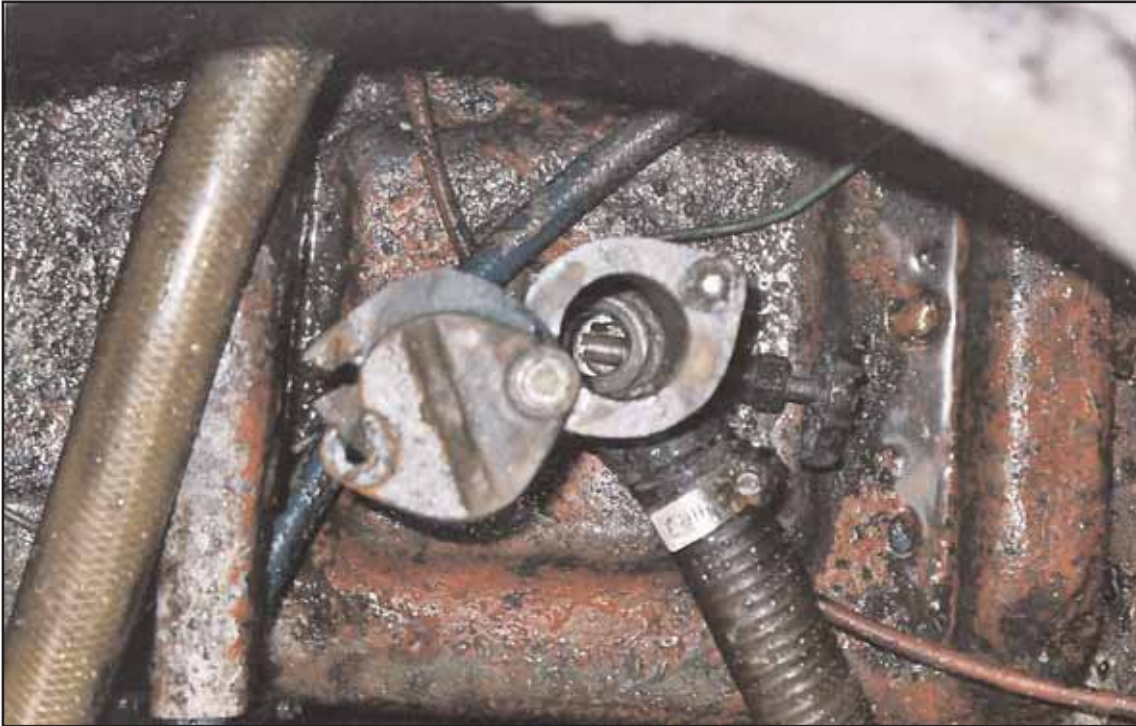
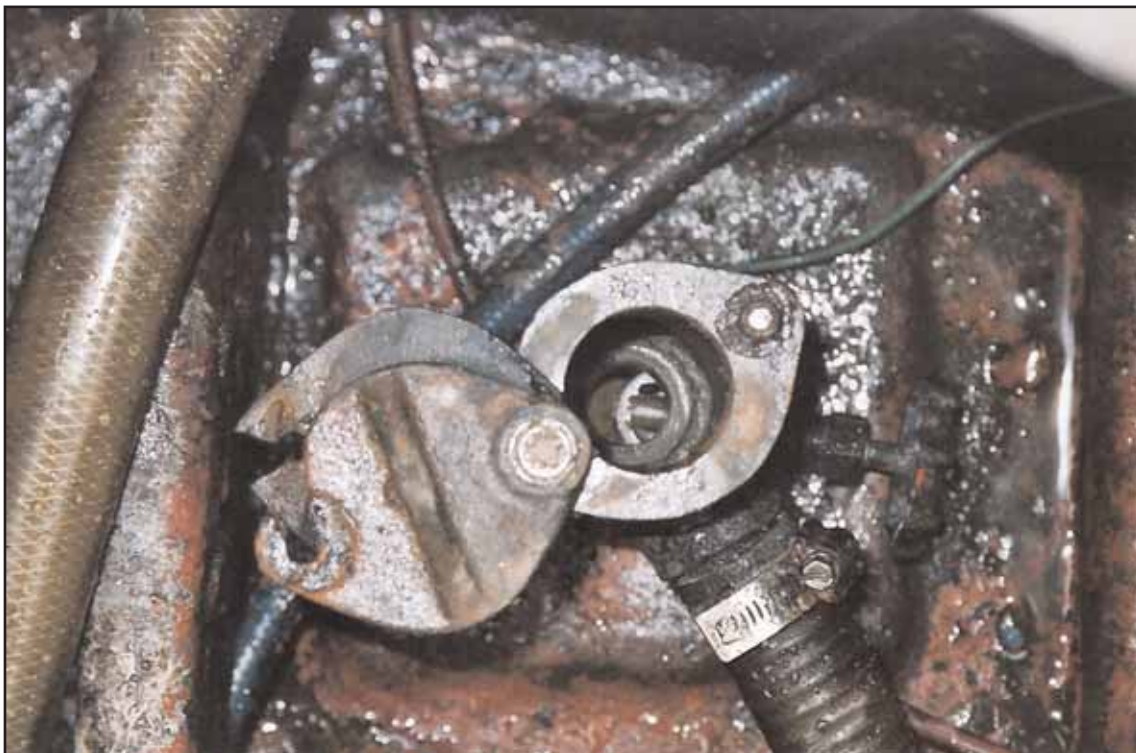
The sea inlet strainer supplying the engine cooling system was opened, the filter removed and valve on the skin fitting sighted. The filter was clear of obstruction. The valve was found in the partly open position. Attempts to close the valve, by turning the handwheel, moved the valve disc no further closed than about one quarter open. Similarly, attempting to fully open the valve moved the valve no further than one third open (**Figures 14 & 15**). Any attempt to move the valve beyond these limits resulted in the spindle turning freely, with no corresponding movement of the valve disc.

Sea inlet valve, limit of closing

Sea inlet valve, limit of opening

Once the skipper had cut the engine's seawater inlet hose, water was able to flow into the engine space through the defective sea inlet valve, which could not be properly closed. This added to the rate at which water entered the vessel.

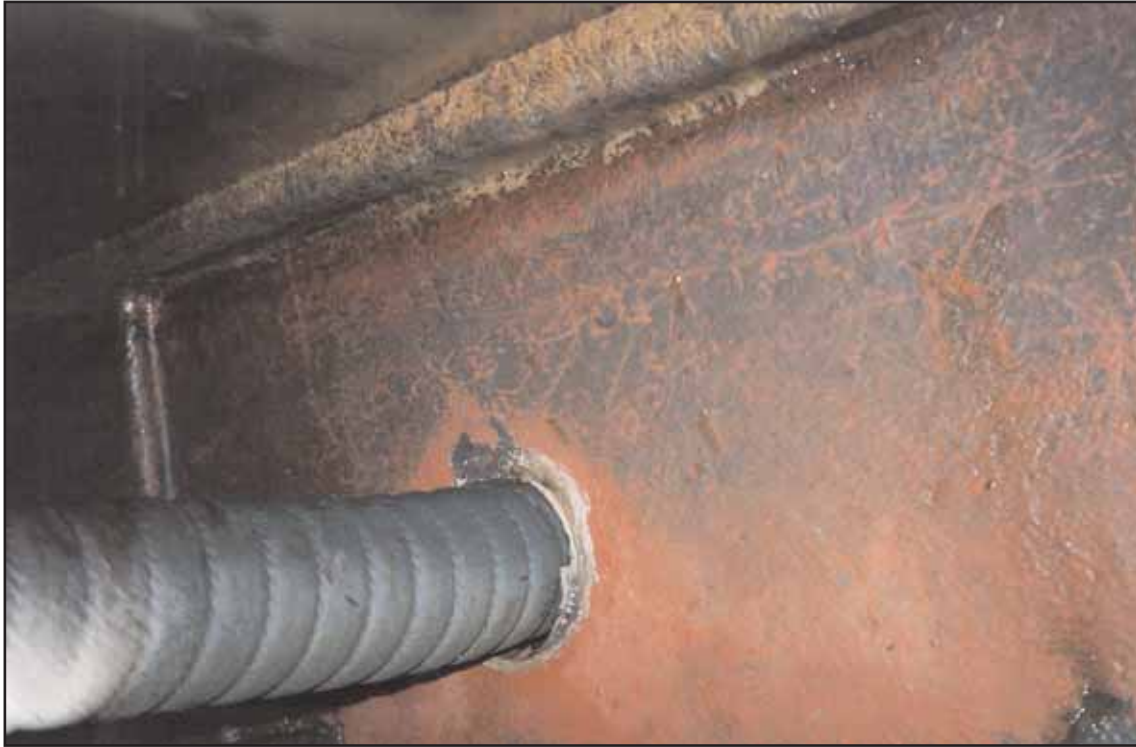
Figure 16

The engine exhaust hose passed through the aft bulkhead without being sealed, so losing the watertight integrity of the bulkhead (**Figure 16**). This hose was inspected visually and tested with water, but showed no sign of damage or leakage.

Penetration of aft bulkhead by exhaust hose

At the end of the second haul of the fishing gear, the skipper observed water in the stern well, indicating that water had entered the aft void. The lack of a watertight bulkhead between the void and the engine space means water might have entered the void from the engine space through the opening around the exhaust hose where it passed through the bulkhead.

Had the aft bulkhead been made watertight, by properly sealing the penetration of the exhaust hose, most flooding would have been confined to the aft void. Comparatively small quantities of water might still have entered the engine space through the damaged area of the hull, but this could probably have been handled by the electric bilge pump in that space.
