Report on the investigation of

the capsize of

Breakaway 5

River Bure, Norfolk

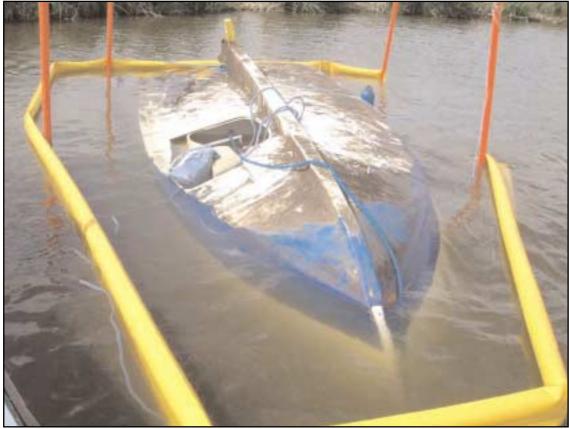
On 20 July, MAIB inspectors visited *Breakaway 5* at the scene of the accident. Other than the hole cut to allow the removal of the two trapped people, and a very shallow scratch running along the length of the underside of the boat's hull on her starboard side, no other significant damage was evident **(Figure 2)**.

Photograph of Breakaway 5 capsized

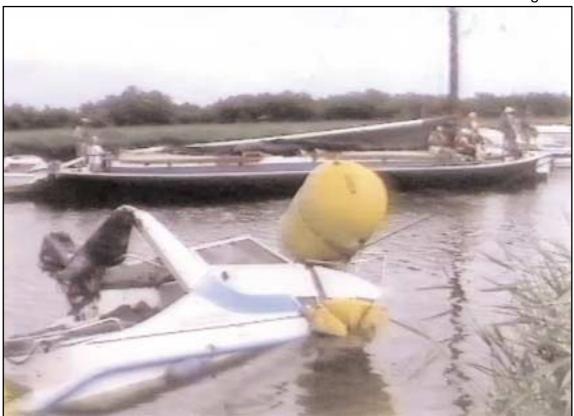
On 22 July, a temporary repair was made to the hole in the hull of *Breakaway 5*, which was then righted and refloated by the Norfolk Constabulary, assisted by the Broads Authority (Figure 3).

- The engine throttle was in the full ahead position
- There was no evidence of water ingress via through-hull fittings below the normal waterline, other than a small weep through the rudder stock
- The steering gear was serviceable
- The engine cooling and exhaust systems were free of leaks when pressure tested
- None of the skin fittings on the topsides of the hull were likely to cause backflooding into the hull
- The bilge pump was serviceable, and its float switch functioned as intended
- The bilge pump switch was in the 'off' position

Photograph taken during the recovery of Breakaway 5

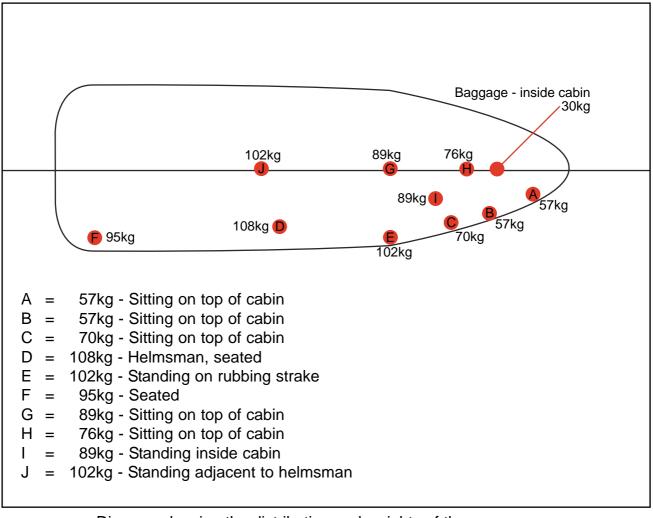
Figure 4

At the time of capsize, the six children were forward of the driver; three were sitting with their legs under the guardrails on the starboard side, two were seated near the centreline of the foredeck, and the other was standing on the rubbing strake, outboard on the starboard side. The parents were dispersed as follows: one man was at the wheel, but possibly leaning out to starboard to try and see ahead; the second man was lying on the seating behind him; one woman was in the cabin area; and the second woman was adjacent to the driver. It is reported that the latter woman, who later died, had just moved to that position after being seated at the port quarter. The total weight of the people in the party was 845kg, giving an average weight of 84.5kg. A diagram showing the disposition and weights of individuals is shown at **Figure 4**. The positions of the people have been estimated as closely as possible, but should not be regarded as being exact.

Diagram showing the distribution and weights of the passengers

It is, therefore, concluded that the weight and distribution of the people on board, which was biased forward and to starboard of the centreline, caused *Breakaway 5* to become unstable and capsize. Once the craft had started to heel to starboard, the resulting involuntary movement to starboard of many of the people, and the turn to port, would have exacerbated the boat's instability and increased the speed of capsize. It was not surprising that the movement of one of the young adults to the port side did not check the boat's movement, as a much larger weight would have been needed to counter the momentum of the heel.

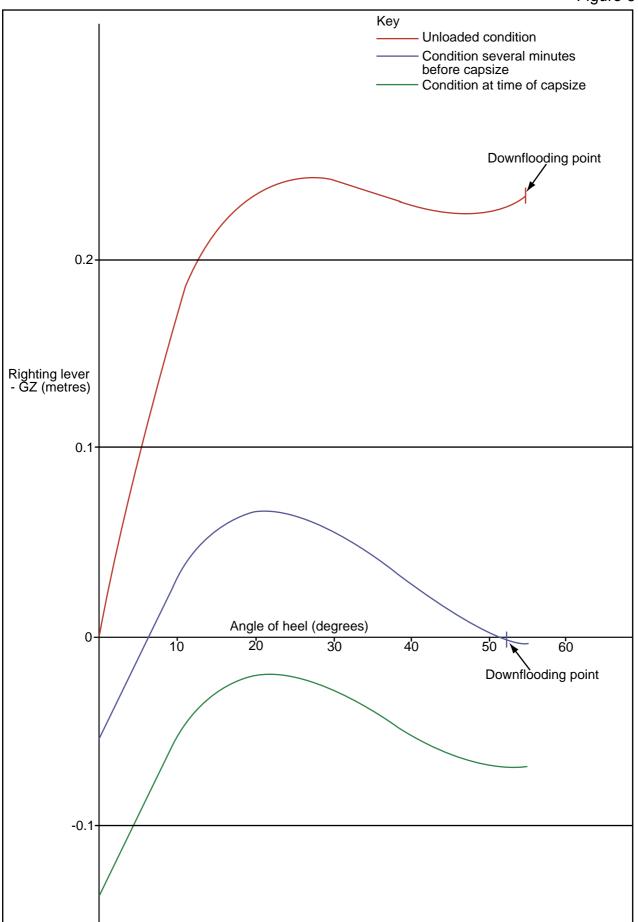
Breakaway 5 GZ curves

From the stability data shown at **Figure 6**, it is evident from the area below the GZ curve that the boat's standard of stability in the unloaded condition is good. Indeed, it almost meets the requirements for vessels operating at sea. In the approximated condition several minutes before the accident, although there is an initial list of about 6° to starboard, a positive righting moment up to about a 50° heel remains. In the condition at the time of capsize, however, which was achieved by moving just three of the party in the previous condition, stability is reduced to the extent that the righting levers do not reach a positive value.

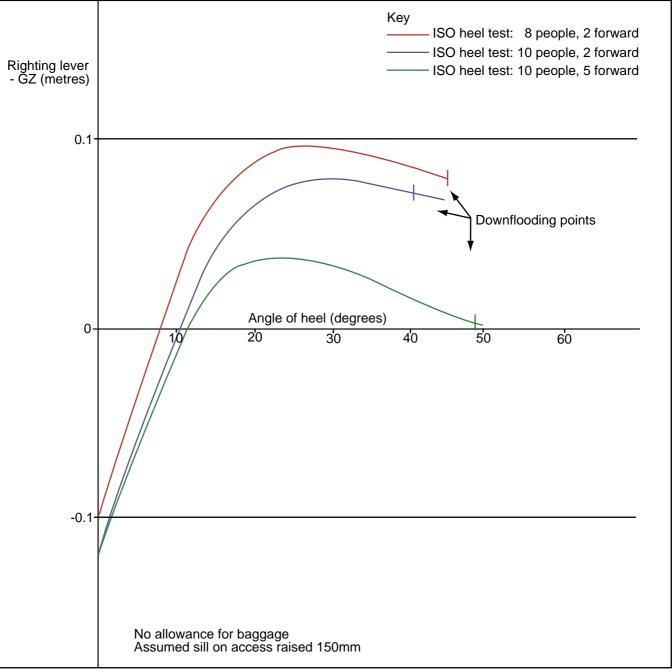
Figure 7

Although the angle of heel achieved during the test was permissible, the area below the GZ curve produced from the *Breakaway*'s condition during the offset load test (five people on the foredeck and five in the cockpit) (Figure 7) indicates that only a small amount of stability remained. This stability can soon be diminished by several factors, such as the weights of the passengers being

Breakaway GZ curves - test conditions

greater than allowed for, and the positions of the passengers being more extreme than expected, both of which contributed to *Breakaway 5*'s capsize. The methodology of the standard does not allow a margin of safety to allow for such possible variations, for the possible differences in the interpretation of the conduct of the offset test, or any dynamic effects when a vessel is underway. If it did, more confidence could be placed in its validity in all cases.

- The MCA is also recommended to:
- 2004/127 Review the stability tests currently required within all its codes of practice for small craft with a view to introducing a margin of safety in their methodology, and to take into account the probability of a person's weight exceeding 75kg.
