Report on the investigation of the
Brenscombe Outdoor Centre
canoe swamping accident
in Poole Harbour, Dorset
on
6 April 2005

Marine Accident Investigation Branch
Carlton House
Carlton Place
Southampton
United Kingdom
SO15 2DZ

**Report No 22/2005
December 2005**

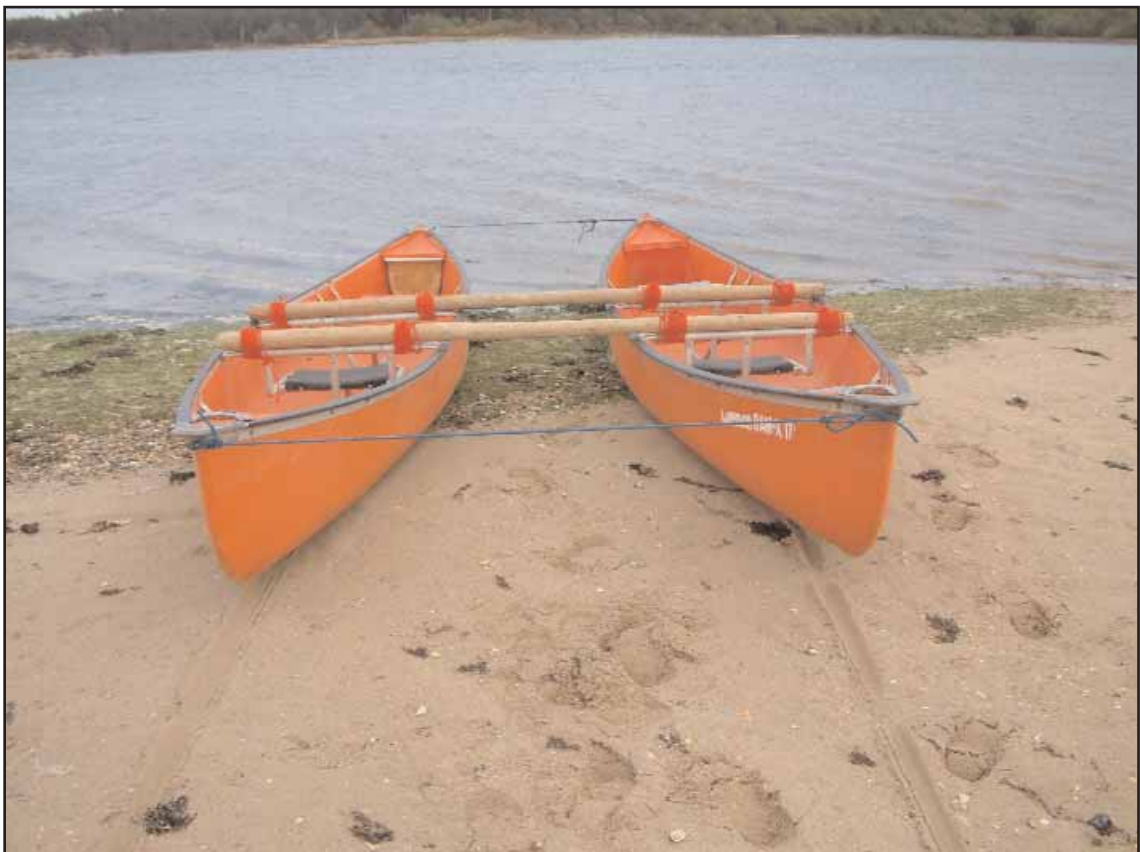
Figure 5

Rafted canoe arrangement

The accident was caused because BOC failed to recognise the risk of rafted canoes being swamped. It had been assumed that the configuration was inherently stable, so no control measures were in place to minimise the chances of swamping when the rafted canoes were being paddled or towed by another boat.

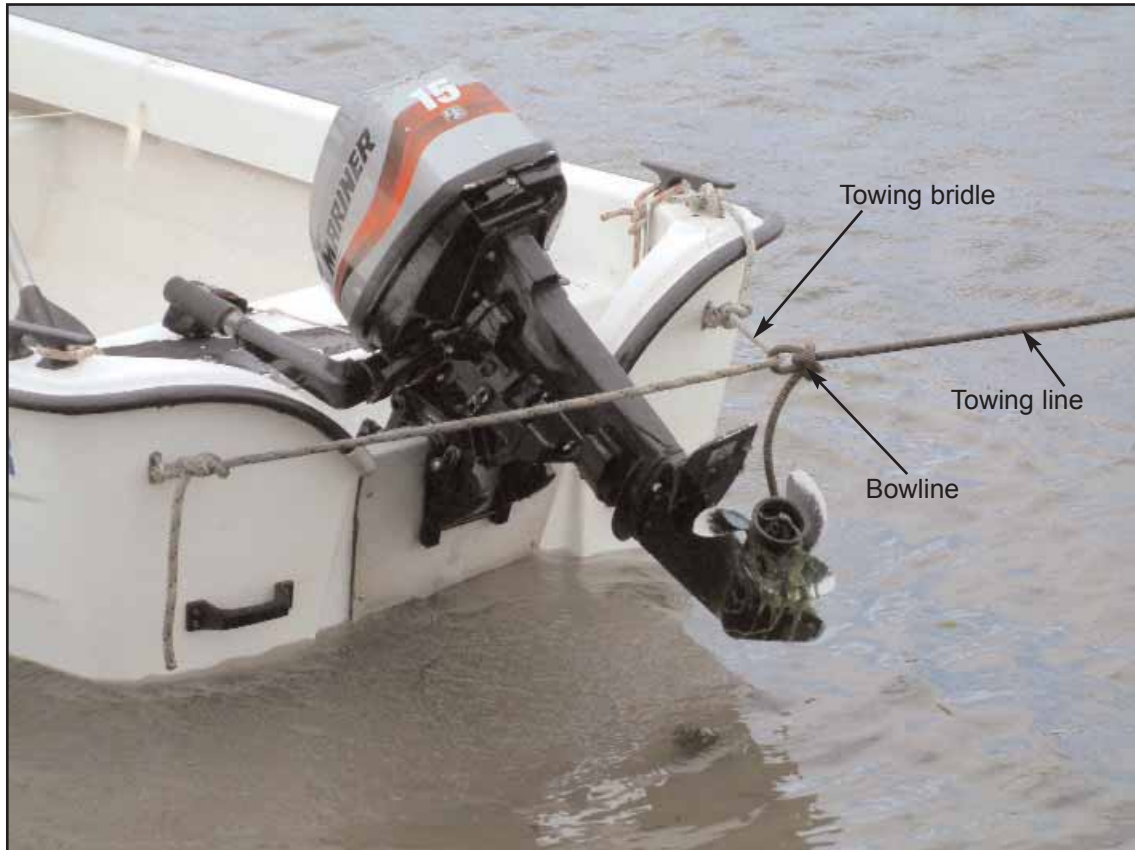
Figure 6

A short towing bridle was fitted to the stern of the safety boat, and a towing line was connected between the bridle and the canoes' stem rope by bowline knots. This enabled the towline to move freely along both the bridle and stem rope. The towing arrangement is shown in **Figures 6 and 7**. In an effort to make up for lost time, the canoes were towed across open water towards Goathorn Point. The option to return to Bramble Bush Bay was not considered, despite the obviously deteriorating weather conditions.

Safety boat bridle and towing line arrangement

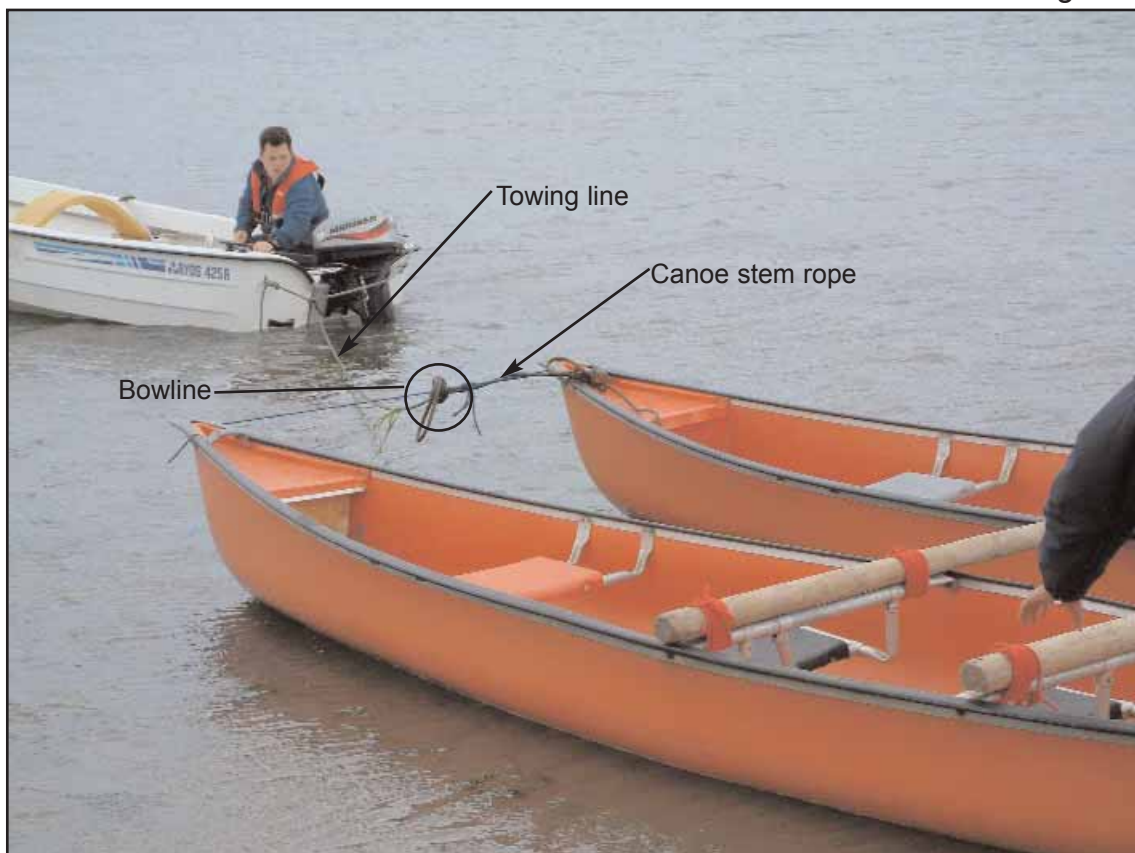
Figure 7

Canoe stem rope and towing line arrangement

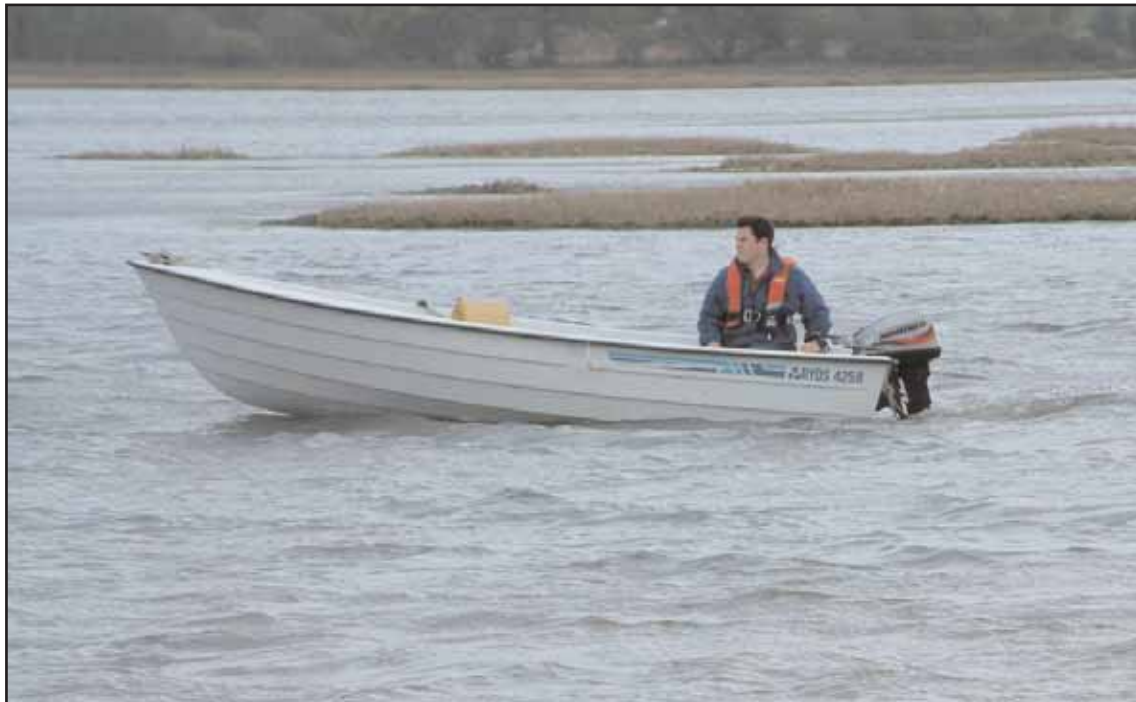
Figure 10

Safety boat - RYDS 425R

14. The safety boat was inadequate for its role and was not equipped with distress flares or a VHF radio. [2.8.2, 2.8.3]
15. The safety boat engine power output of 11.2kW exceeded the boat's designed output of 7.4kW. [2.8.4]
16. The safety instructors were not familiar with towing techniques involving rafted canoes. [2.9.1, 2.9.2]
17. It was not normal BOC practice to inform the Poole Harbour Authorities when entering or leaving the water. [2.10]

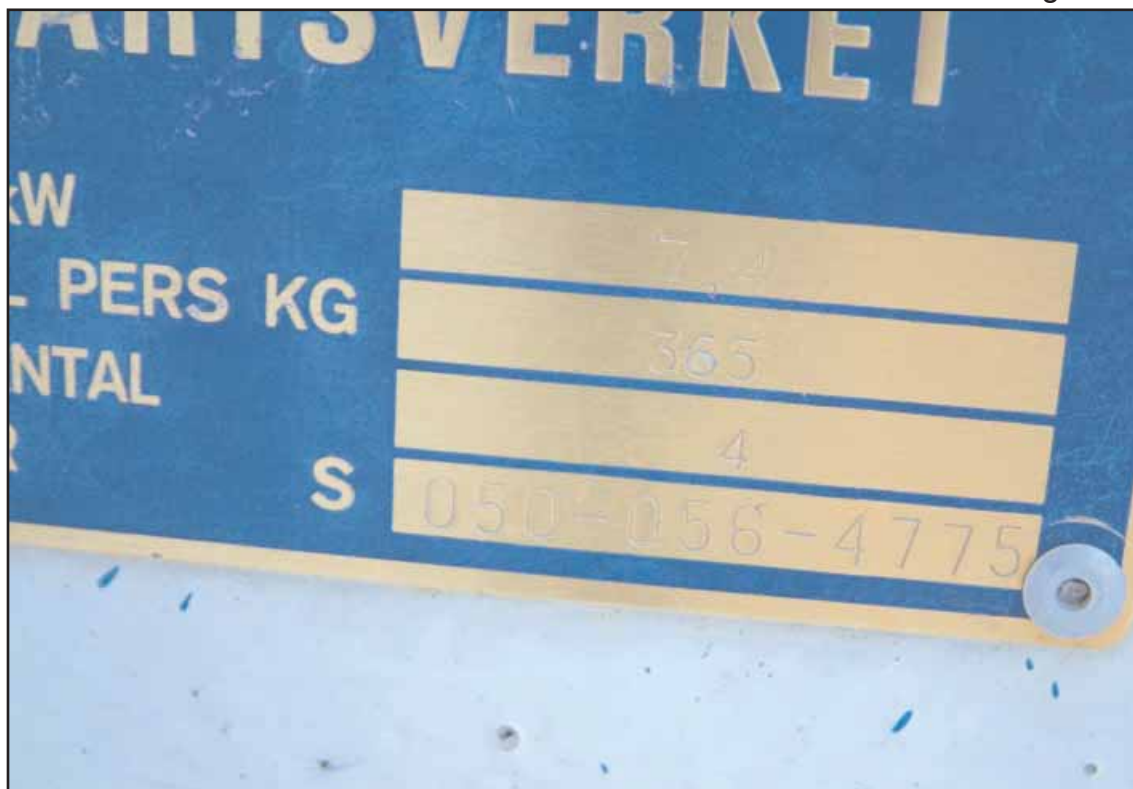
Figure 11

Safety boat identification plate

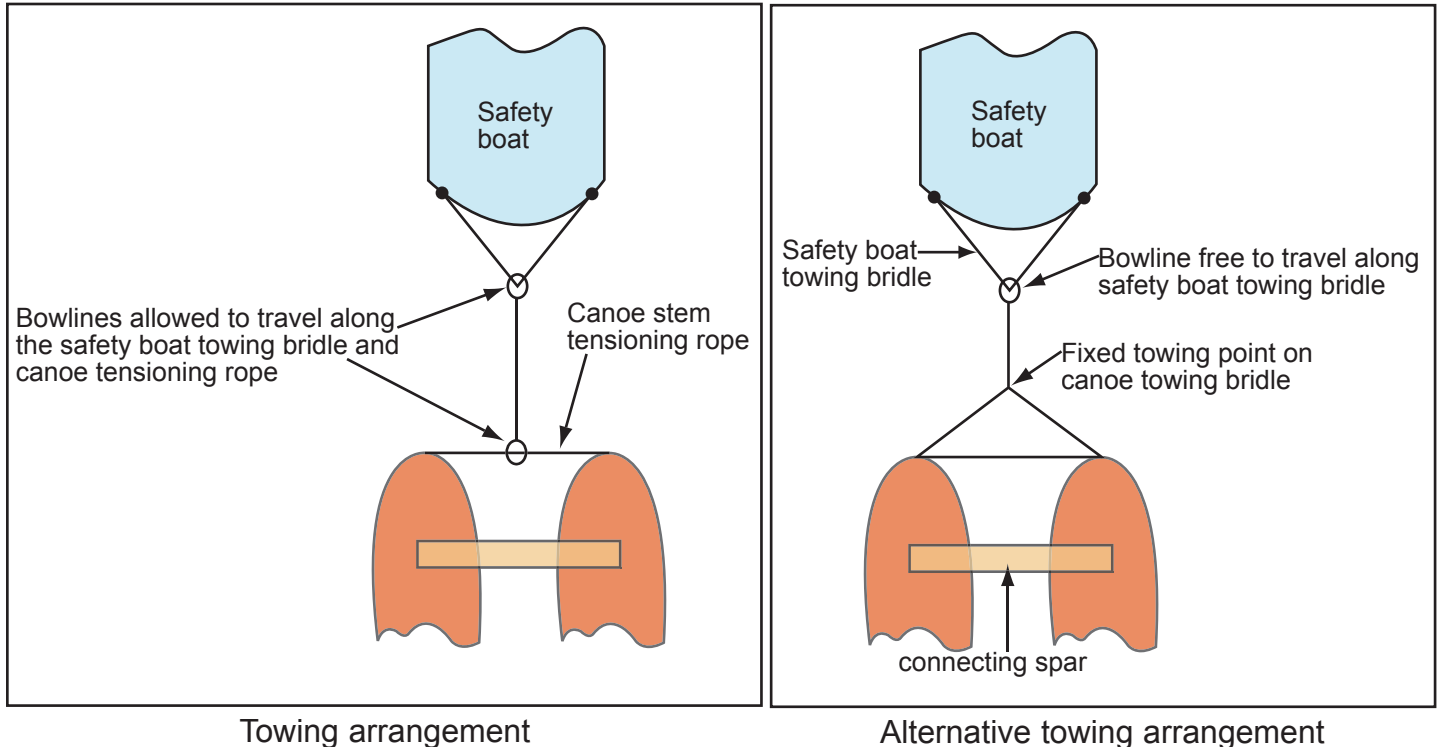
Figure 12

Prior to this accident, the safety instructor had not used the RYDS 425R safety boat for towing, neither had this particular safety boat been used for towing manned, rafted canoes before. The instructor, therefore, had no experience on which to base the best method of towing and safety boat handling. It is likely that this inexperience and lack of familiarity contributed to the accident.

Both the RYA powerboat, and the BCU syllabi, cover various towing techniques, but the rafted canoe configuration is not covered, despite it being in widespread use. Appropriate towing techniques to suit the particular circumstances can be learnt through “on the job” training. Inclusion of rafted canoe towing techniques in the RYA and BCU syllabi would provide a very helpful baseline.
