Report on the investigation of  
the fatality of a shore worker in No 2 cargo tank  
on board the oil/chemical tanker

***Bro Arthur***

at the Cargill Terminal, Hamburg, Germany

**Report No 9/2010**  
**August 2010**

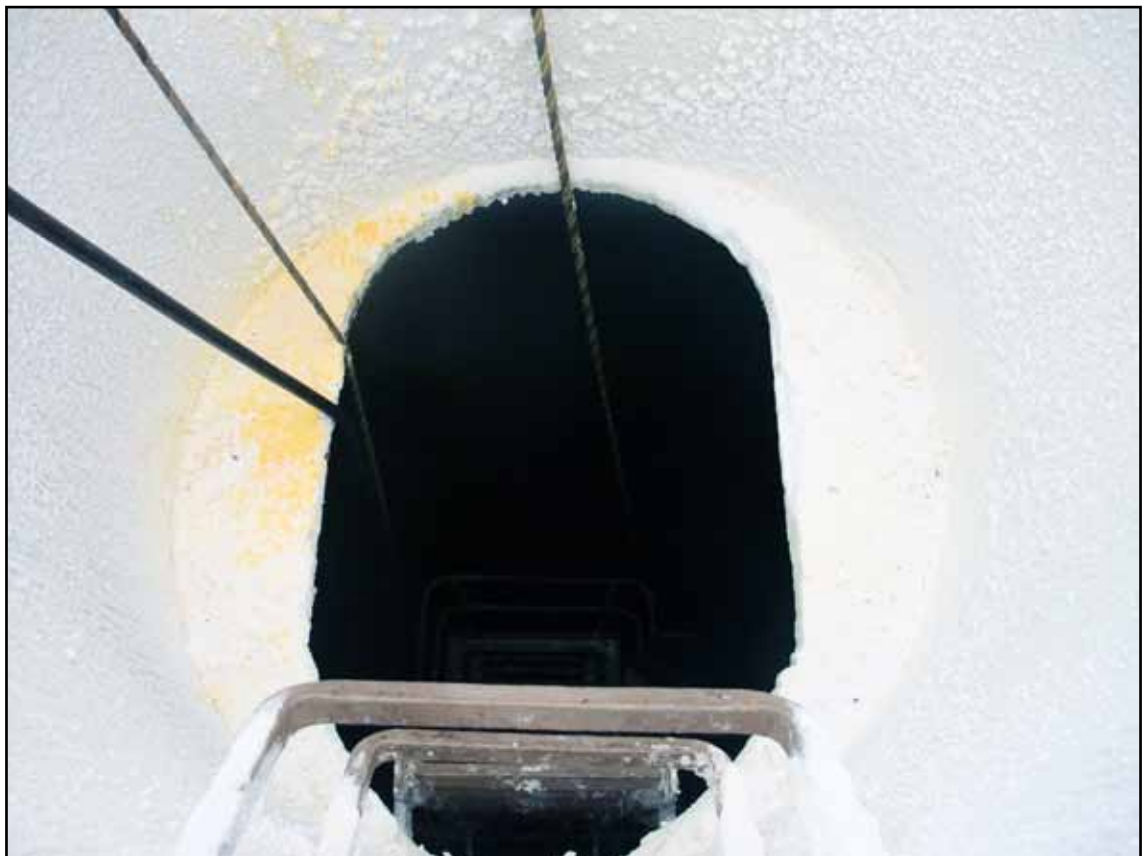
Figure 5

At about 2220 the ventilation fan was restarted and the three "sweepers" met with the chief officer and supercargo adjacent to No 2 cargo tank hatch. Both noticed that the alcohol they had previously smelt had disappeared. As an AB lowered the "sweeping" squeegees to the bottom of the 17.34m deep tank, it was noted that surfaces of the hatch coaming and ladders were covered with a slippery coating of hard, white, waxy, solidified stearin (**Figure 5**).

No 2 cargo tank hatch coaming showing solidified stearin coating

The reason why “Sweeper” 2 fell backwards was probably a combination of his physical impairment due to the influence of drugs, and the slippery nature of the residual solidified stearin cargo on the ladder rungs. He might also have been adversely affected by the tank temperature and fairly arduous work. When the right plasticised faced glove was recovered it was found to be heavily contaminated with solidified stearin, which would have made it extremely slippery and would have made his hand grip on the vertical ladder more difficult, especially in his impaired state.

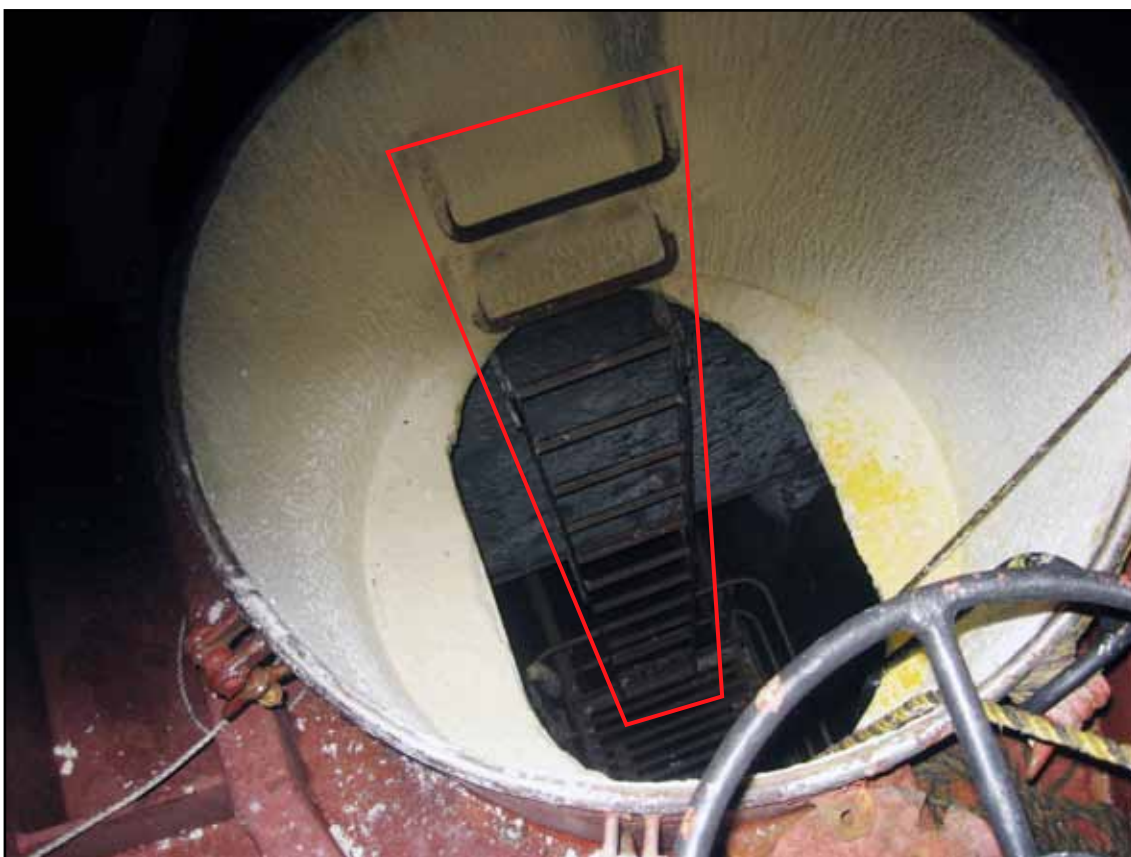
No 2 cargo tank - vertical ladder

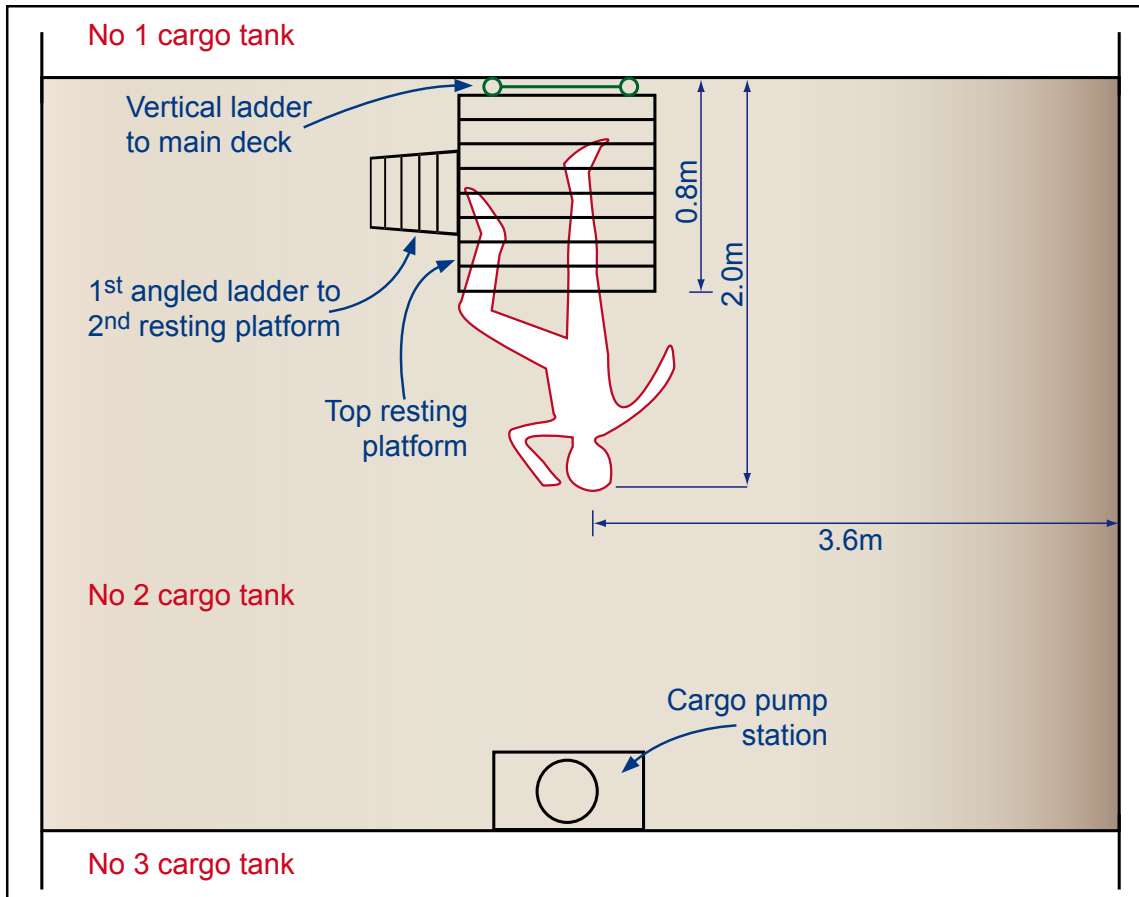
The casualty, who was a 56 year old German national, was found lying on his back with his head pointing towards the after bulkhead of No 2 cargo tank. He was positioned aft of, but directly in line with, the centre of the top resting platform which was also in line with the vertical ladder giving access to and from the main deck. His position is shown in the schematic at **Figure 10**. He was wearing overalls, both his boots and at least his right-hand glove (**Figure 11**). Witnesses were unsure if the casualty was wearing his left-hand glove.

Schematic showing position of the casualty (not to scale)

It is known that the approximately 1.6m tall casualty was found directly in line with the centre of the top resting platform, which is itself directly in line with the centre of the vertical ladder accessing the main deck. The three squeegees were found on the top resting platform, which indicates that the casualty had reached this level.

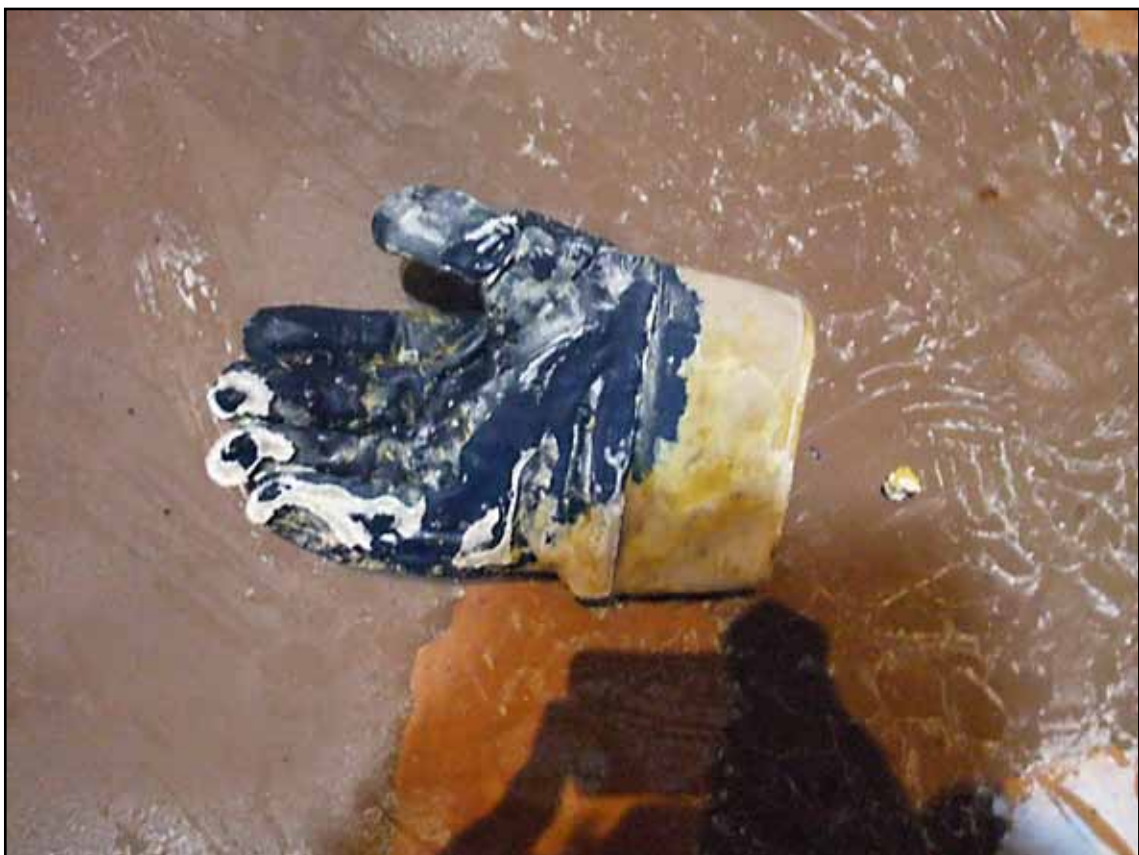
“Sweeper” 2’s right hand, palm plasticised faced glove

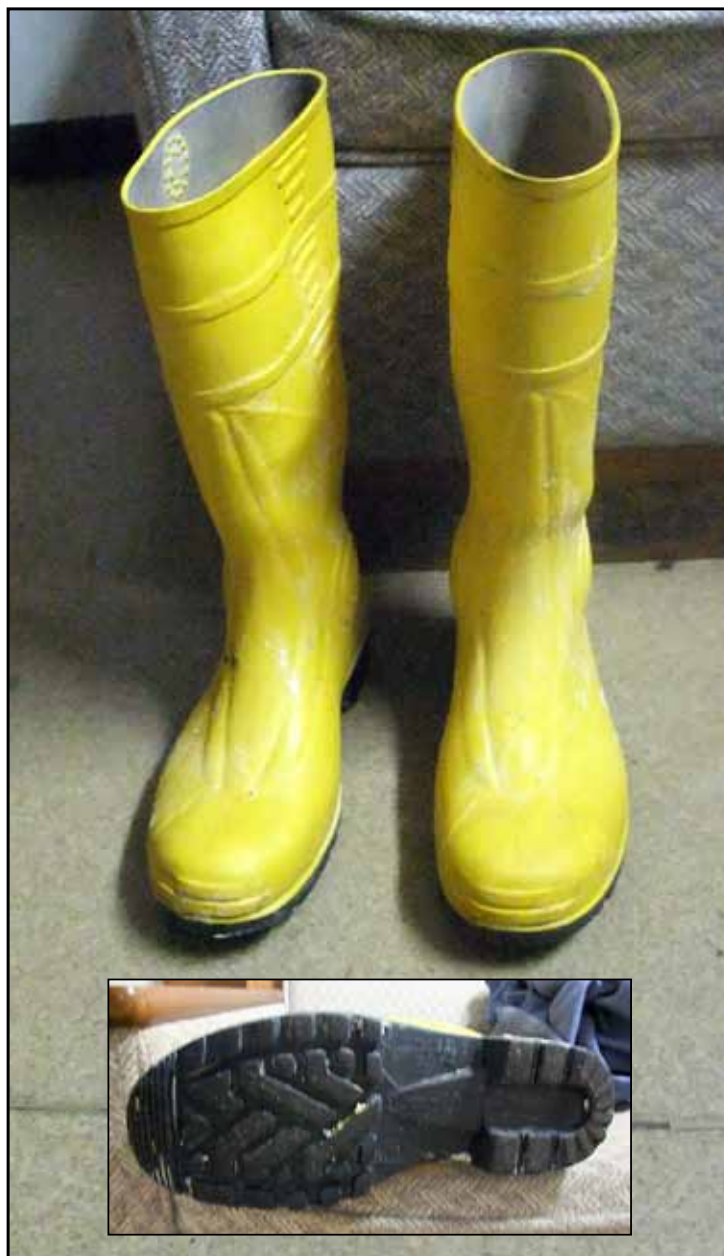
Figure 12

Hamburg “sweepers” industrial rubber boots

The casualty’s industrial rubber boots were in very good condition with a deep tread which would have given good grip. Had his feet slipped while maintaining a hand-hold, he would have fallen vertically onto the platform.

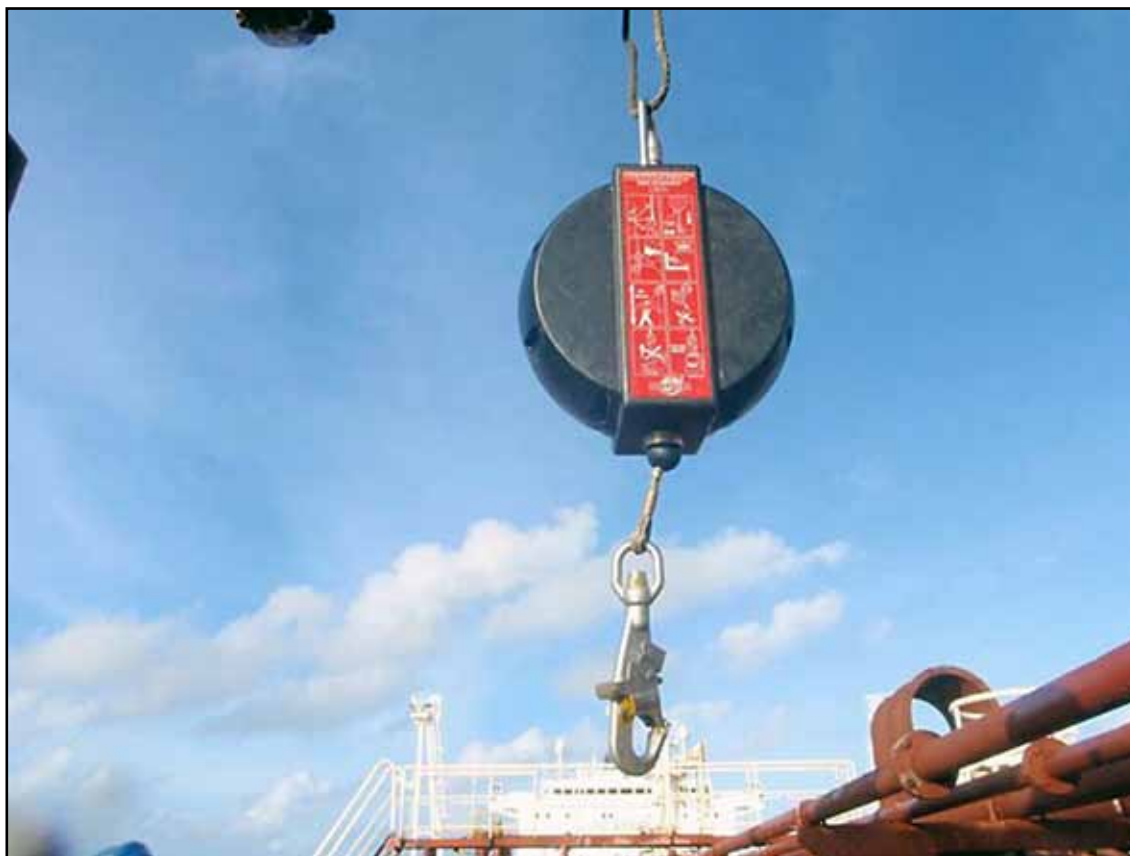
At the time of the accident, *Bro Arthur* carried three safety harnesses conforming to European Norm (EN) 361, but no fall arrestors. The harnesses were manufactured in 2006. There was evidence of wear on the web strapping, the spring clip screwed securing sleeves were found to be partly corroded, and the attached lifelines were abraded.

Fall arrestor

After the accident the harnesses were replaced with double clip versions conforming to EN 355. A fall arrestor was also provided which could be connected to the safety harness and secured at the hatch coaming or to an overhead support (**Figure 15**).

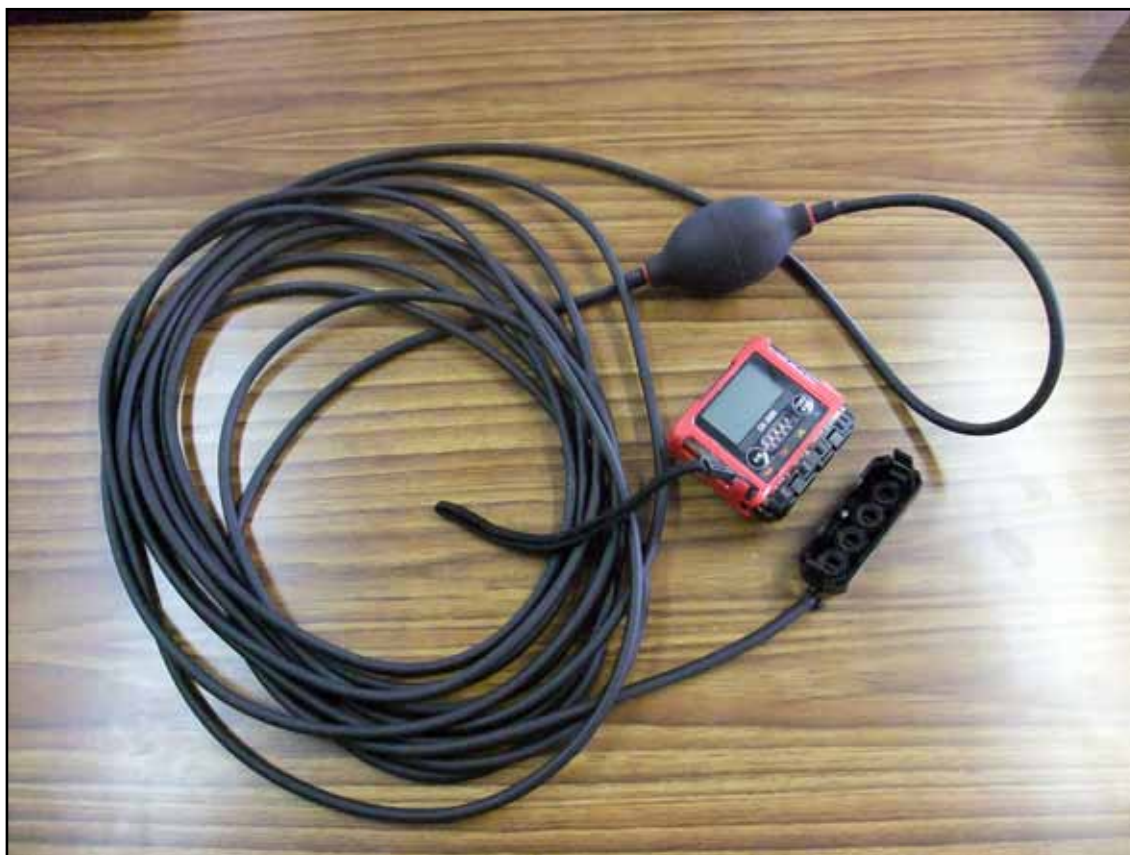
Figure 18

Riken Keiki GX-2009 (Ex Type A) Personal Gas Monitor, with aspirator and 10m sampling hose extension arrangement

This was not the case when the atmosphere was tested for the presence of other gases including CO. The tests were carried out from the main deck using the Riken Keiki, GX-2009 Personal Gas Monitor connected to a 10m extension hose. The readings obtained for combustible gas, H<sub>2</sub>S and CO levels were 0%. It was on the basis of these readings, and the 20.9 - 21% O<sub>2</sub> obtained using the O<sub>2</sub> meter, that it was decided that the tanks were safe to enter and the Entry Permit signed. This was an unsafe act because the hose was only 10m long

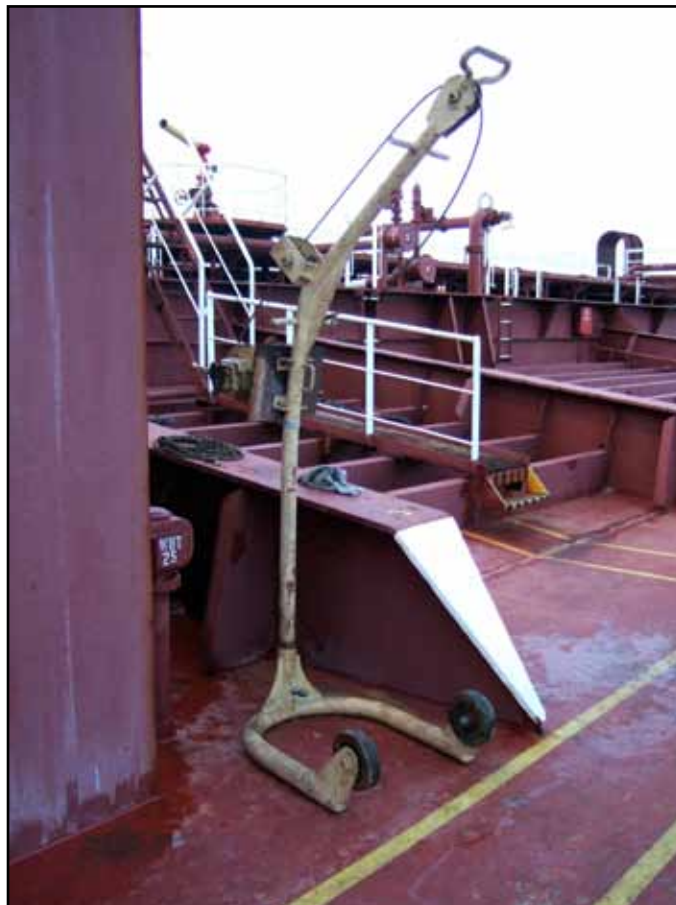
Figure 19

*Bro Arthur's casualty rescue equipment*

During a demonstration of *Bro Arthur's* casualty recovery equipment it was noted that, because of its weight and awkward design, it was very difficult to man-handle across the deep, main deck longitudinals. Once adjacent to No 2 cargo tank hatch it was found that the davit arm was unable to directly plumb the hatch when fitted to the unit's base. The davit arm was removed from the base and attempts made to secure it to the hatch coaming's external rungs using rope because there were no brackets or sockets fitted to the hatch coaming (**Figure 21**). This proved very difficult, and the arm was extremely unstable, and again a straight plumb through the hatch could not be achieved. In addition, when the wire was eventually lowered, it repeatedly came off the central guide wheel.

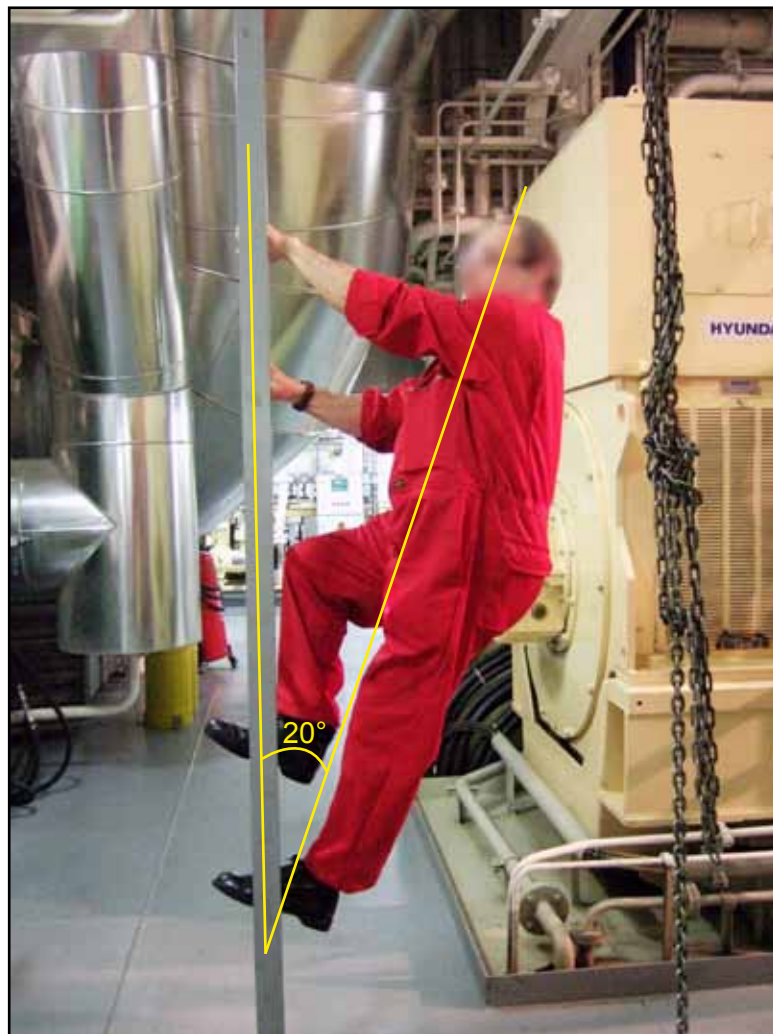
It is likely that the casualty was at least on the fourth rung up of the vertical ladder (about 1.2m from the top resting platform), and as he adopted the naturally backward leaning posture of about 20° to the vertical (**Figure 20**) he lost his handgrip and fell backwards, initially pivoting about his feet on the ladder rung. As he rotated backwards he is then likely to have passed over the top guardrail of the top resting platform and fallen about 18m onto the tank top. If he was lower than 1.2m on the vertical ladder it is doubtful that his body pivot point would have been low enough for him to pass over the top guardrail, in which case he would have landed on the platform itself.

Position of person ascending a vertical ladder

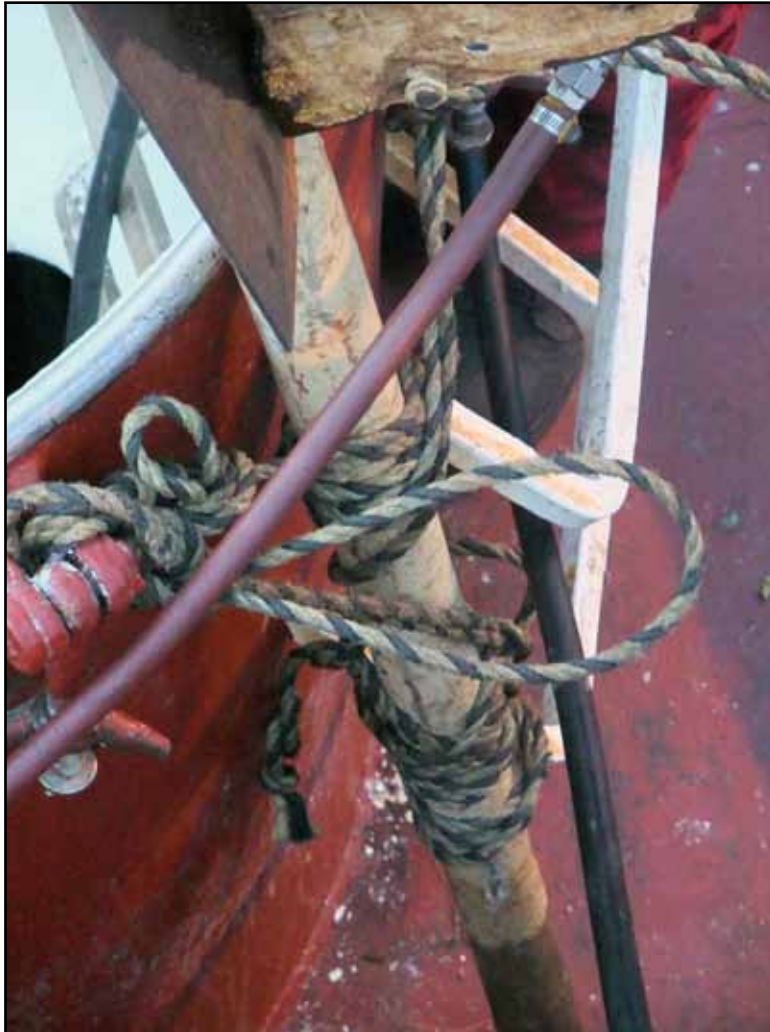
Casualty rescue equipment securing arrangements to  
No 2 cargo tank hatch coaming

The team was clearly unpractised in rigging the equipment for recovery. The demonstration took 18 minutes from the initial movement of the unit from outside the deck store to the wire passing through the hatch. Even then it was poorly secured, and it is quite possible that its use could have caused additional injuries to a casualty.
