Report on the investigation of
the grounding of
fv *Brothers*
with the loss of two lives
off Eilean Trodday
on
1 June 2006

Marine Accident Investigation Branch
Carlton House
Carlton Place
Southampton
United Kingdom
SO15 2DZ

**Report No 1/2007
January 2007**

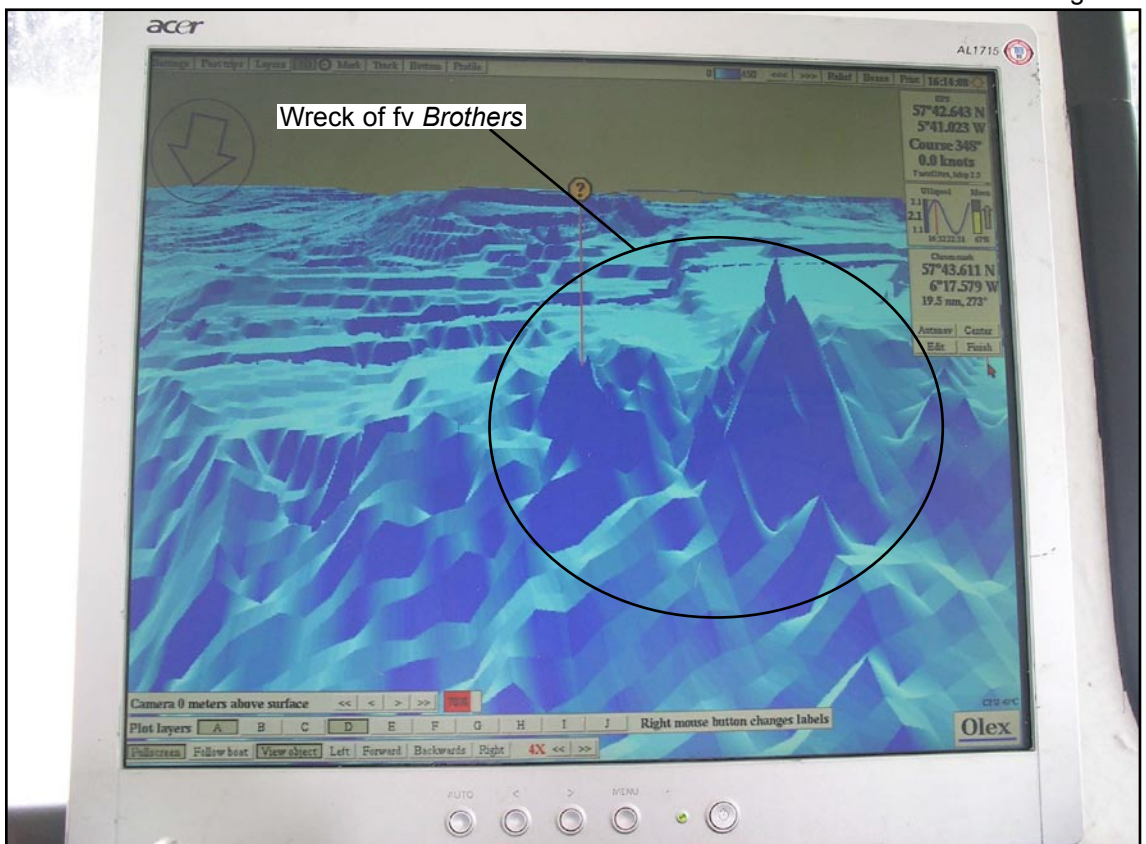
Figure 4

A little after midday, one of the fishing boats which was searching off the north-east coast of Eilean Trodday, reported that fuel could be seen coming up from the seabed and that an oil slick had formed on the surface. Upon closer investigation, they reported seeing an unusual trace on their fish finder and what appeared to be a mast under the water in the area where the oil was coming to the surface (**Figure 4**).

Fishfinder trace of sunken vessel

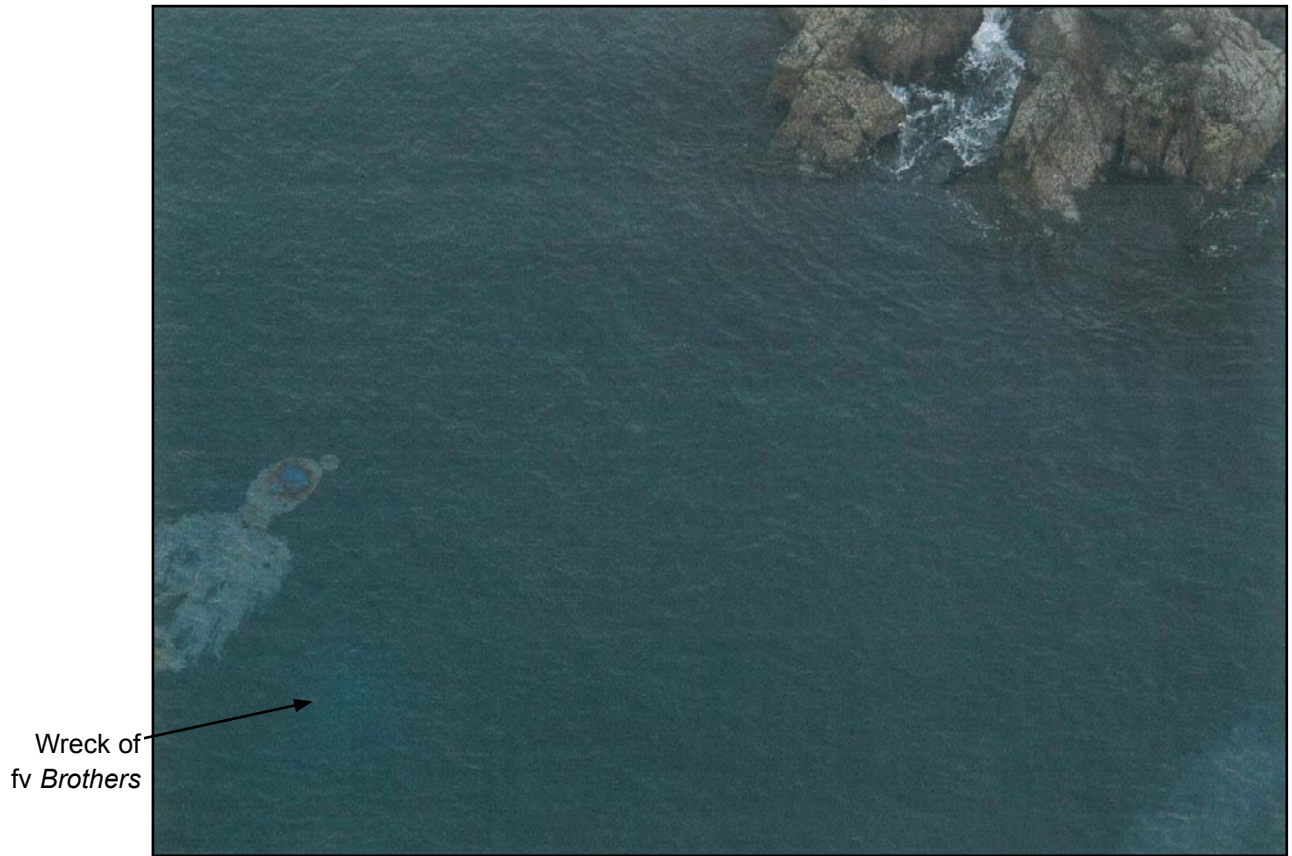
Figure 5

Wreck of
fv Brothers

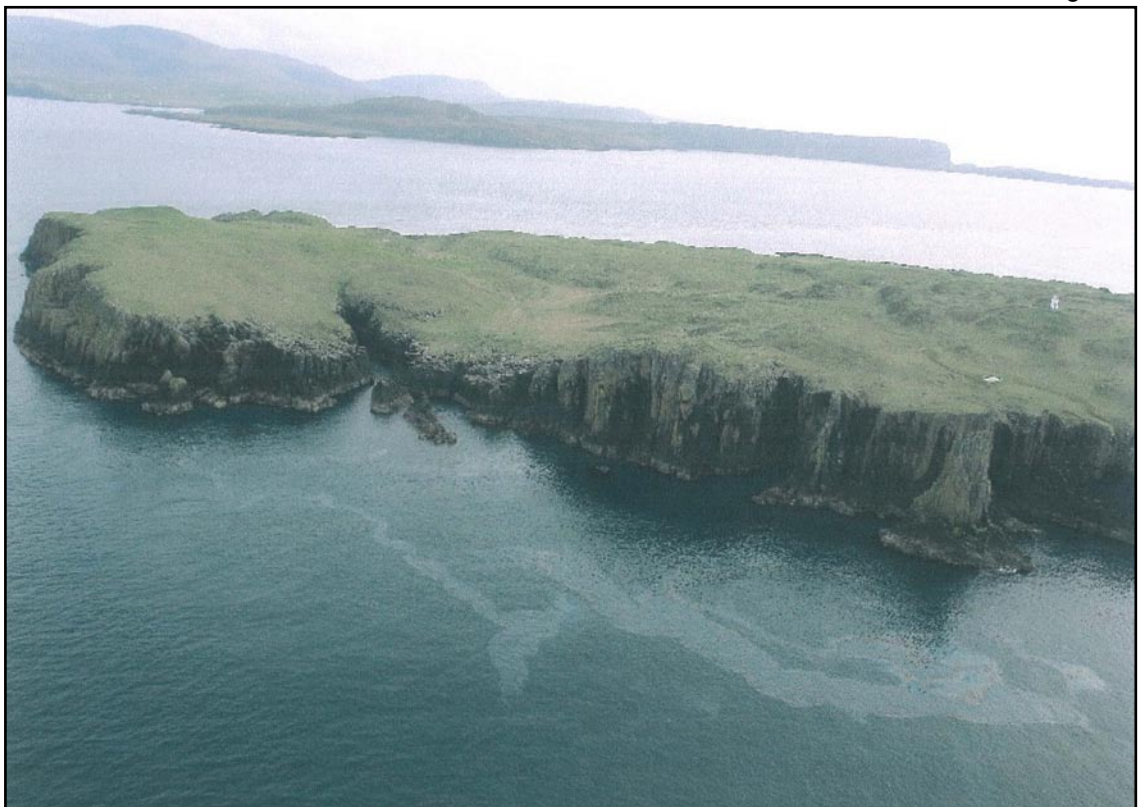
Figure 6

Oil on surface off Eilean Trodday

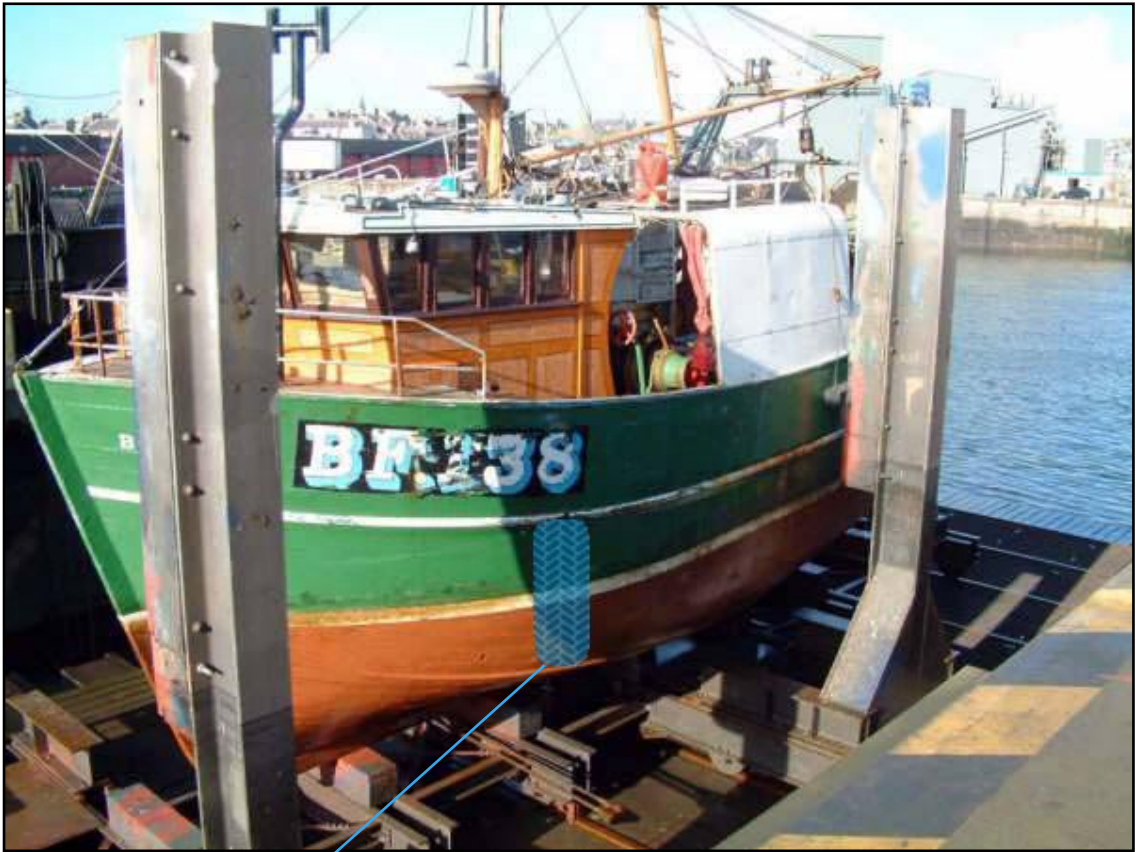
Figure 9

- *Brothers* was lying about 40m off the coast, upright on the seabed in a depth of about 14m;
- No sign of the skipper or crewman was found in the spaces searched;
- The liferaft was still lashed to its cradle. The liferaft was subsequently cut away by the divers and recovered;
- The engine throttle control was set in the astern position;
- The CPRS unit was switched on;
- The vessel's hull was holed in the area of the port bow – the hole measuring about 2.5m x 1.5m spanned both the cabin and engine spaces;
- The escape hatch for the cabin was open.

Area of damage to vessel

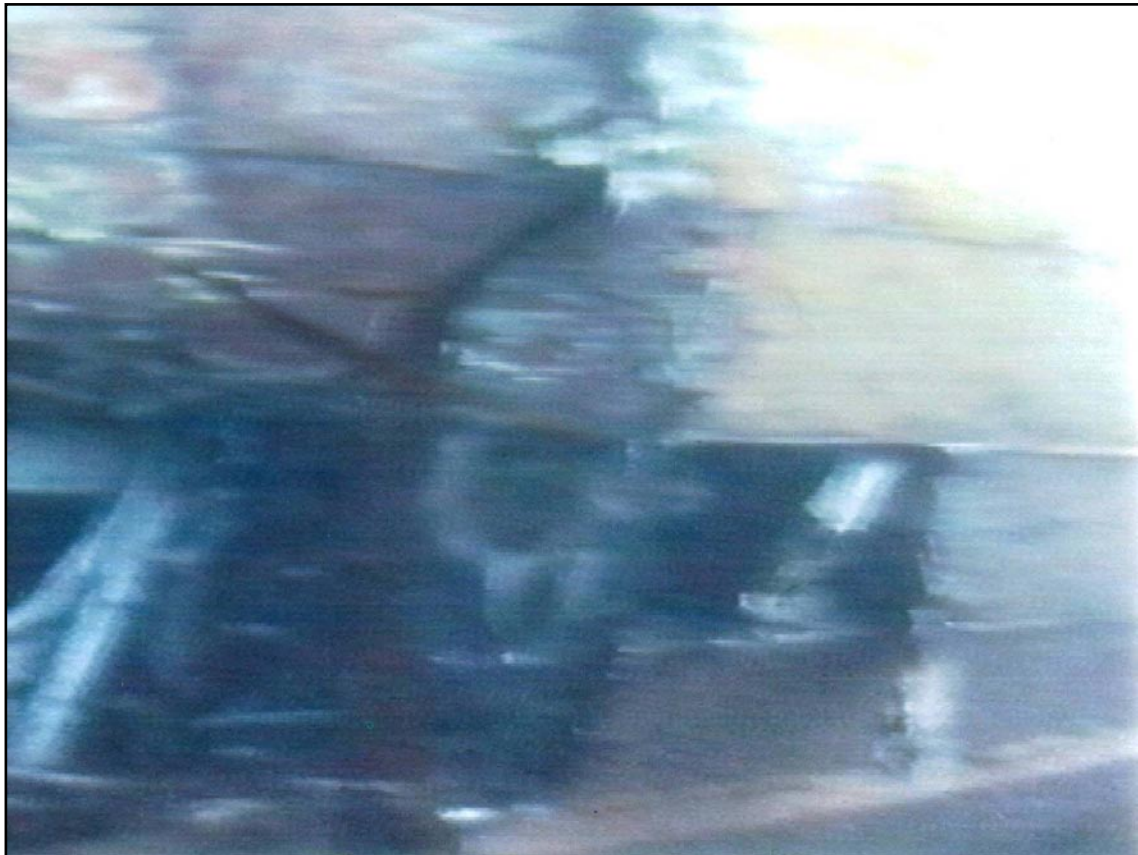
Figure 10

Damage to timber hull

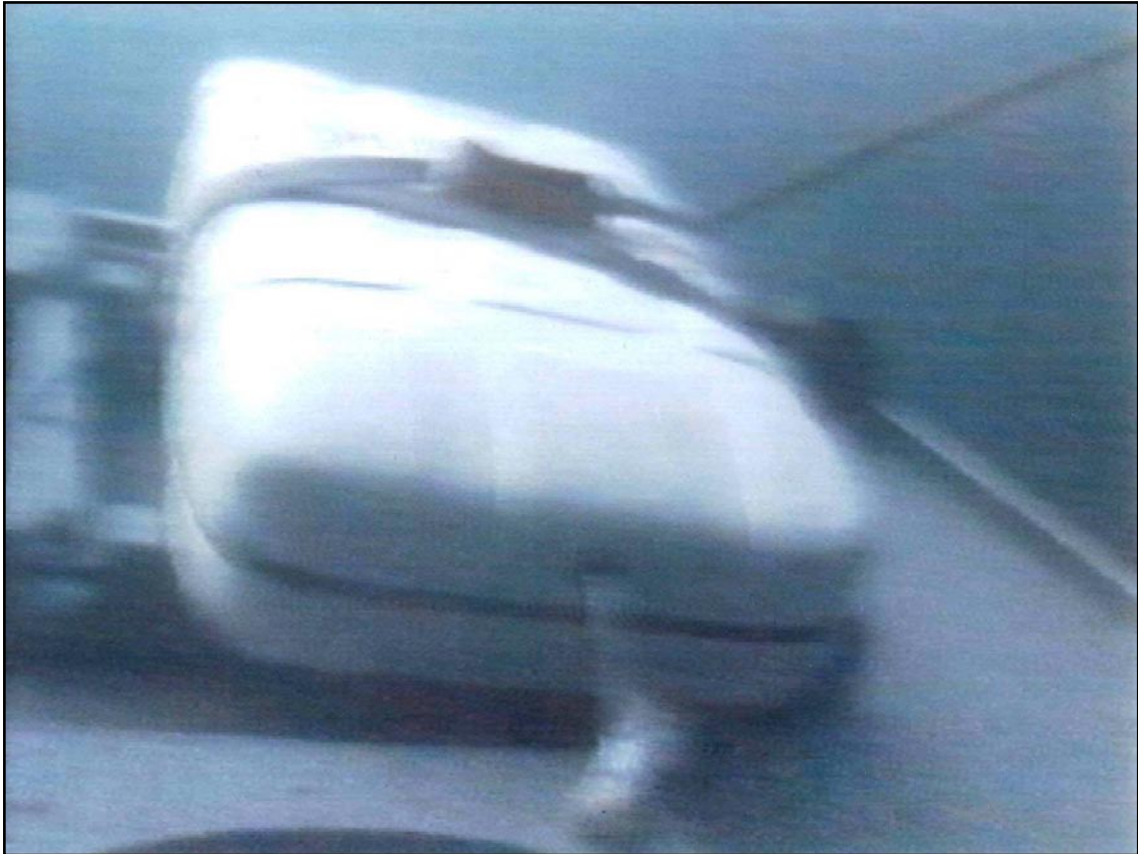
Figure 11

Brothers had a fully serviced 4-man Lifeguard Oceanic liferaft on board, even though there was no requirement to carry one. The raft was lashed by rope to a purpose-built cradle on top of the wheelhouse, and the painter was left unsecured (**Figures 11 and 12**). If the vessel's liferaft had been fitted with a hydrostatic release unit, it would have been released from its cradle, allowing it to float to the surface soon after the vessel foundered. A liferaft would have provided protection for the two fishermen for several hours, or longer, as well as making a potential search more likely to succeed. The RNLI fishing safety team developed a Hydrostatic Release Unit (HRU) Installation Guide during 2004, which has been widely distributed to the fishing industry (**Annex 3**).

Liferaft lashed to cradle on wheelhouse top

6. If the vessel's liferaft had been fitted with a hydrostatic release, allowing it to float free when the vessel sank, it would have been of great benefit to the two fishermen in the water. [2.3]

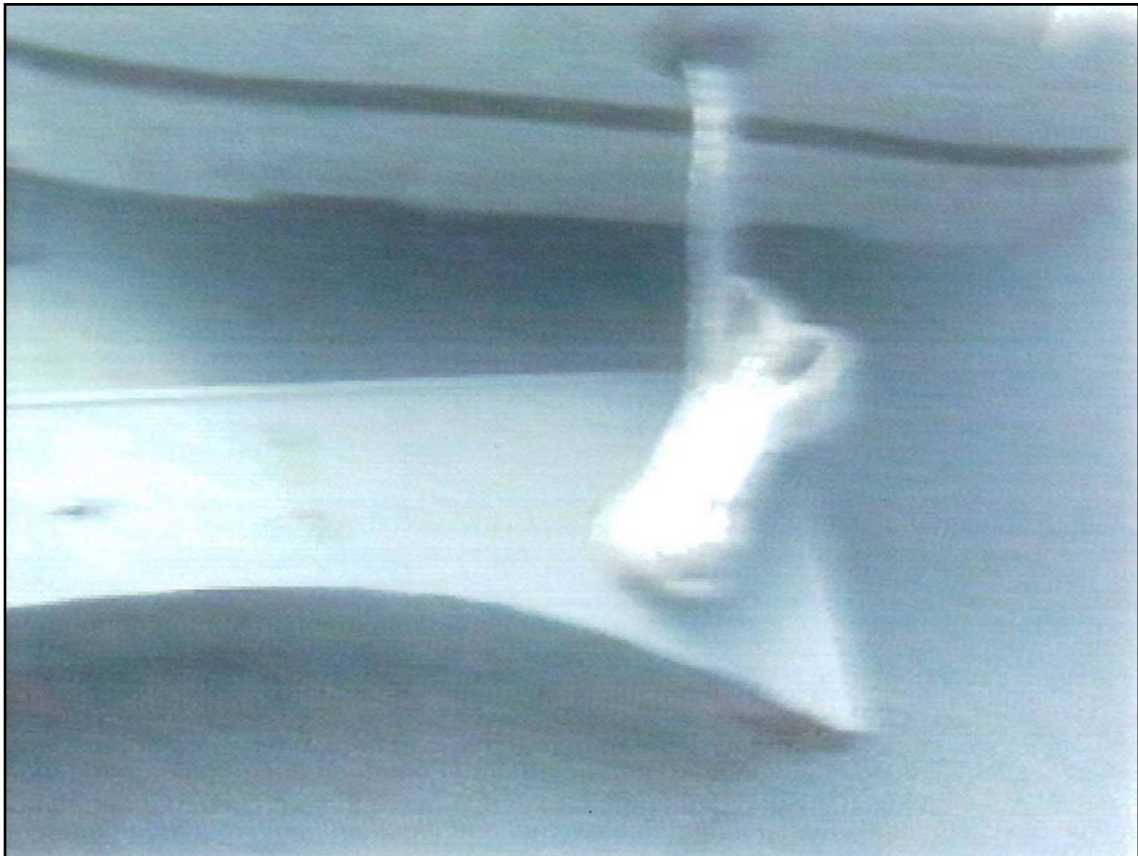
Figure 12

Unsecured liferaft painter

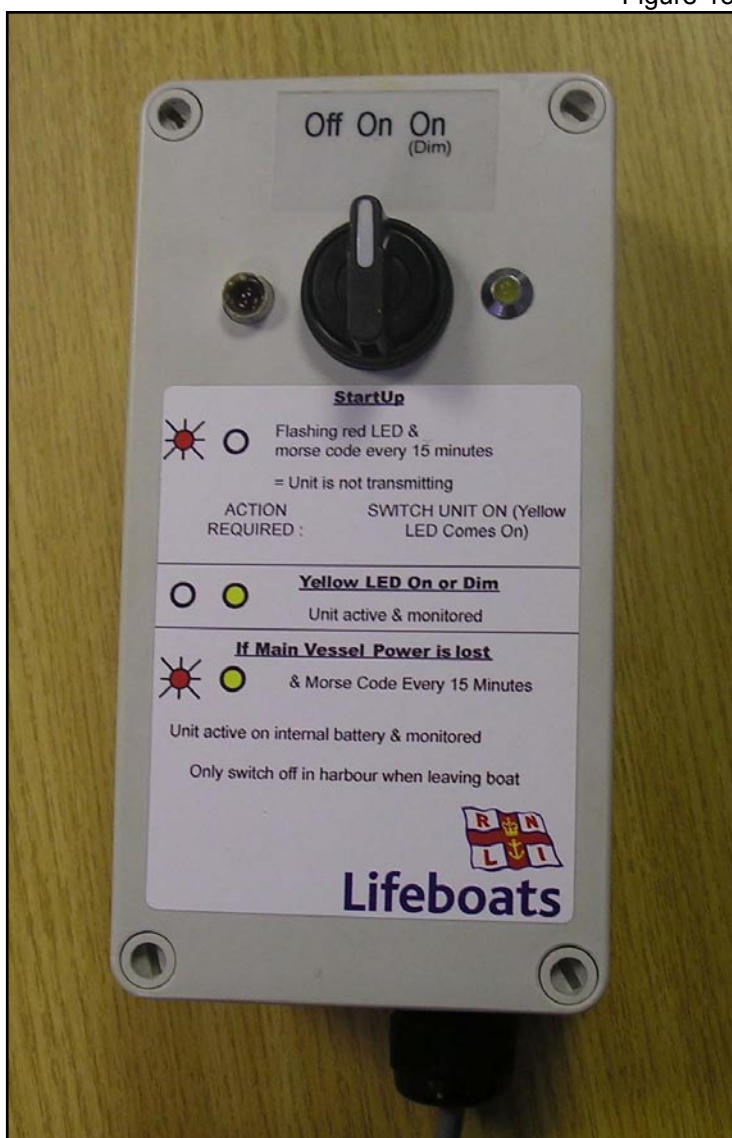
Figure 13

CPRS control unit switched ON
(Sample unit)

The skipper was known to have switched the unit on each time he left port, and to switch it off on return. Further evidence that this was the case is highlighted by the unit being found switched ON or in the “seagoing position” after it was recovered from the wreck (**Figure 13**).

As stated above, the precise message passed to the skipper in October 2005 is not known. However it is unlikely that he was told the unit had completely failed because there is strong evidence to suggest that he continued to switch the unit “on” and “off” for the next 8 months, presumably in the belief that it was working or, at least, might work in an emergency. It is improbable that he would have continued to have done so had he been told that it had completely failed.
