Report on the investigation of

the grounding of

CFL Performer

Report No 21/2008
December 2008

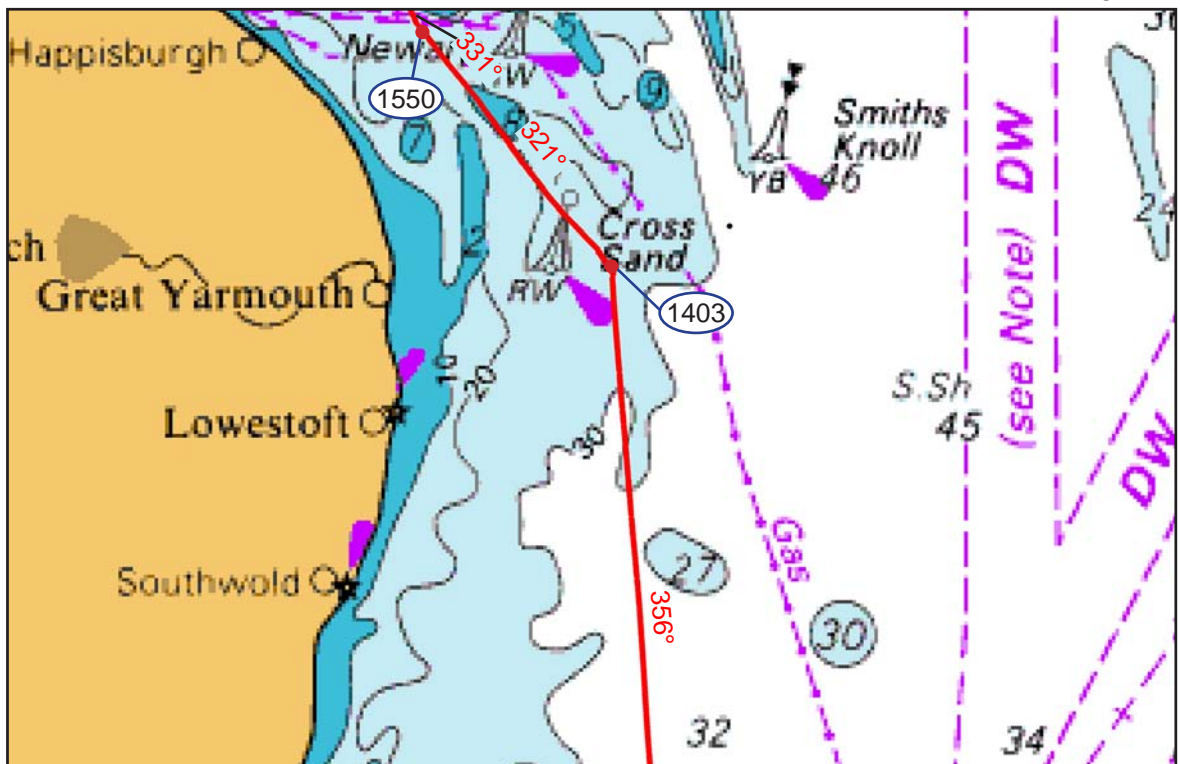
Figure 1

Vessel's track recorded by AIS

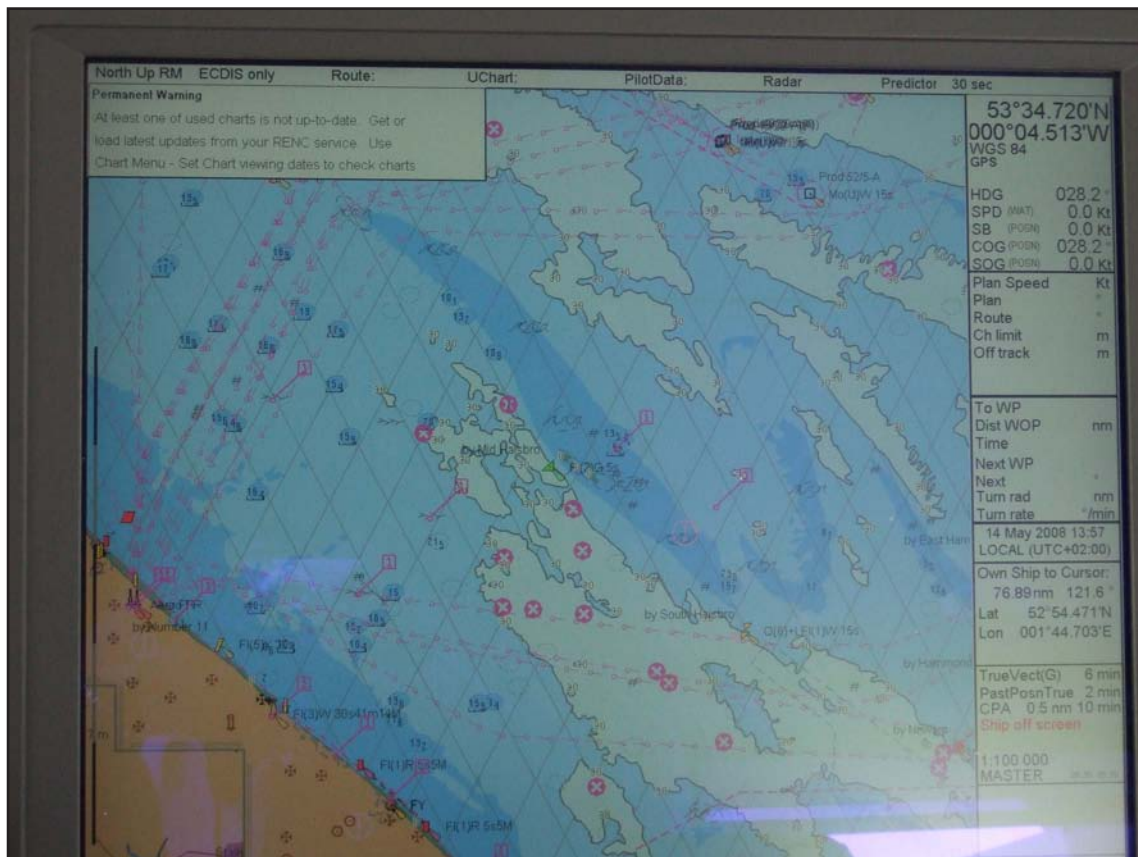
Figure 2

ECDIS display at 1:100000 scale

The scale selected was 1:100,000, which was the scale in use when the second officer relieved the master at 1200. The name of the plan and the intended track were displayed in red, and the channel limit was set to 185m. No watch

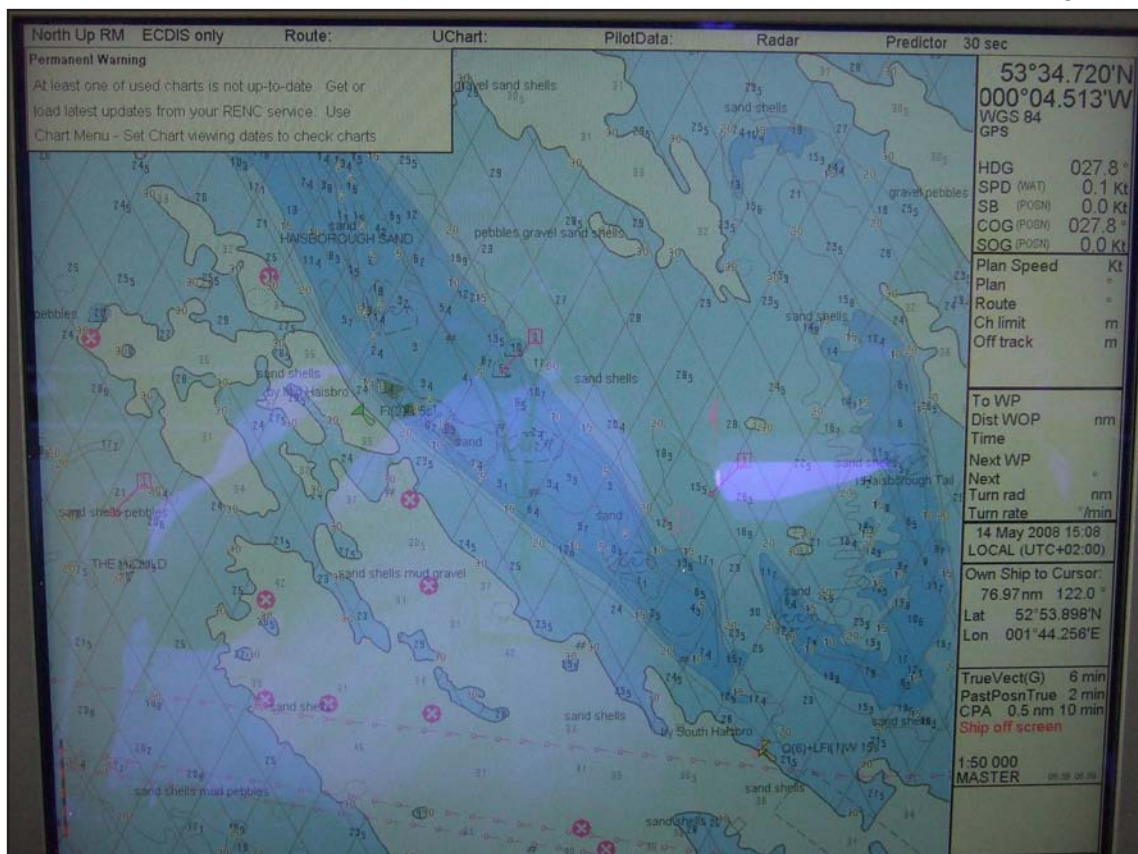
Figure 3

ECDIS display at 1:50000 scale

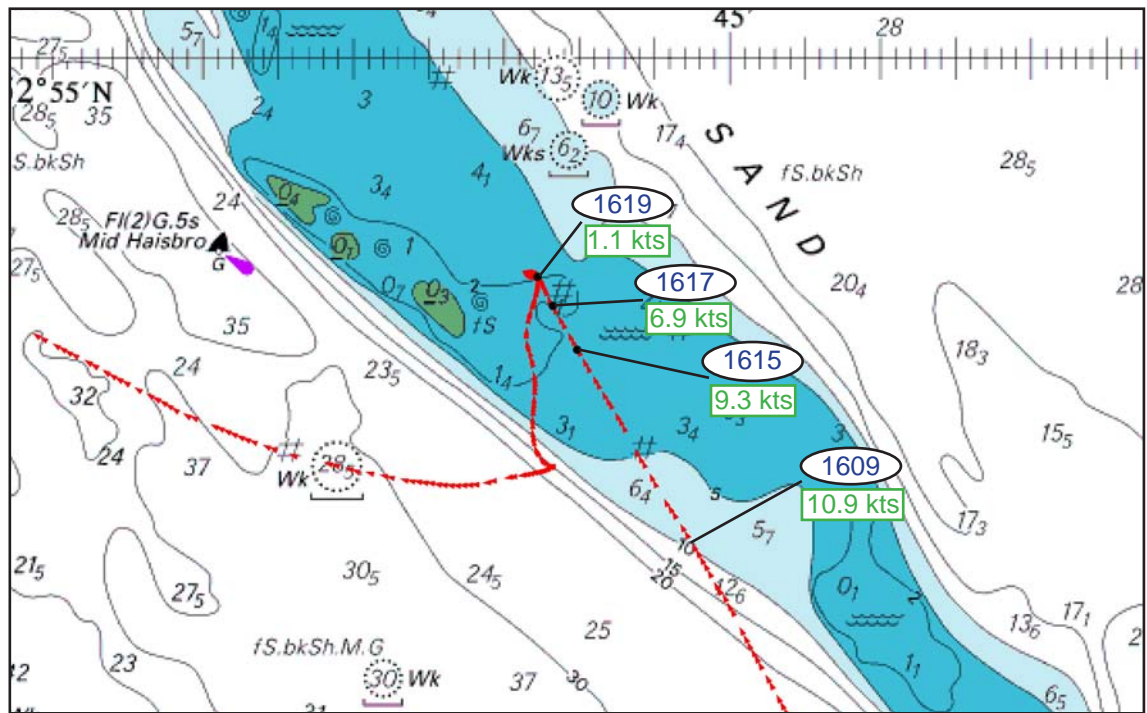
The reduction in the vessel's speed was detected by Yarmouth coastguard using the Automatic Identification System (AIS) (**Figure 4**). At 1634, the coastguard station called *CFL Performer* on VHF radio to establish if the vessel was aground and needed assistance. The master, who had quickly made his way to the bridge with the chief officer, informed the coastguard that the vessel was aground but did not require assistance. He then put the propeller pitch to full astern, and the vessel refloated without difficulty. The chief officer checked the soundings of the double bottom tanks and the chief engineer checked the temperatures of main and auxiliary machinery; no problems were found.

Vessel's AIS track over Haisborough Sand

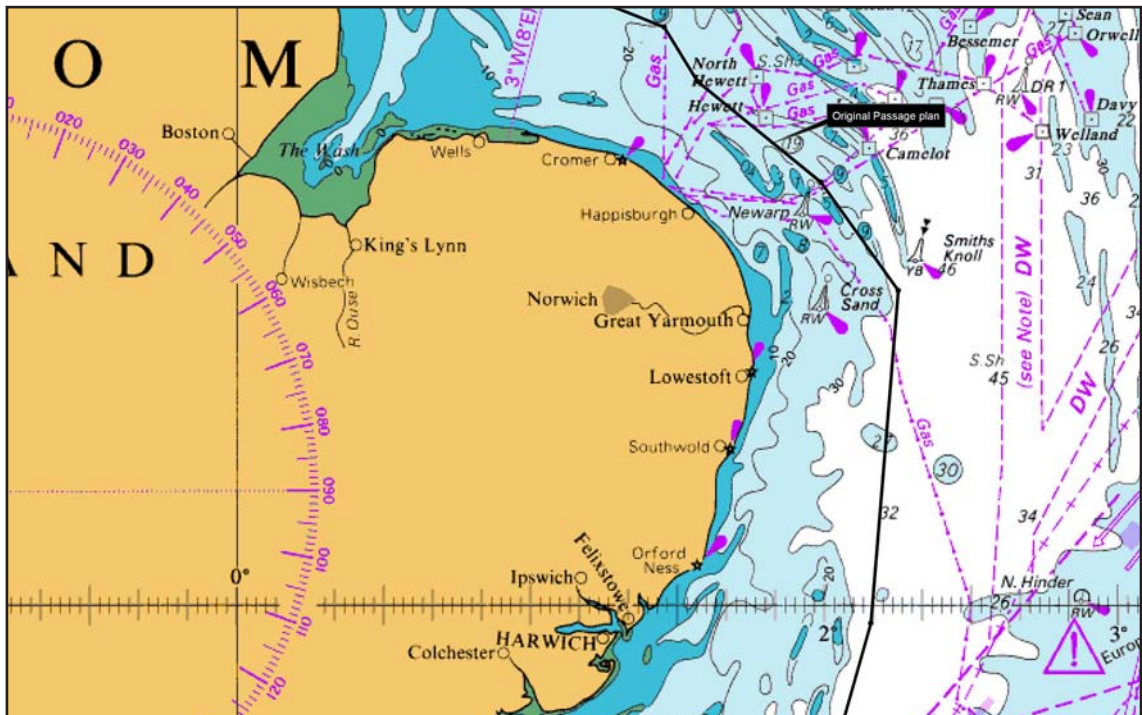
Figure 5

The voyage from Paramaribo to Grimsby was planned on the ECDIS by the chief officer before he was promoted. The plan was named *Paramaribo-Grimsby* and an extract is at **Figure 5**.

checked each leg of the new plan to ensure they were clear of hazards. In doing so, he noticed that the vessel would leave a green conical buoy to port in the vicinity of Haisborough Sand, but did not investigate further. The new voyage plan took about 5 minutes to complete, and was in use when the second officer took over the bridge watch at 1200 on 11 May 2008.

Extract of the original passage plan

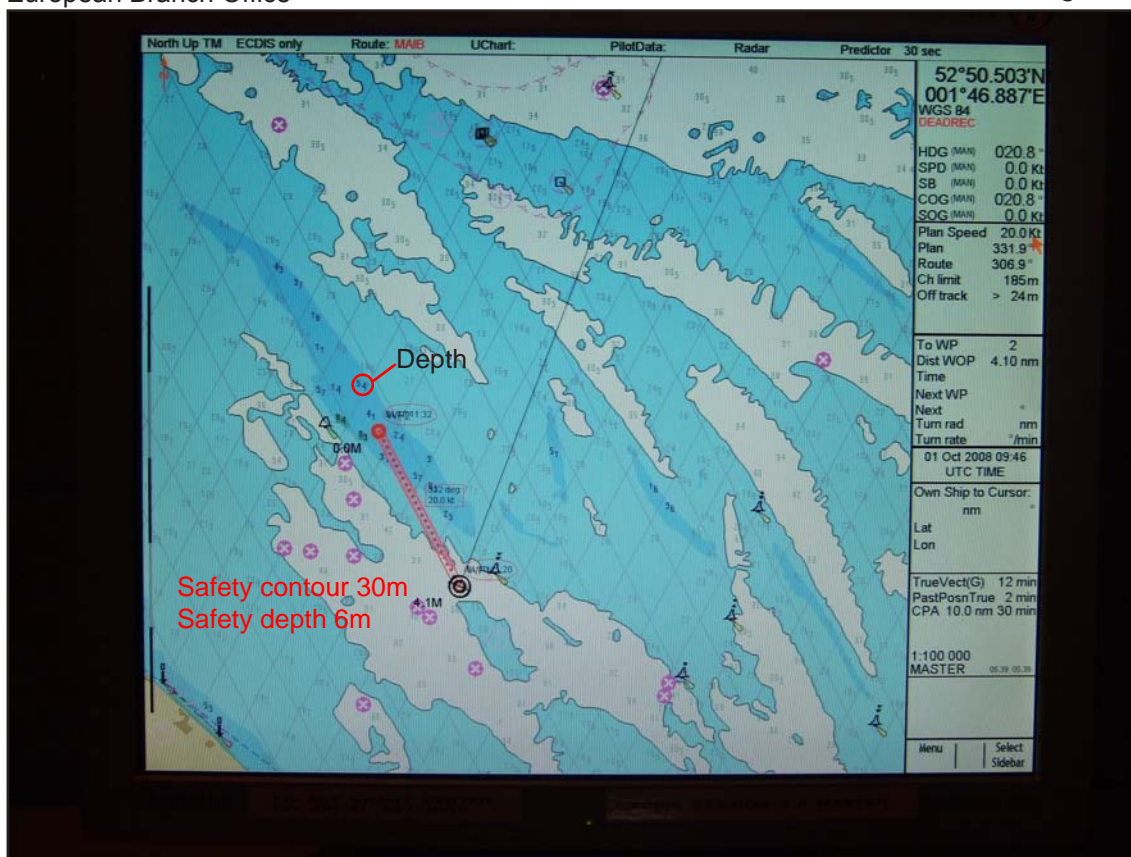
The safety depth applies to spot soundings, the depth of which is insufficient for a vessel to safely pass over. Spot soundings less than the safety depth are displayed in bold type to provide a more accurate representation of a vessel’s ‘no-go’ line than the safety contour (**Figure 6**).

Screen shot of ECDIS display showing depth and contour settings
(taken at the Furuno European Branch Office)

safety contour alarm will not activate. When an un-checked plan is monitored, the name of the plan at the top of the ECDIS screen is displayed in red, as are the areas within the channel limits where the safety contour is crossed (**Figure 6**).

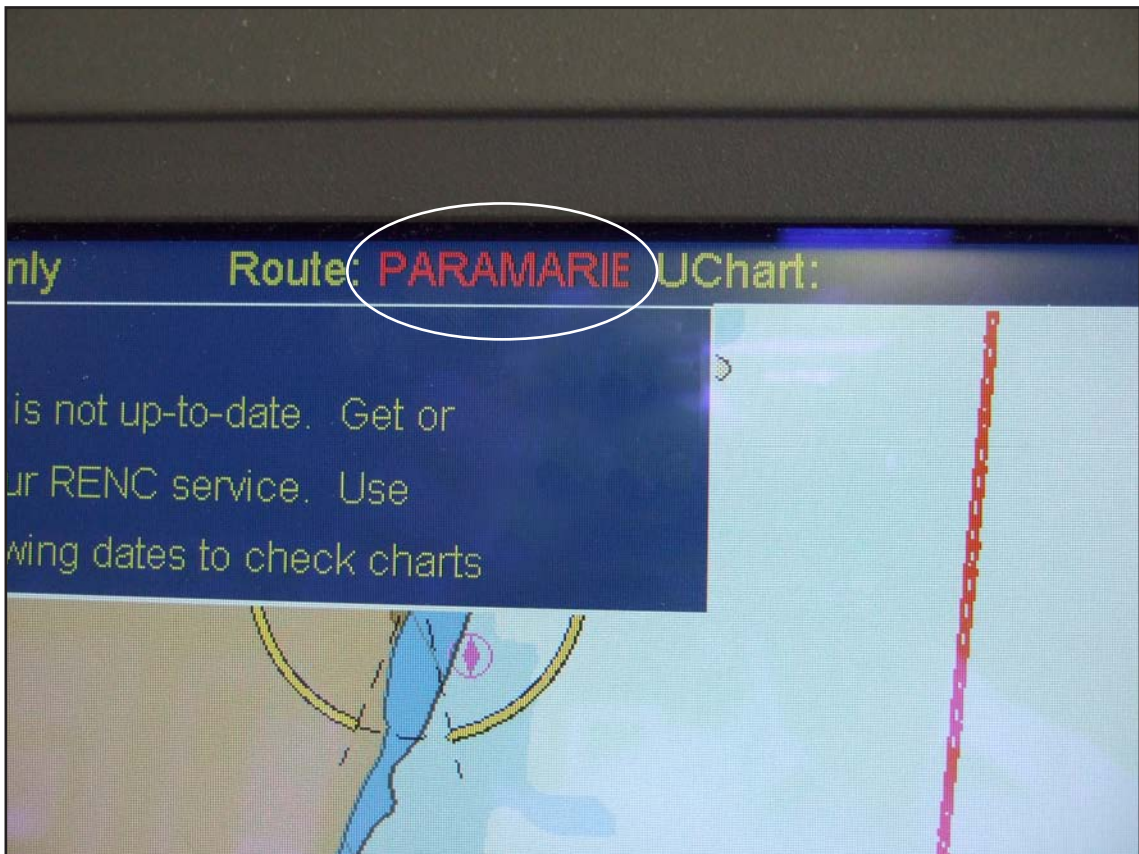
Figure 7

Screen shot showing title of original plan

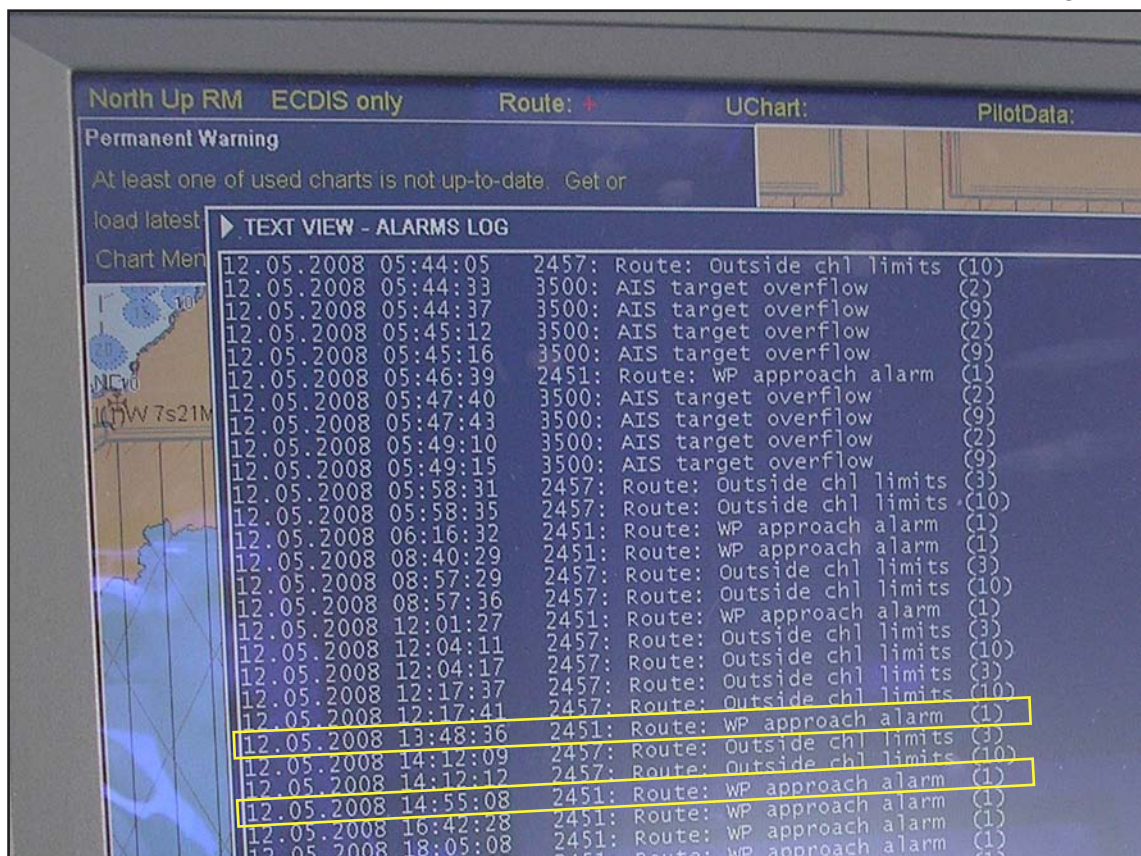
Figure 9

- The waypoint approach alarm activated immediately prior to the vessel's course alterations at 1403 and 1550 on 12 May 2008 (**Figures 1 and 9**).
- The safety contour alarm did not activate at any time during the voyage (**Figure 9**).
- The voyage log file did not record the name of the passage plan in use, but contained sufficient information to reconstruct the vessel's track.
- The chart usage file was deleted.
- All of the charts required for the vessel's passage to Grimsby were official ENC's.

Screen shot showing alarm log

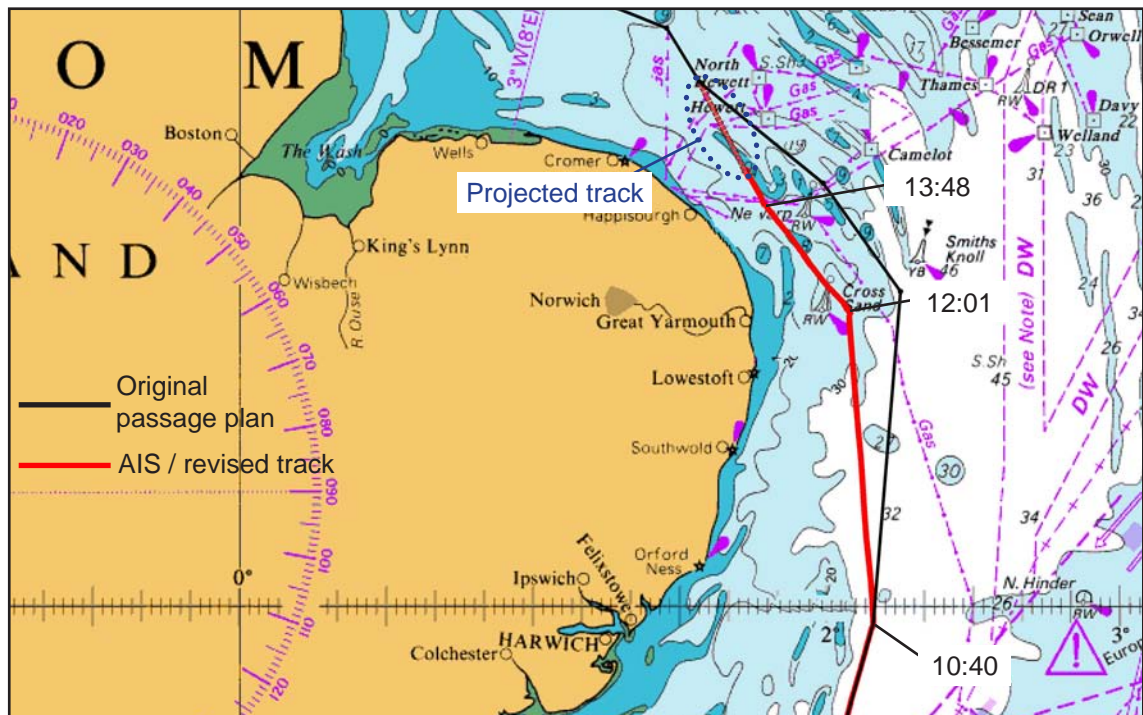
Figure 10

Vessel's original and revised planned routes

The route was planned and executed on the vessel's ECDIS, which had numerous in-built safeguards intended to prevent an accident of this nature. However, it is evident that on this occasion these safeguards were not utilised, and system warnings were not acted upon, either when the route was planned or when it was monitored. In particular:

- The system's check page was not used to check each leg of the route for navigational hazards.
- The plan was executed despite its title remaining red, indicating that the intended route crossed the safety contour set or other defined dangers.
- The safety contour alarm did not sound as the vessel approached the shallow because a watch vector had not been set.

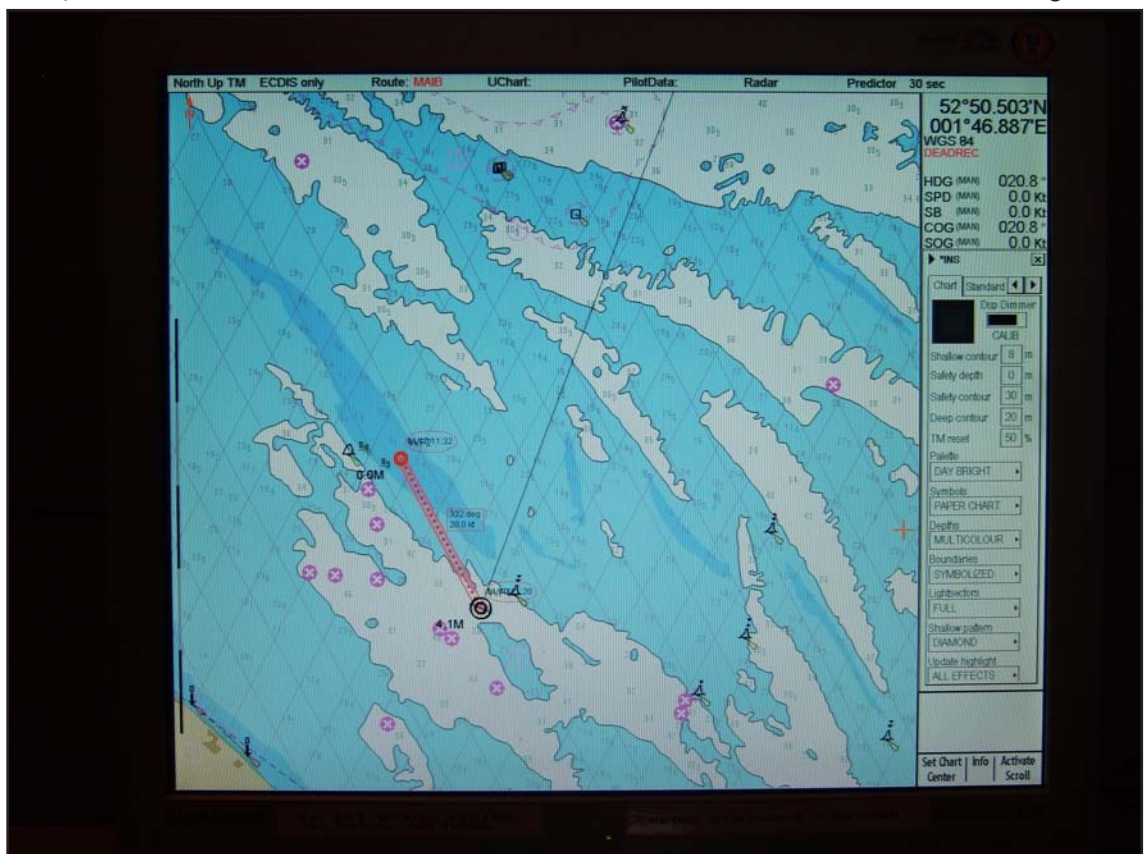
Figure 11

Screen shot showing display with 0 metres safety depth set
(taken at the Furuno European Branch Office)

would have affected the officers' ability to see the shallows, the drying patches in the vicinity of the Mid Haisbro' buoy would have been visible regardless of the settings applied. As these were not seen when the route was planned, and as the vessel's intended track would have passed over dark blue shading and the diamond hatched markings, which are similar to the conventions used for marking shallows and 'no-go' areas on paper charts, it is evident that the planner's visual check was only cursory. It is also evident that the amended route was not cross-checked by the master.
