MARINE ACCIDENT INVESTIGATION BRANCH

FLYER TO SHIPPING INDUSTRY

CP VALOUR:

FAILURE OF BRIDGE TEAM MANAGEMENT AND ONBOARD AUDITING

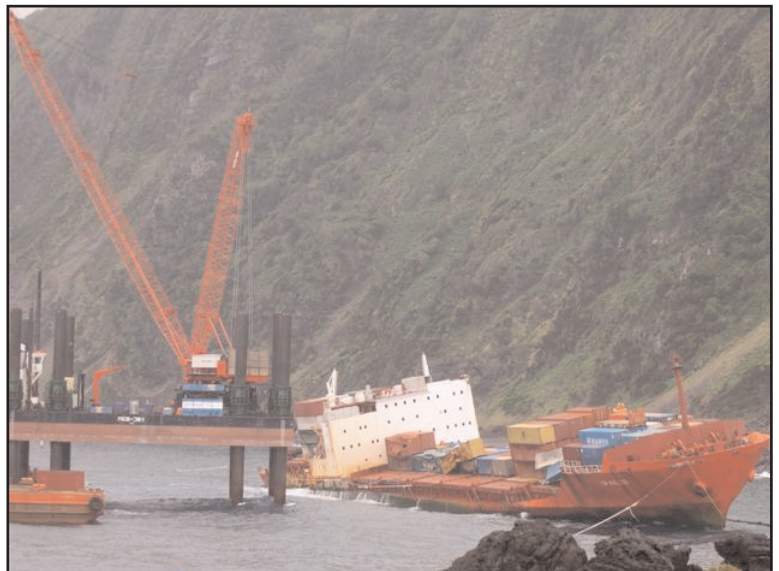
Initial salvage attempts by a local tug were unsuccessful and the vessel was driven further aground the next day as the wind veered to blow directly into the bay. The 1172 MT of heavy fuel oil and 118 MT of gas oil onboard began leaking in to the sea. By the time a powerful salvage tug was on scene and able to assist, the vessel was hard aground and unable to be moved and she was abandoned on 25 December 2005.
