High speed craft; motion, ergonomics and injury: A summary report for the MAIB

HIGH SPEED CRAFT; MOTION, ERGONOMICS & INJURY: A summary report for the MAIB.

Trevor Dobbins and Stephen Myers

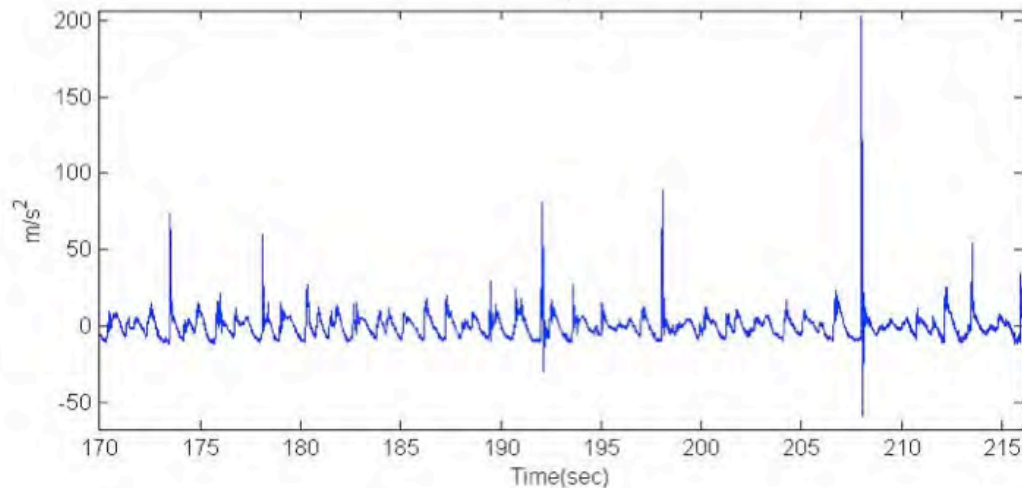
i) High Speed Craft (HSC) have been shown to experience impacts in excess of 20g perpendicular to the deck, and in excess of 10g parallel to the deck. An example of typical motion experience in a HSC is shown in Figure 1. This illustrates a section of a three hour transit in a 28' RIB, travelling at ~40 knots, in a sea state 1-2. Note the predominance of impacts of around two to three g, a number of impacts around seven g, and a twenty g impact.

Figure 1. An example of the deck motion (gZ) of a 28' RIB travelling at ~40 knots in a sea-state 1-2.

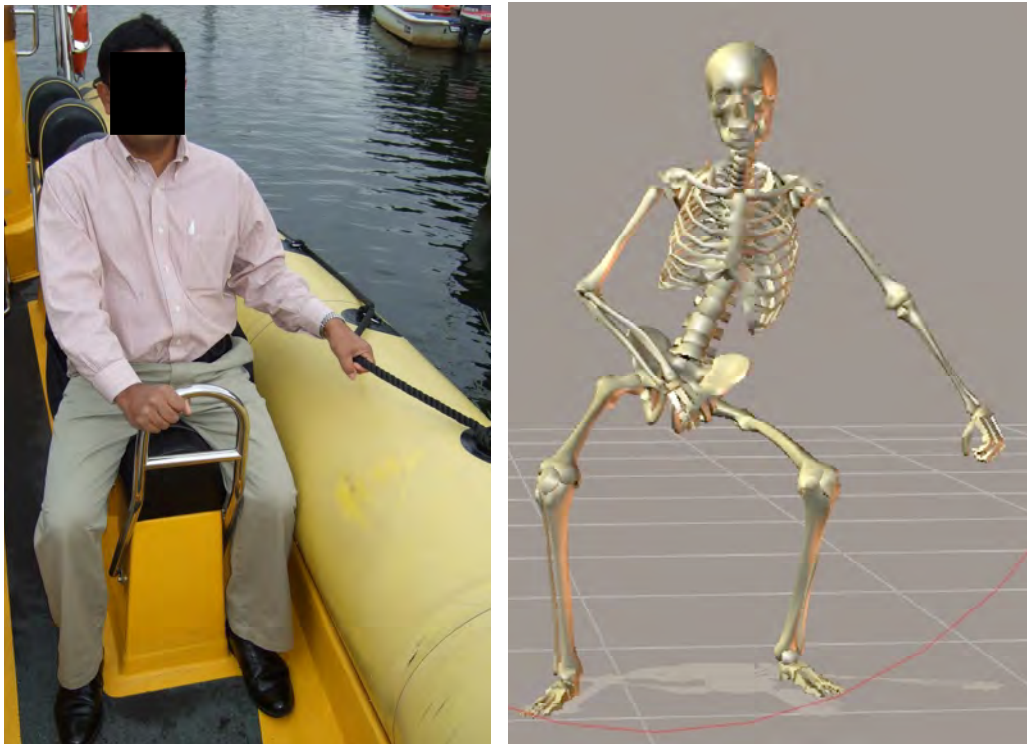
i. Posture; the principal issue is with the front seat and its handle. The position of the handle is considered to be too low and too narrow. By being too low it provides no support to stop the individual from being thrown forward as the boat impacts with the water. By being too narrow it provides little lateral support to the individual when the boat impacts with the water or during cornering. This poor support means that the individual will use other means of support and stability wherever possible. In this case the individual used the rope on the RIB sponson to provide additional lateral support. The problem with this is that it can result in the spine being misaligned and therefore being put at an increased risk of injury. Also the position of the seat means that the left foot of the occupant is not placed on the flat deck with a non-slip surface, and is therefore on an angled surface that will be slippery when wet. This may also reduce the stability of the seat occupant. This situation can be avoided by repositioning the seats so that they have the appropriate non-slip deck space around them. This would most likely require the number of passenger seats on the boat to be reduced. The issues with seat design and the occupants posture are graphically described in Figures 2, 3 and 4 where an illustration using a skeleton has been used to describe the resultant posture of the spine.

Figure 2. An illustration of the casualty's anticipated posture during the transit indicating the curvature of the spine.

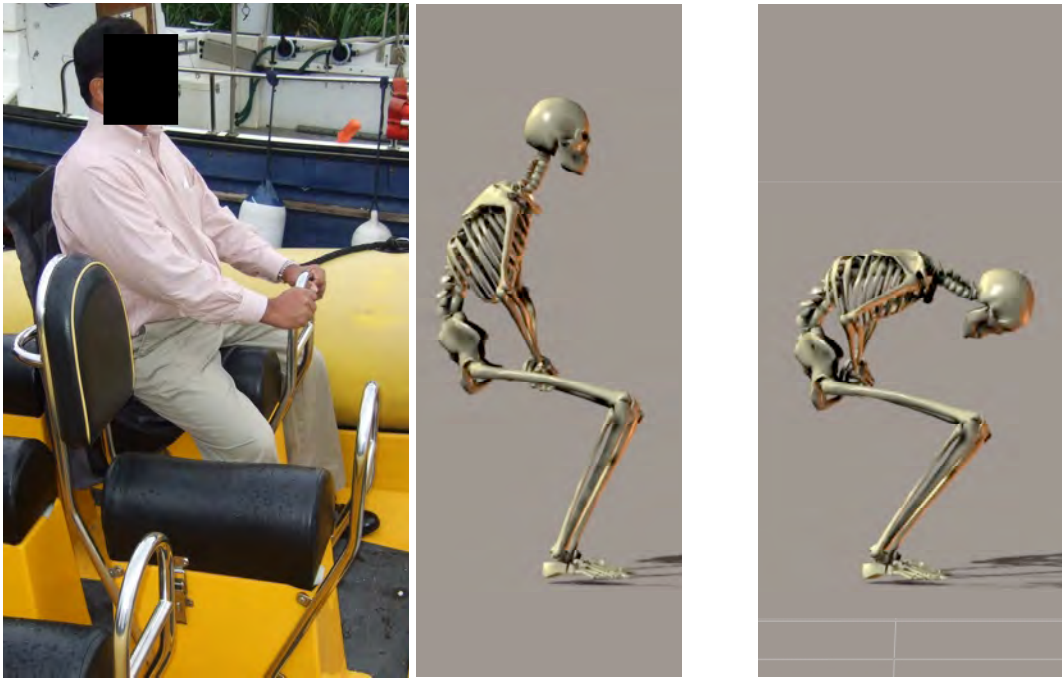
Figure 3. A graphical representation of the effect of using a 'low, narrow' handle on the seat occupants posture pre and post wave impact indicating the inability to maintain a good posture with spinal alignment.

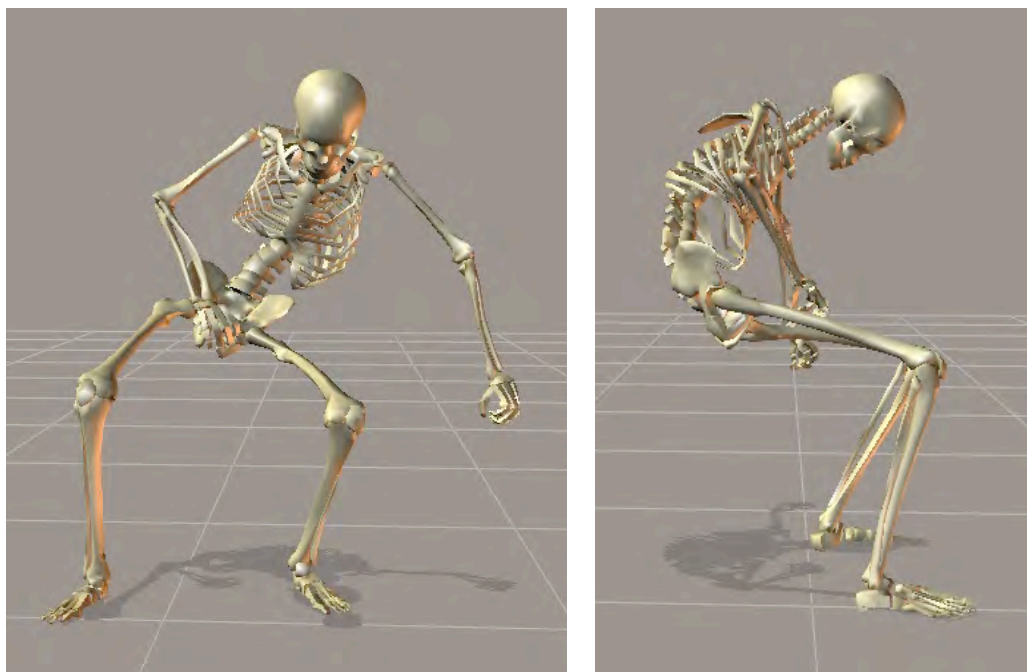
Figure 4 An illustration of the casualty's anticipated posture during the wave impact.

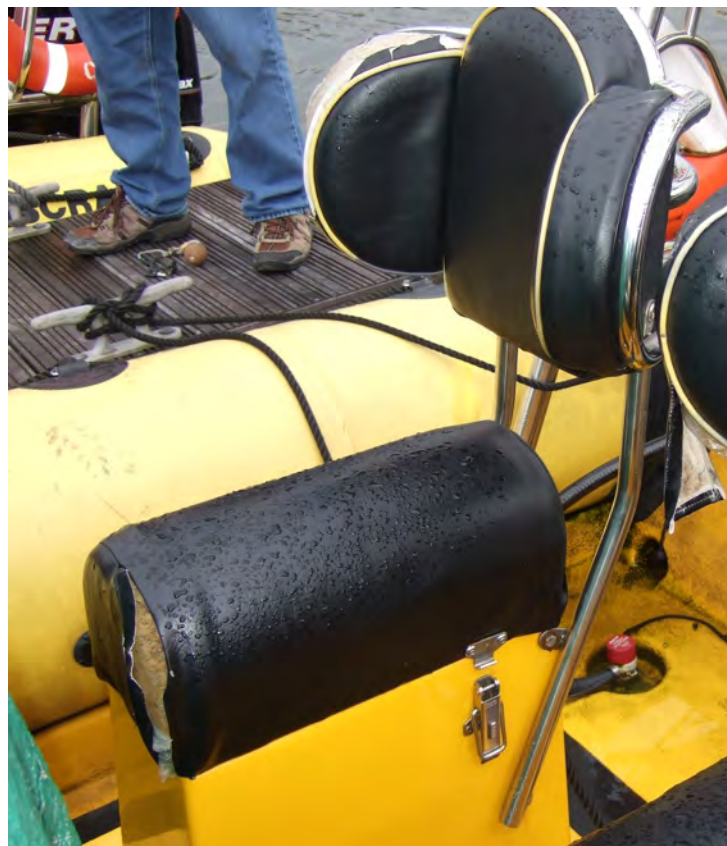
iii. Unfortunately the HSC industry does not recognise the seat as being one of the most important features of the boat. An example of this is shown in Figure 5 where the seat cushion covers have been allowed to degrade and no maintenance has been undertaken. This lack of maintenance will allow water ingress to the cushion, as well as the foam material to protrude through the holes, both of which will accelerate the degradation process.

Figure 5. An example of wear-and-tear on a RIB seat, demonstrating a lack of maintenance, which accelerates the degradation of the seat cushion.

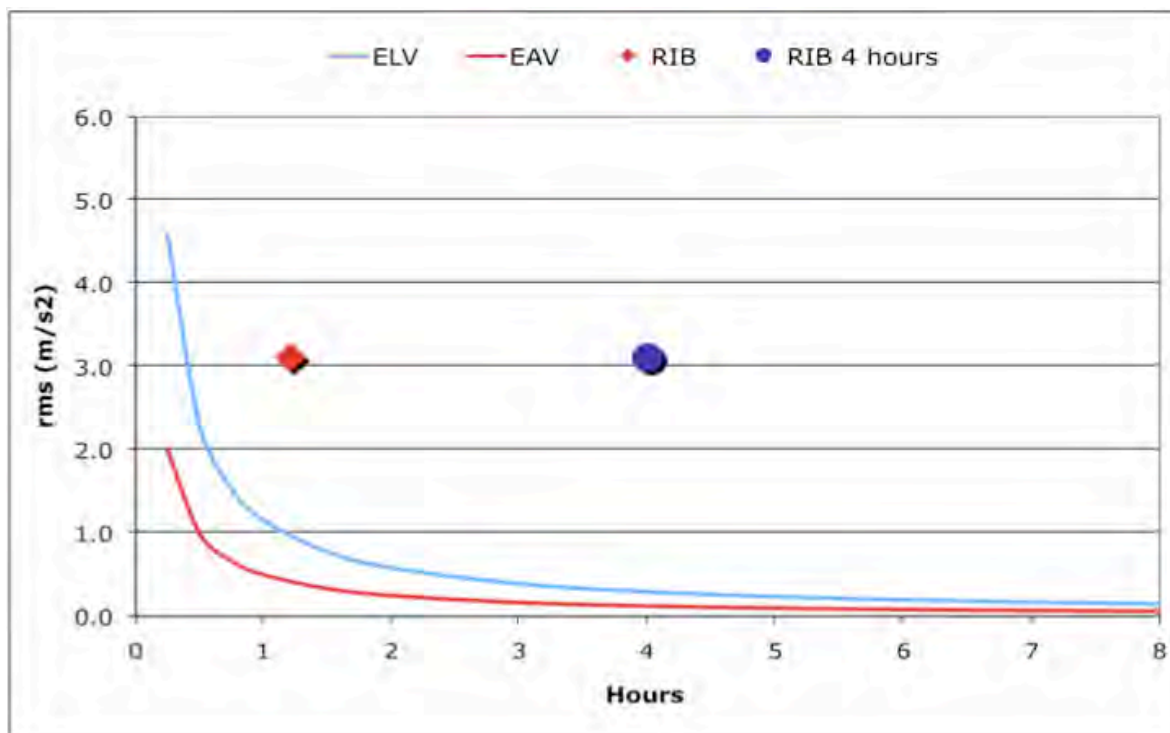
- i) The EU Physical Agents Directive includes the control of exposure to whole body vibration (WBV).
- ii) This legislation for the UK marine industry is overseen by the UK Maritime and Coast Guard Agency (MCA). An MCA Marine Guidance Note has been issued and can be found at www.mcga.gov.uk/c4mca/353.pdf.
- iii) An example of how extreme HSC motion is compared to terrestrial transport is that the 8 hour WBV exposure action value can be exceeded within 15 minutes in an 8.5m RIB travelling at ~40kts in a seat state 2. The graph shown in Figure 6 indicates how far in excess of the recognised Exposure Action Value (EAV) and Exposure Limit Value (ELV) a 28' RIB travelling at ~40kts in a sea-state 2 will be. At one hour the exposure is 7.5 times the EAV, while at four hours the exposure is 10 times the ELV and 24 times the EAV.

Figure 6. An example of how a 28' RIB travelling at ~40kts in a sea state 2 will exceed the EU WBV Exposure Action and Limit Values.

- iv) Compliance with this legislation by the HSC industry sector will assist in reducing both the risk of the acute injuries described above and chronic injuries that are common in professional HSC operators.
