Report on the investigation of  
a close-quarter situation between

***Costa Atlantica***

***Grand Neptune***

in the Dover Strait on 15 May 2008

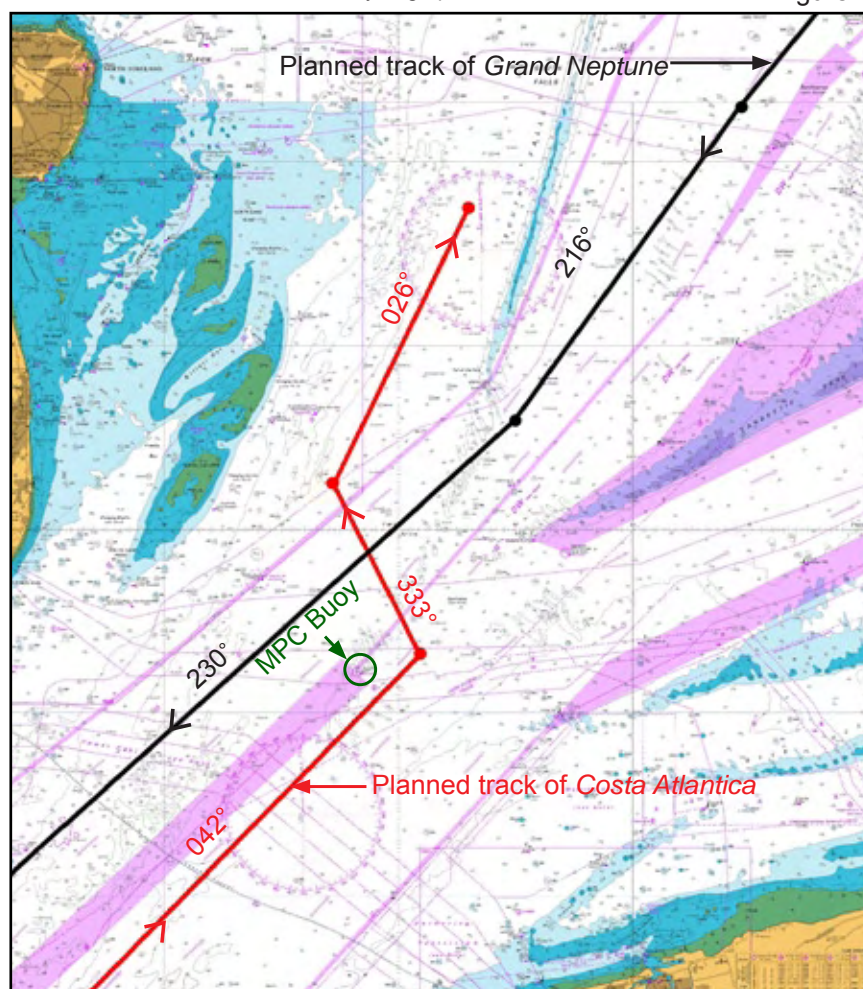
Figure 1

At 0211, *Grand Neptune* altered course to 216° and at 0245 to 230° in accordance with her passage plan (**Figure 1**). At 0249 the target of *Costa Atlantica* was acquired by radar when at a range of 5nm (**Table 1**). At 0253, the ARPA alarm sounded warning the bridge team of a dangerous target; *Costa Atlantica* was now 2.89nm away, with a CPA of 0.21nm in 5.12 minutes (**Figure 2**).

Extract of chart BA 323 - Dover Strait

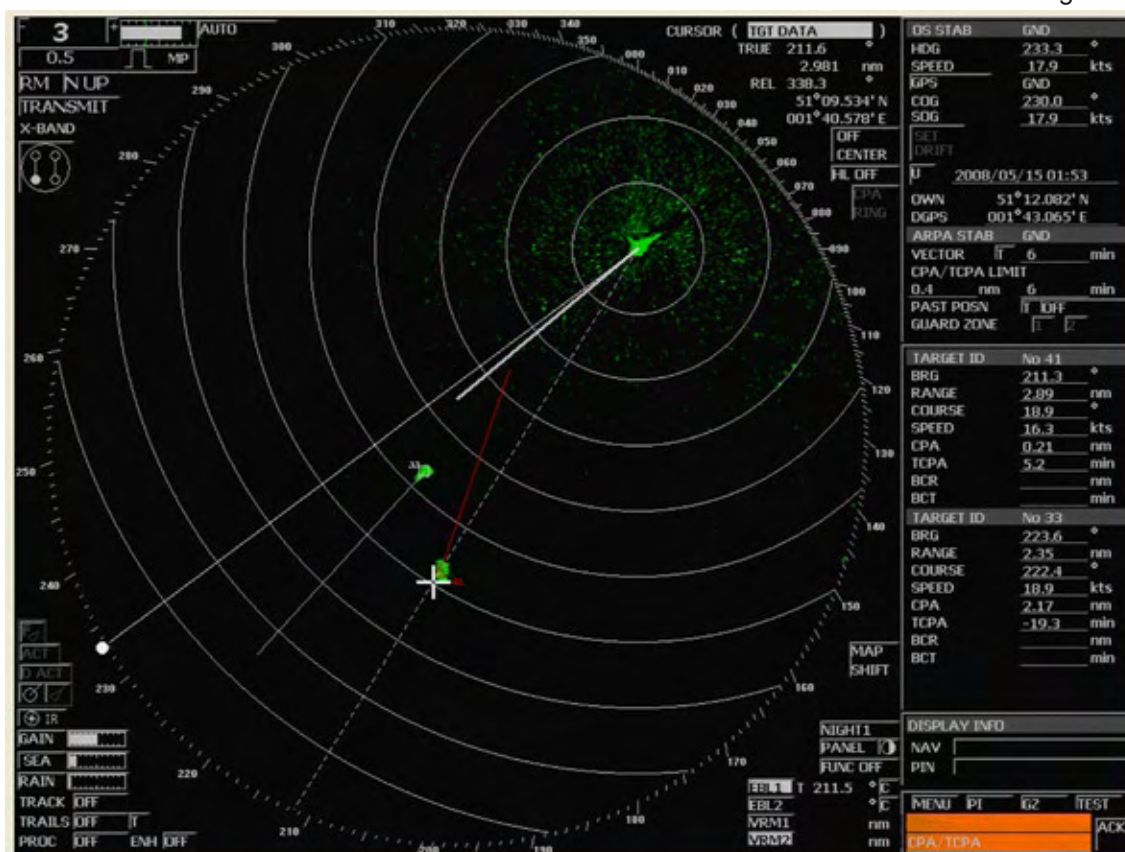
Figure 2

*Grand Neptune* - screen shot of radar at 0253

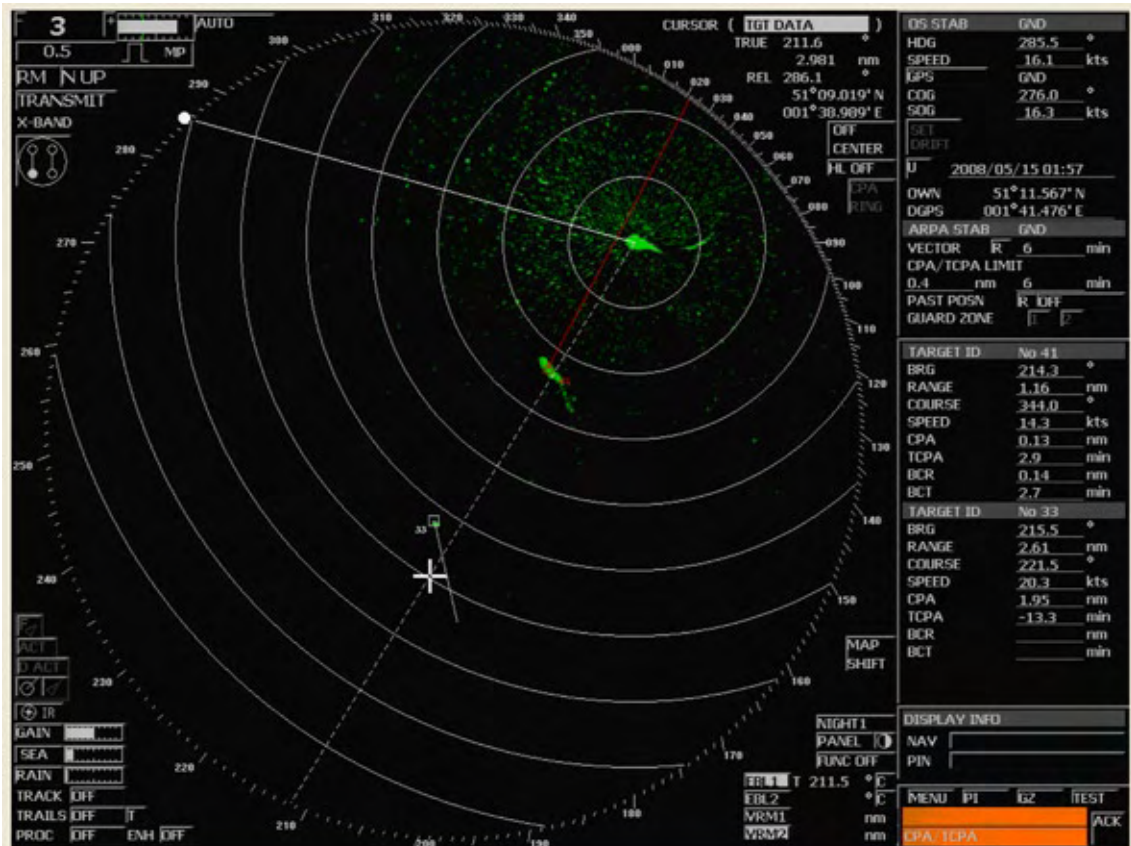
Figure 3

At 0257 the pilot ordered the helm to hard-a-starboard. *Costa Atlantica* was 1.16nm away, with a CPA of 0.13nm in 2.9 minutes (**Figure 3**). He also informed *Costa Atlantica* on VHF radio:

Grand Neptune - screen shot of radar at 0257

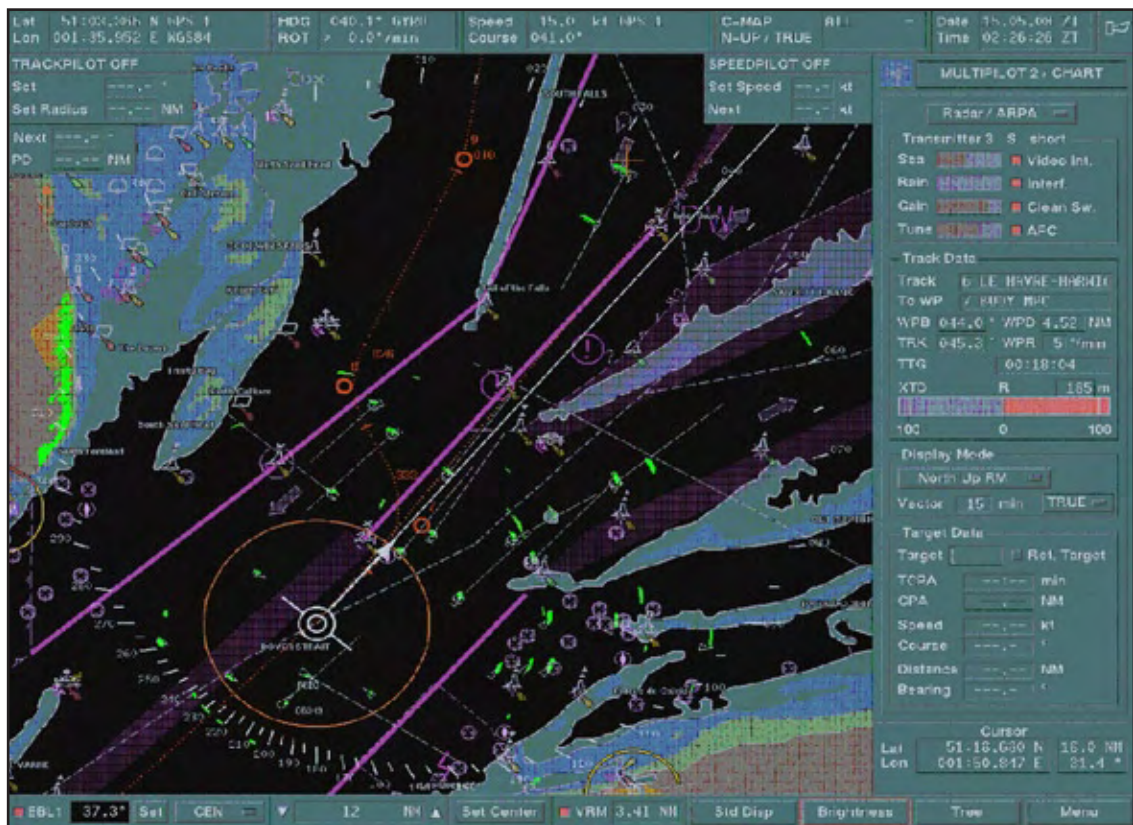
Figure 4

*Costa Atlantica* - screen shot of radar when *Grand Neptune* acquired

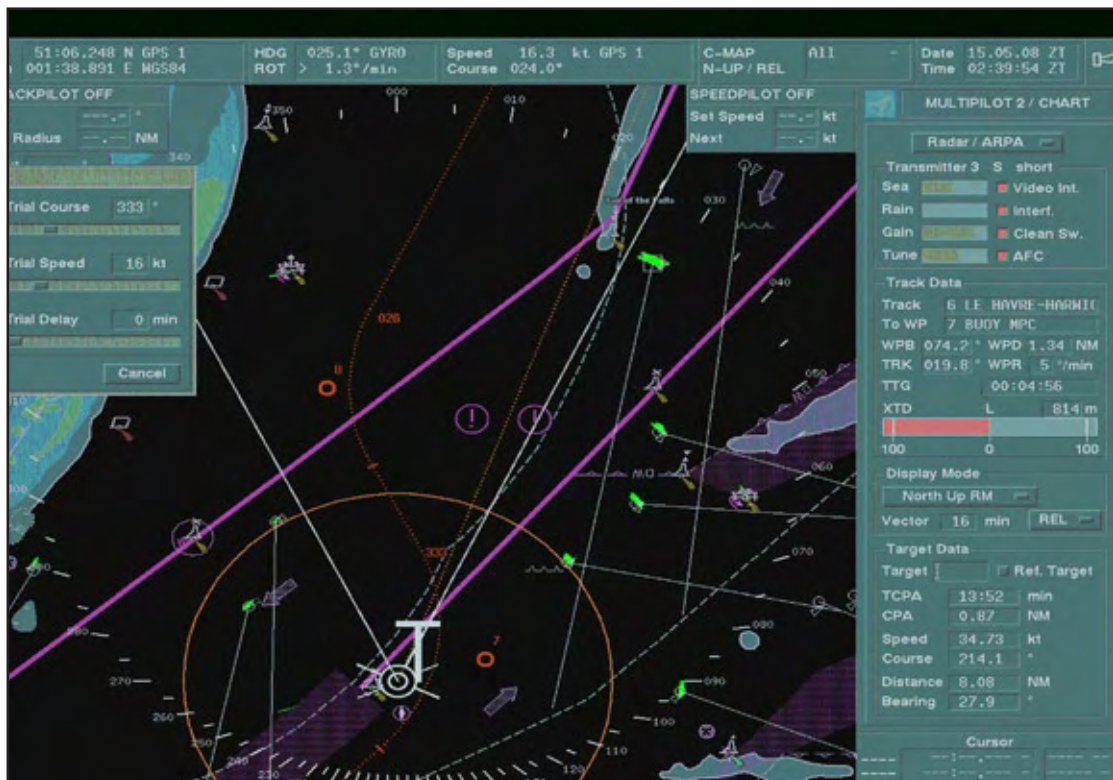
Figure 5

The master instructed the second officer to carry out a trial manoeuvre<sup>1</sup> on the ARPA radar to accurately assess the situation before committing to an alteration of course. This was conducted by the second officer at 0239 (**Figure 5**) and was witnessed by the master, who was standing to the left of the second officer (**Figure 6**). No time delay was entered. The master and second officer read the CPA information displayed at the bottom right hand side of the screen, which indicated *MSC Serena* had a CPA 0.87nm in 13.5 minutes, and understood it to be the results of the trial manoeuvre.

In line with the company's recommended practice, the master intended to cross the south-west lane using a slow rate of turn to achieve a 3nm radius (**Figure 5**). The master estimated that, by the time the vessel had completed her turn to port, the CPA of *MSC Serena* would have reduced significantly. Accordingly, the second officer was told to initially adjust the course to pass close astern of *MSC Serena*, and continue the alteration to port to pass ahead of *Grand Neptune*.

Trial manoeuvre carried out by *Costa Atlantica* at 0239

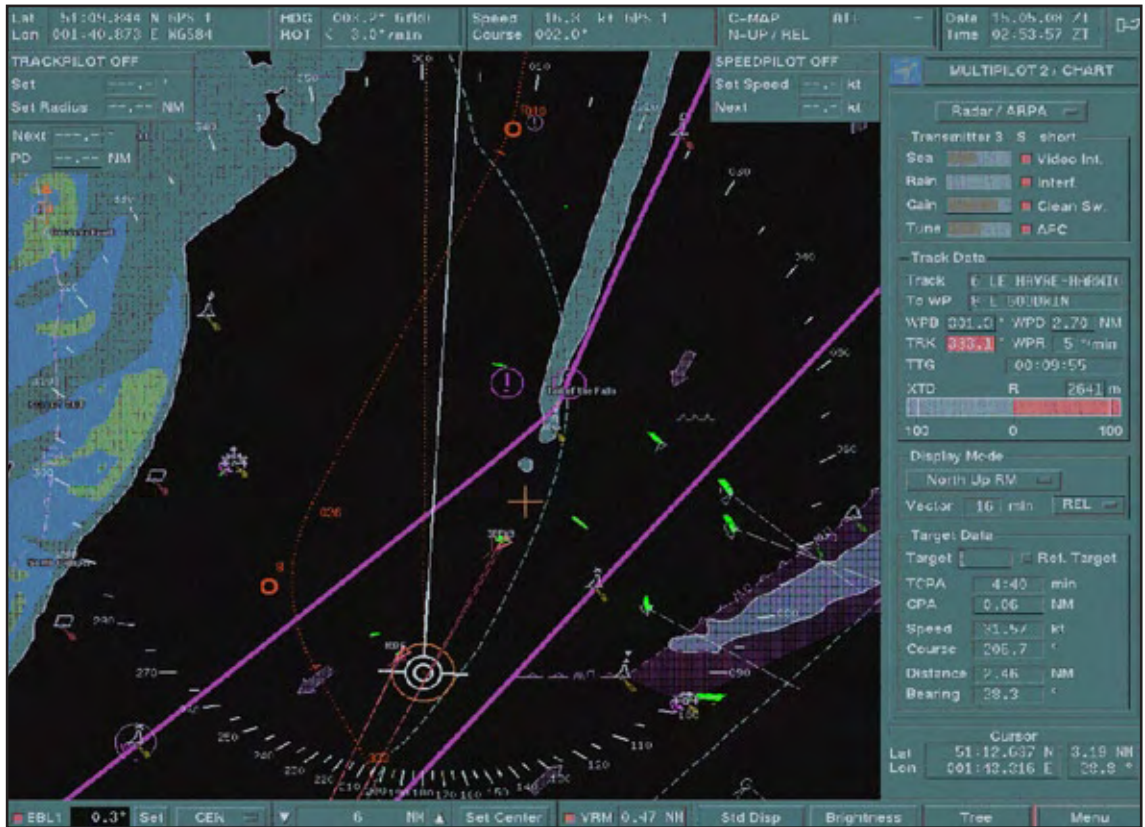
Figure 7

As *Costa Atlantica* neared *MSC Serena* at 0254, which was now passing clear, *Grand Neptune* was 2.46nm on her starboard bow with a CPA of 0.06nm in 4.4 minutes (**Figure 7**). *Costa Atlantica* was still under helm to port, but to increase the rate of turn and the CPA with *Grand Neptune*, the second officer ordered port 10 when the heading was 002°, followed by port 5 and, finally, amidships when the heading was 355°. He then gave a series of further orders to continue the vessel's turn to port.

Costa Atlantica - screen shot of radar at 0254

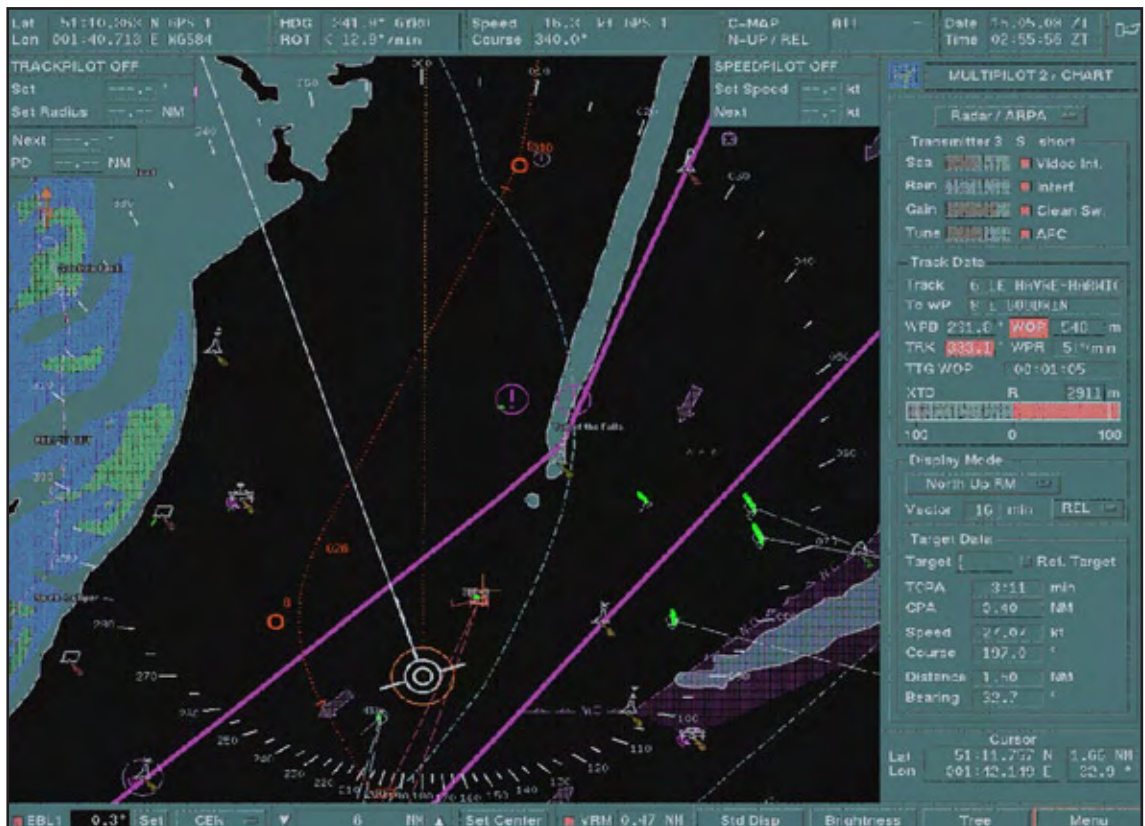
Figure 8

At 0256, Dover Coastguard called *Costa Atlantica* requesting she contact *Grand Neptune* on VHF Channel 16 (**Annex A**). In response, the second officer stated his intention to pass *Grand Neptune* with a CPA of 0.4nm (**Figure 8**).

Costa Atlantica - screen shot of radar at 0256

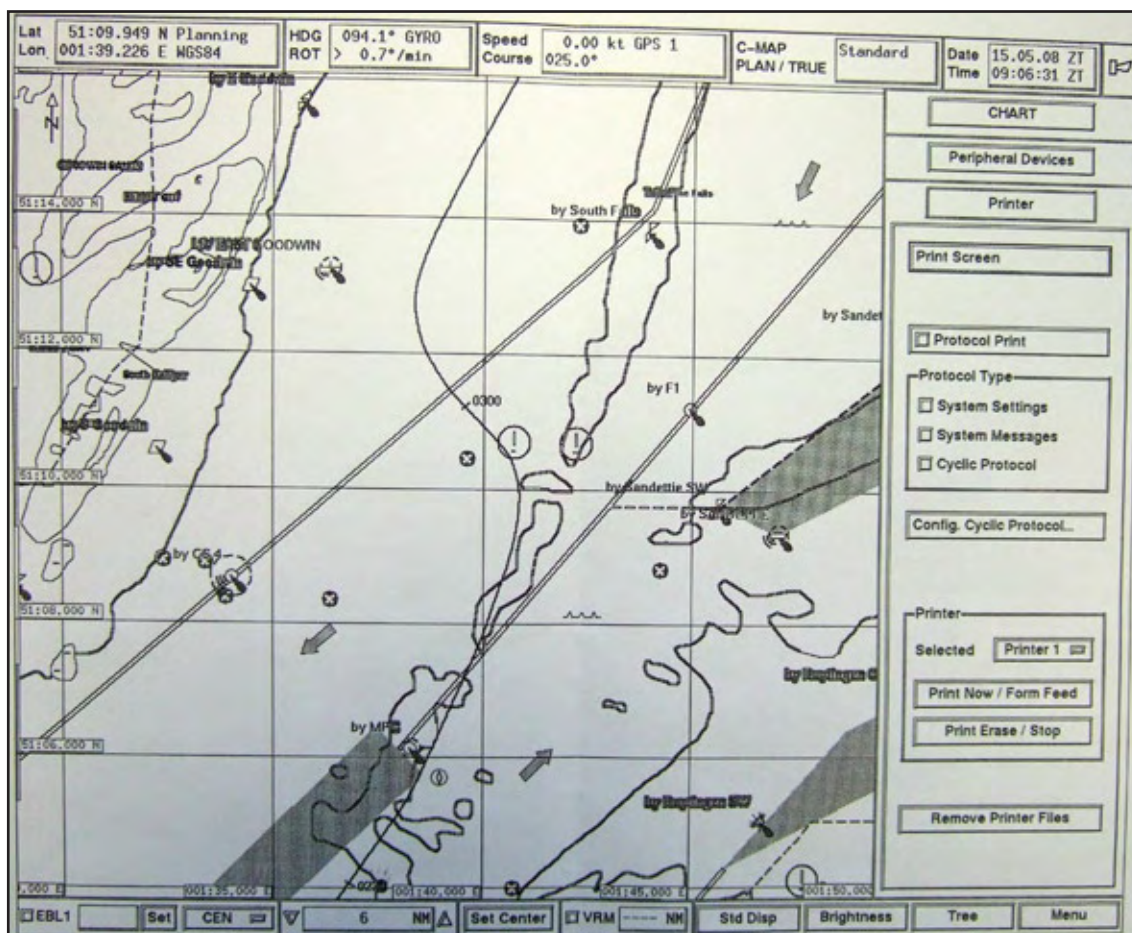
*Costa Atlantica*'s speed was then further increased from 98 RPM to 103 RPM and she was steadied on a course of 320°; the vessel exited the TSS at 0301 without further incident. The resultant track made good by *Costa Atlantica* from passing the MPC buoy to exiting the TSS is at **Figure 9**.

Resultant track of *Costa Atlantica*

As *Costa Atlantica* entered the south-west traffic lane on a course to take her close astern of *MSC Serena*, she did so at a shallow angle (**Figure 9**). This was far from the 90° to the direction of the traffic flow as required by Rule 10(c) of the COLREGS. Indeed, she was sailing more against the general flow of the traffic, rather than across it. It was therefore not surprising that the pilot on board *Grand Neptune* was unsure of the passenger ship's intentions. In addition, although *Costa Atlantica*'s course was progressively altered to port to pass close astern of *MSC Serena* and ahead of *Grand Neptune*, the rate of turn was incremental, and far too slow to be readily apparent either visually or by radar as required by Rule 8(b) of the COLREGS.

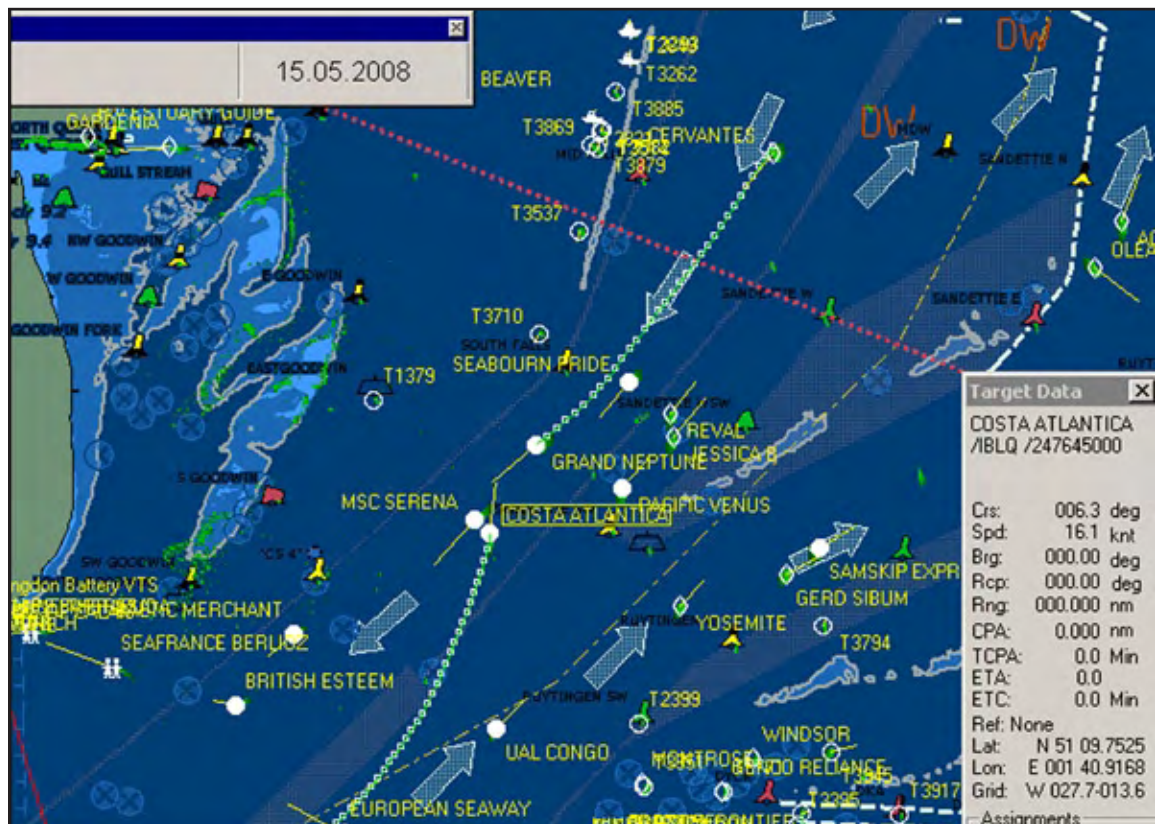
Figure 10

Screen shot of CNIS recording at 0254

A radar plot for 0254 on 15 May recorded by the CNIS is at **Figure 10**. This shows two vessels which were following *Grand Neptune*, *Seabourn Pride* and *Cervantes*. The distance between *Grand Neptune* and *Seabourn Pride* was 2.9 nm, and the distance between *Seabourn Pride* and *Cervantes* was 6.7nm.
