Report on the investigation of the contact made by  
the UK registered ro-ro ferry

*Daggri*

with the breakwater at Ulsta, Shetland Islands

**Report No 6/2005**  
**April 2005**

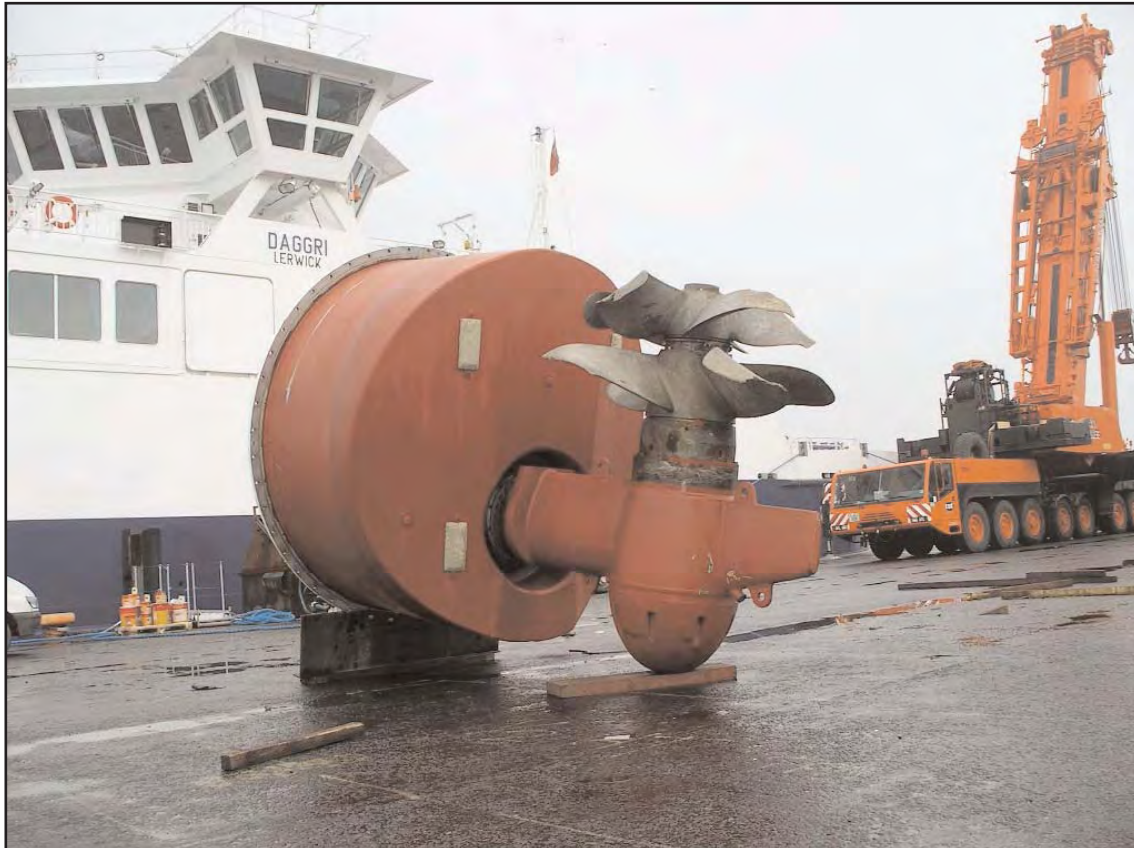
Photograph 5

After the accident, all compartments were checked for ingress of water. None was found. However, the forward azimuth thruster unit was damaged and could not be used. One of the propeller blades for this unit was missing, and the remainder were all severely distorted (**see Photographs 5 and 6**). There was also minor scoring to the bow, but this did not affect the seaworthiness of the vessel.

The damaged "forward" thruster unit

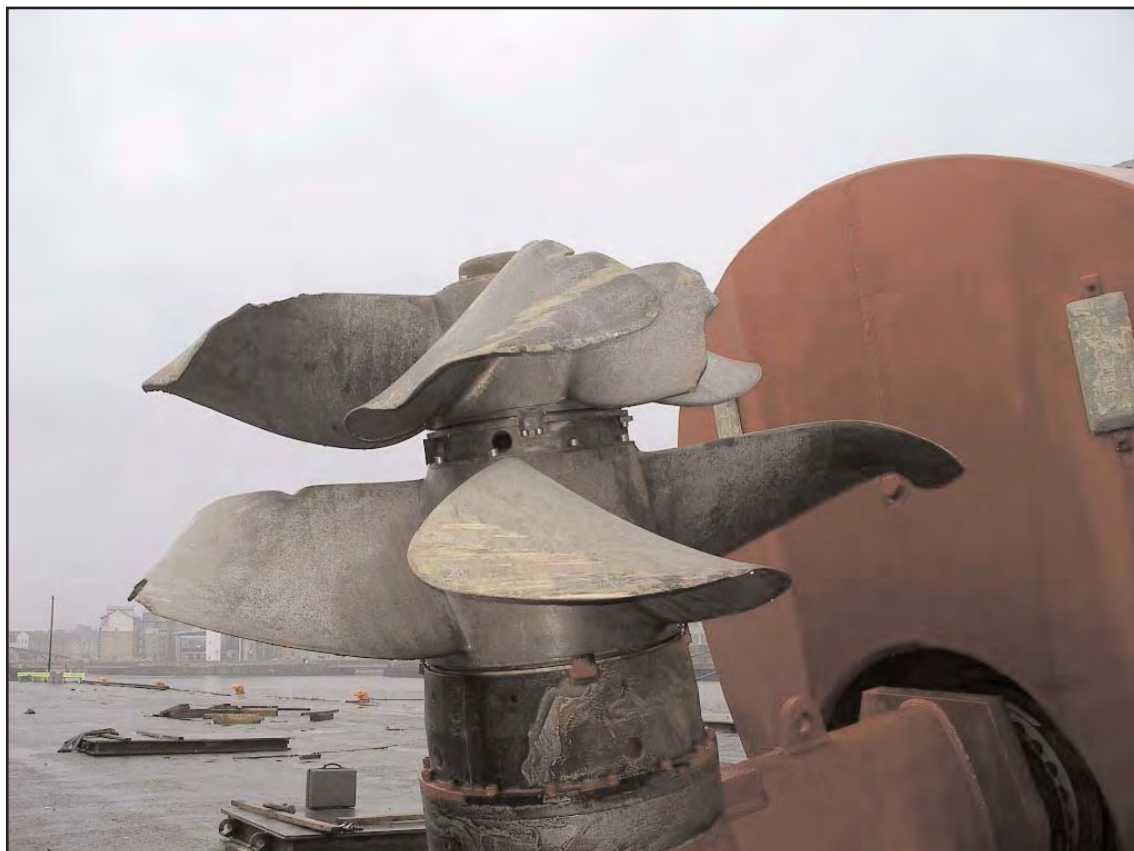
Photograph 6

A closer view of the damaged propeller blades

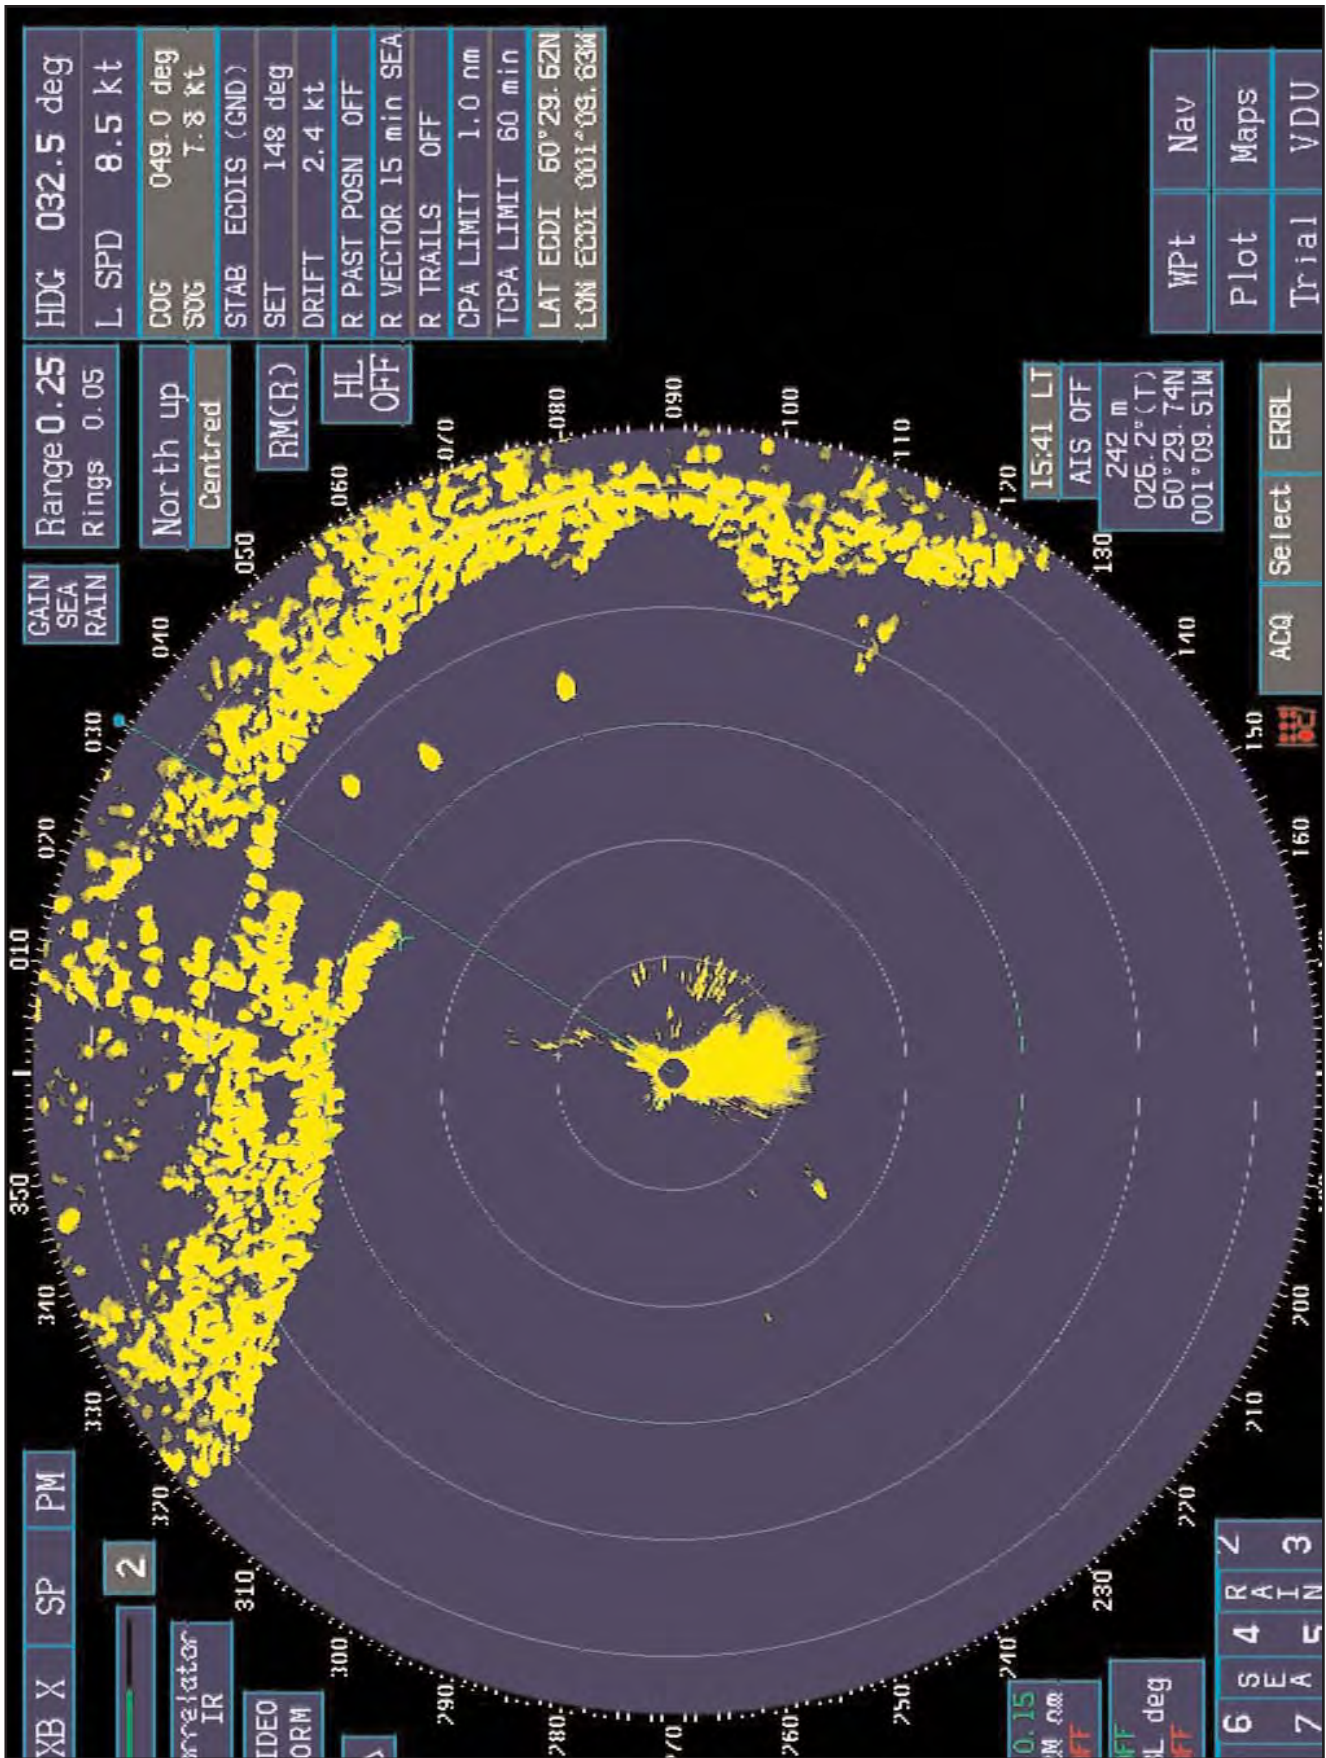
The mate had gained experience using modern radars when he operated his own fishing vessel. However, this did not prevent him from making an error when interpreting the radar range of *Daggri* from the breakwater just prior to the accident. The VRM and the EBL were switched off, and parallel index lines were not displayed on the screen. Because the radar was not being used to its full potential, when the mate was navigating *Daggri* across Yell Sound, in restricted visibility, he was unable to advise the master properly when the latter had taken the con.

Had *Daggri's* mate not become distracted, and his concentration not been impaired while talking to the visiting mate, he could have rectified the mistake he made when he read *Daggri's* distance from the breakwater, and he could have alerted the master accordingly.

An extract from the VDR

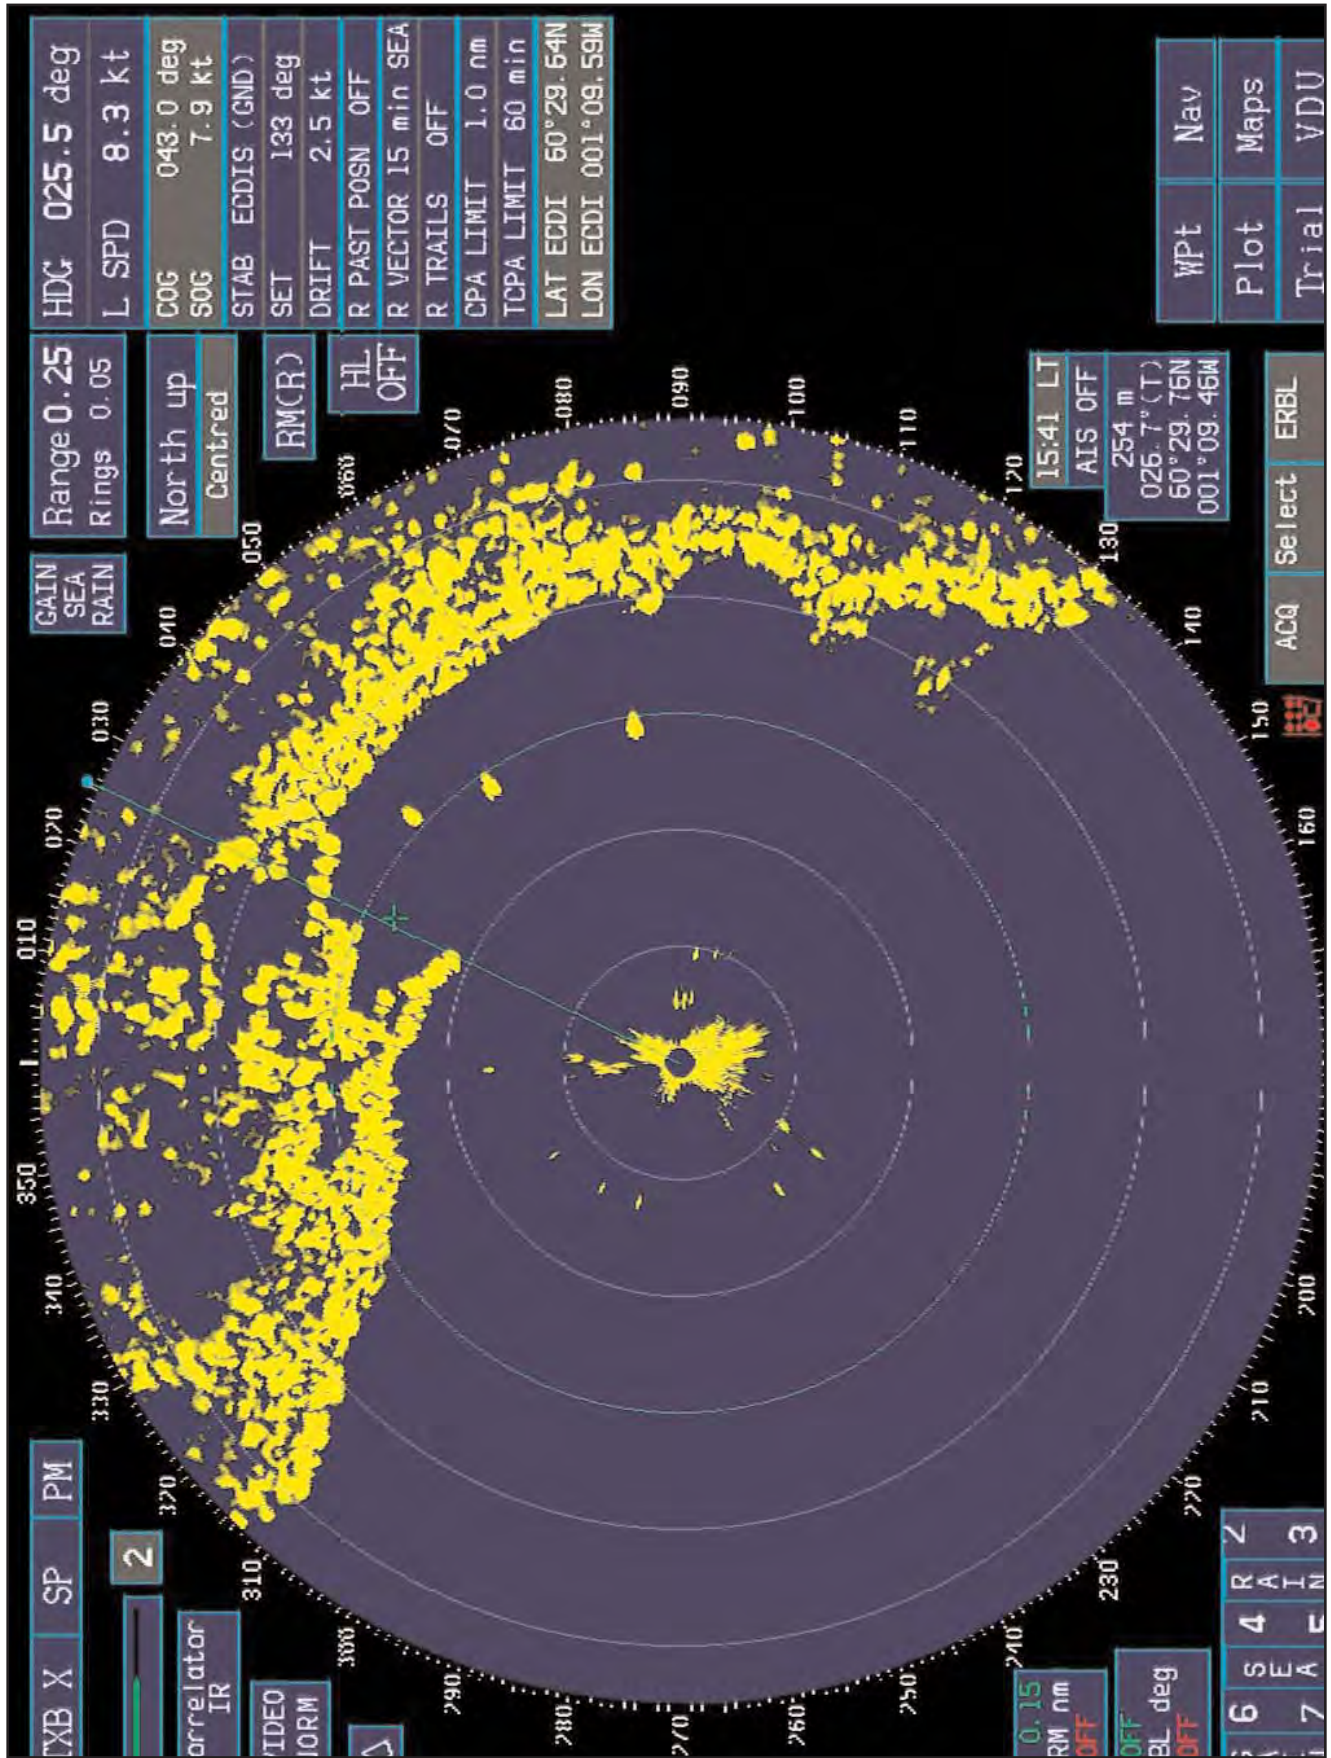
VRM and EBL off

An extract from the VDR
