Report on the investigation of  
the major injuries sustained by a deckhand on board

**fv *Danielle* BM478**

on 6 June 2006

**Report No 5/2007  
March 2007**

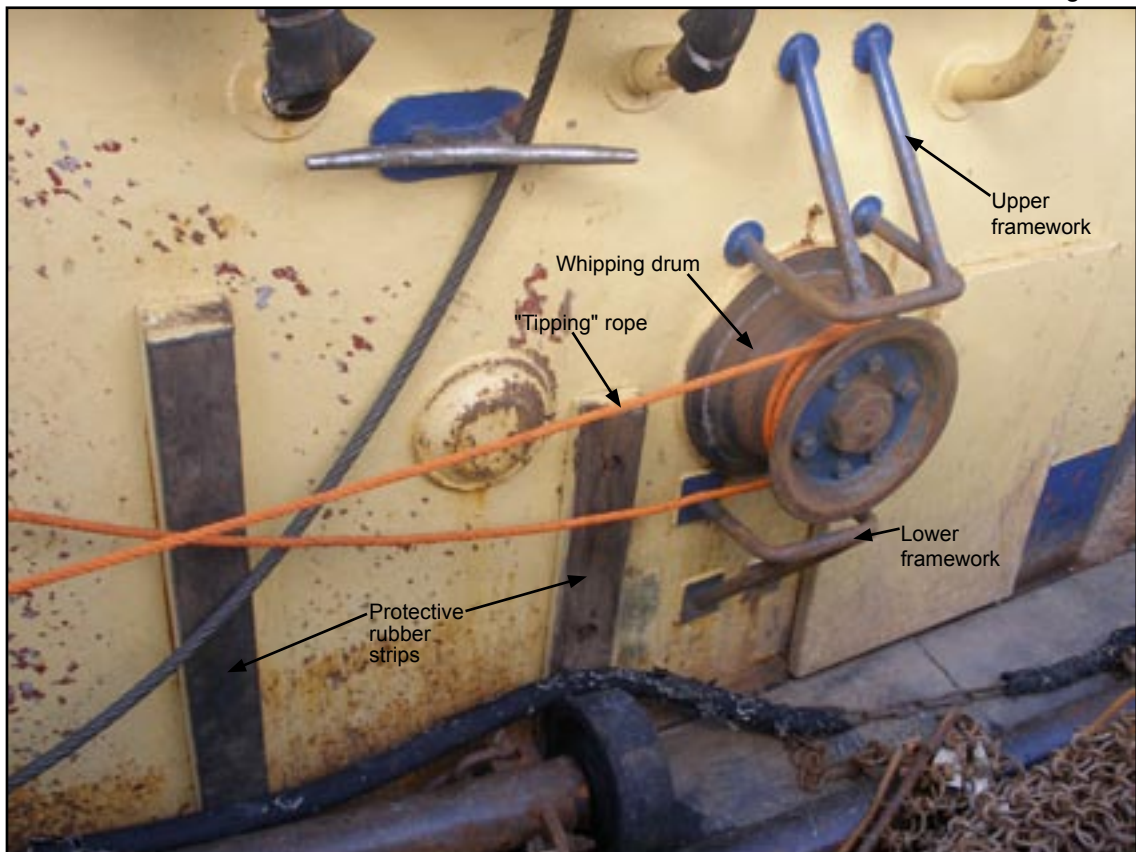
Figure 9

Port whipping drum, with turns of "tipping" rope

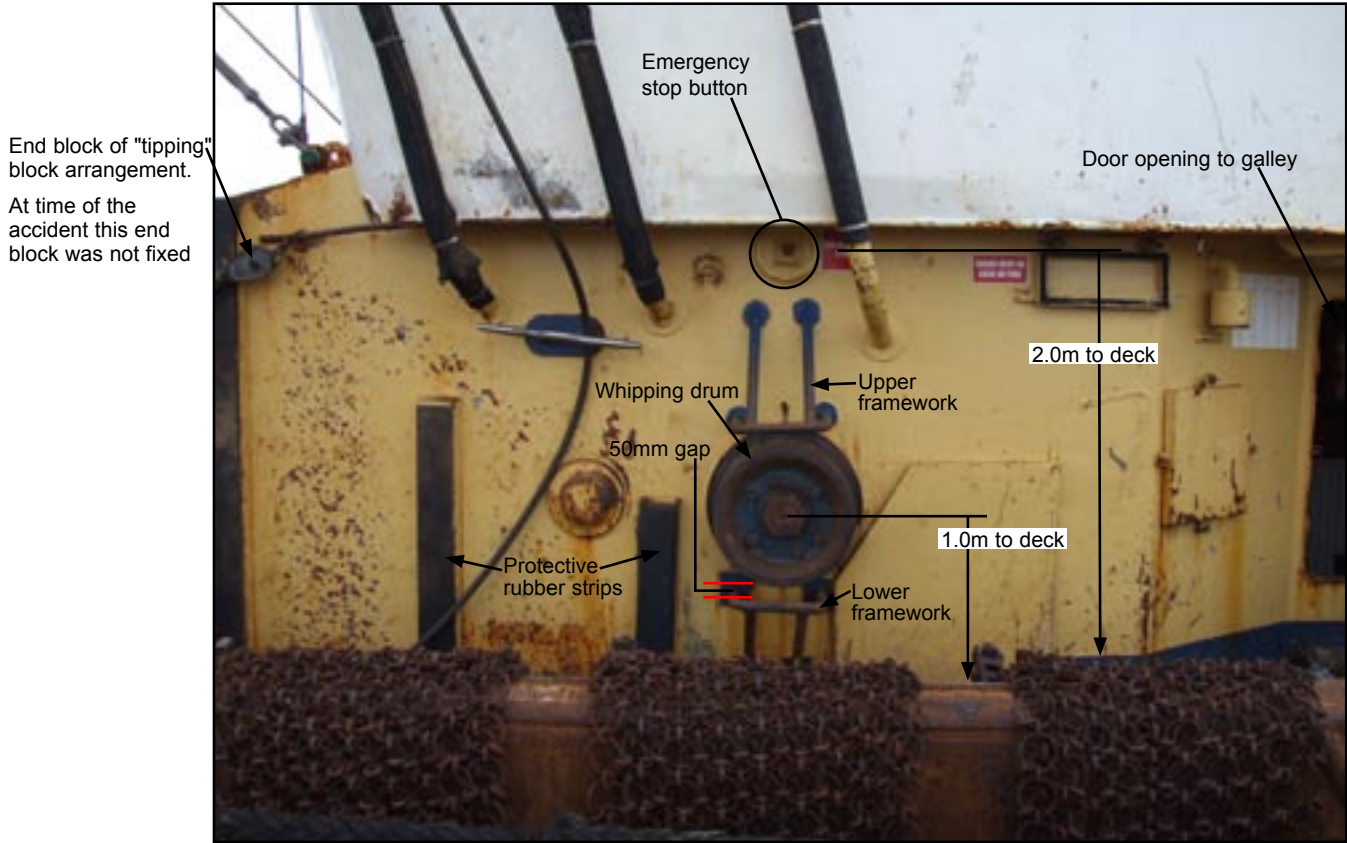
Port whipping drum and emergency stop button position

The framework, combined with the bars added to protect the wheelhouse sides from the gear, also meant that the original emergency stop button positions were no longer easily accessible, and were rendered inadequate.

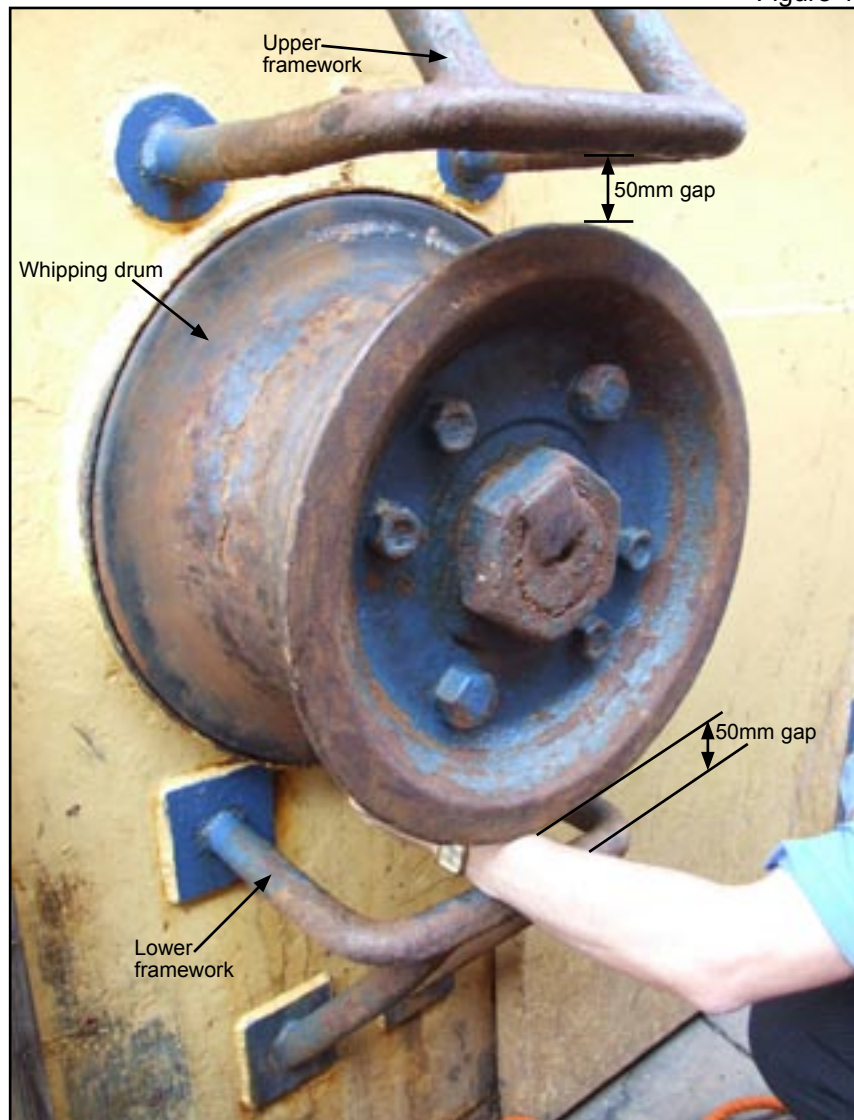
Port whipping drum with demonstration of an arm in the gap between winch head and lower framework

As his hand and arm were dragged into the gap between the lower framework and the anti-clockwise turning winch head, he did two backward somersaults, as he was dragged right round the winch. Following the second circuit, he landed heavily on his heels, and again could not reach the recessed stop button above the winch head. Having already sustained horrific injuries, he realised that if he went round a third time, he might not survive, and therefore managed to stand up and stretch to hit the stop button, following which the winch took about half a revolution to stop. He had remained conscious throughout, and ended up pulled in tight against the framework above the winch, with his ribs against the rim of the whipping drum, and his face against the bulkhead. He immediately started to shout and bang the bulkhead to try to raise the alarm.

More significantly, substantial guard frameworks were fitted above and below the whipping drums. Their purpose is not considered to have been to protect individuals from the winch, but to guard it from being struck or snagged during deployment and hauling of the dredging gear. The presence of these frameworks created additional hazards. In fact, the horrific injuries sustained by the deckhand were largely caused by this framework, as he twice was dragged around and over it, with his arm trapped in the narrow gap between the winch head and the framework.

Alternative configurations of guard framework exist on other vessels that would be less likely to pose a hazard to crew. The current arrangement on *Danielle* needs to be reviewed.

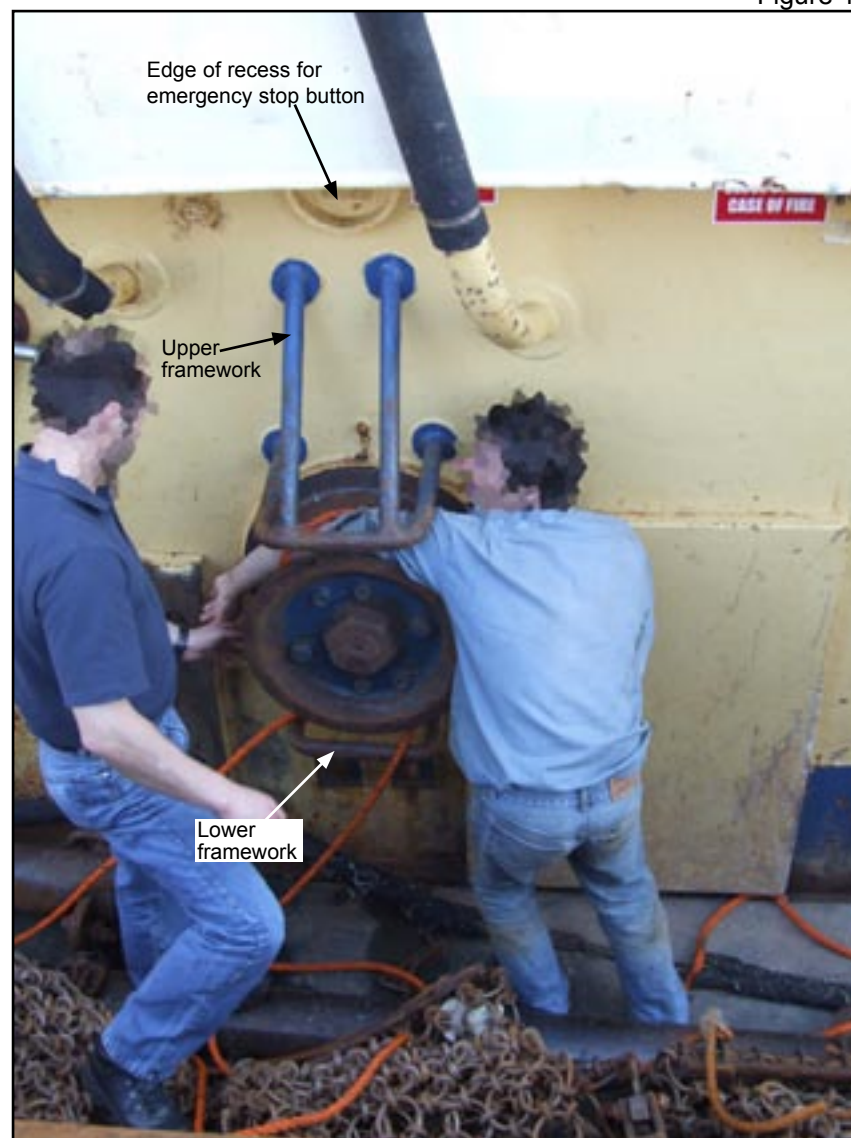
Figure 12

Demonstration of “as-found” position of deckhand, trapped in whipping drum

By the time the skipper had arrived at the whipping drum, the Latvian had already removed the turn of rope over the deckhand’s upper arm. Both estimated that there were about 6 or 7 turns round the winch and the deckhand when they found him. The skipper then supported the deckhand, and began to unravel the turns of rope running over his hand on the winch head. In the process of doing this, the deckhand was able to pull away slightly from the winch and release his hand from the left glove, which remained trapped in the rope. This revealed that the flesh had been stripped off his left little finger and ring finger.

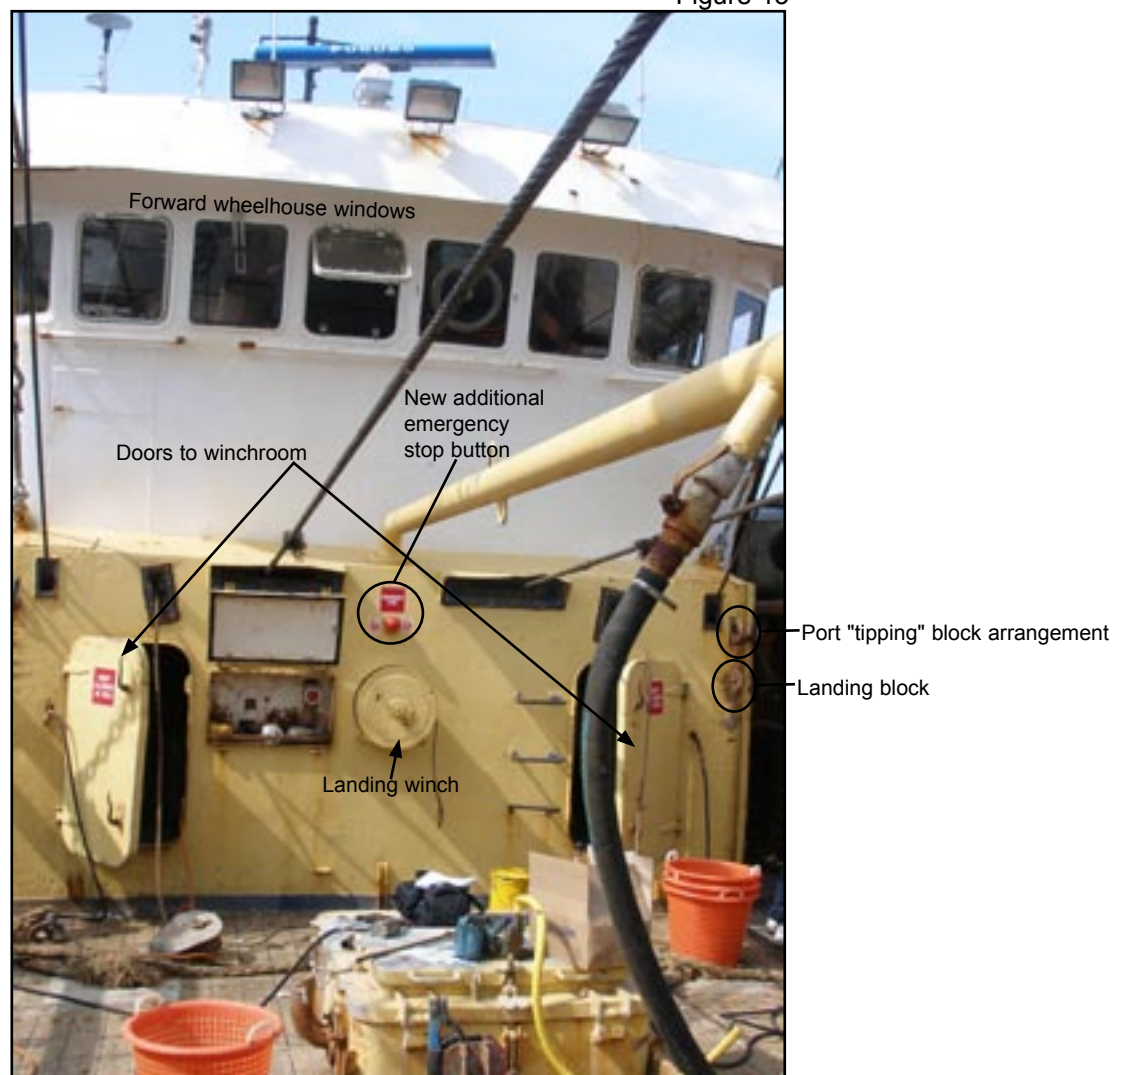
Figure 15

Forward end of wheelhouse showing new emergency stop button

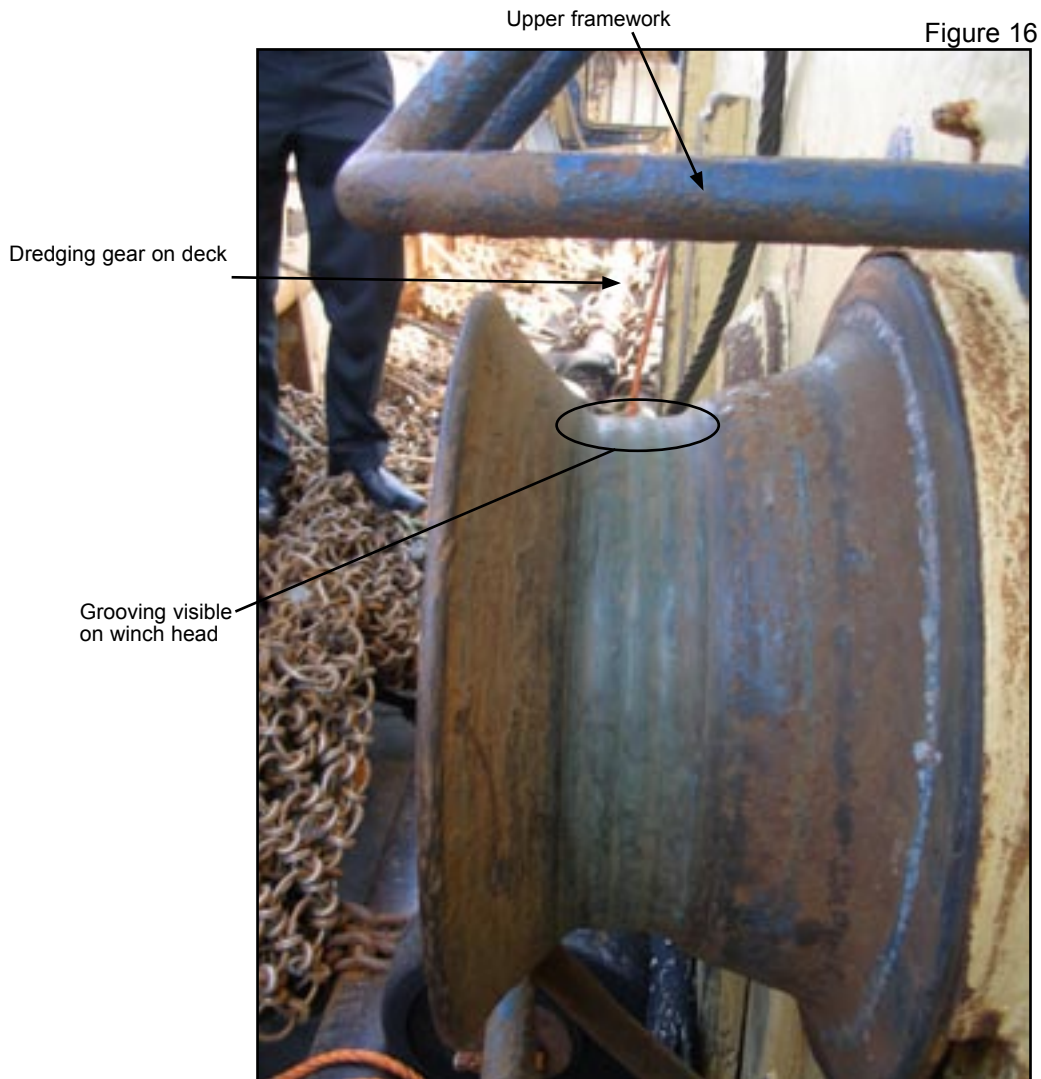
The owner reported that the whipping drums eventually become worn with use, and are then removed and machined smooth. **Figure 16**, taken two days after the accident, illustrates some grooving of the winch head, which the owner did not consider to be excessive.

Close-up view of grooving on port whipping drum

**Figure 16** indicates that the condition of the port side whipping drum was in question, with visible grooving. Again, it is not known whether this contributed to the particular riding turn, but such grooving will affect the performance of a whipping drum, and should be regularly attended to.
