Report on the investigation of the  
parting of a mooring line on board

***Dublin Viking***

alongside at Berth 52 in the Port of Dublin, Ireland

**Report No 7/2008**  
**March 2008**

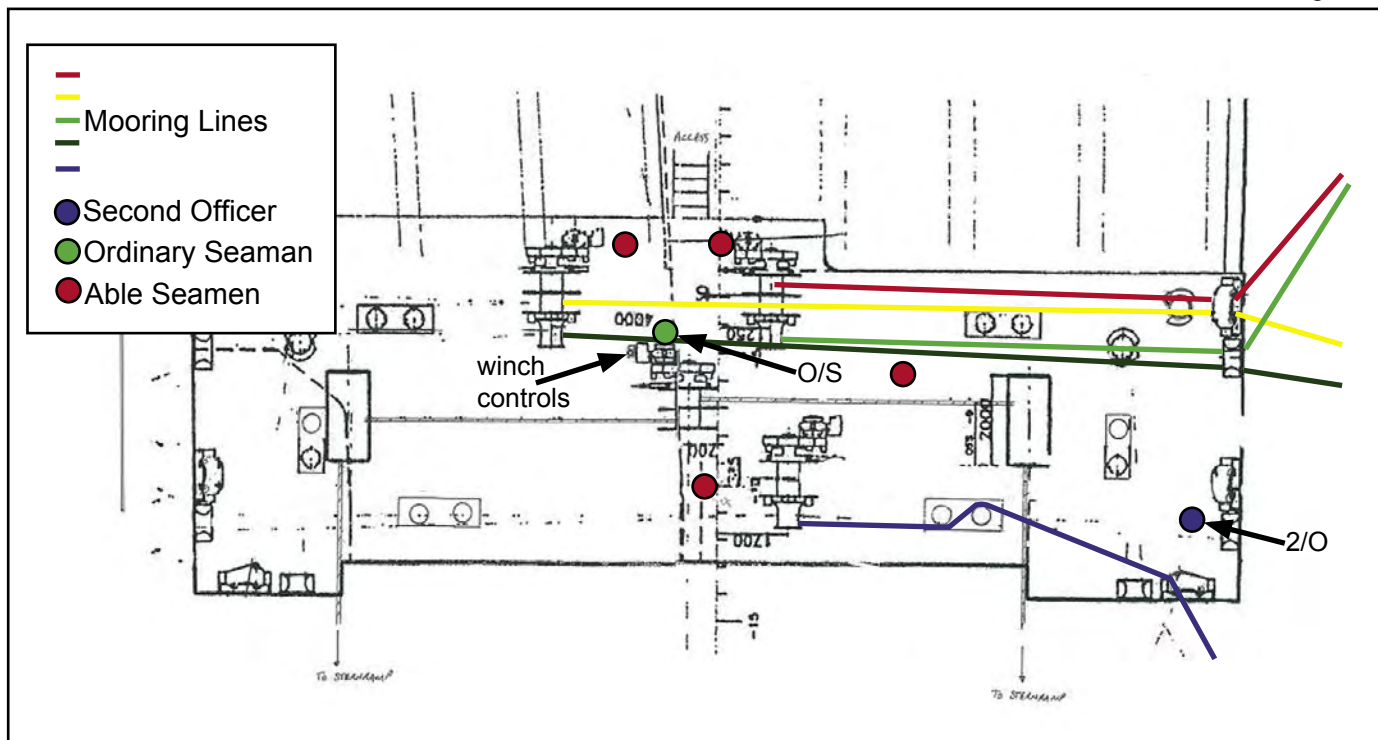
The second officer, in charge of the after mooring deck, was obliged to stand in 'snap-back' zones near the fairleads, so that he could relay orders to line handlers ashore and deck crew. Analysis of the mooring line after the accident showed that it had deteriorated, its breaking load having reduced from 60 to 35 tonnes, largely due to exposure to Ultraviolet (UV) radiation from sunlight. Although the vessel's mooring ropes were required to be inspected, the onboard procedures were informal and no records were kept.

Position of crew on the after mooring deck

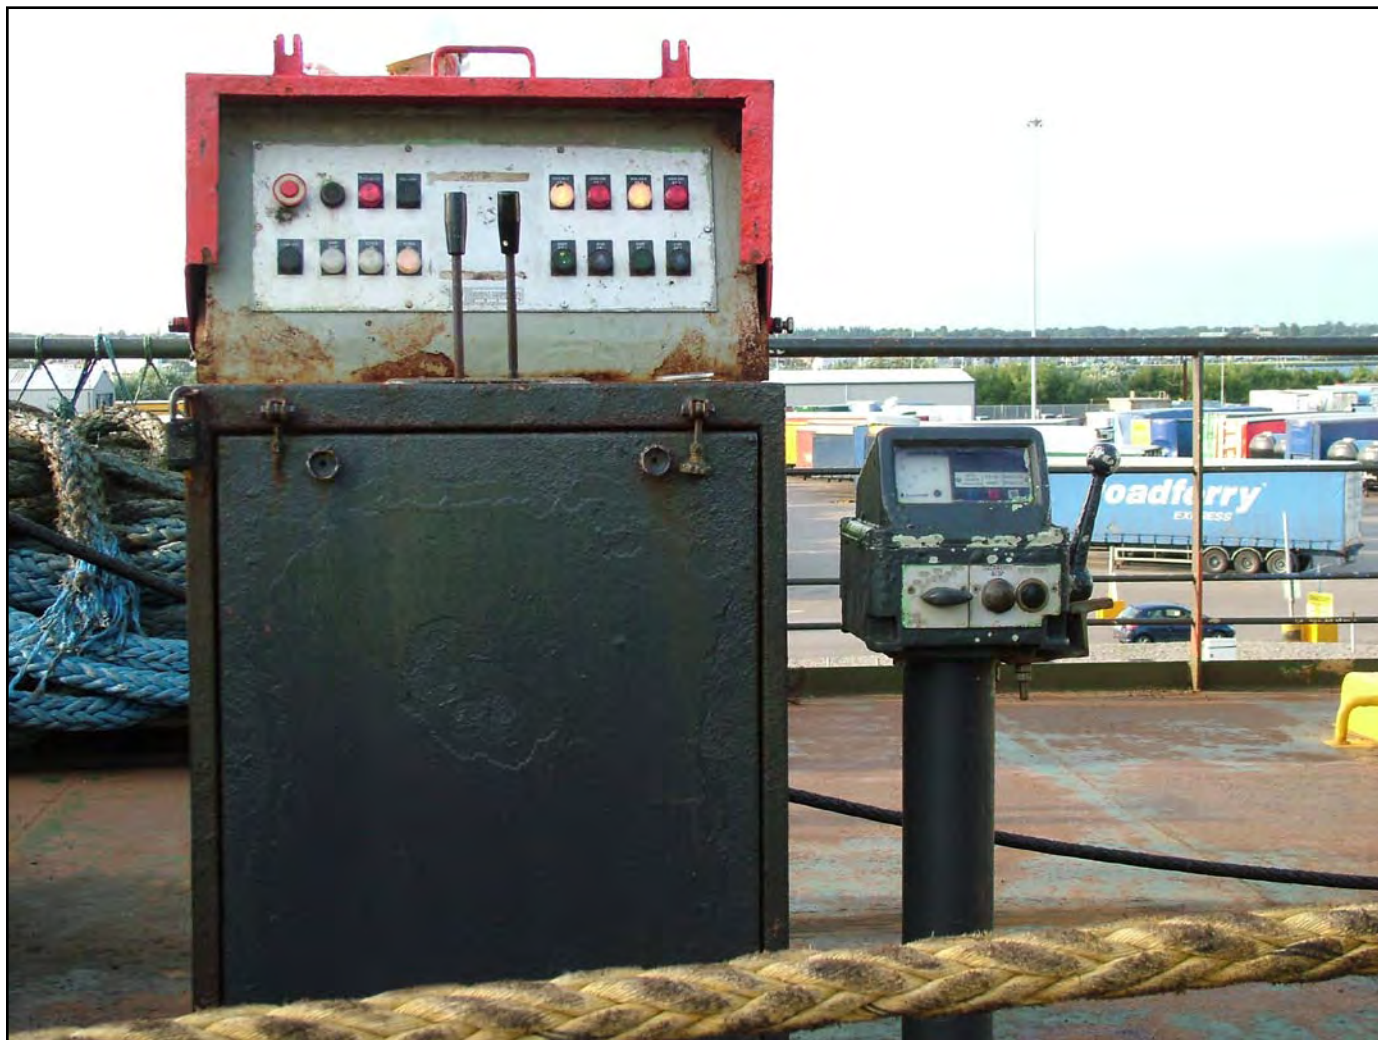
Stern line and stern ramp winch controls

and pushed the lever of the mooring winch away from him, intending to pay out the stern line. The winch turned in the opposite way from the intended direction, applying more tension to the stern line. The two ABs standing nearby heard the line start to make cracking noises, and fell to the deck to protect themselves. The 2/O was some distance away from the stern line when it parted, making a loud cracking noise. The OS saw the 2/O fall to the deck, stopped the mooring winch and went to assist him.

The winch was inspected by a manufacturer's service technician and found to be generally in working order, with two exceptions: the wiring connection to the strain gauge in the auto tensioning system was reversed, and the springs to automatically return the control lever to the neutral position had corroded and failed.

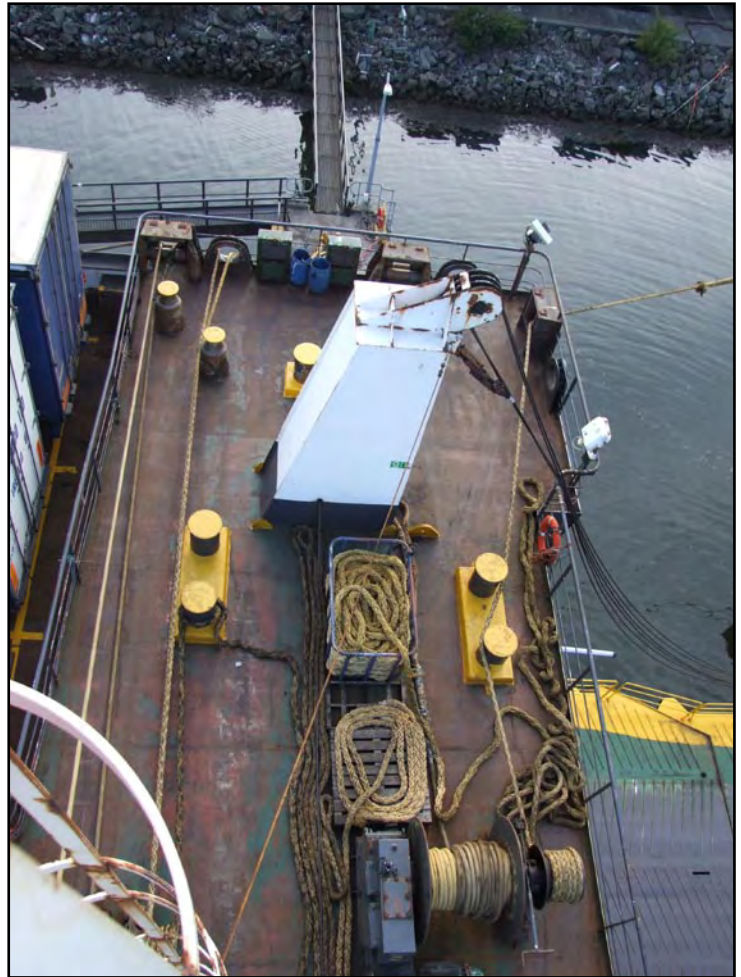
Starboard side of aft mooring deck

The paint coating on the aft mooring deck had deteriorated and been worn away in several places, exposing the deck material. Corrosion products and other debris had accumulated on the deck. This was in contrast to the forward mooring deck, which was

well presented and marked with yellow areas indicating potential rope snap-back zones. The lack of snap-back zone markings on the aft mooring deck was identified in an MMM internal inspection, ISM and safety report dated August 2006. This subject had been raised at each of the subsequent monthly safety meetings thereafter, with poor weather being stated as the reason why the markings had not yet been painted.

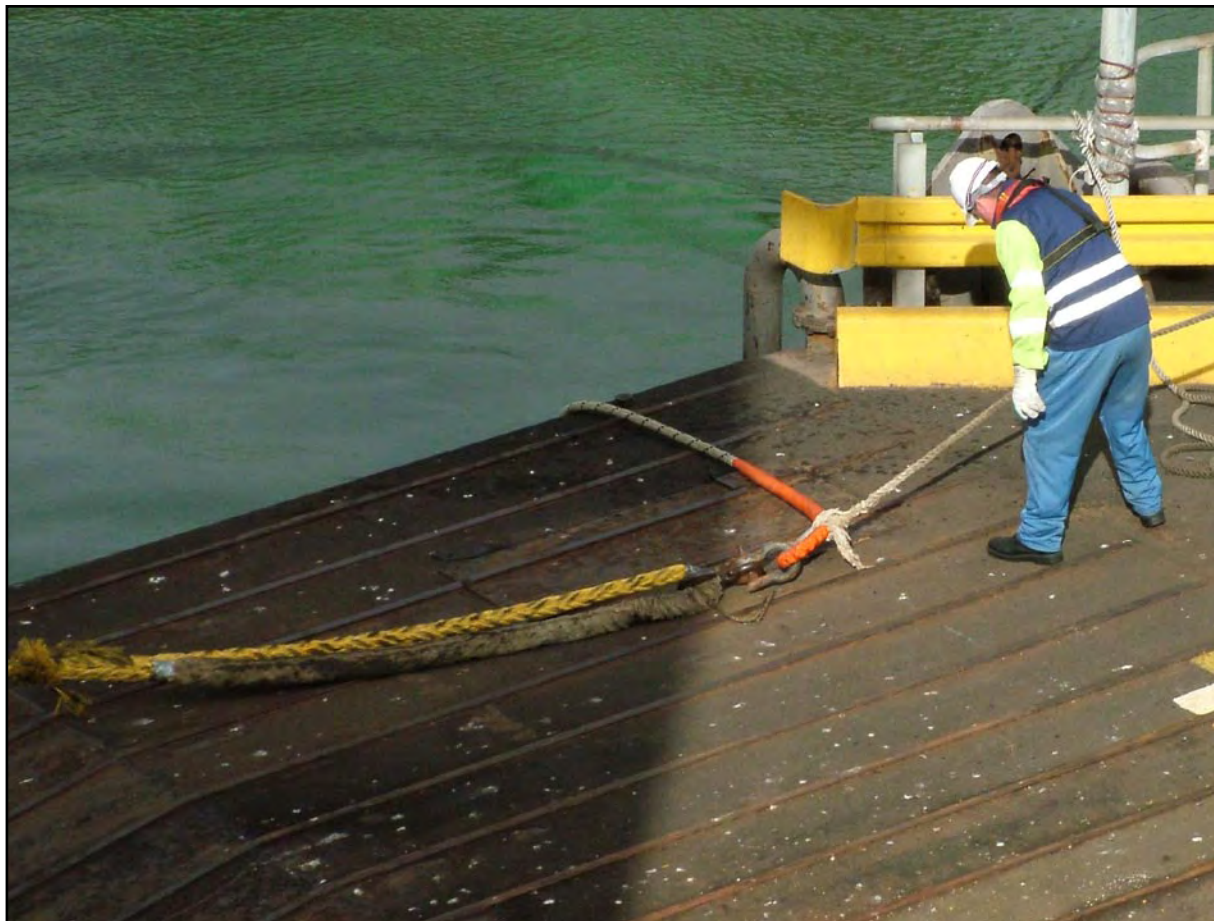
A single composite stern line was used, made up of several shore supplied components terminating at a hook, which was connected to an eye in the ship supplied line (**Figure 8**). Measurements of the ship's line with no tension applied varied between 62 and 70mm in diameter, and it was of 12 stranded multiplait construction and blue in colour. The connection to the shore supplied hook was approximately 9m outboard from the ship's stern, and the line then came inboard through a universal roller fairlead at the starboard quarter. This fairlead was on the transom, rather than the ship's side, and the line then led to a set of bits and onto the warping drum end (**Figure 7**). The bits were positioned with the intention that they could be used to back up a line coming from the winch in the opposite direction, but in this instance had the effect of

Connection between ship and shore supplied stern lines

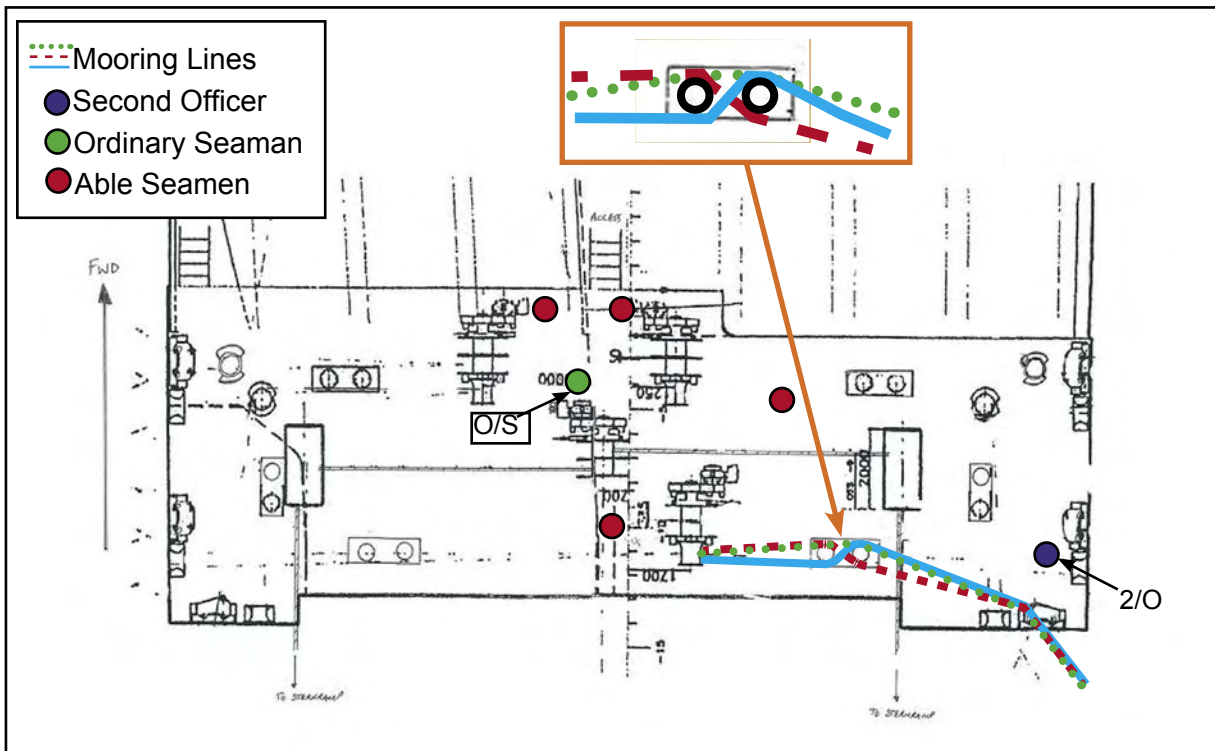
Figure 9

straightening the lead from the transom fairlead to the winch. It was possible to lead the stern line around the bitts in three different configurations, each considered to be correct by different witnesses (**Figure 9**). The position of the bitts dictated that the stern line had to be turned up from the bottom of the warping drum so that it did not ride over the bitts. Inspection of the mooring winch rope storage barrel and band brake arrangement indicated that this was the correct orientation to place the band brake deck connection under tension as the strain came onto the stern line (**Figure 10**).

Possible line configurations around bitts (light blue is the most likely)

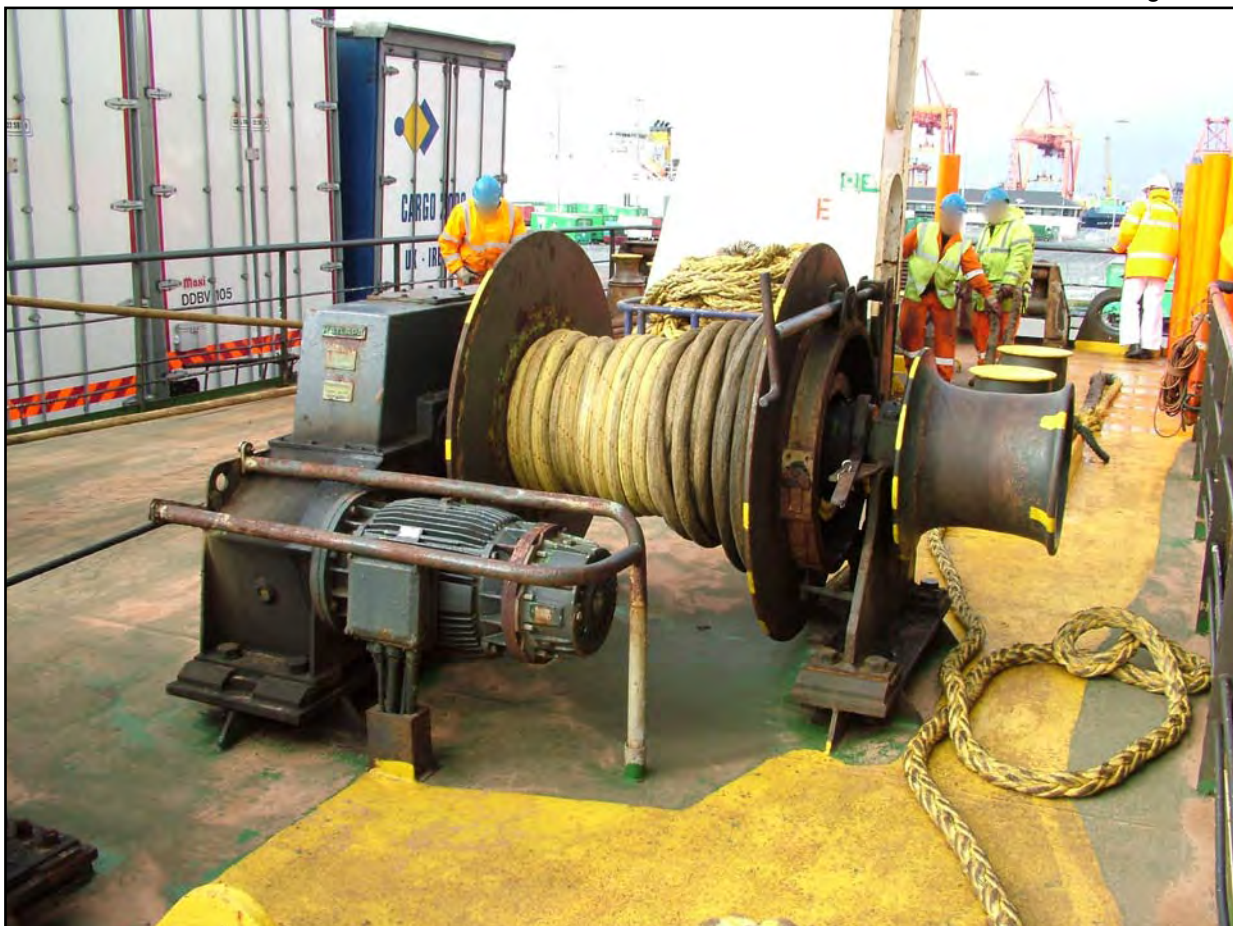
Figure 10

Orientation of band brake on mooring winch

Over subsequent months it became common practice for winch barrels to be left in gear, with their band brakes on and with lines turned up on drum ends, either loosely backed up or not backed up at all (**Figure 12**). The band brake was applied to the rope storage barrel, and the barrel was left clutched into the main shaft, transferring the braking effect to the warping drum end.

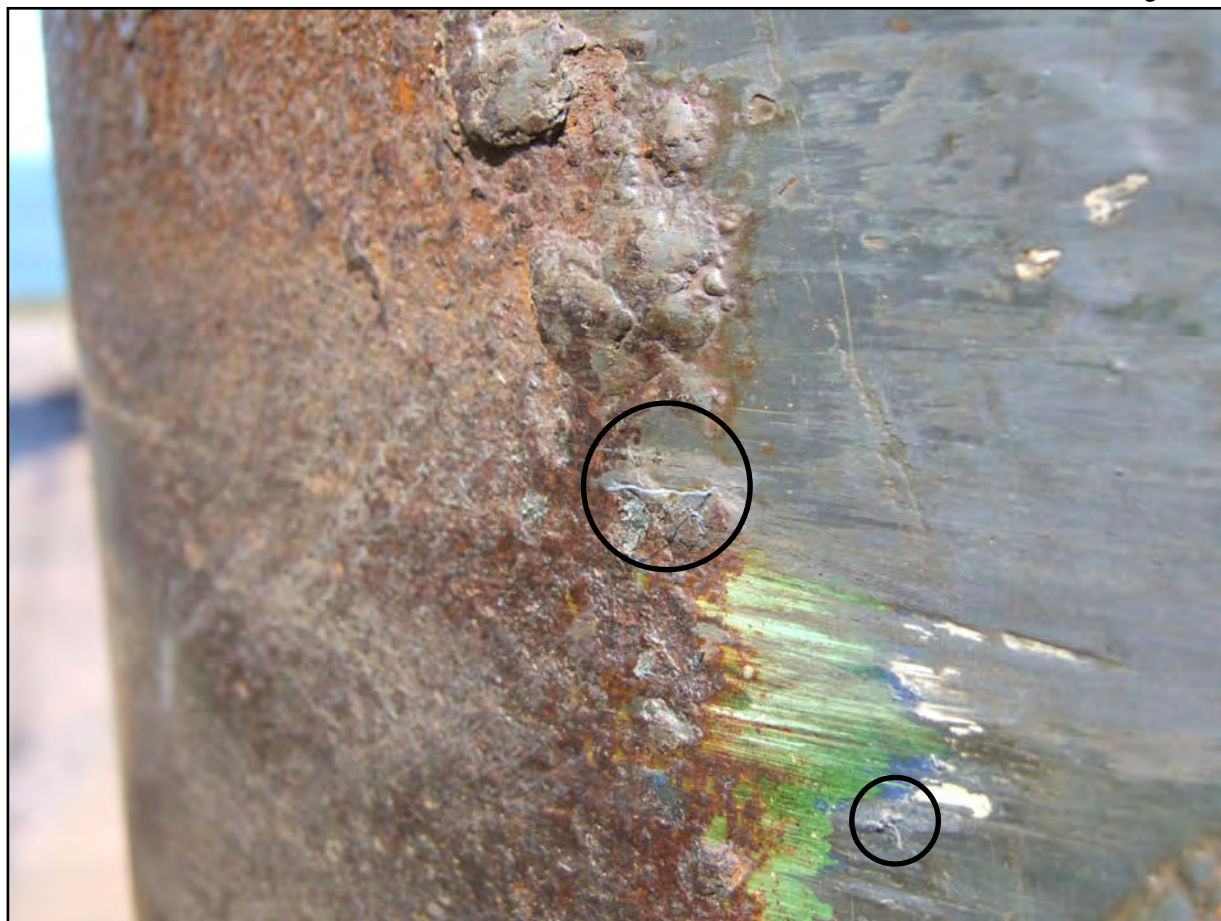
All the mooring equipment showed evidence of wear and polishing on areas in regular use. Rust and scale had developed in other areas such as the reverse side of bitts (**Figure 11**) where a single yarn from the parted rope was seen to have caught. The lower and inboard rollers on the universal fairlead being used for the stern line were both free to turn, but several other rollers in less frequent use had seized. Ship's staff had recorded these defects in the vessel's maintenance management system in October 2005, and also during an internal audit conducted by MMM in July 2006, but repair work had been deferred from a maintenance period in November 2005. Vessel managers had instructed crew to either free the rollers themselves, or use the seized universal rollers as a panama fairlead. The order for replacement parts was cancelled in January 2007. Grooves and rough edges resulting from the time spent working with steel wire ropes had been filled and smoothed.

Snagged yarn from parted rope on mooring bitts

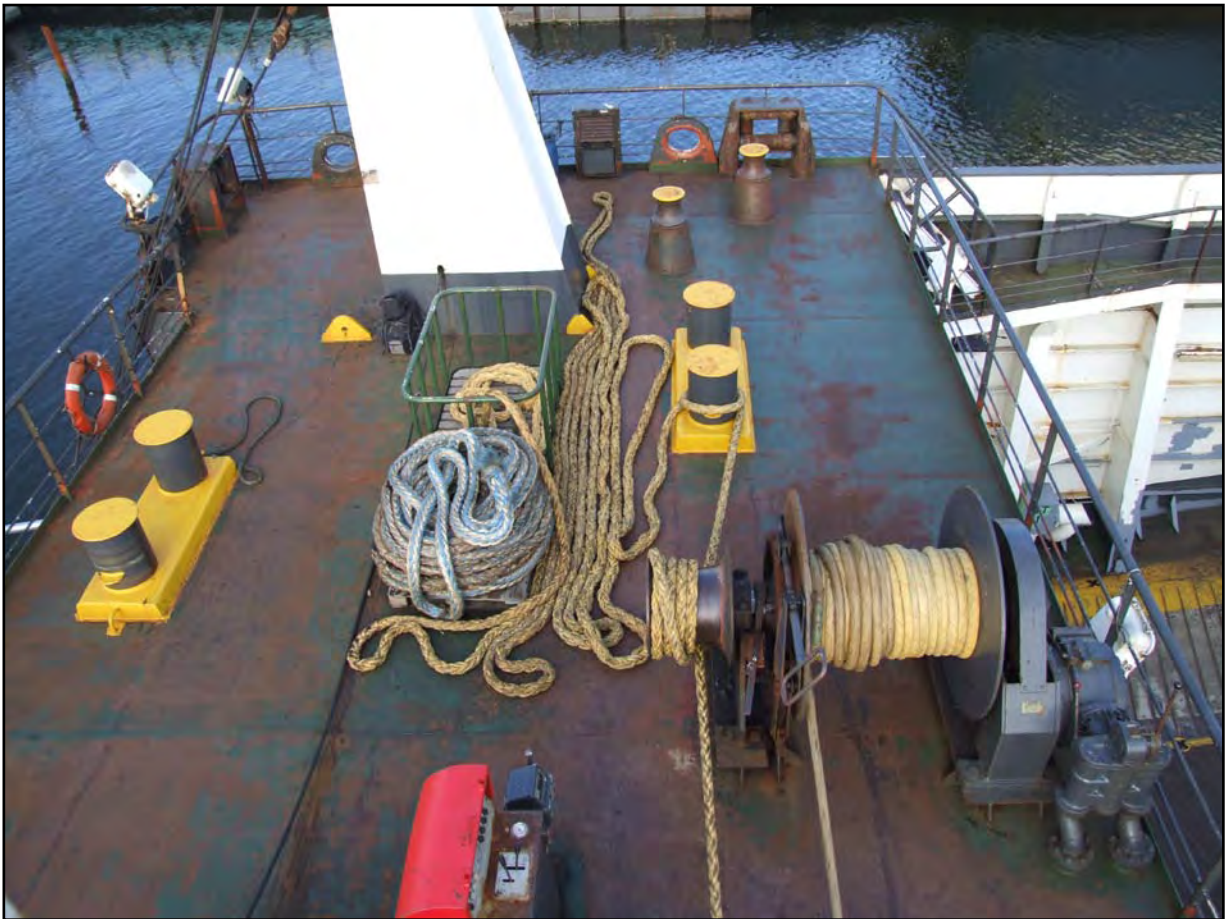
The Marine and Safety Manager (MSM) responsible for the vessel had noted in a Safety and Quality Assurance audit in January 2007 that crew were leaving mooring lines turned up on warping drum ends. He considered that this was contrary to the principles of good seamanship, and included it as a supplementary note in his occupational health and safety inspection report of the after mooring deck. The issue was discussed between crew, senior officers and the management company and the consensus reached was that, although it was recognised that the practice was undesirable, it was acceptable if lines were backed up on bitts. This decision was recognised as a balance between the risk and effort involved in stoppering off a mooring line and transferring it to bitts, against leaving it turned up on the warping drum and backed up.

Example of methods used to secure mooring lines

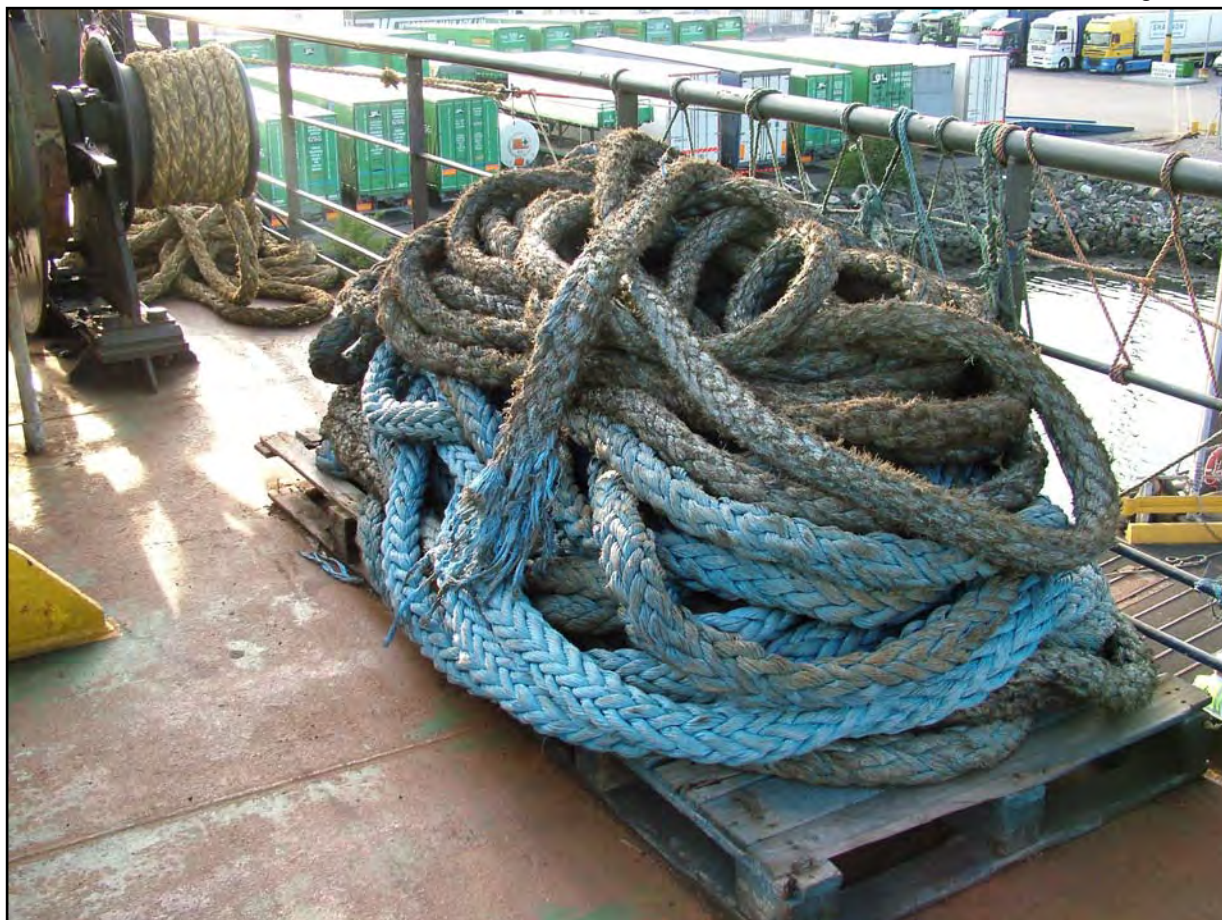
Figure 13

Parted stern line in normal storage position

The stern line that parted during this accident was thought to have been brought into service in January 2007, and 'end for ended' in April 2007, due to the poor condition of the soft eye. It was still considered to be in a satisfactory condition, but there were no formal records of inspection. It was not possible to match this mooring line to any of the rope certificates held on board, with any confidence. One certificate was found for a mooring line with similar 12 stranded construction, made from polyolefin and supplied in April 2004, but subsequent tests on the parted line found that it had been made from polypropylene. A purchase order dated 30 March 2005 was also found for 6 polypropylene lines, but the construction was 8 strand rather than the 12 strands of the parted line.
