MARINE ACCIDENT INVESTIGATION BRANCH

FLYER TO THE SHIPPING INDUSTRY

Fatal accident to a crew member during mooring operations

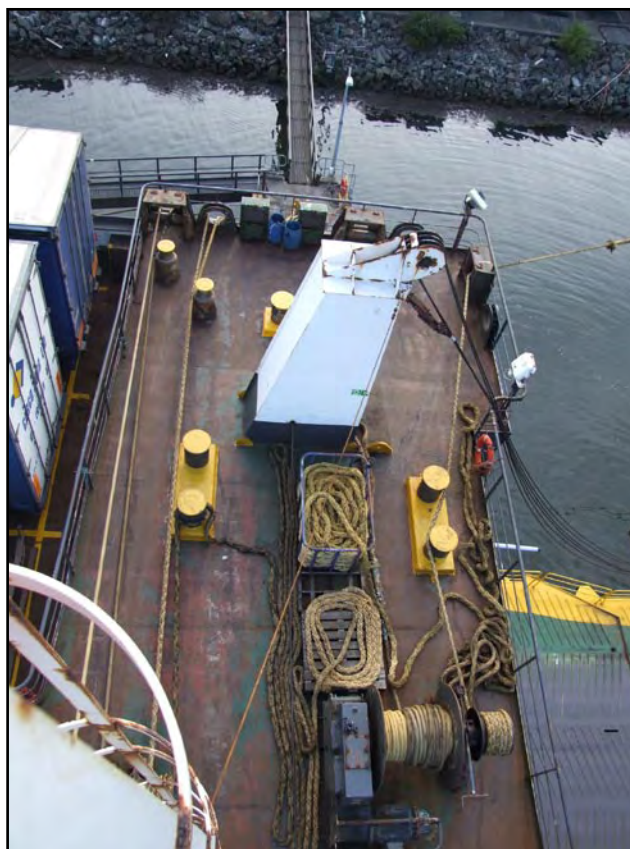
The stern line was made up of a polypropylene length from the ship, which connected to a High Modulus Polyethylene (HMPE) line permanently secured ashore. The difference in elasticity of the two lines meant that the shorter, more elastic, polypropylene length was subject to material fatigue effects from the constant cycle of stretching and release. It was further degraded by exposure to ultraviolet (UV) radiation from sunlight. Subsequent tests revealed its breaking load to have reduced from 60, to some 35 tonnes.

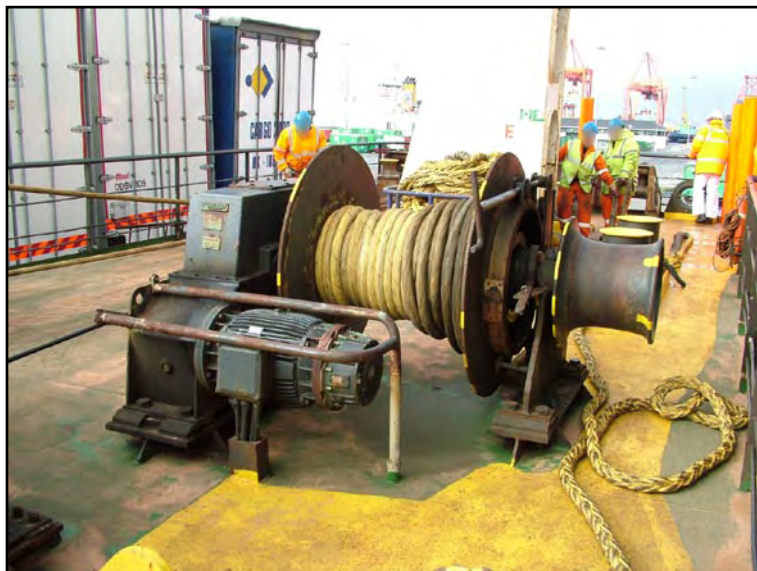
The electric mooring winch used for the stern line had a stated nominal load of 12.7 tonnes, and it was not immediately clear how this could have parted the rope, even in its degraded state. However, tests showed that the winch was capable of pulling up to 37 tonnes for a short period on first starting. There were no indications, either on the winch markings or in the manufacturer's manual, that the starting load was so much greater than the running load, nor was there any reference to the Minimum Breaking Load (MBL) of the rope to be used on the winch.

- Ensure that the full capabilities of mooring winches are known and understood by all those involved in conducting and managing mooring operations, including the Minimum Breaking Load of ropes to be used.
