Report on the investigation of

a fatal accident on board

mfv Dunan Star (CY 26)

Report No 38/2000

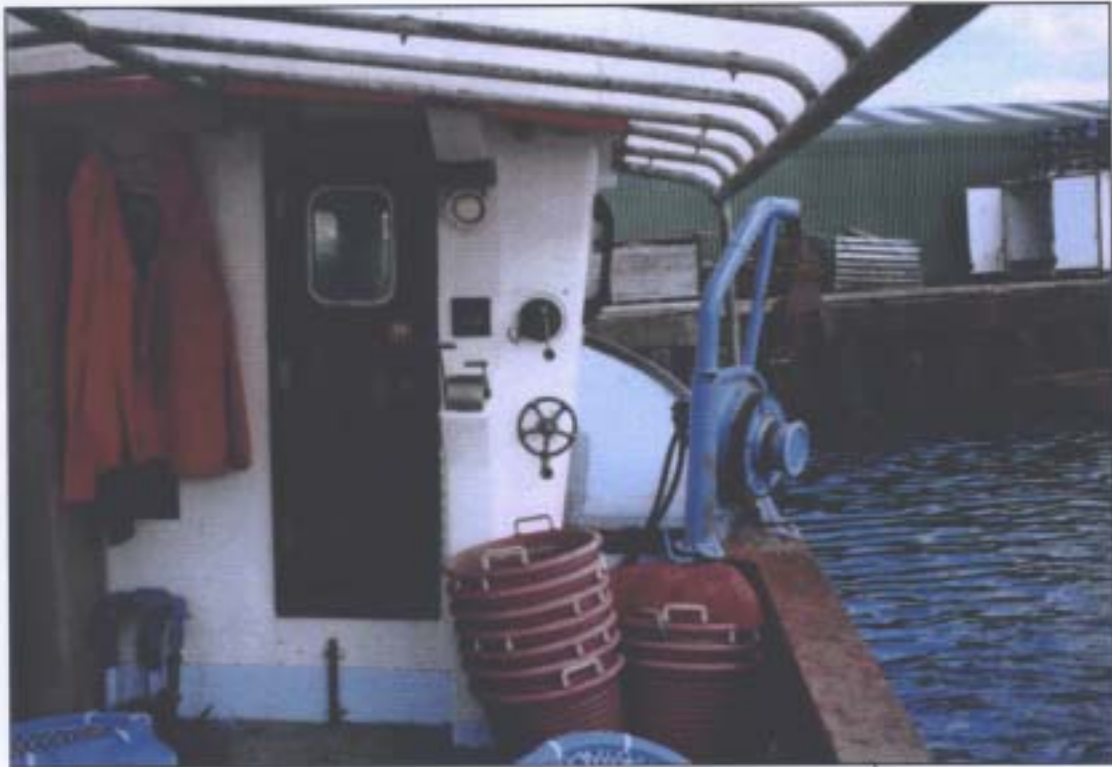
Figure 2 - Pot hauler and control position

An additional helm position was situated on deck on the starboard side of the wheelhouse, close to the hydraulic pot hauler and its controls.

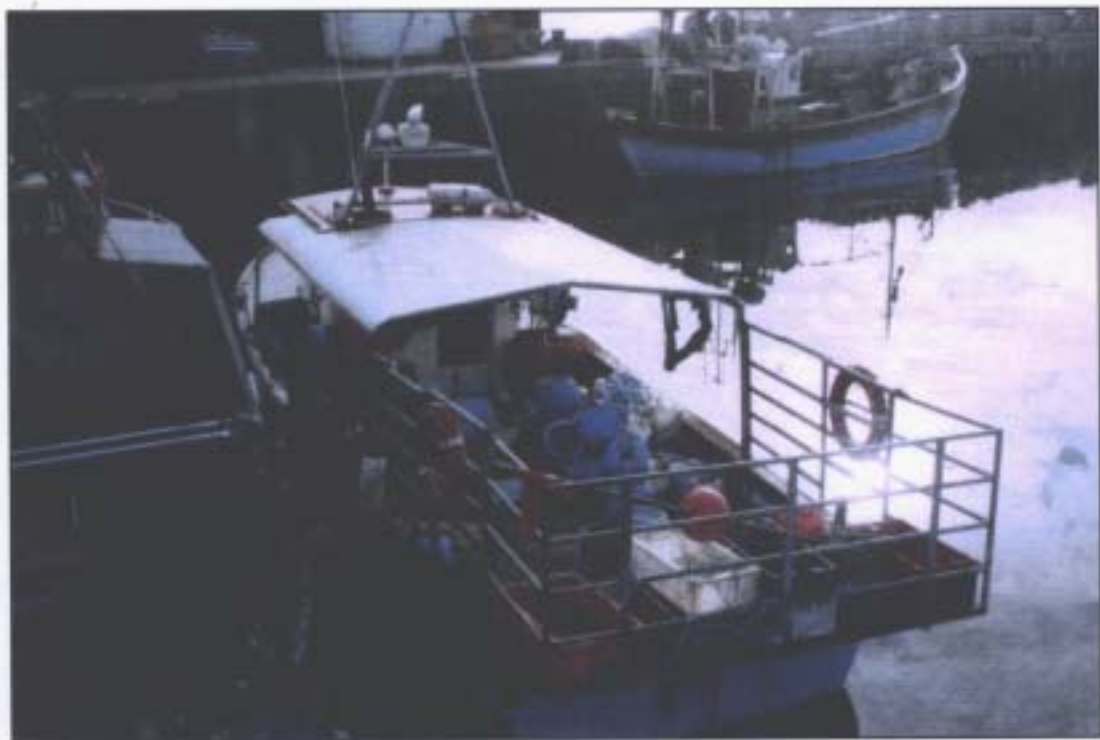
Figure 3 - Working deck

A shooting bar (a vertical steel pole set into the gunwale or similar arrangement) guides the back rope over the vessel's bulwark as the rope is pulled from the pile across the deck by the forward motion of the vessel.

The pots are taken from the stack in reverse order. A crewman lifts the pot from the stack and passes it over to another crewman positioned at the shooting bar. The pot is then lifted on to the gunwale and held until it is pulled overboard. One man has to complete both tasks if the crew is reduced to two men, and the skipper is in the wheelhouse during the shooting operation. It then requires the crewman on deck to move about, increasing the risk of being snagged in the back rope.

The crewman holds the pot on the gunwale, and the back rope crosses the deck near his feet. As each pot goes overboard, the next pot in sequence is placed on the gunwale ready for shooting. Meanwhile the back rope is still being pulled overboard, and often whips across the deck in bights. The crewman must take particular care at the shooting position to ensure that he is not caught by one of these bights.
