Part 2 – Fishing Vessels

Small Hole – Costs a Life

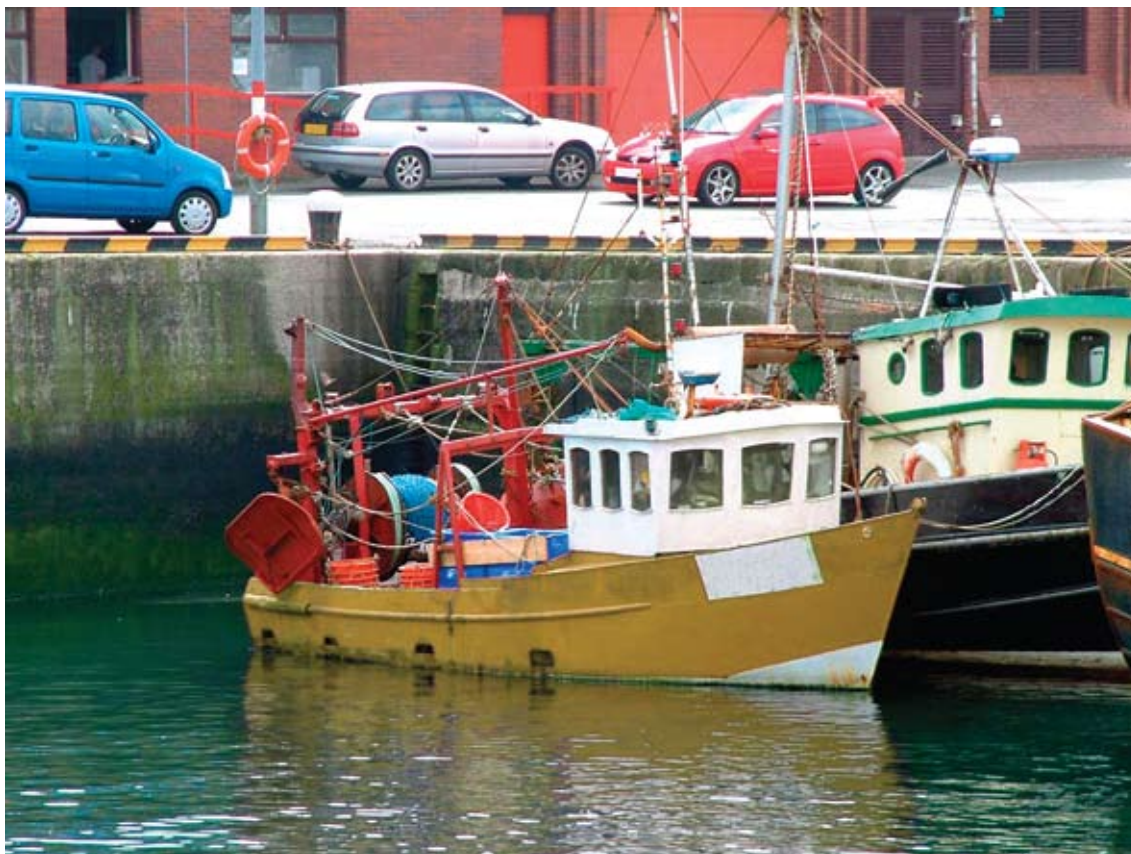
The vessel had a single undivided space under deck from the wheelhouse to the transom, and had a low freeboard, resulting in water coming onto deck through the freeing ports when the vessel was underway.

The skipper had also previously reported having problems with his engine exhaust. The exhaust system was a dry exhaust, which

vented to atmosphere via an outlet at the top of the stern gallows. The exhaust gases flowed through the steel box section of the gallows, with no internal flue liner fitted.

One of the major components of engine exhaust gas is sulphur oxide which, when in contact with water, combines to produce sulphuric acid. In this case, the location of the exhaust trunking created ideal conditions for corrosion to take place, which would have led to water entering the below deck space.

1. This tragic case illustrates the vital importance of having – and maintaining – an adequate freeboard and keeping your vessel watertight.
2. While there are no statutory requirements for fishing vessels of less than 15 metres in length to undertake stability tests, it is prudent for all skippers to be aware of the stability condition of their vessel at all times.
3. Never underestimate how much water can flow through relatively small holes, and make sure you have an operational bilge alarm and bilge pump system.

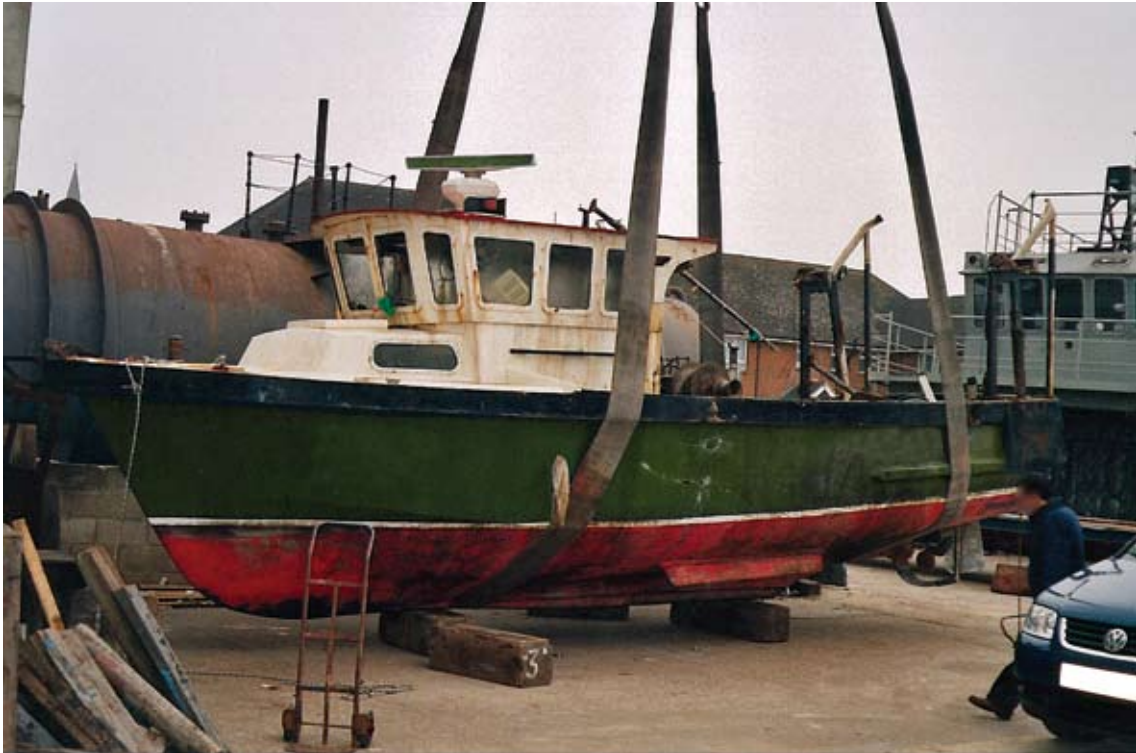
Vessel after recovery

The vessel was raised so that the cause of sinking could be established. It was found that her starboard quarter was damaged such that water could enter the hull under conditions of limited freeboard or poor weather. At the time of her loss, she had additional weight on deck in the form of water tanks which held live catch. This weight reduced the freeboard sufficiently to allow flooding through the damaged area of the hull. To complicate matters further, the skipper had removed the electrical bilge pump to use it to provide a flow of sea water to the holding tanks, and there was no bilge alarm.

It is not certain when the hull damage occurred. Because protective rubber matting largely covered the area of damage, it was obscured to the casual observer and might have been present for some time, becoming critical only when the freeboard was reduced by extra weight.

1. The skipper was unaware that the hull of his vessel was breached above the waterline and would let in water in a moderate sea or when heavily loaded. Check your hull regularly, especially the areas that are not easy to see, such as under matting or fenders.
2. During this trip, the vessel was unsafe. Although the skipper was unaware of the hull damage, he further compromised the safety of his vessel by heavily loading the deck with tanks, removing the only working bilge pump to fill those tanks,

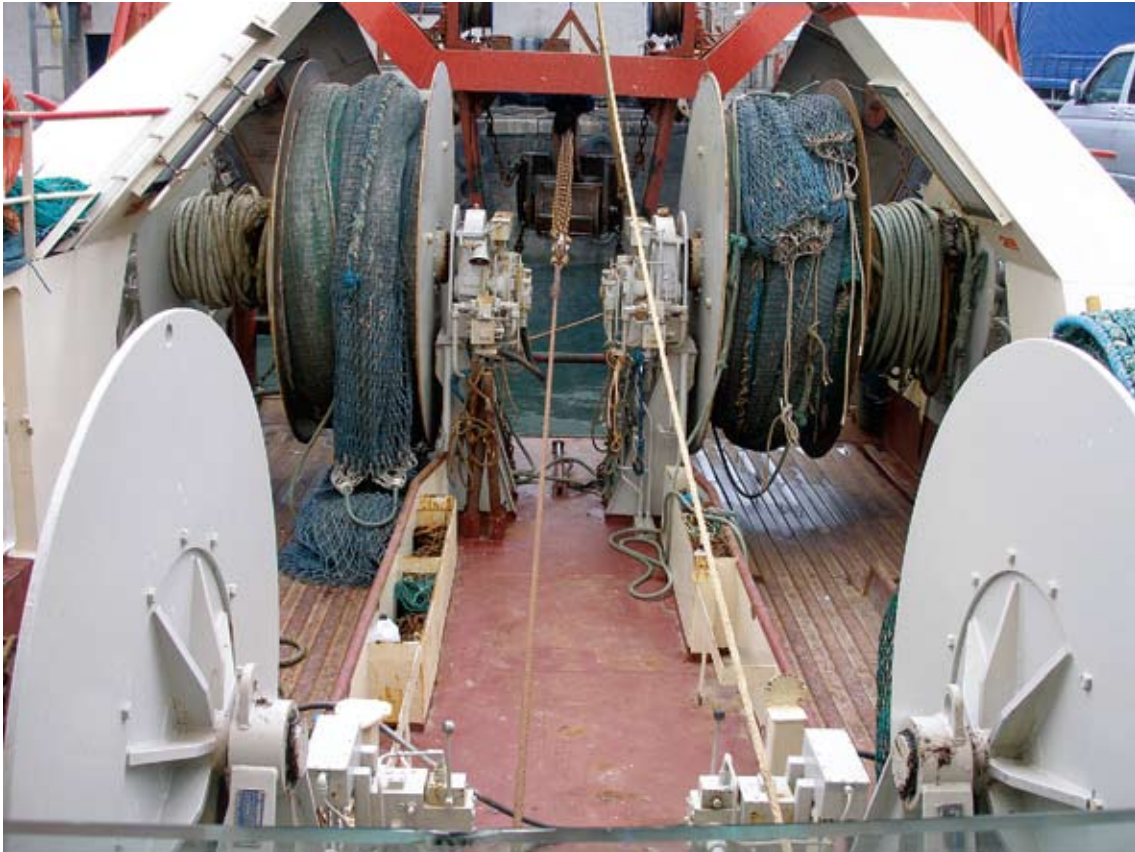
The crewman had assumed that the cod ends were ready to be lifted on board, and had lain across the net while clearing the dog rope (which had become twisted around the bag). The net drum operator was usually informed when it became necessary to clear twists from the dog rope; unfortunately, on this occasion he was not. The net drum operator's view was restricted by the physical size of the net drum, and he was unaware that the crewman was working with the dog rope when he veered the net back into the sea to enable fish in the bag to drop into the cod end. As the net was veered, it also carried the casualty overboard.

Operator's view towards net drums

1. Ideally, deck machinery controls should be placed where the operator has an unrestricted view of the surrounding area. However, if the view is restricted, communication between parties is essential before controls are operated. Communication is a two way thing: it should be given, and should then be acknowledged by the recipient to prevent any misunderstanding.

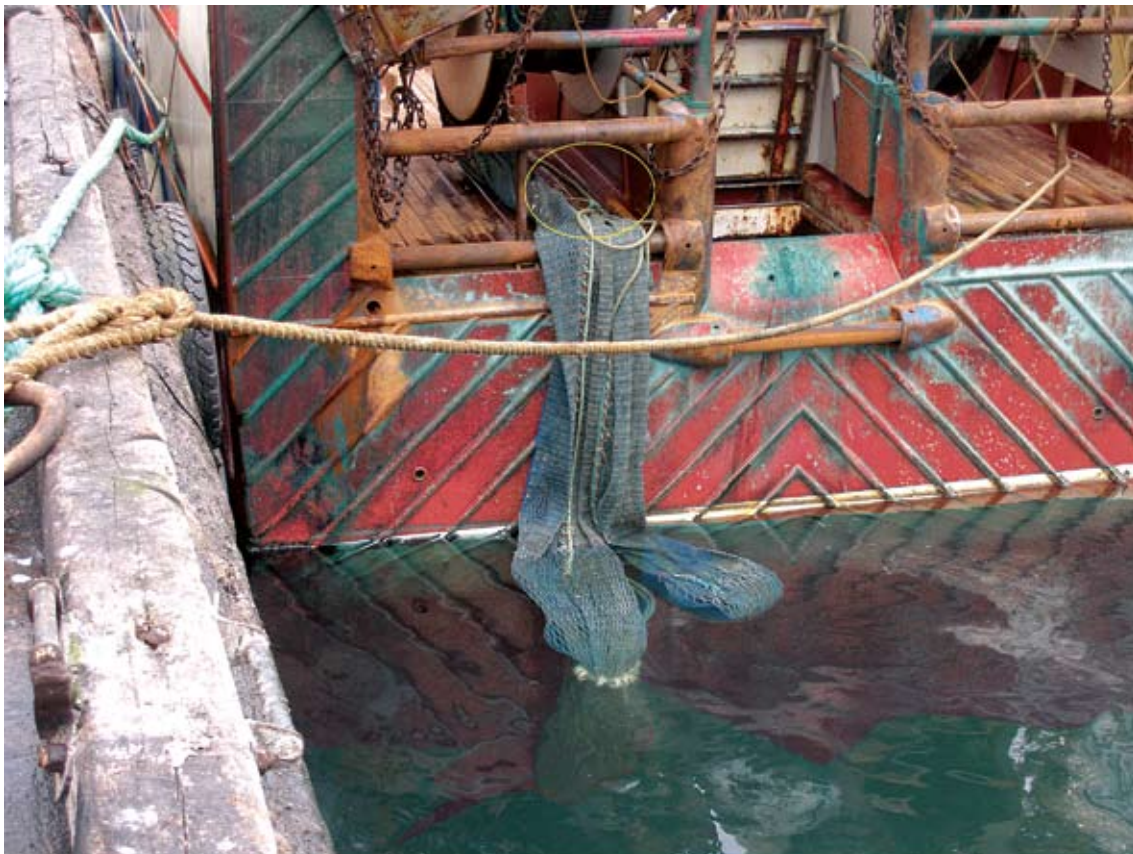
Position of the casualty before going overboard

4. Carrying out tasks on board a fishing vessel will sometimes necessitate leaning overboard. The simple precaution of wearing some sort of flotation aid will help mitigate the obvious risks and will increase your chances of survival if you fall overboard. The casualty involved in this case had been a fit and healthy man, yet after just a few minutes of being immersed in the cold water, the debilitating effect of cold shock rendered him unconscious.

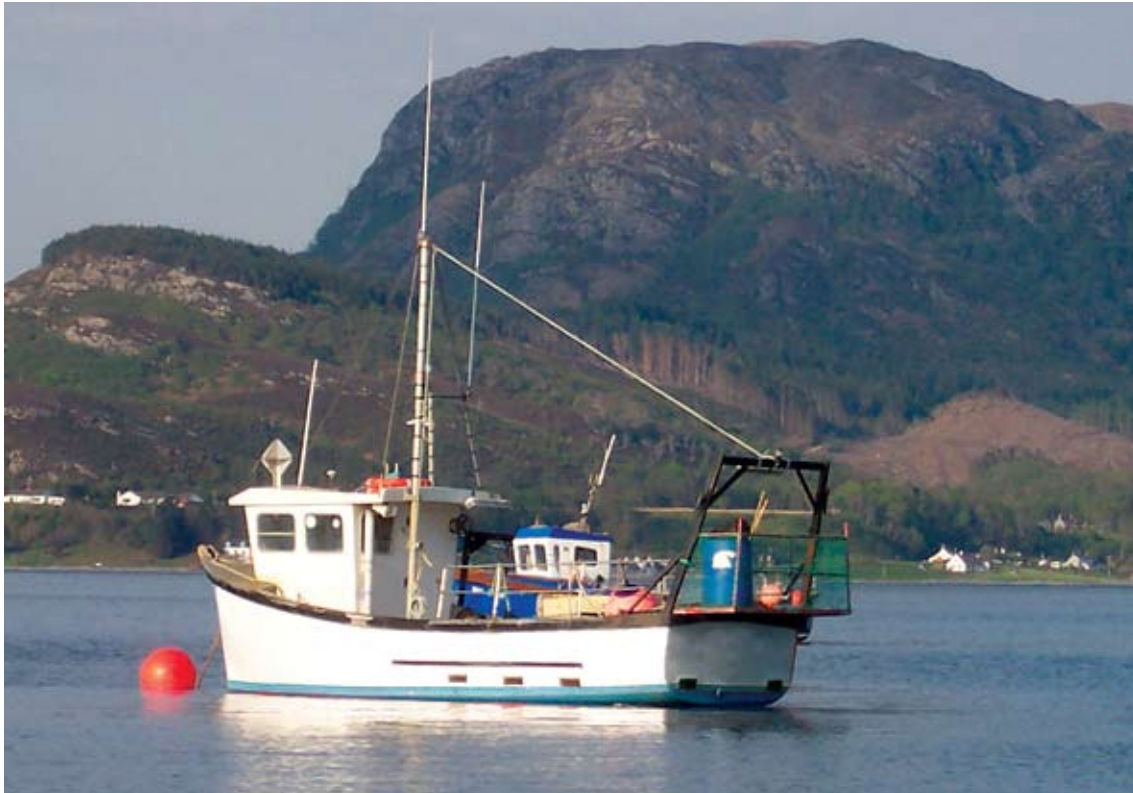
Figure 1

In the morning, the skipper and his crew tried to locate the boat, but were unable to do so. They believed that it was probably dragged out to sea by the tides and had sunk. However, they continued to search the inlets and eventually found it at low tide resting on rocks. The wheelhouse, deck and most of the hull had been consumed by the fire.

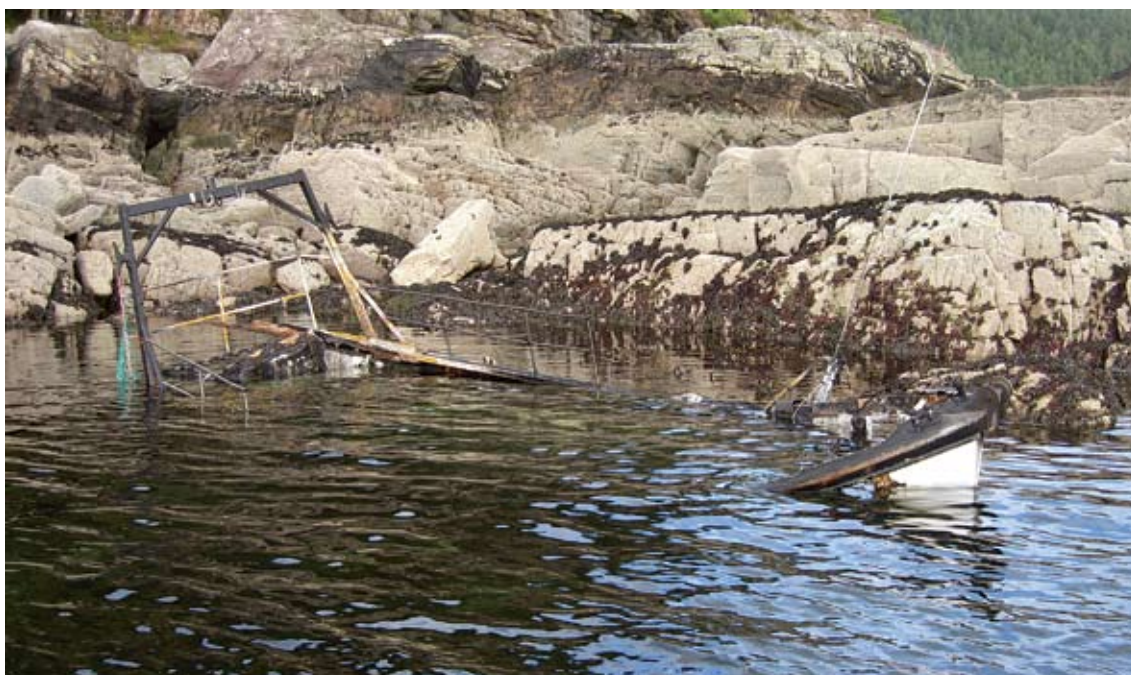
Figure 2

Discussions with the local authorities confirmed that the boat was well maintained, and that the skipper took good care of it and of his fishing gear. There was no suggestion of arson or foul play. All the indications suggest that the fire was probably caused by an electrical fault on the bilge pump or high bilge level float switch circuit which were the only circuits that were live while the boat was at the mooring.

1. Make sure that electrical circuits are maintained in good condition, that connections are tight and corrosion free, and that insulation is in good order.
2. Attend to electrical defects promptly. The constantly flickering light or intermittent power supplies are sure indications of potential problems.
3. Do not install additional electrical equipment until you are certain that the cable carrying capacity and fuse ratings are adequate.
4. Isolate as many electrical circuits as you can before you leave your boat.
5. Always properly isolate and use correct terminations for redundant circuits.
6. Makeshift plugs, sockets and fuses should not be used.
7. When in doubt, seek professional advice/assistance from a qualified electrician.

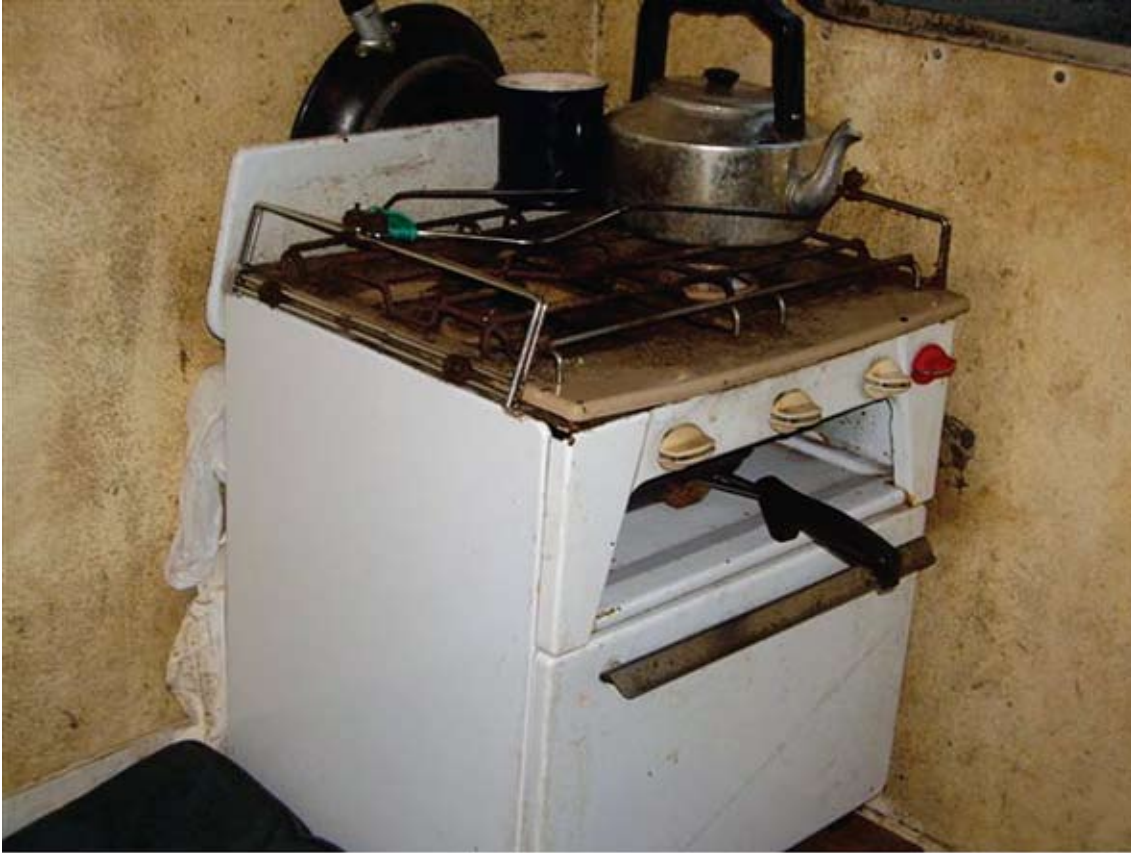
Cooker with old fiddle and kettle

The skipper later inspected the fiddle to establish why the kettle had been able to fall from the stove. He found that the fiddle had not been properly adjusted to suit the kettle which had been recently supplied to replace an older and different sized model.

The skipper ensured that the fiddle was properly adjusted to fit the kettle before the stove was used again.

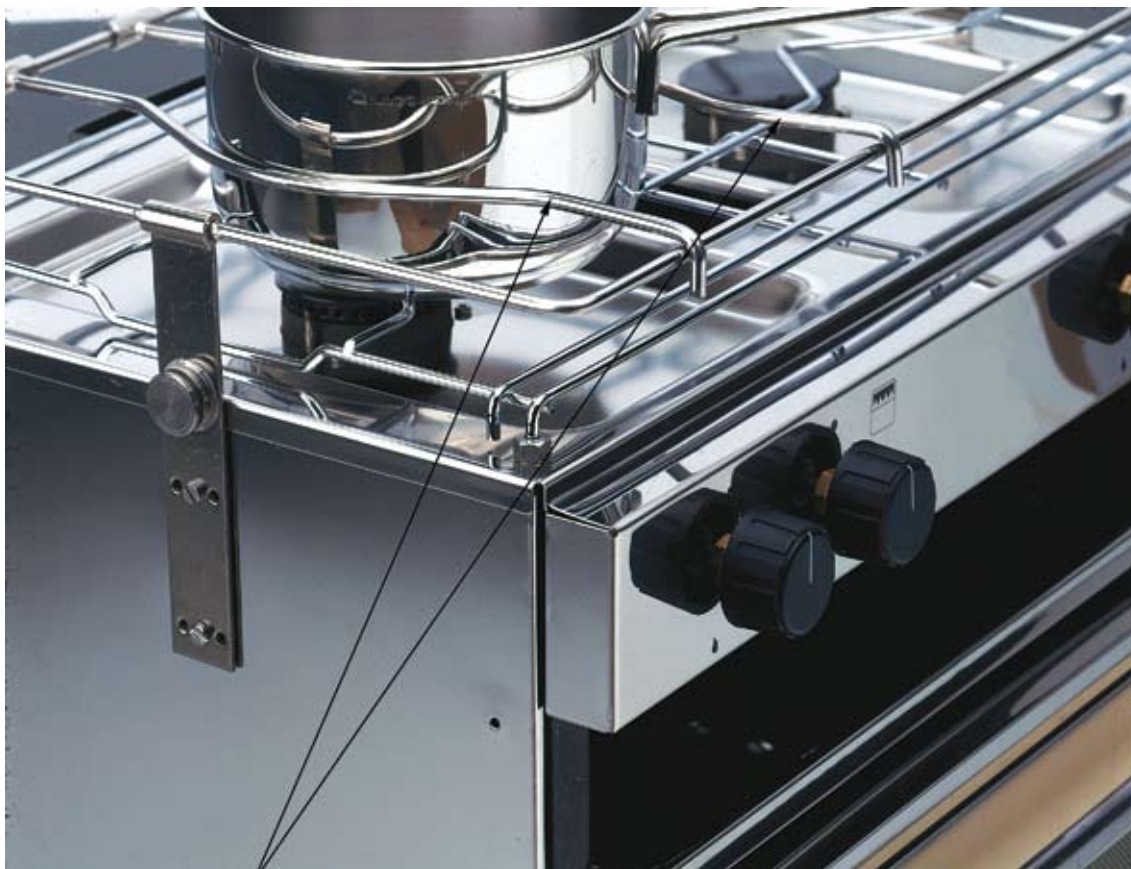
Ensure the fiddle is properly positioned when placing pans on a stove

1. The supply of hot drinks is one of the key requirements on any vessel. However, as with any other items of equipment, it is essential that the kettle can be used safely in all weather conditions.
2. Fishing boats can be expected to roll, especially when trawling in a beam sea. The skipper had taken the precaution of securing various items of working gear but had not foreseen the hazard caused by a defective fiddle.
3. Galley equipment should not be overlooked when securing for adverse weather, especially on a small boat.
