Report on the investigation  
of the loss of the tug  
***Flying Phantom***  
while towing  
***Red Jasmine***  
on the River Clyde  
on 19 December 2007  
resulting in 3 fatalities and 1 injury

Marine Accident Investigation Branch  
Carlton House  
Carlton Place  
Southampton  
United Kingdom  
SO15 2DZ

**Report No 17/2008**  
**September 2008**

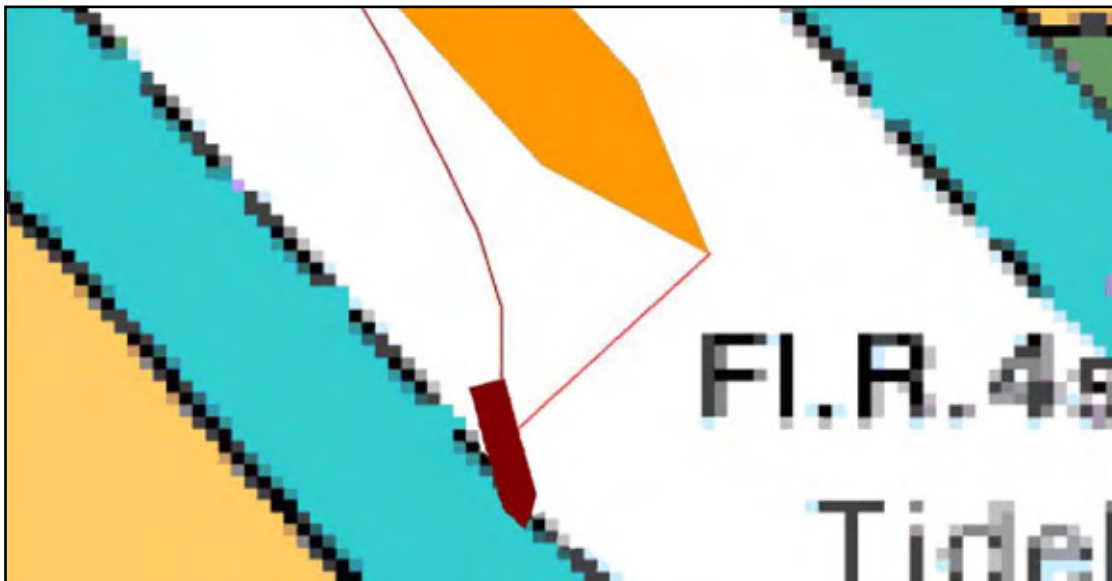
Figure 9

17:59.20 - *Flying Phantom* informs pilot they are aground

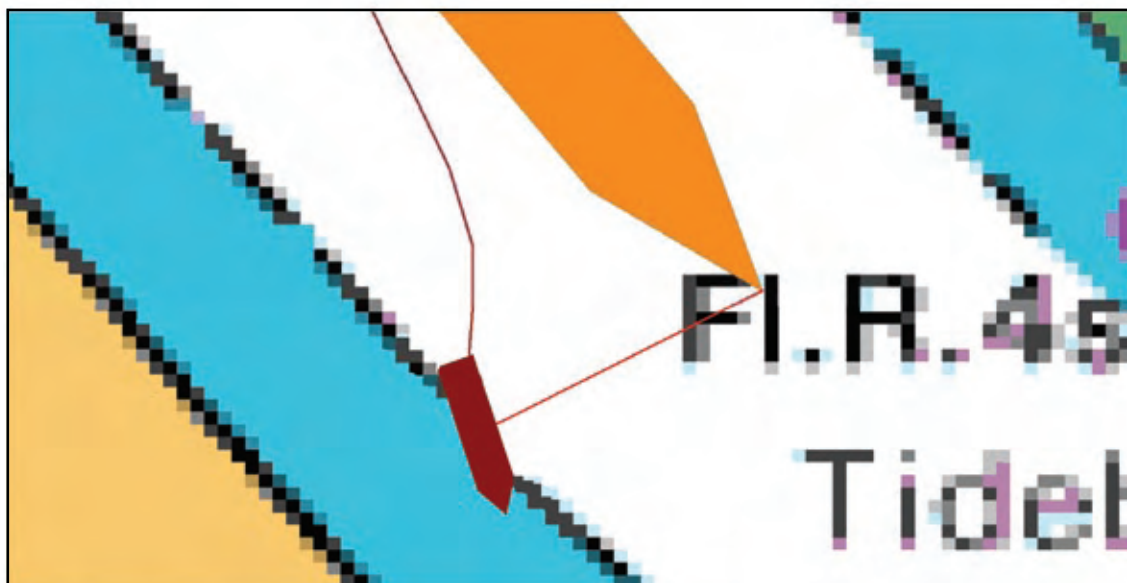
Figure 10

17:59.30 - Girting sequence (estimate of tug heading only)

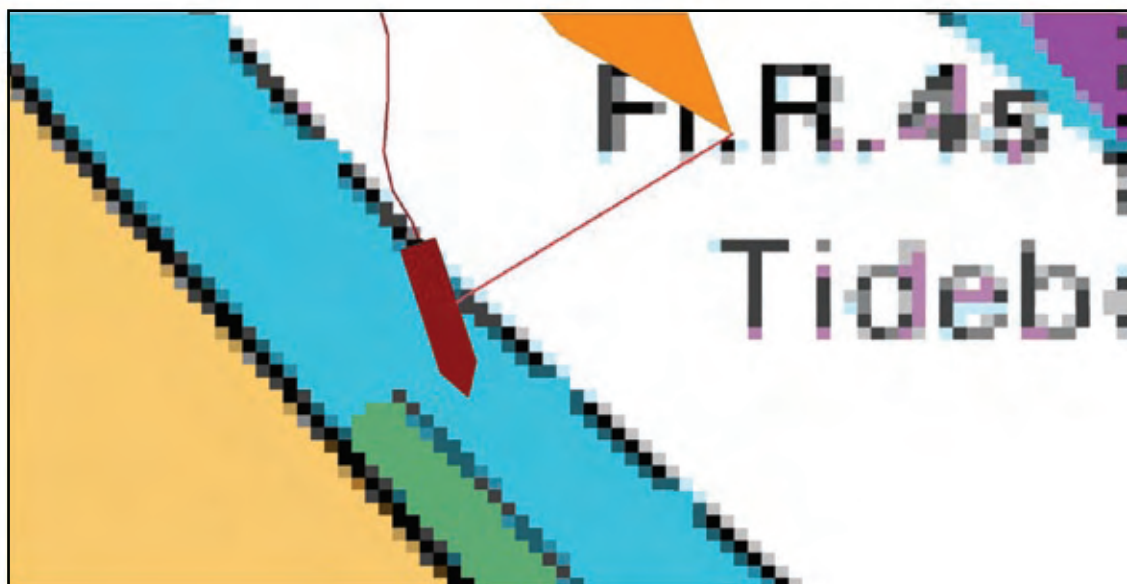
Figure 11

17:59.40 - Girting sequence (estimate of tug heading only)

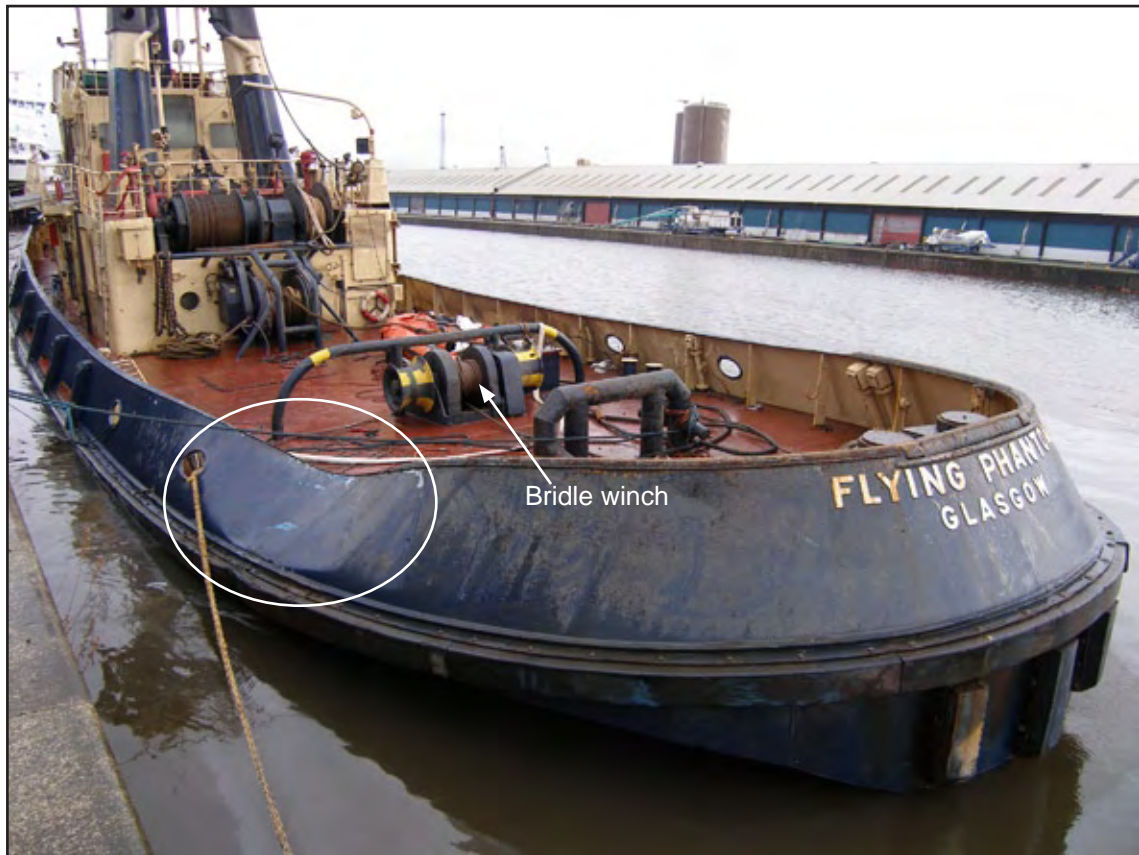
Figure 22

To raise the wreck, *Flying Phantom* was parbuckled (rolled upright), using two wire strops attached to the tug's stern tube. During this process the bulwark on the port quarter was bent towards the deck (**Figure 22**). Once the tug was upright, the top section of the mast was removed and placed ashore to prevent it from fouling the lifting wires. Once access to the vessel was possible, it was found that the Aquamaster had been pushed up 0.5-0.6m into the hull and its mechanical linkage was damaged. This damage was caused during the parbuckling operation, as the hull of *Flying Phantom* was rolled on to the Aquamaster.

Aft deck showing parbuckle damage and location of bridle winch

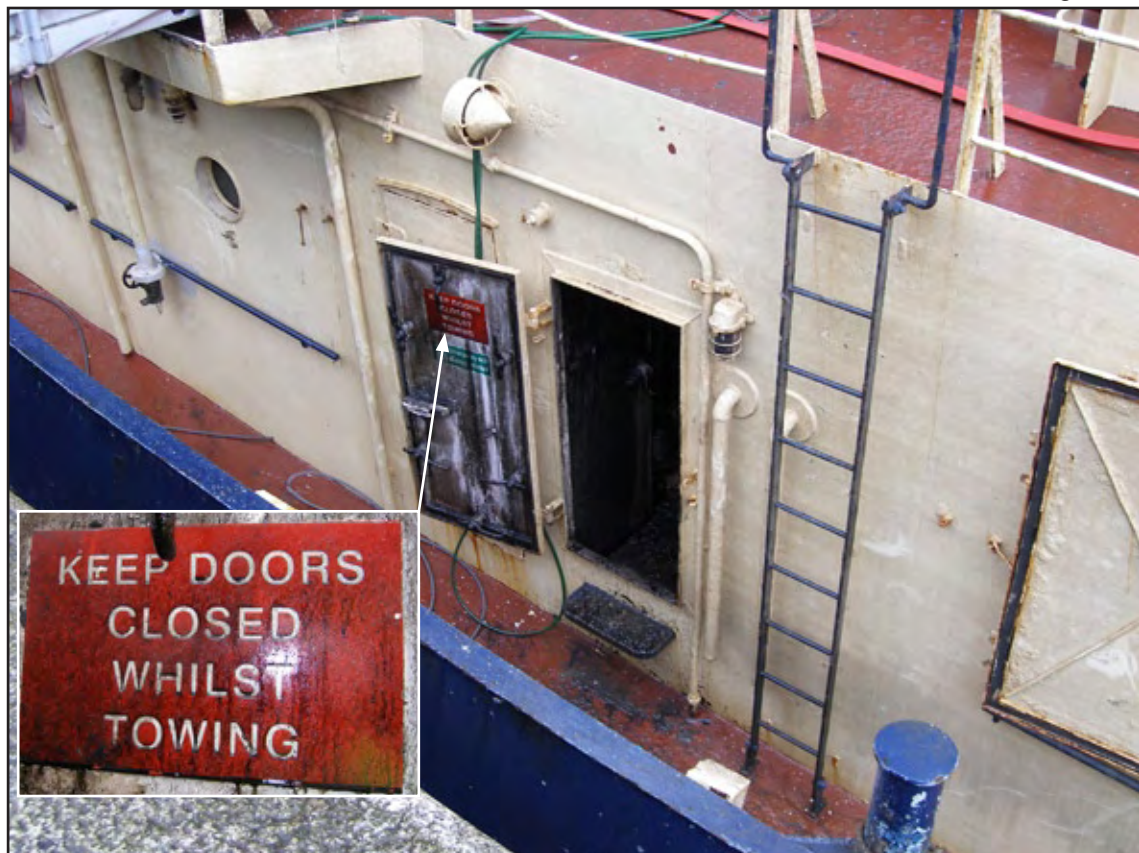
Figure 23

Along with the other watertight doors on the main deck, this door was closed during salvage, while the tug was still submerged. This was to allow water to be pumped from the hull to reduce the load on the lifting wires, and it accounts for the dirty oily condition of the inside of the door (**Figure 23**).

Engine room watertight door

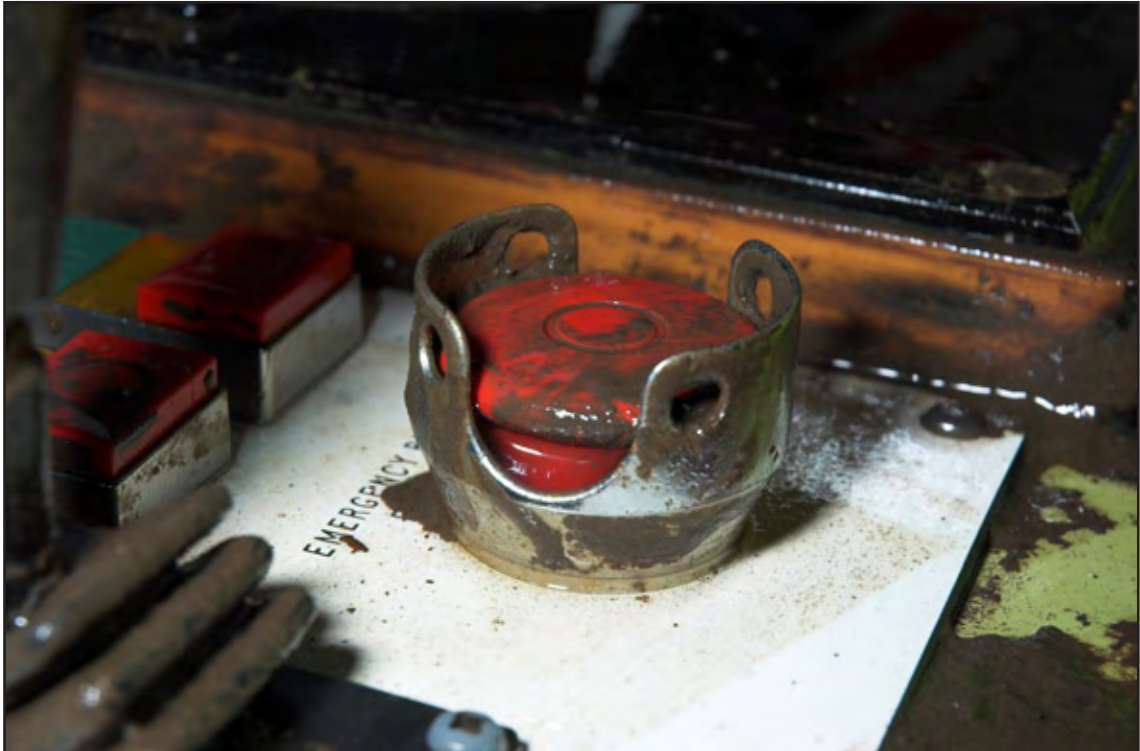
Figure 24

The towing winch emergency release button on the starboard wing console was found depressed (**Figure 24**). The other two emergency release controls had not been operated.

Starboard emergency release button

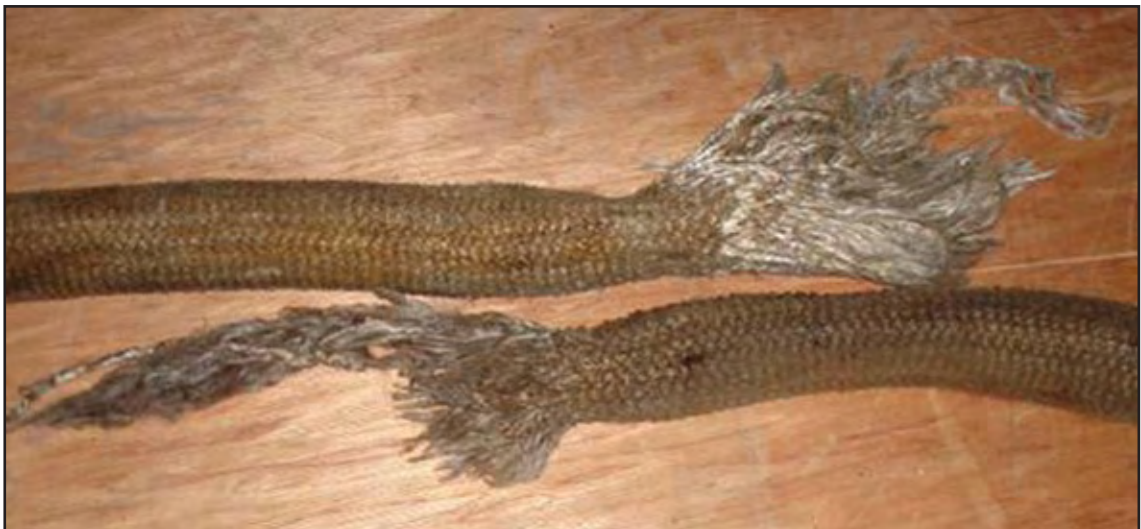
Figure 25

The tow rope was found to have parted, about 9m from the winch drum. The length of the bridle wire from the swivel fairlead at the stern to the inside of the bow shackle was 6.6m. The parted end of the tow line from the winch drum met with the bridle shackle when both were laid out on deck.

Forensic examination<sup>3</sup> of the tow line revealed that the rope was generally in good condition and was as described on the test certificate. The rope recovered from the towing winch was found to have a twist about 10m from the parted end. The area of the failure (**Figure 25**) showed indications of localised abrasion and of the rope failing under tension, while loaded over a fixed edge. Three samples of the rope were tested to assess their breaking strength, the lowest breaking load was 72.48t, which occurred in way of the eye splice required to effect the test.

Tow rope failure

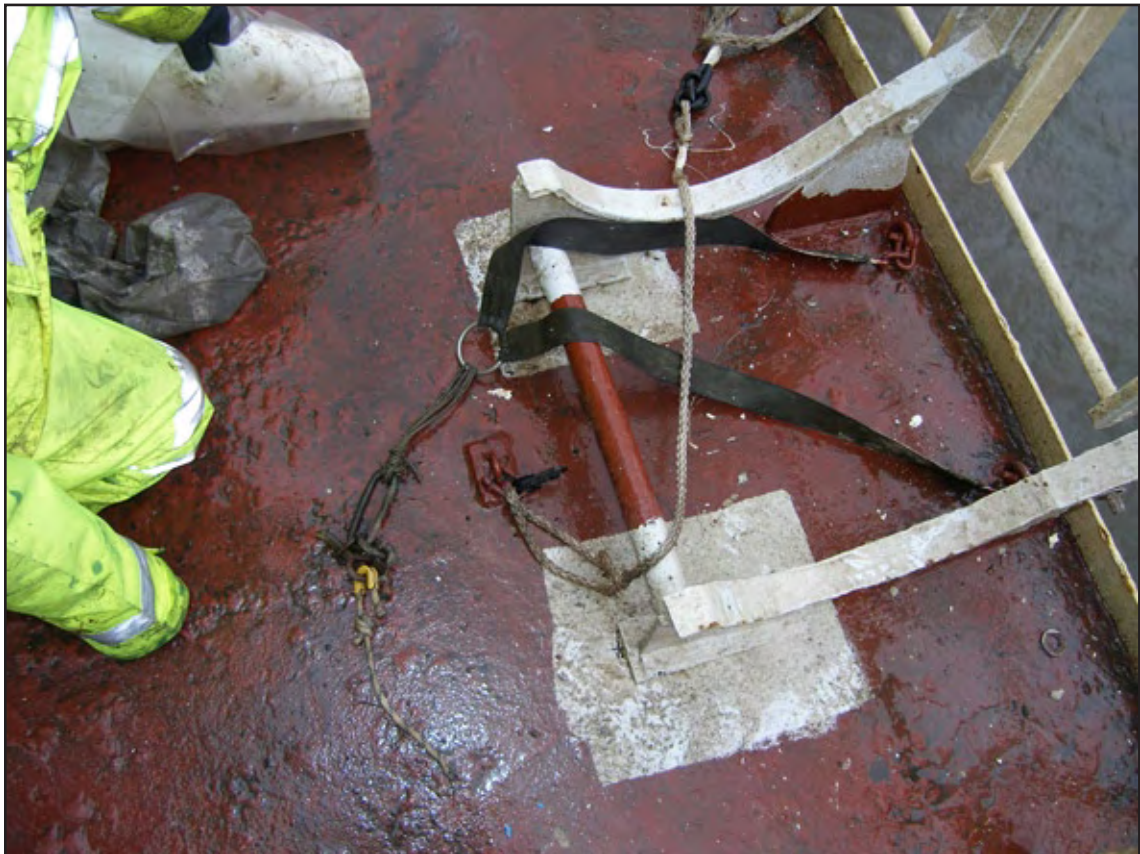
The liferaft, which was still attached to the wreck by its painter, was cut loose after *Flying Phantom* was parbuckled. After salvage, it was found that the hydrostatic release for the liferaft had activated and released the liferaft canister. However, the liferaft had become tangled in the superstructure, had not pulled out the full length of painter, and consequently did not inflate. Although having no bearing on the outcome of this accident, the painter was found to be directly attached to the tug and not to a weak link (**Figure 26**). Had *Flying Phantom* been lost in deeper water, the liferaft, even if it had inflated, would have been lost with the tug.

Liferaft painter
