Report on the investigation of
the grounding of

mv Harvest Caroline

Tanera More, Summer Isles
north west coast of Scotland

**Report No 13/2007
June 2007**

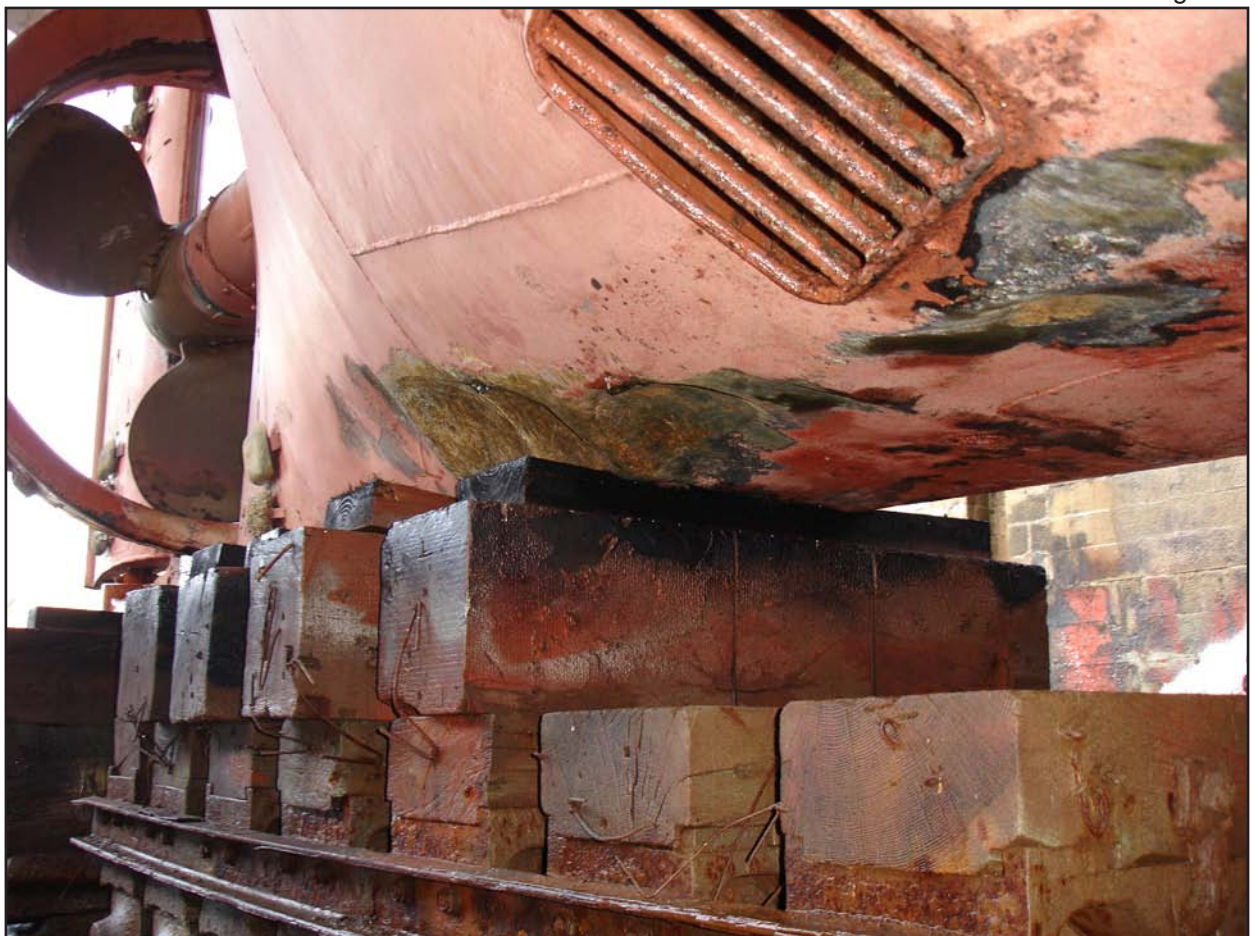
Figure 2

the ship to fall broadside onto the rocks. The starboard anchor was then let go underfoot. The chief engineer checked for damage in the engine room and found a small number of indentations in the underwater hull plating (**Figure 2**). A small ingress of water in the engine room bilge was also detected.

Photograph of damage to hull plating

On completion of an underwater survey and temporary repair to a small area of underwater hull plating, *Harvest Caroline* sailed from Ullapool on the evening of 1 November 2006. She arrived in Greenock the following day, where permanent repair was undertaken.

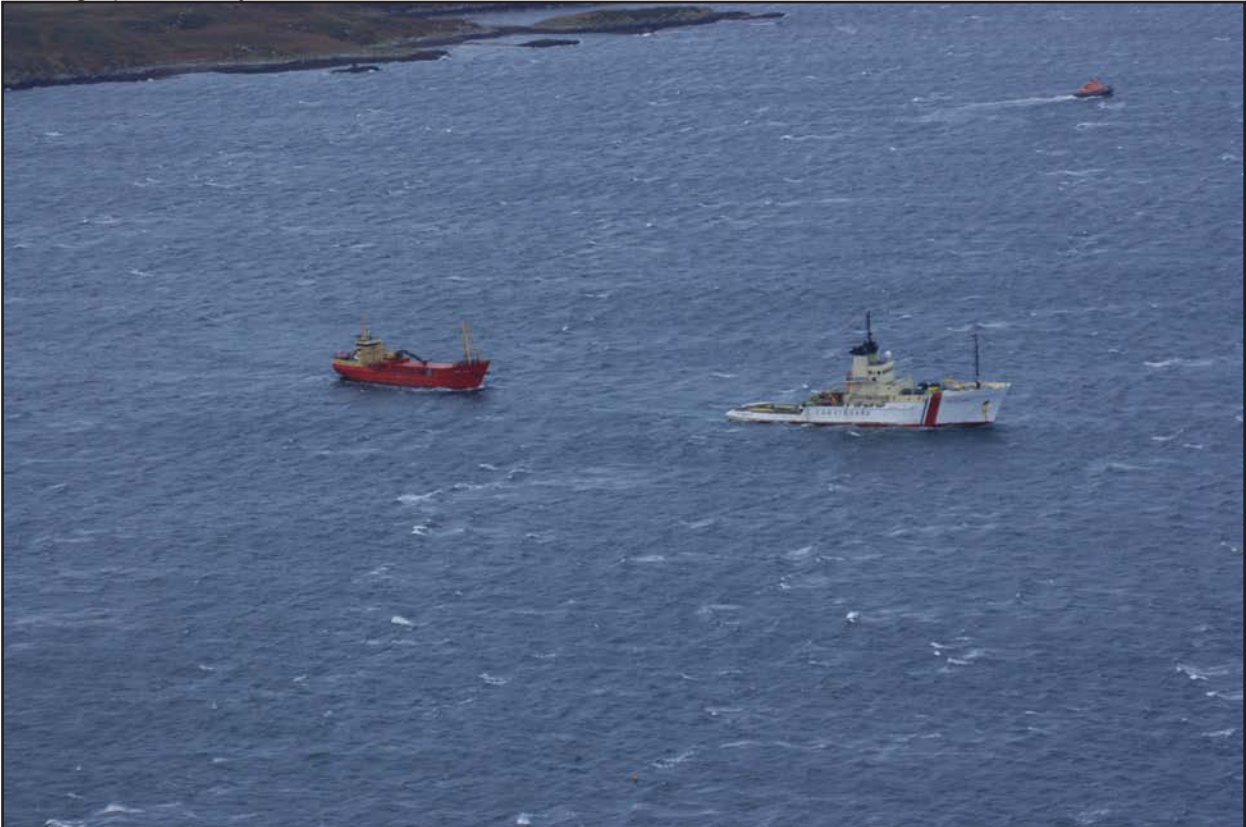
At 0727, the SAR helicopter winched a salvage pump onto, and the female passenger from, *Harvest Caroline*. When *Anglian Prince* arrived at the scene at 0940, *Harvest Caroline* had already started to re-float on the rising tide. She was taken in tow by the ETV (**Figure 3**), and was clear of the rocks by 1050. No pollution was detected by coastguard aircraft, either at the scene, or during the vessel's passage to Ullapool, where she arrived the same day.

Photograph of tow in progress

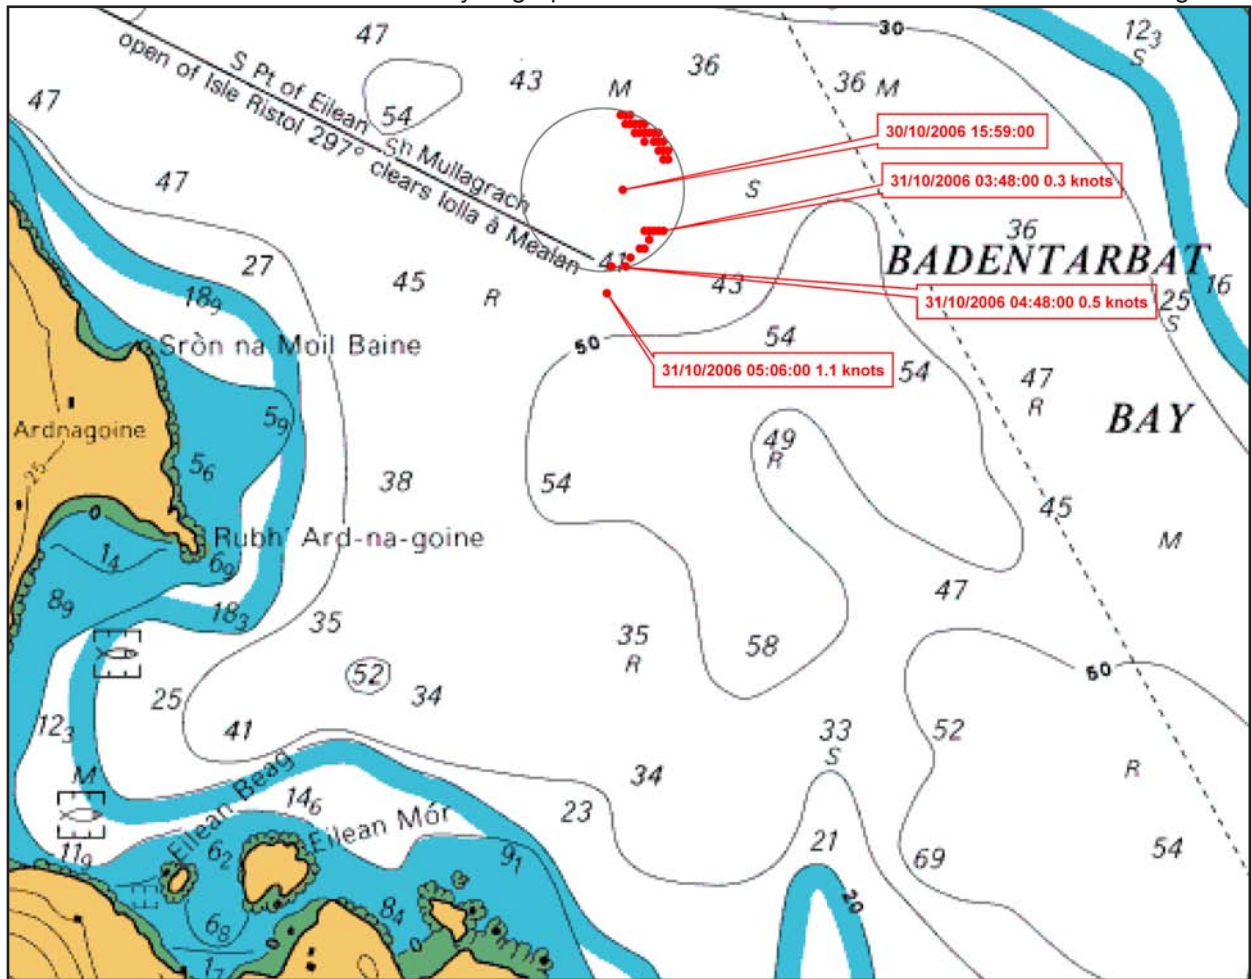
Positional data transmitted by the ship's AIS between 0300 and 0506 on 31 October 2006 is shown at **Figure 4**. No transmissions were received after 0506 until the ship grounded. The ground track from the ship's anchorage to the position of grounding, recovered from the ship's GPS receiver, is at **Figure 5**. No positional information was recorded on the ship's ECS.

AIS Positional Data

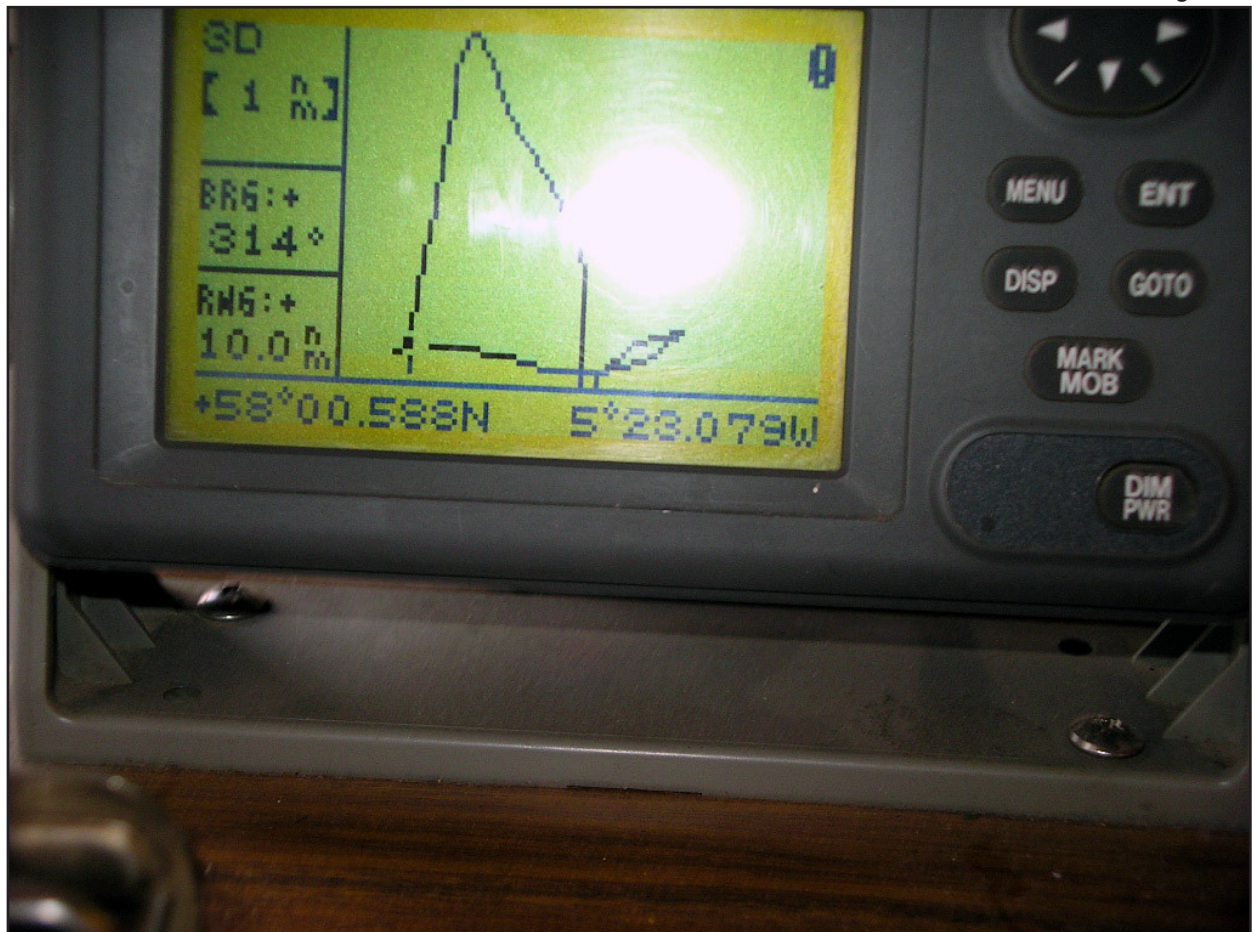
Figure 5

Photograph of GPS data

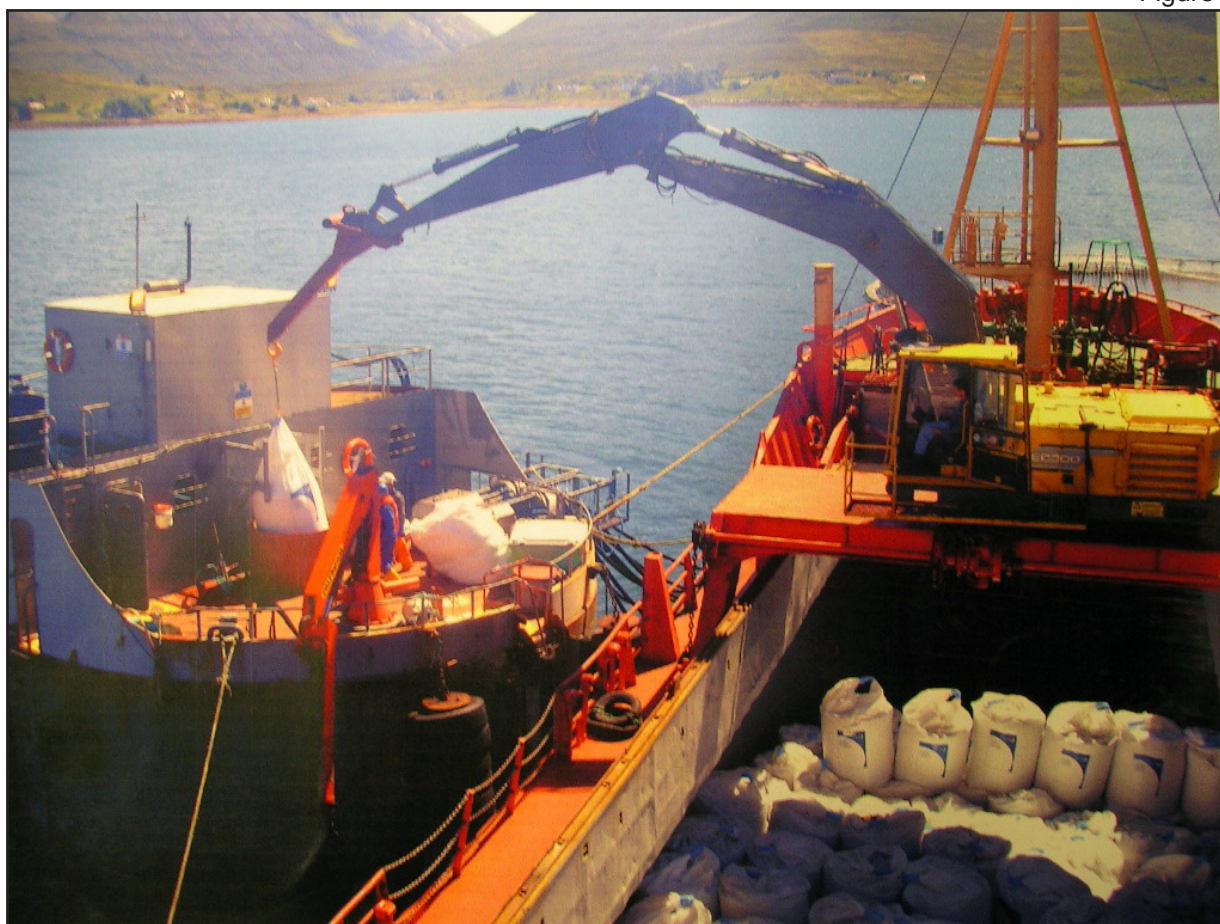
Photograph of ship unloading cargo at a 'C' cap
