Report on the investigation of the collision between  
two Offshore Circuit Racing powerboats

in Dover harbour

8 August 2009

**Report No 7/2010  
July 2010**

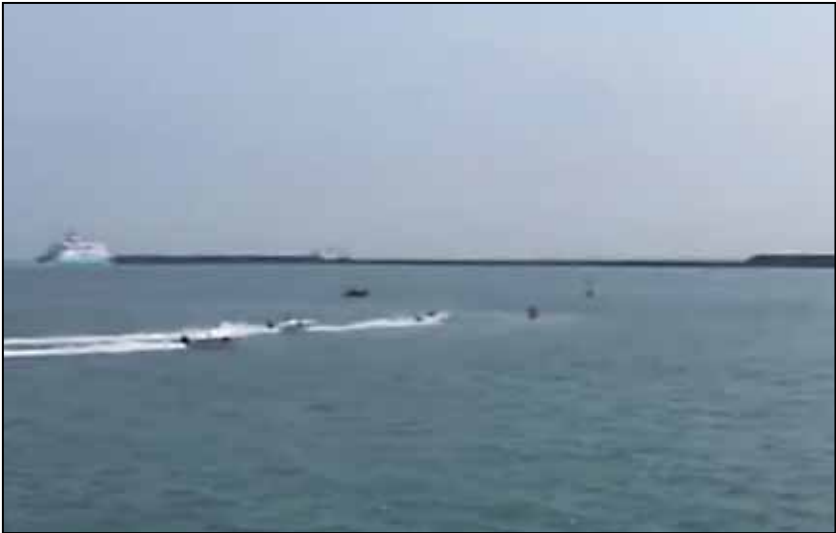
Figure 3

Boats B27, A28 and A89 approaching buoy no. 8

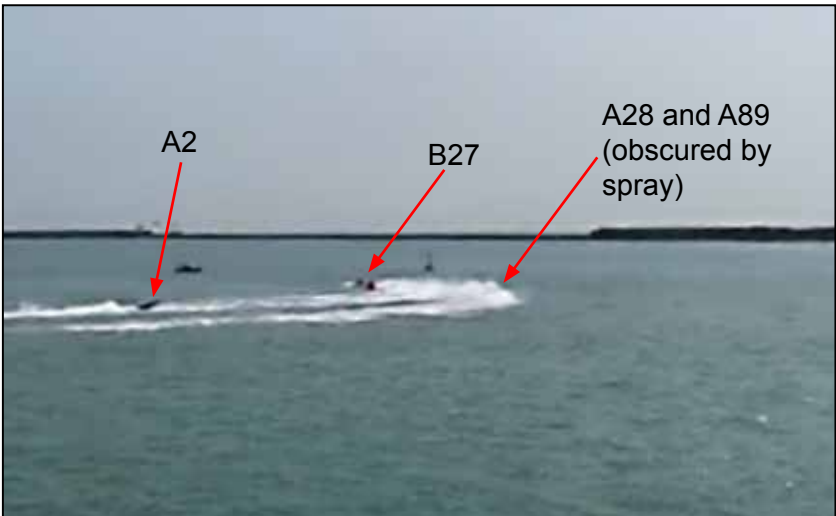
Figure 4

Boats A28 and A89 entering the turn at buoy no. 8

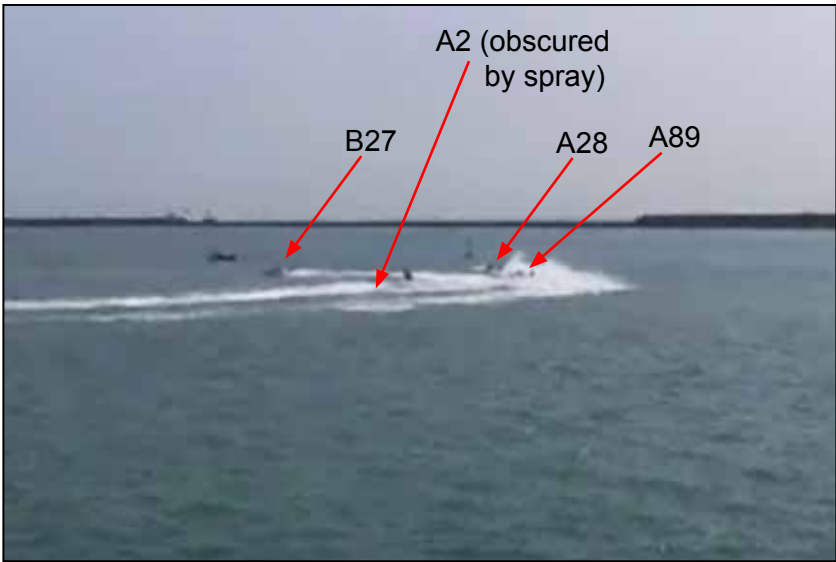
Figure 5

Boat A89 hooking

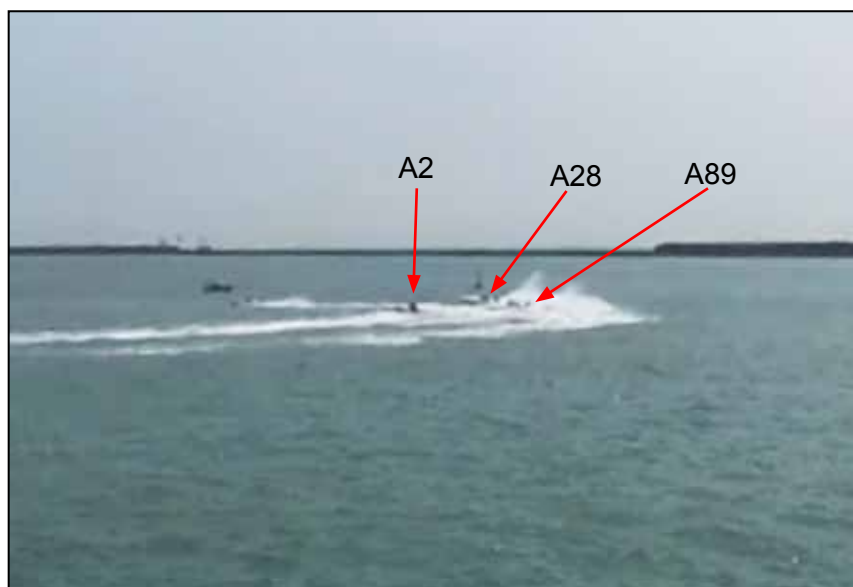
Figure 6

Boat A2 approaching the turn at buoy no. 8

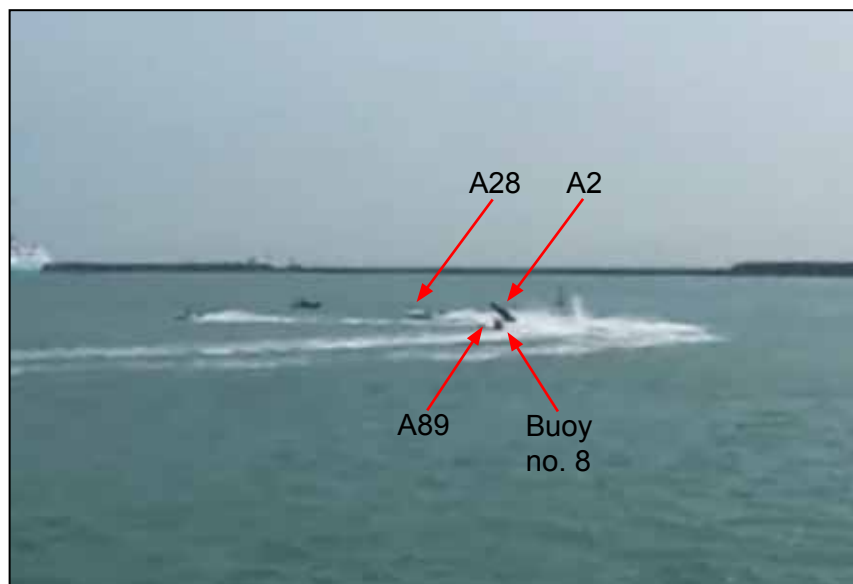
Figure 7

Boat A2 was several boat lengths behind A89, but closed the distance quickly as it took a tight line into the turn at buoy no. 8 (**Figure 6**). Boat A2 began to turn and its crew saw A89 directly ahead, lying across their path. A2 struck A89 on the port side, in the part of the boat where the crew were seated. A2 was launched upwards and out of the water (**Figure 7**). As it crossed over A89, it struck A89's starboard side coming immediately behind the driver's seat, and rolled to starboard. The driver of A2 was thrown clear, but the co-driver remained in the boat as it landed upside down in the water. After some initial difficulty, the co-driver swam clear.

Collision between boats A2 and A89

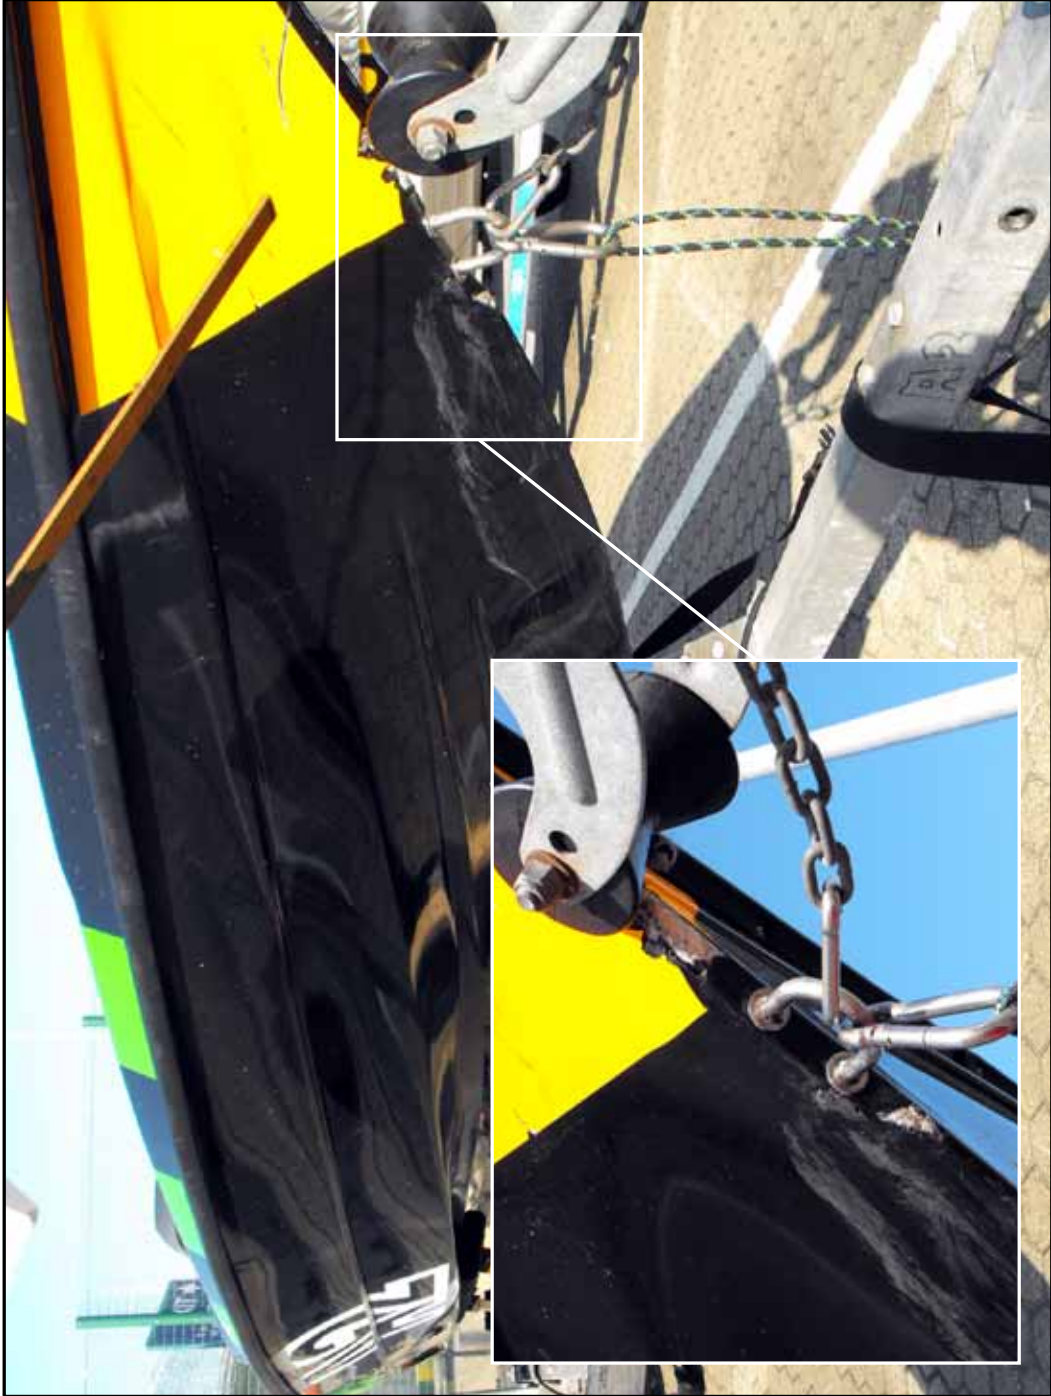
Figure 11

Boat A2 was found to have impact damage around the towing eye at the bow and scuffing marks down the starboard side near the keel (**Figure 11**). The chine was damaged on the starboard side in the area immediately behind the driver, and the hull had been penetrated where the two surfaces had split apart. A deck moulding that covered the area behind the crew had been deformed and split in places. The outboard engine was securely attached to the transom. Throttle, gear and steering connections worked satisfactorily. The engine could be moved throughout its full range of trim, but was not marked with a pink band to denote that the driver was a provisional licence holder as required by PB1.

Damage to the bow of boat A2

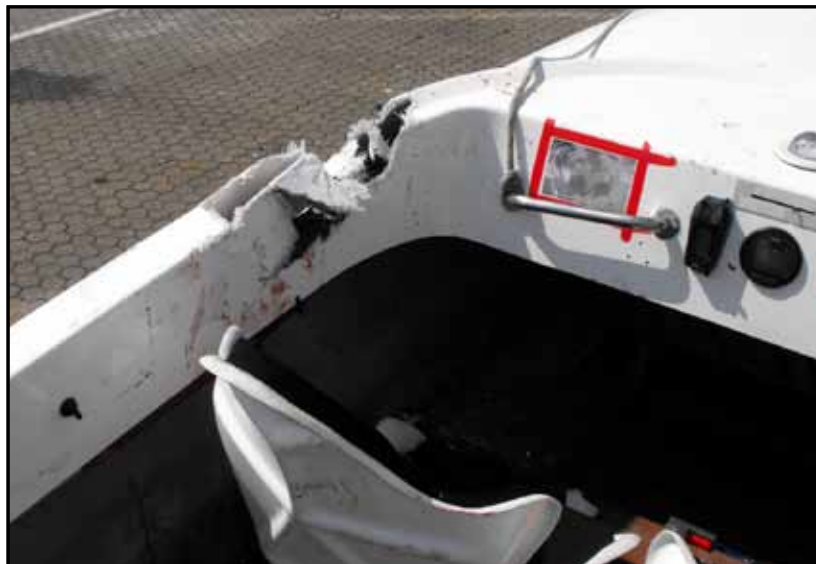
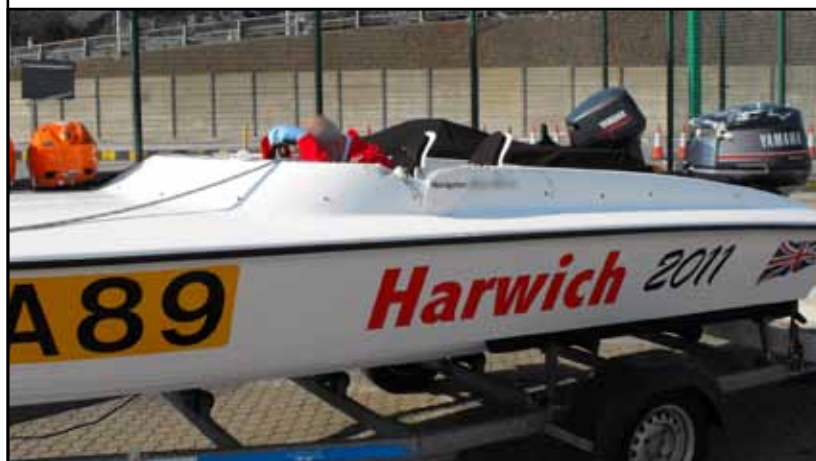
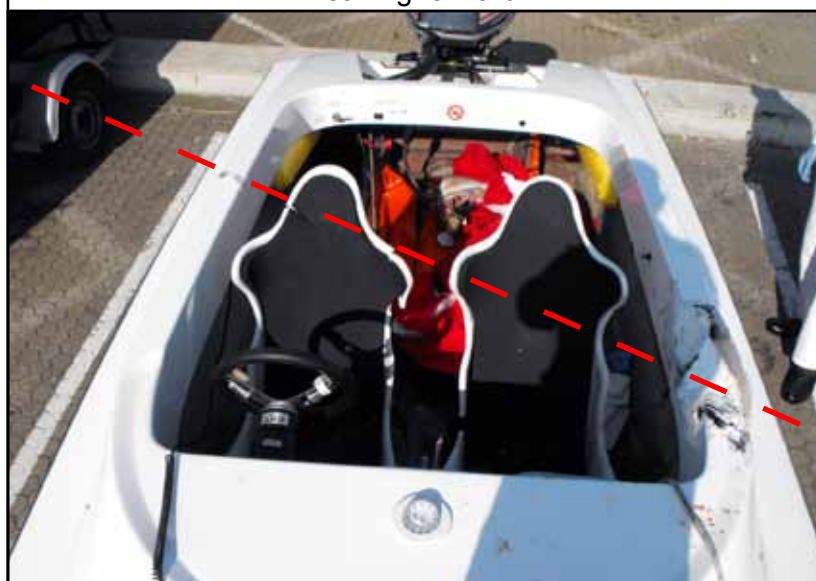
Damage to boat A89

Boat A89 was damaged at the coaming on the port side next to the co-driver's seat. A 'v' shaped section of the coaming moulding had been broken away. Both the co-driver's and driver's GRP seats were cracked in several places. The coaming on the starboard side, immediately behind the driver had also been damaged, with blood and tissue embedded in the GRP structure (**Figure 12**). The outboard engine was still attached to the transom, but the engine cowling had been pushed downwards, fracturing the cowling and causing damage to the starter motor and the forward part of the engine. There was no evidence of a pink marking band required to indicate that the driver was a provisional licence holder. The transom was cracked along its upper edge and delaminated in places. Throttle, gear and steering connections worked satisfactorily and, with battery power applied, the engine could be moved throughout its full range of trim.

Impact damage to port side cockpit coaming

View looking at point of impact and showing 'driver' leaning forward

Approximate direction of travel of A2 as it crossed A89

OCR rules do not require boats to have any additional measures to protect the crew from a collision. By plotting a line through the damaged area on A89 it can be seen that Mr Edmonds would have borne much of the force from the impact. However, both seats were damaged and the driver was extremely fortunate to have escaped without injury (**Figure 12**). All the boats in the OCR and the UKFFORC classes had similar levels of protection to boat A89, and their crews would all have been equally vulnerable to severe injury in the same circumstances. While some other powerboat classes have introduced safety features in their boats to protect crew, the investigation found no evidence of any attempt to improve crew protection in OCR class boats prior to this accident.

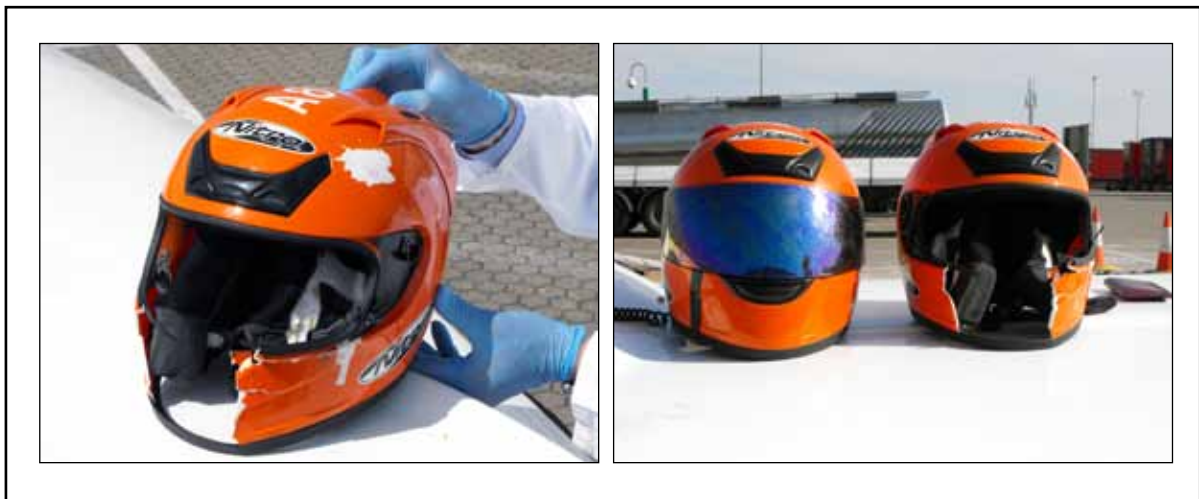
Figure 13

Examination of the helmet (**Figure 13**) showed that the outer coating had been removed on the left hand side above the temple area, and on the chin guard close to the cheek. The centre and right hand side of the chin guard had shattered and was missing. The padding insert was later recovered, but the outer polycarbonate shell could not be found. The visor was also missing. Padding and the inner lining of the helmet had also come away from the shell on both sides, but the chin strap was still secured.

Helmet damage
