Report of the Investigation  
into the loss of the Fishing Vessel  
**HEATHER BLOOM INS 110**  
with the loss of one life  
on 3 December 1994

Marine Accident Investigation Branch  
5/7 Brunswick Place  
SOUTHAMPTON  
SO15 2AN

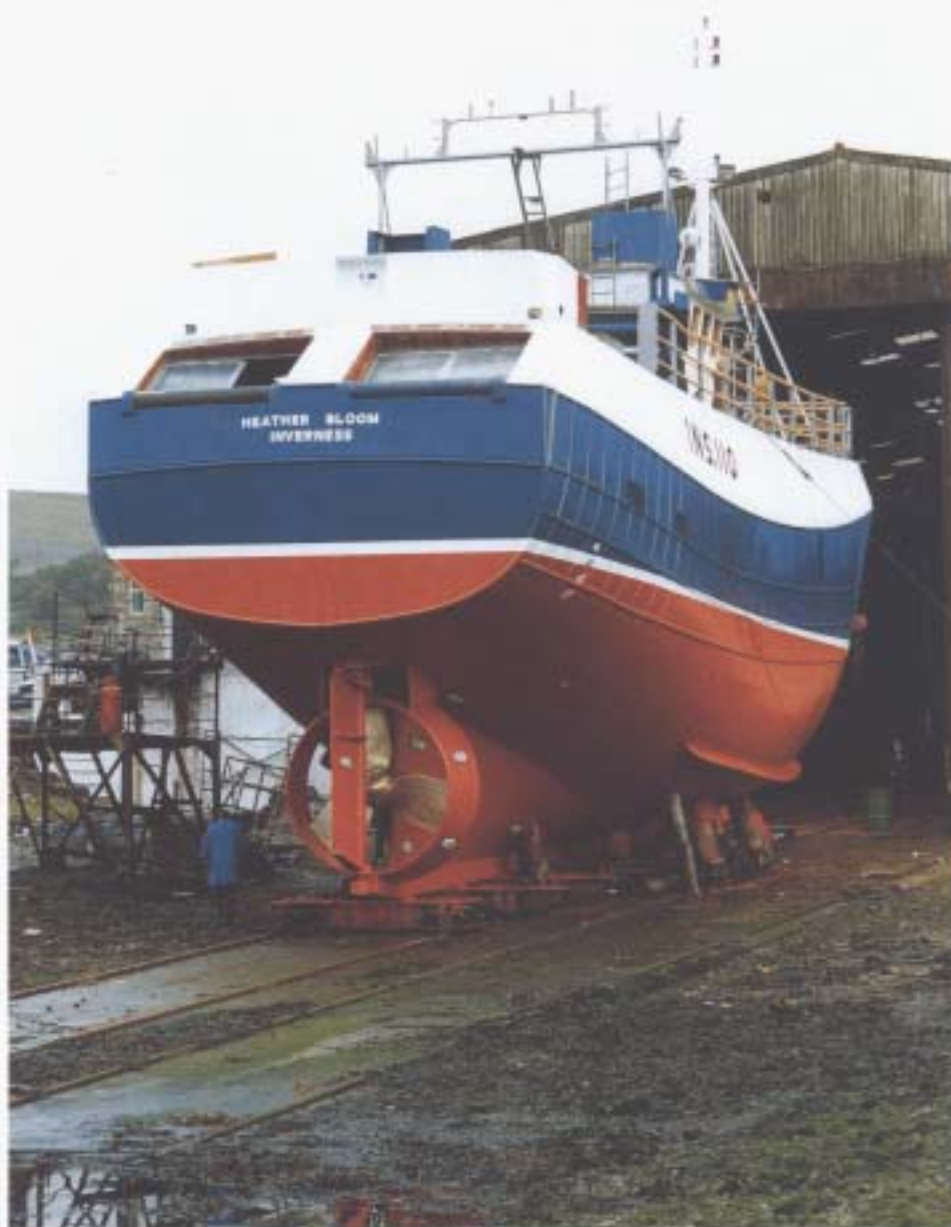
FIGURE 7

HEATHER BLOOM near completion,  
showing the transom openings and doors

- 9.3 The Marine Safety Agency is recommended to take steps when conducting fishing vessel safety surveys, to ensure that any transom doors (section 6.2) fitted to fishing vessels can be opened and closed efficiently and easily.

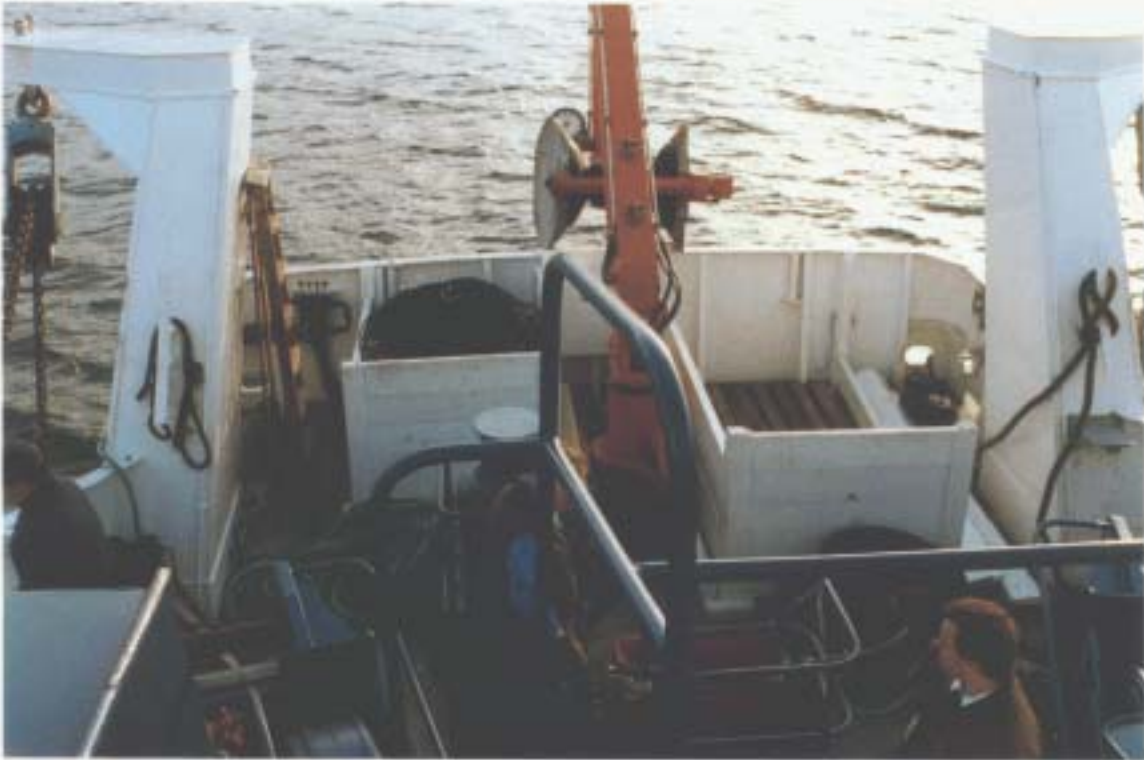
FIGURE 8

View of After Shelter deck

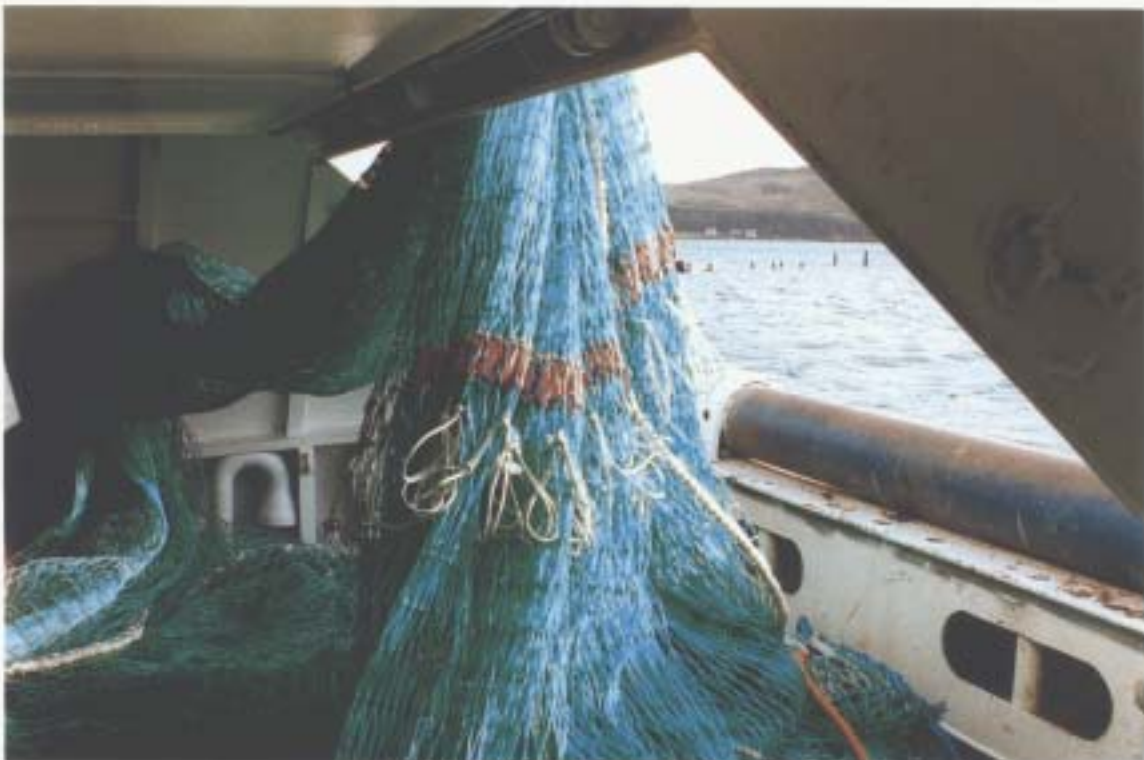
Transom door opening
