Report on the investigation of  
the starboard boiler explosion resulting in  
one fatal and one serious injury on board the  
Liquid Natural Gas tanker

***Hilli***

10 October 2003

**Report No 4/2007**  
**March 2007**

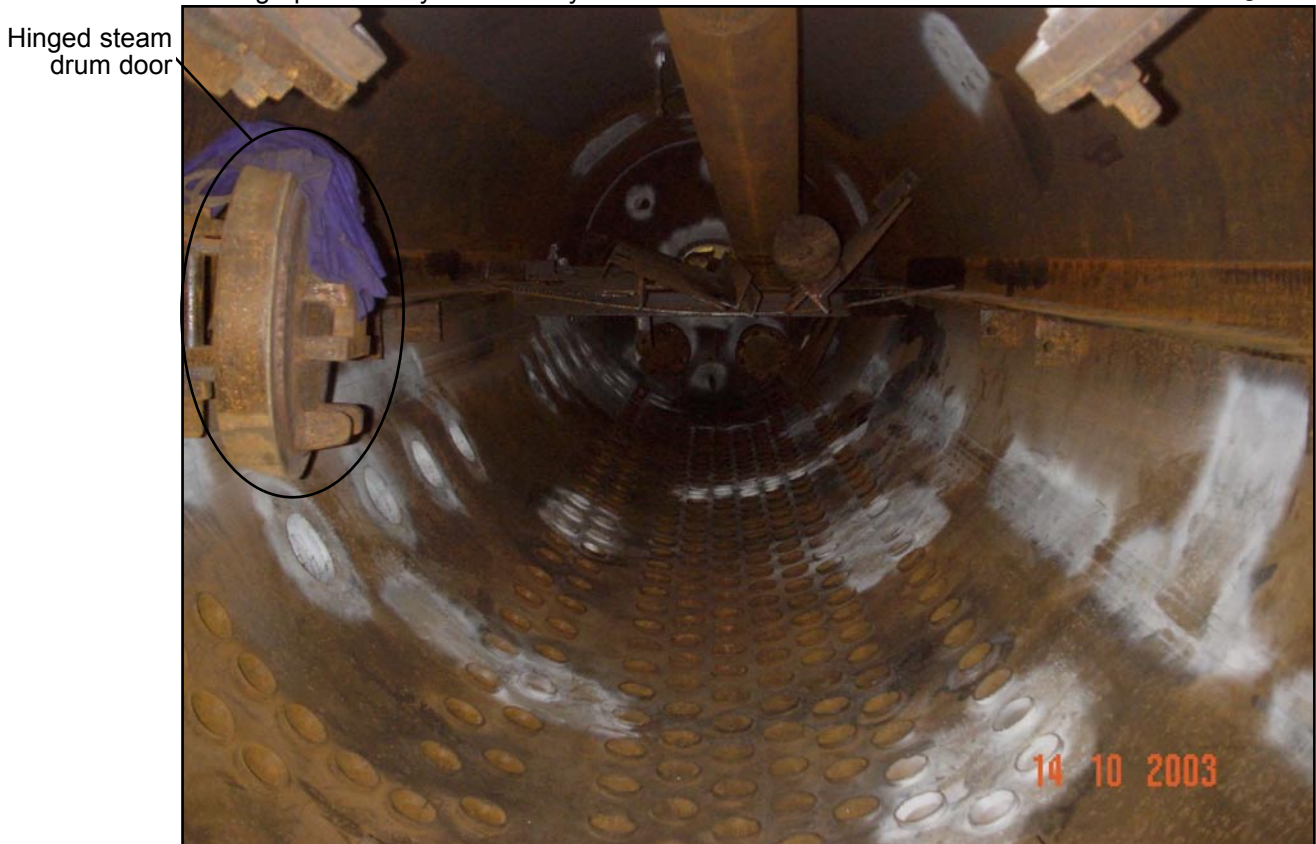
Figure 8

Starboard boiler – open steam drum

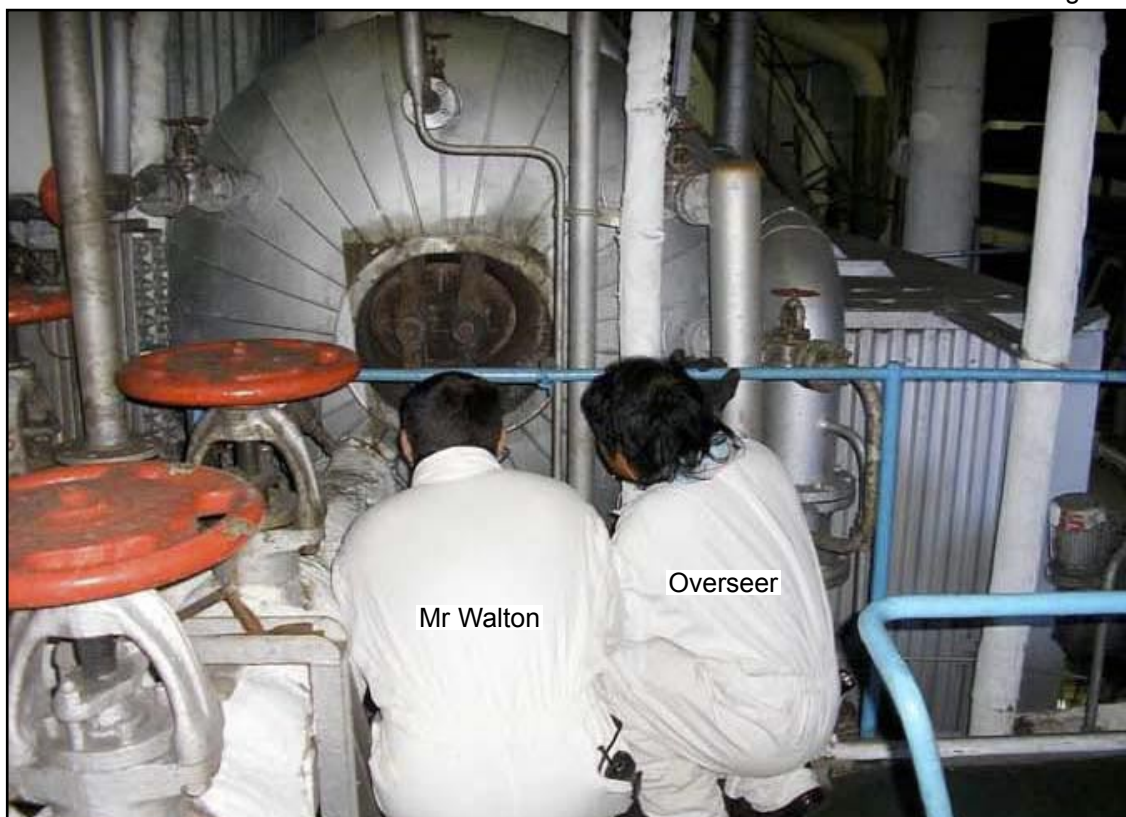
Figure 9

At 2200 Mr Walton and the overseer approached the opened steam drum. The overseer was surprised that the boiler room ventilation fans were not running and there appeared to be no method of forced ventilation to purge the steam drum of gases. However, he did not say anything to Mr Walton about his concerns. Both men looked into the steam drum and noticed that the internal surface was clear of scale and corrosion products. Neither Mr Walton nor the overseer had any equipment with them to test for the presence of toxic or flammable gases in the steam drum.

Re-enactment of Mr Walton's and the overseer's positions in front of the starboard boiler steam drum immediately prior to the explosion

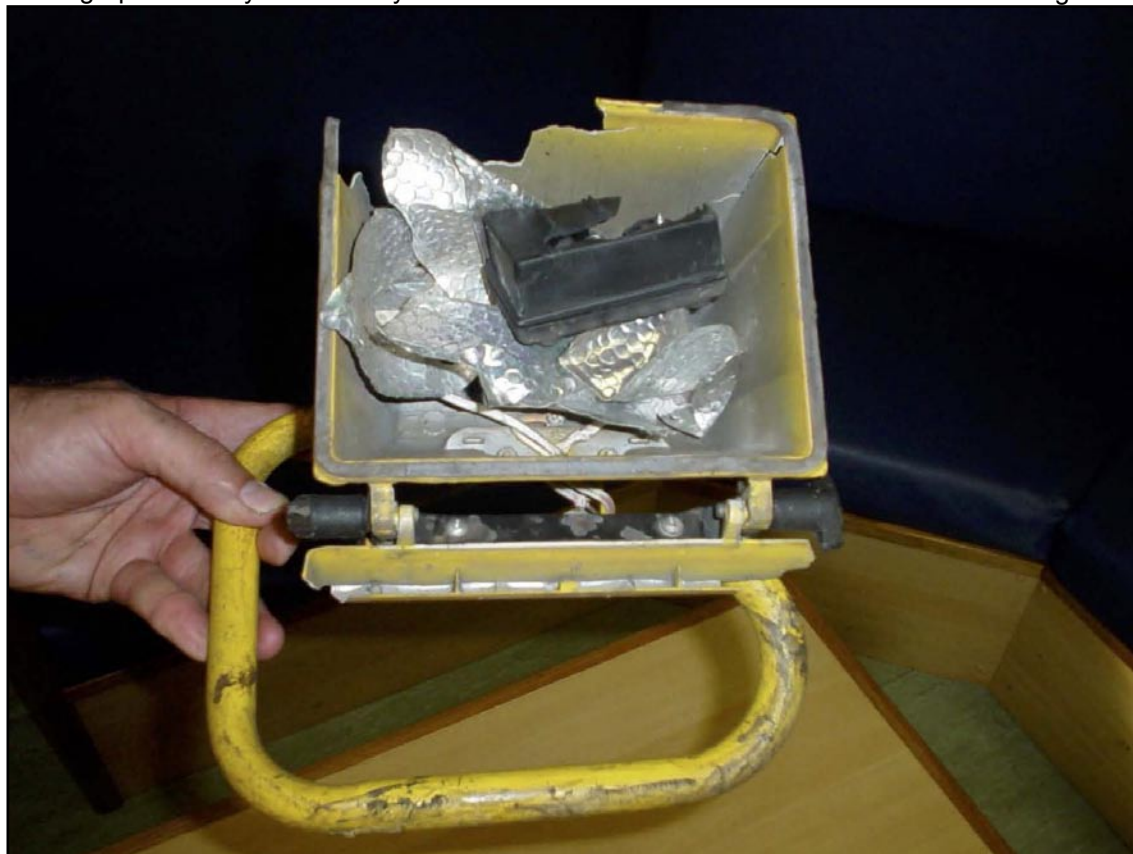
Figure 10

The Technical Superintendent noticed the now badly damaged halogen lamp and saw that its lens was missing (**Figure 10**). He also observed that the area was hot, and there was a slight haze, but there were no obvious, unusual smells. With the exception of a very small paper fire, and barely noticeable scorching of a small area of paintwork, there was no other evidence of explosion or fire.

Damaged halogen lamp

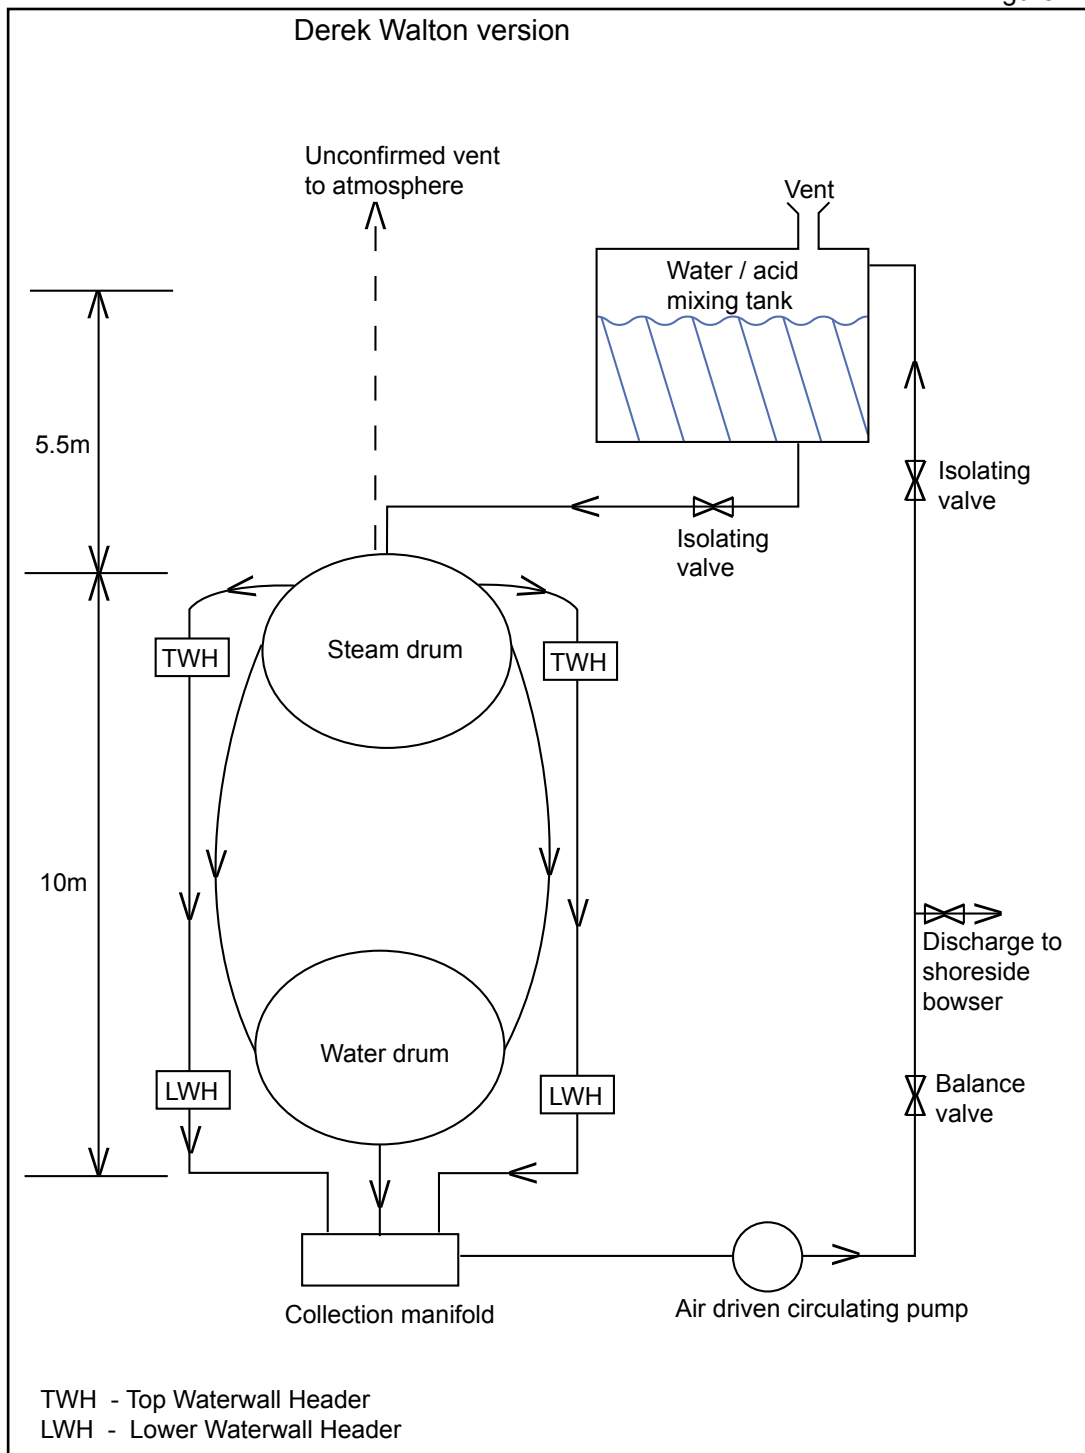
Figure 11

Schematic of the boiler cleaning water/acid circulation

A water/acid mixing tank, with a non-gastight top, was situated at the after, starboard side of the main deck approximately 5.5m above the top of the steam drum. A plastic hose connected the mixing tank to the steam drum via one of the removed safety valve flanges (**Figures 6, 11 and 12**).

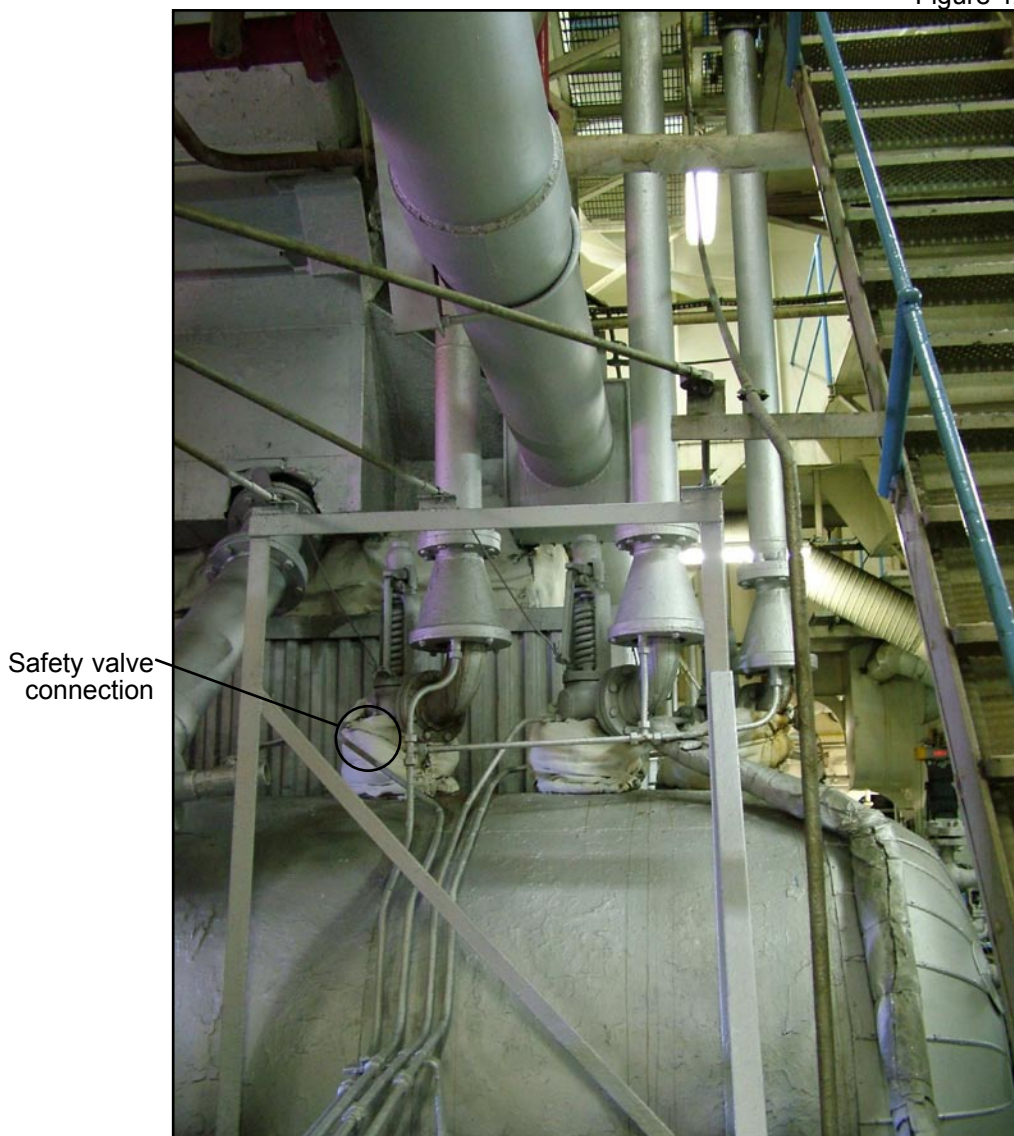
Figure 12

Starboard boiler steam drum safety valve – position of water/acid connection

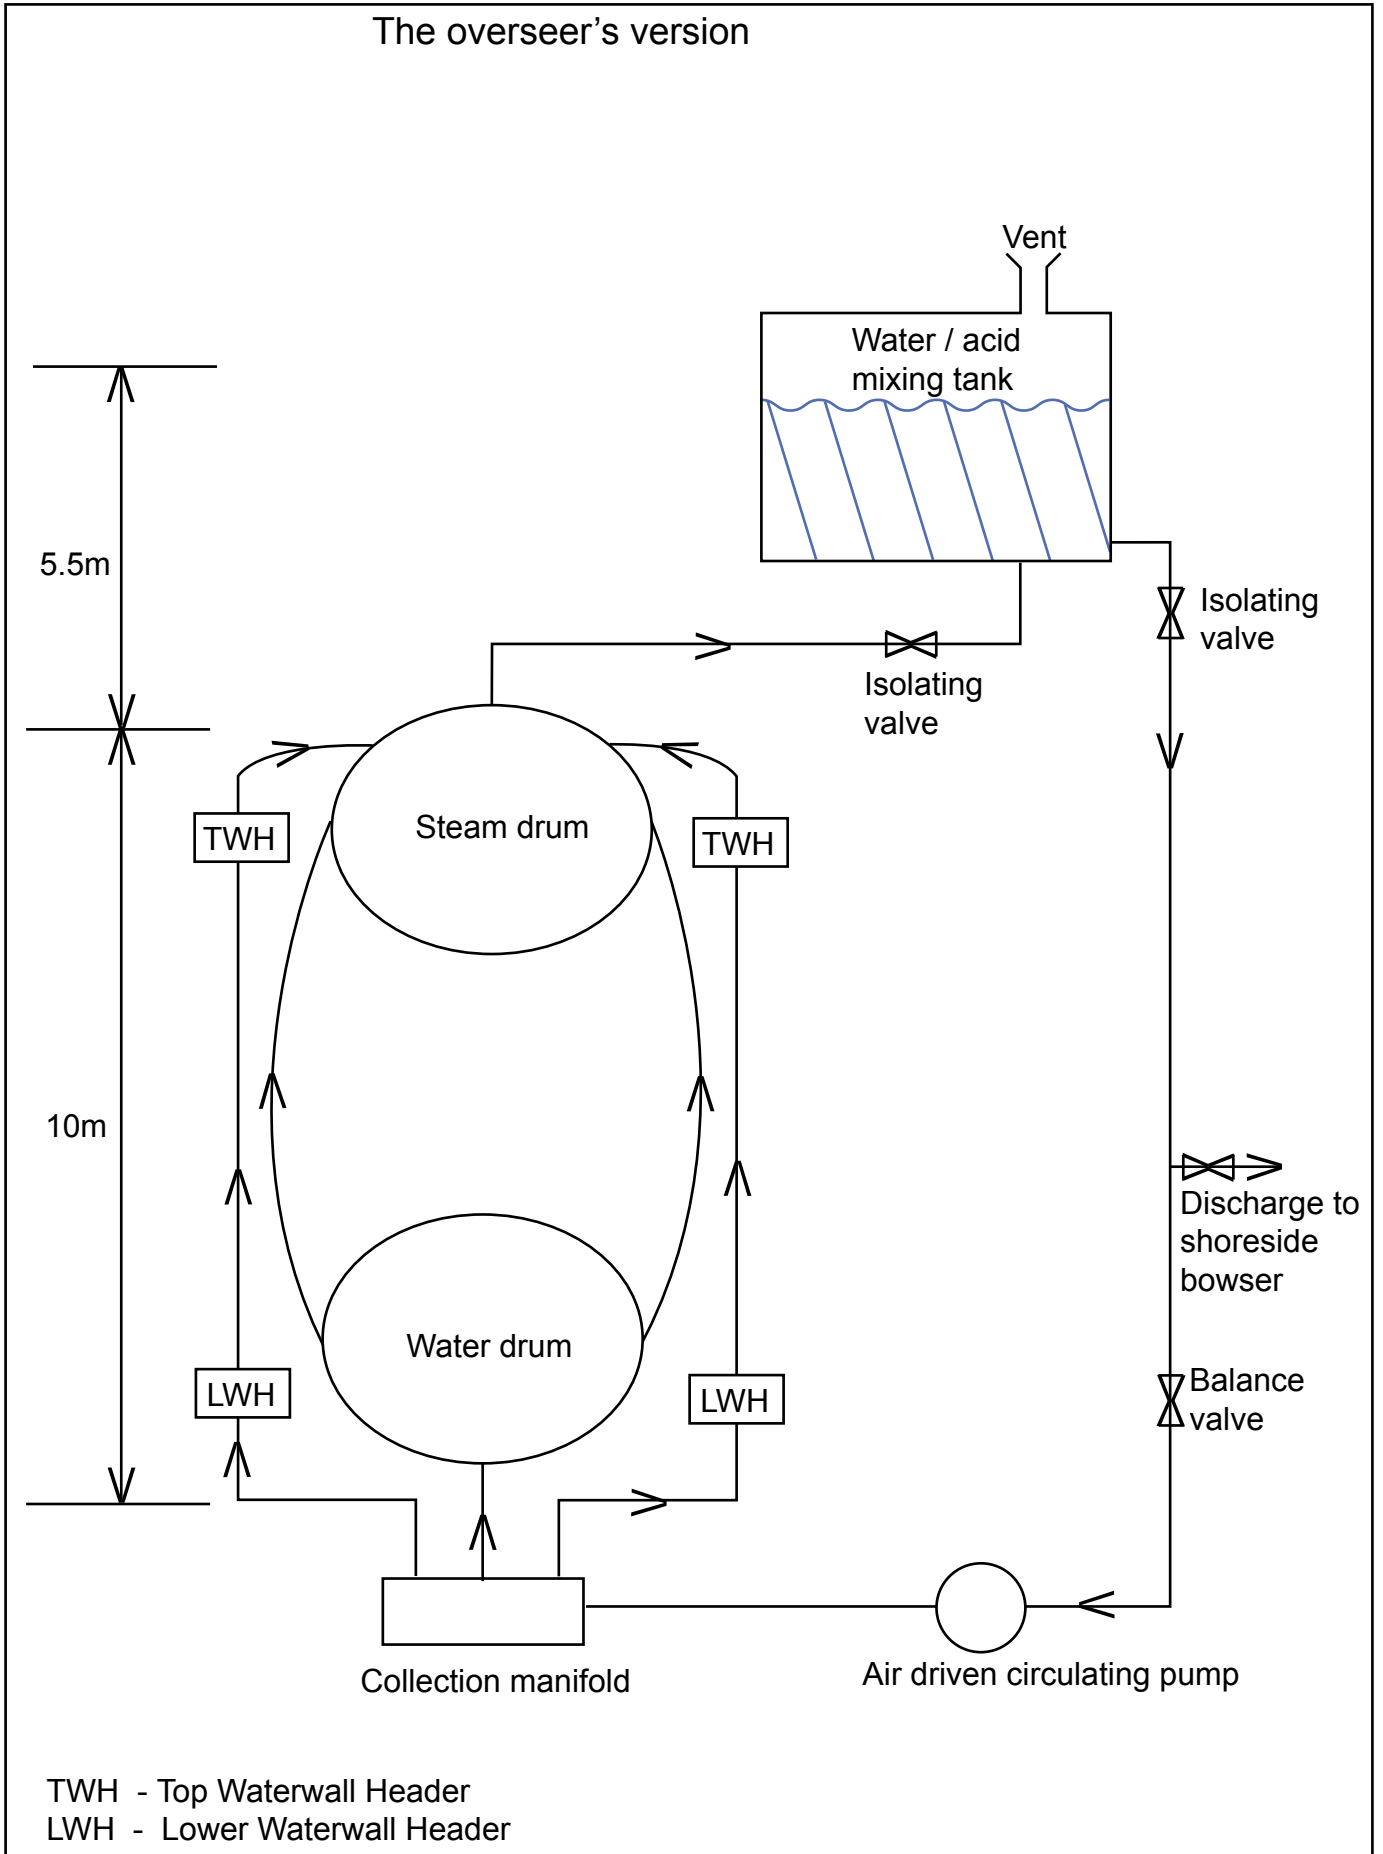
There are only two probable connections that would have been made to ventilate the boiler. The first would have entailed connecting a flexible hose to the second safety valve's 100mm bore flange (**Figure 12**) on the steam drum, and leading it to a position on the upper deck. This is considered unlikely. Most of those interviewed could remember only one hose fitted to the safety valves, and this would have been the gravity feed hose from the water/acid mixing tank.

Schematic of the overseer's interpretation of the boiler cleaning water/acid circulation

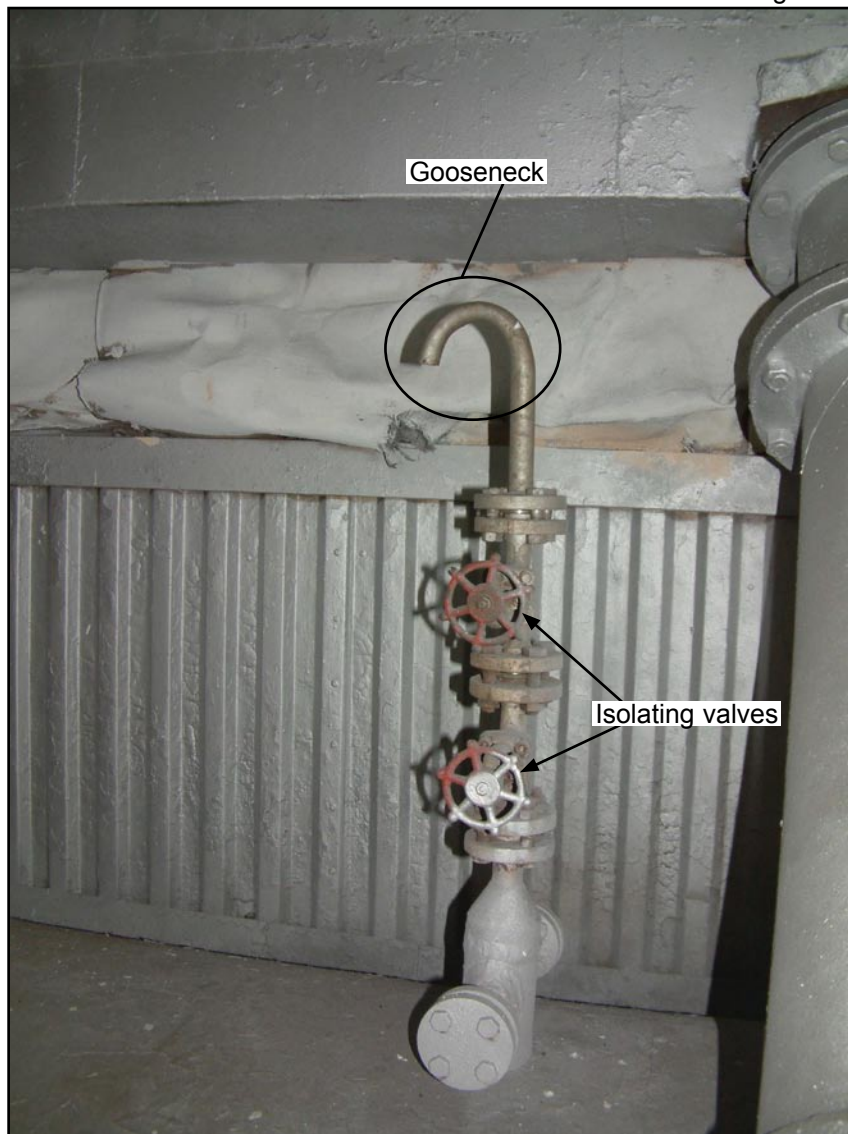
The only other likely option would have been to connect a small bore hose to the steam drum air release cock arrangement (**Figure 16**). This could have been fitted either to the goose neck, or directly to one of the flanges if the goose neck had been removed. In each case, the hose would have been led vertically, and secured, to allow the gases to escape to atmosphere.

Starboard boiler – steam drum air cock arrangement

Had a hose been connected, there are a number of reasons why this might have been ineffective: the internal bore of the air release pipework was small, at 20mm; it was possible that it was of insufficient bore, even if unobstructed, to carry away the volume of gases being generated; it might have been that Mr Walton simply overlooked opening one or both of the valves; it was possible that the hose collapsed because of poor securing arrangements, causing the hose to “crimp” and create a blockage that prevented ventilation; and finally, a door might have been closed on the hose, or another object inadvertently placed on it, causing a restriction.
