Report on the investigation of  
the loss of a passenger overboard from

***Hurlingham***

at Westminster Pier, on the River Thames

**Report No 12/2009**  
**June 2009**

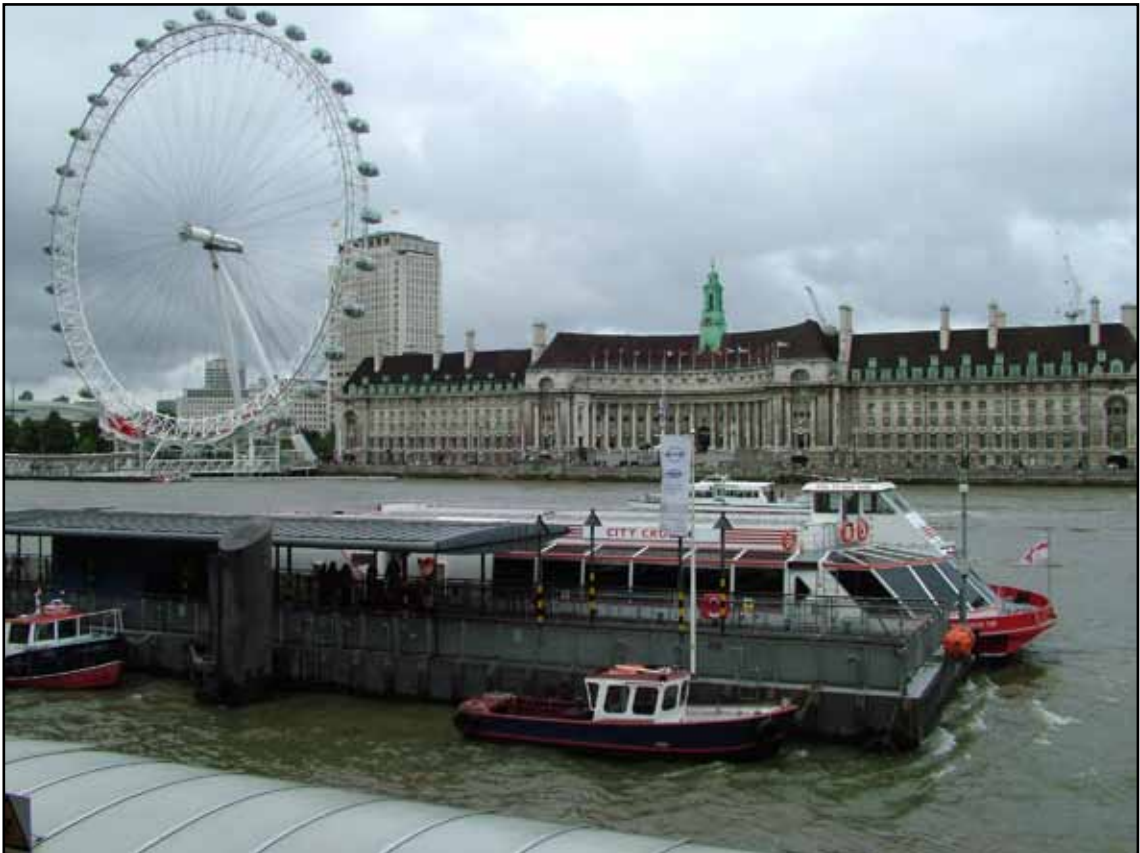
Figure 3

*Hurlingham* returned to Westminster Pier and the skipper began his own search around the inboard parts of the pier (**Figure 3**). He met up with the ILB crew, who confirmed that they had not been able to find the missing passenger on either side of the pier.

Westminster Pier viewed from the river bank

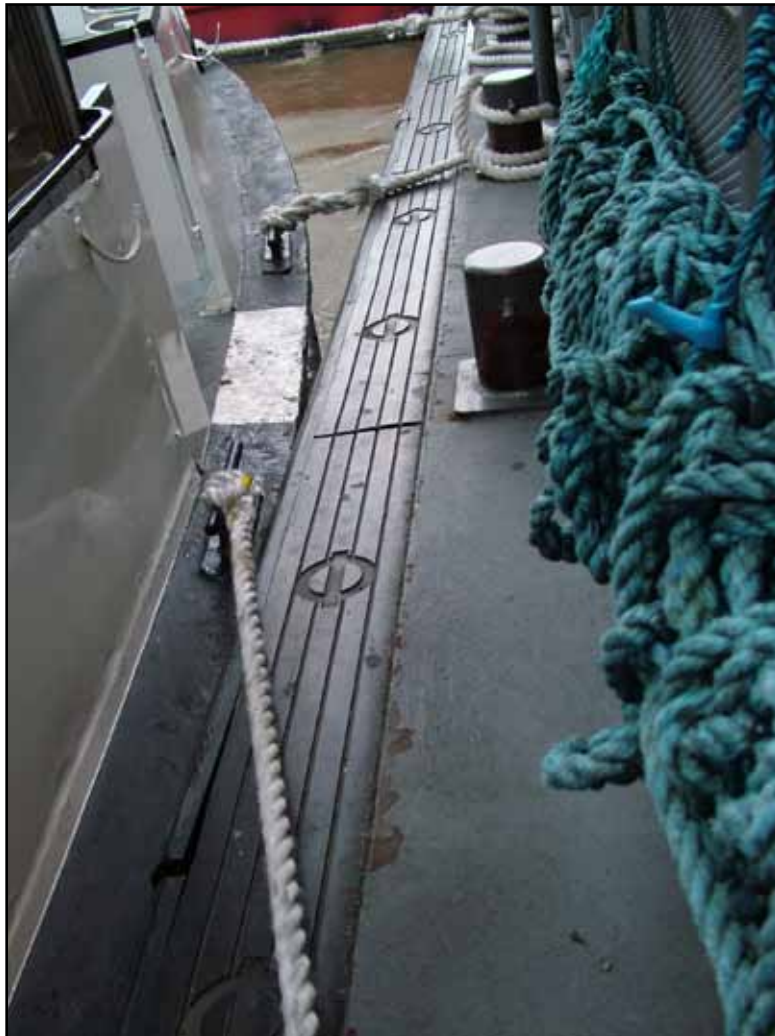
Figure 4

During the investigation, *Hurlingham* was brought alongside Westminster Pier to examine passenger access (**Figure 4**). It was found that by bringing the boat into the pier at a shallow angle, the deck edge at the forward boarding gate could be brought up against the pier, without leaving a gap. *Hurlingham's* deck was lower than the pier, requiring passengers to step up a distance of between 17 and 23cm depending on the number of people on board.

Possible means of access from *Hurlingham* to Westminster Pier

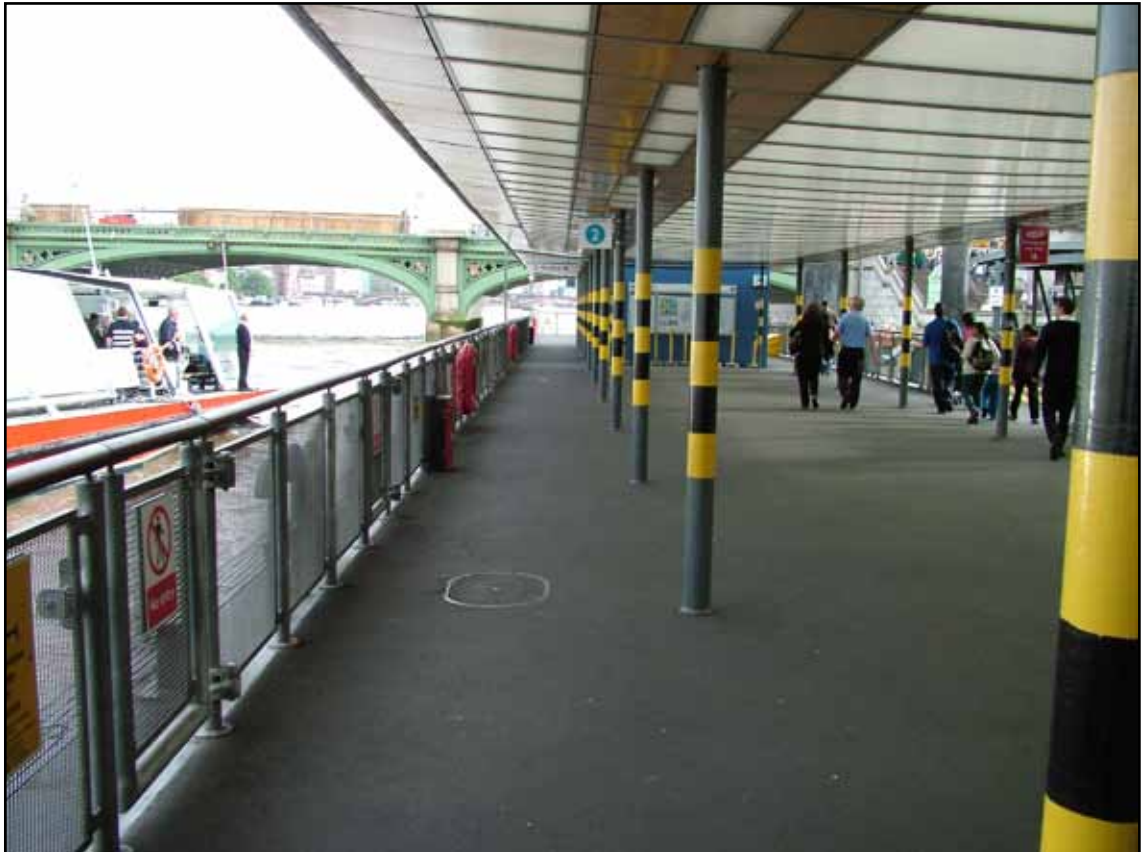
The fore deck disembarkation area was lit by background light from the accommodation of *Hurlingham* and from overhead lights on Westminster Pier. The combination provided general lighting but, on the evening of the accident, the immediate area of the gates on the boat and pier would have been in shadow (**Figure 5**). The deck edge of *Hurlingham* was painted white, and the fender material at the edge of the pier was black.

General arrangements on Westminster Pier

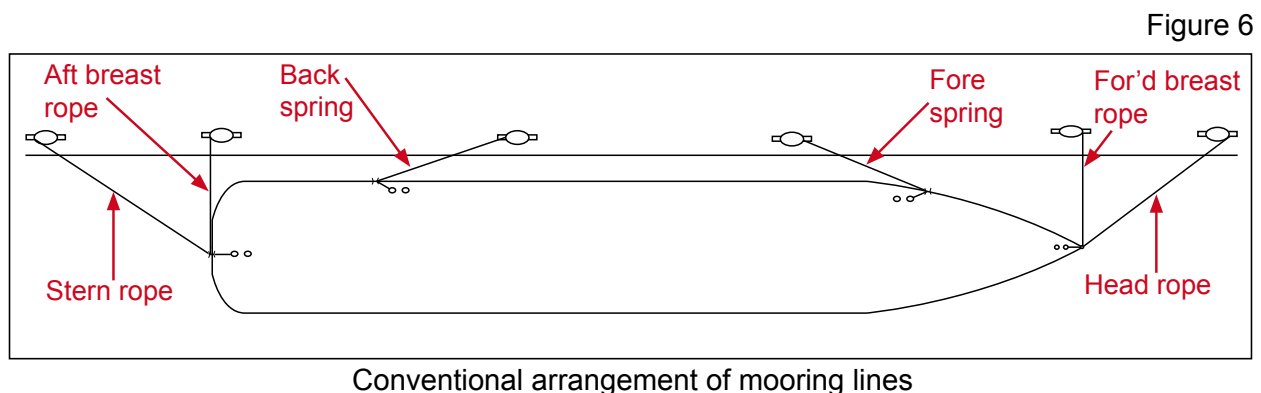
Any vessel alongside a pier will move in a combination of four principal ways: surging forwards and backwards along its longitudinal length, laterally sideways, yawing about a vertical axis and lastly, pitching and rolling with the motion of waves or wash from other vessels. Conventional mooring practice uses several ropes (**Figure 6**) to resist the longitudinal, sideways and yawing movement.

These ropes can, to some extent, also limit vertical motion from waves and wake. Equally, as the vessel is restrained by ropes leading in different directions it can only move a limited amount, and there is generally no need to use engine power to keep it in position.
