Report on the investigation

into the loss of the tug

Ijsselstroom

in the port of Peterhead

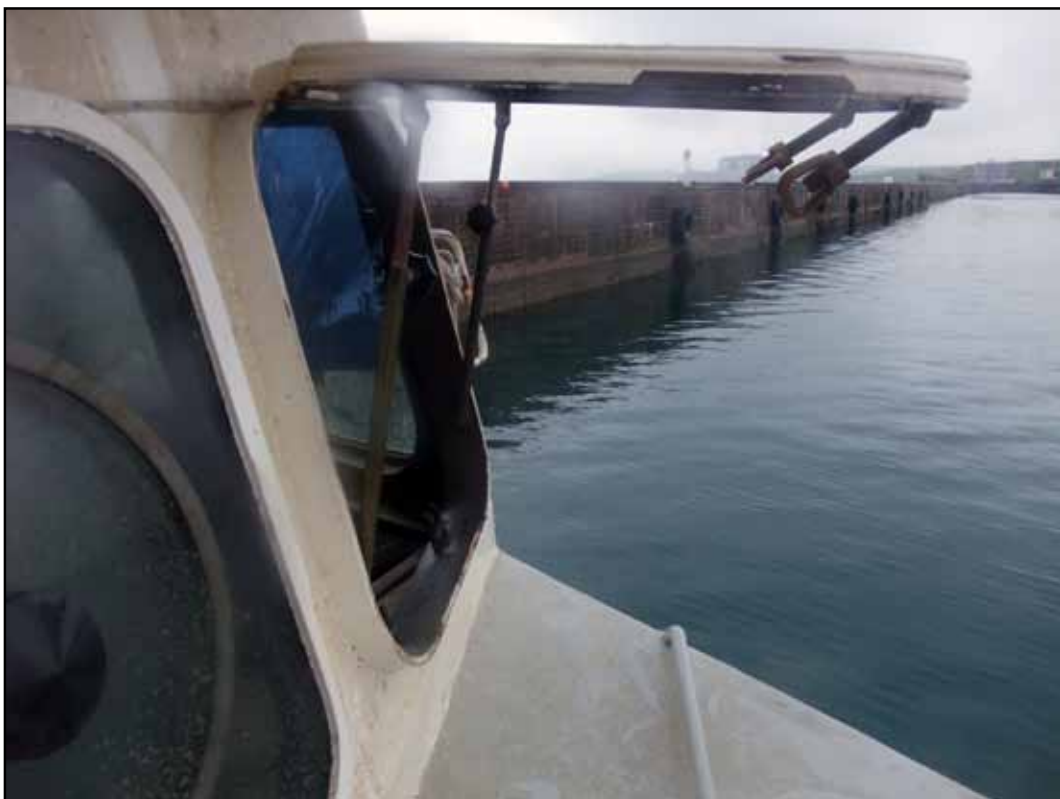
Figure 8

Ijsselstroom's skipper was in the wheelhouse, and as the tug sank by the stern he was unable to exit through the aft door. However, he was able to climb through the port forward window of the wheelhouse (**Figure 8**). Having recovered the two men in the water, the pilot boat made its way to *Ijsselstroom*, which by then was lying vertically in the water with her stern fully submerged and her bow pointing up (**Figure 9**). The skipper was found standing on the now horizontal wheelhouse front, and he was able to step off into the waiting boat. He was not wearing a lifejacket.

Wheelhouse window through which the skipper escaped

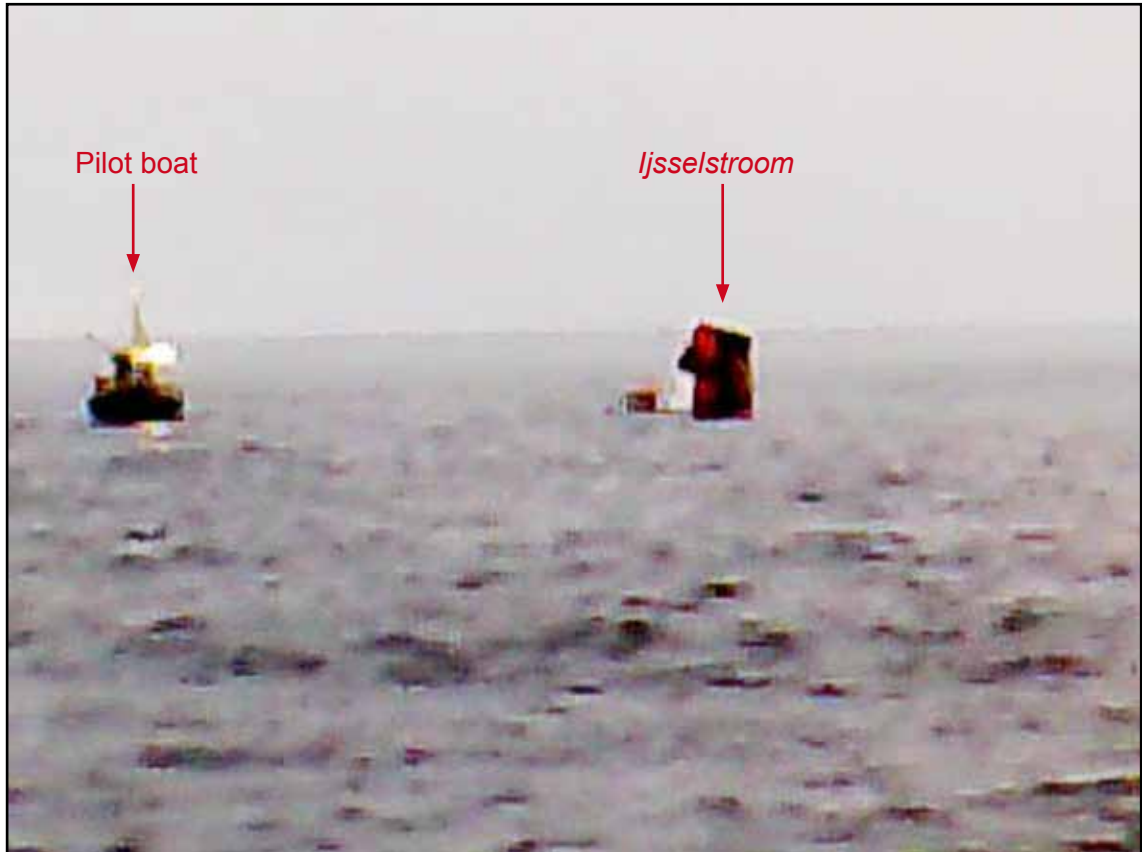
Still from eyewitness' mobile phone showing *Ijsselstroom* just prior to sinking

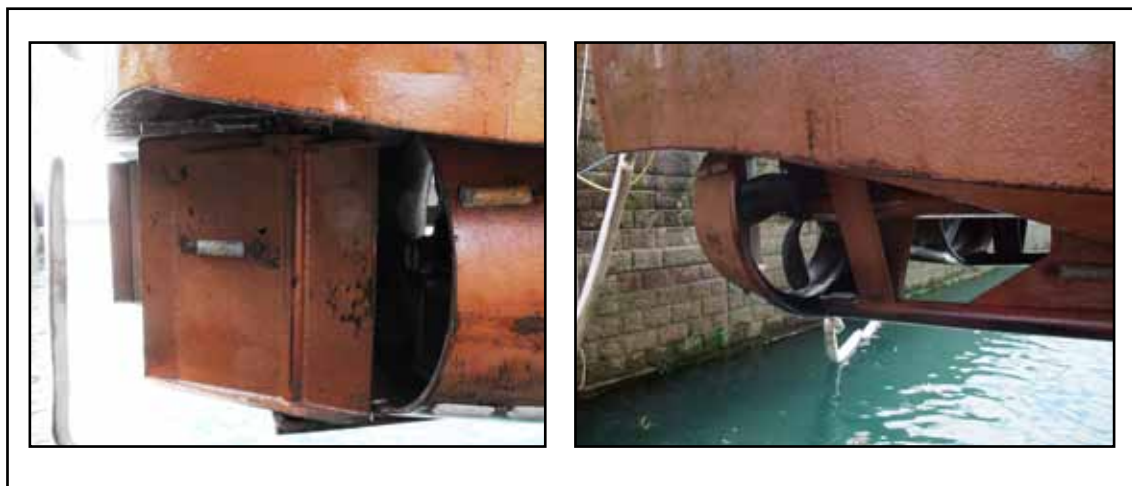
Figure 20

BMT noted that the large A-frames that supported the ducts, the braces for the propeller shafts, the hard chine edges of the hull and the unbalanced rudder, all created underwater obstructions towards the stern of the vessel (**Figure 20**). When moving astern, these obstructions could all have added to the destabilising moment, and the destabilising effect would increase as the speed astern increased.

Stern gear showing 'A' brackets, nozzles and rudders

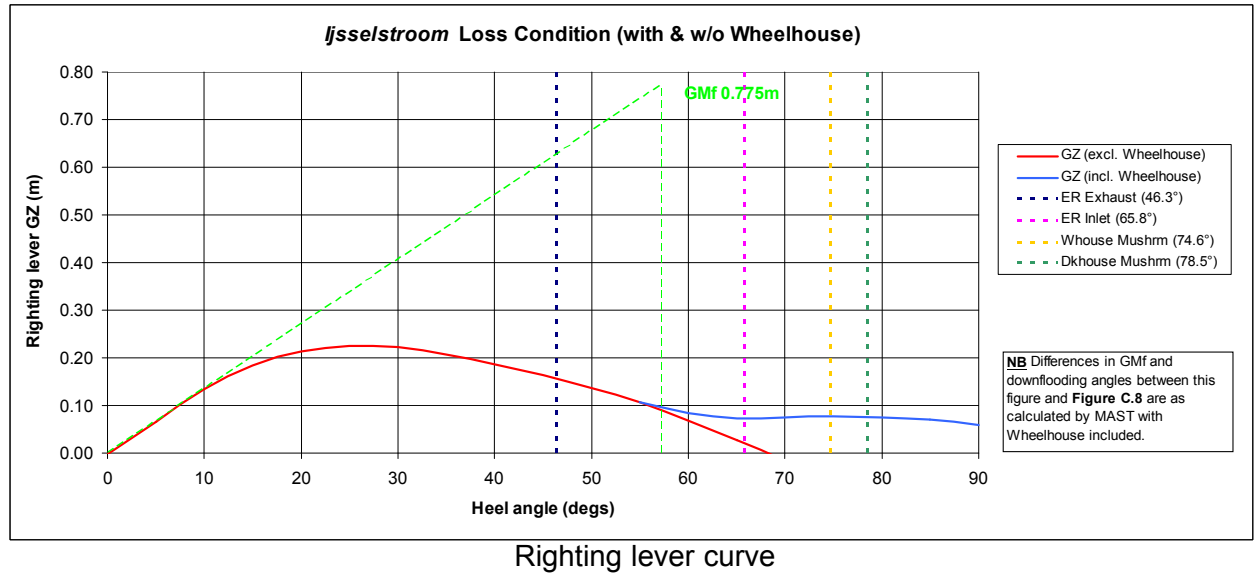
Ijsselstroom had a very low freeboard, and it was calculated that the aft working deck would have become immersed at an angle of only 7.6°. The first major downflooding point was the starboard engine room exhaust at 46.4°; the second was the inboard face of the starboard funnel at 65°; the third was the wheelhouse mushroom vents at 73.2°; and the fourth was the deckhouse mushroom vents at 75.7°. The angle of vanishing stability, that is the angle at which the vessel would capsize and not be able to right herself, was found to be 67.9°. However, at further angles of heel the volume of the deckhouse acted to provide a righting moment (**Figure 21**).
