Report on the investigation of the release of cargo vapours
resulting in two casualties on board the chemical tanker

Jo Eik

at the Vopak Terminal Teesport on

**Report No 24/2009
November 2009**

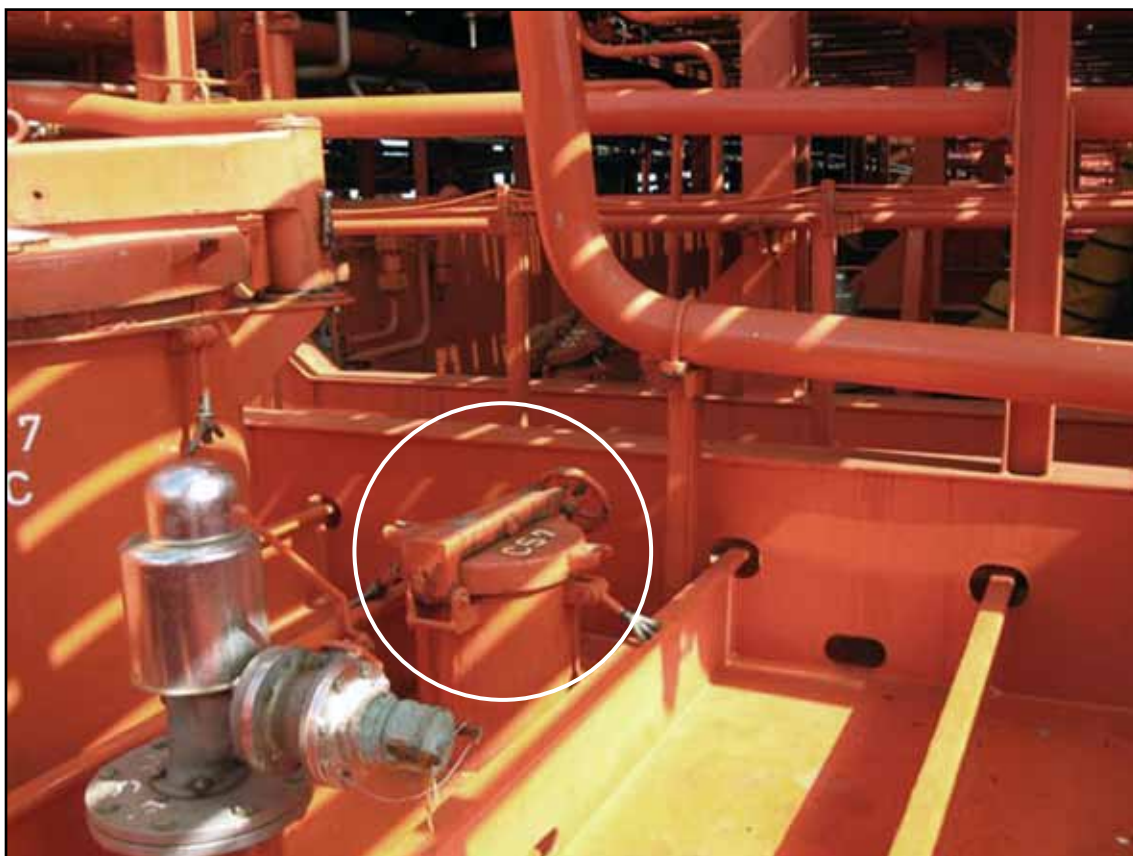
At 1500 the Intertek OCA surveyor and the Vopak loading master met with the chief officer. The surveyor was accompanied by an AB from *Jo Eik*, who opened up the Butterworth hatches of cargo tanks P6 and S6 for Sylfat cargo sampling. He then took samples of the CST from cargo tanks CS6, CS7 (**Figure 3**) and P10. During sampling the surveyor wore his full face respirator. The AB wore no respiratory protection.

Cargo tank CS7 Butterworth hatch

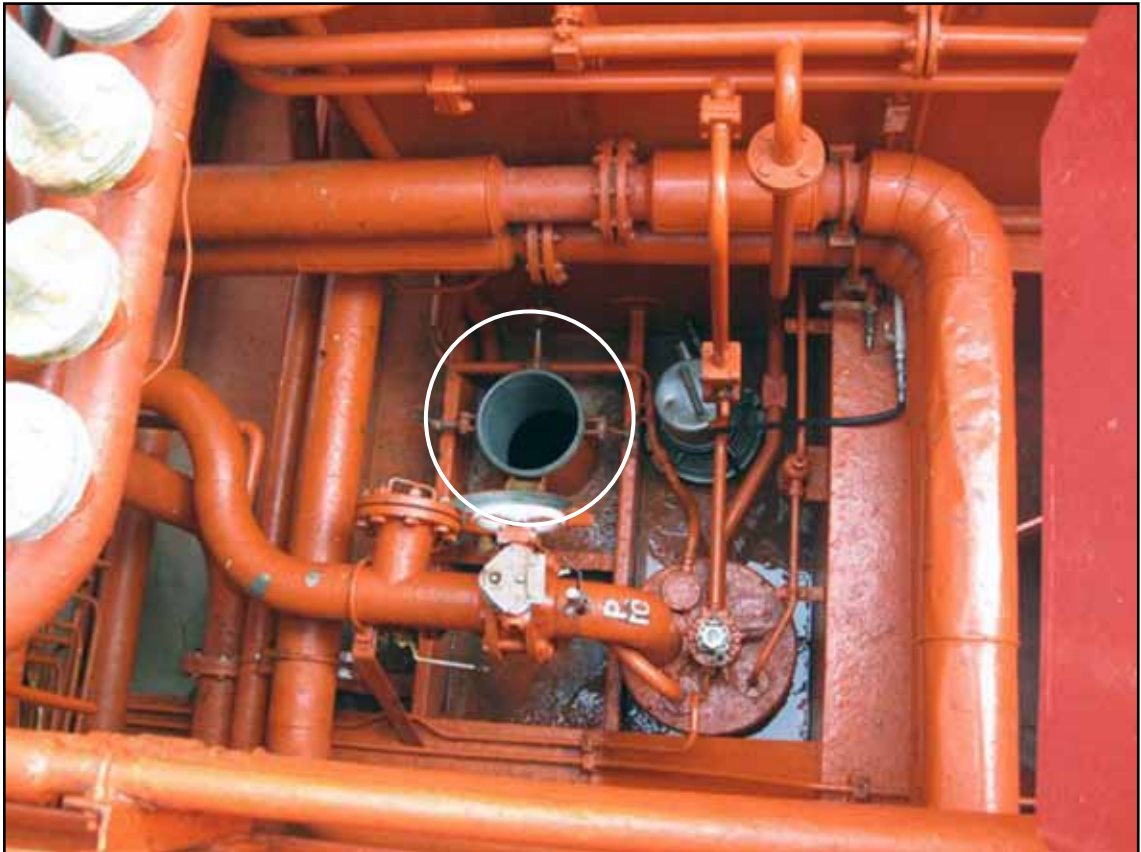
Figure 4

In the meantime, two portable washers were rigged with salt water supplies to clean P10 cargo tank through the tank's two Butterworth hatches¹. The hoses were passed through the hatches and the outboard hatch cover was then dropped onto the hose. The inboard hatch cover was left in the fully open position (**Figure 4**).

Cargo tank P10 open inboard Butterworth hatch

Throughout the washing procedure the inboard Butterworth hatch was left open with the portable washing equipment water supply hose passing through it. As the washer agitated the atmosphere in the tank, sufficient heavier than air cargo vapours were driven out of the open Butterworth hatch with the water mist to create a hazardous environment in the vicinity of the hatch.

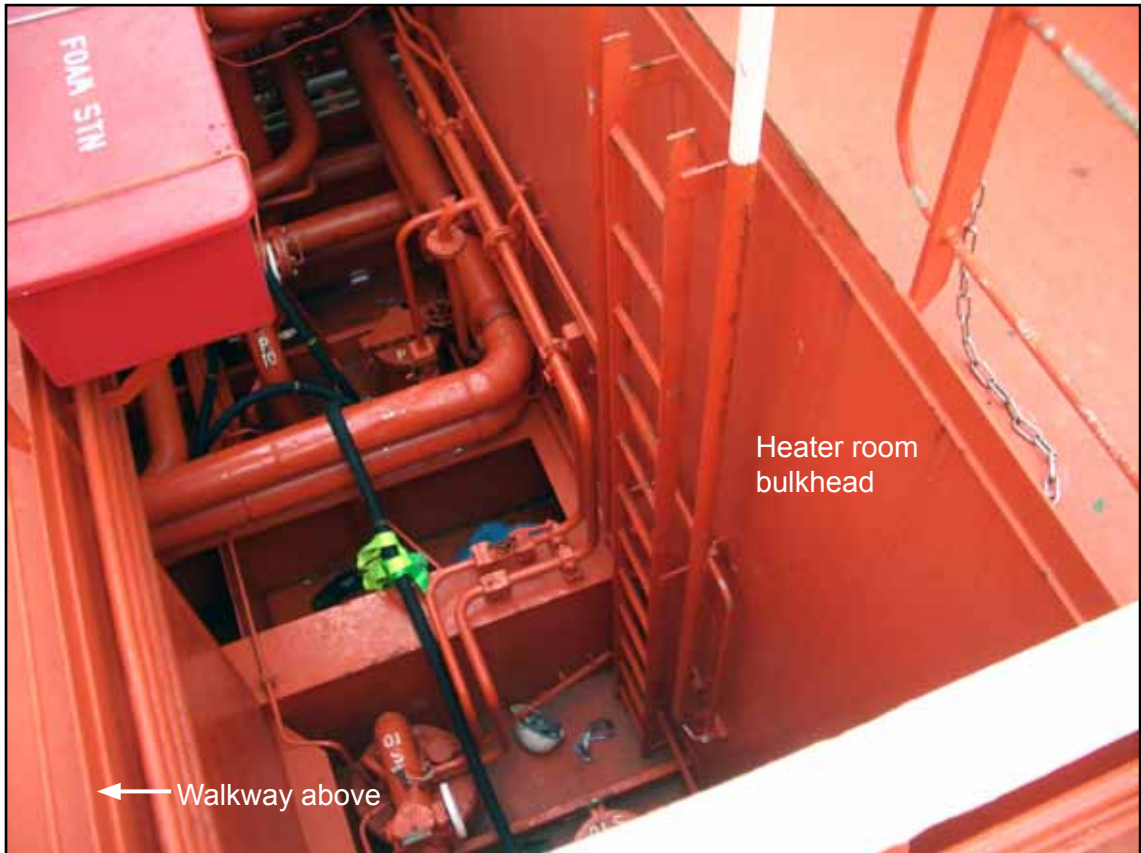
Figure 5

The on watch AB went up to the walkway immediately aft of P10 inboard Butterworth hatch (**Figure 5**) and noted that the pungent smell was stronger than he had previously noticed. A vertical plume of water mist came up from the Butterworth hatch and extended above his head height. To avoid getting wet he moved to the port side of the walkway.

Walkway aft of P10 inboard Butterworth hatch

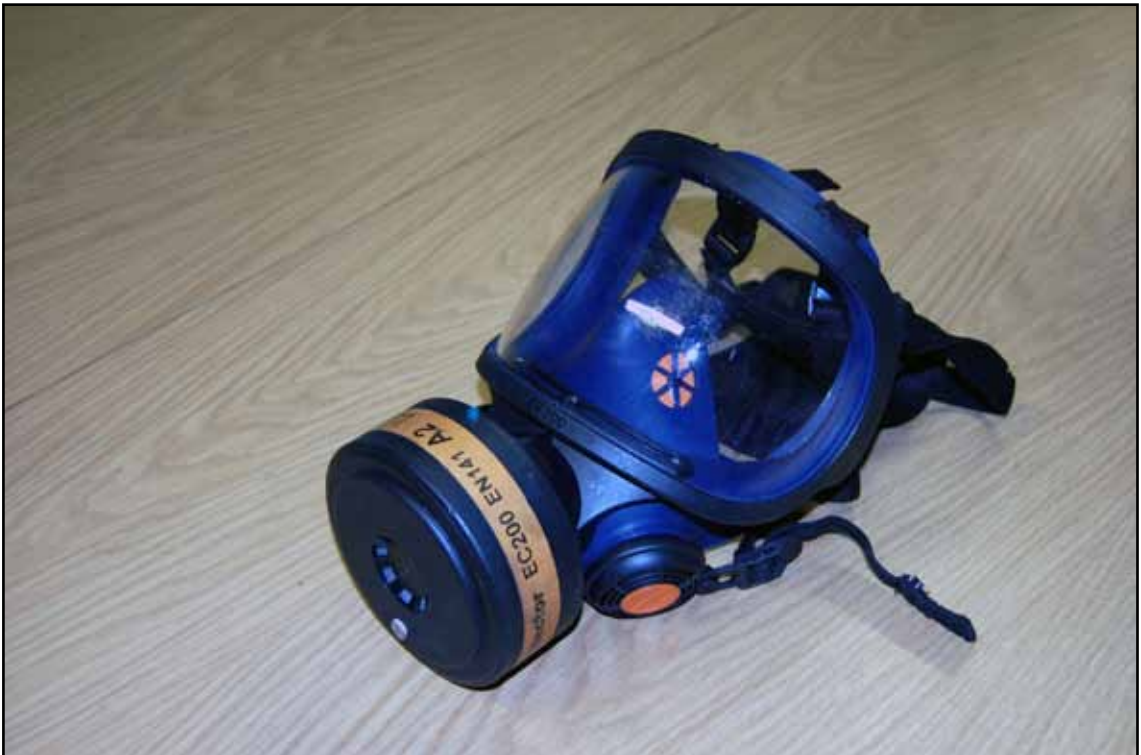
Figure 15

Intertek OCA surveyor's respirator fitted with an EN 141 A2 filter

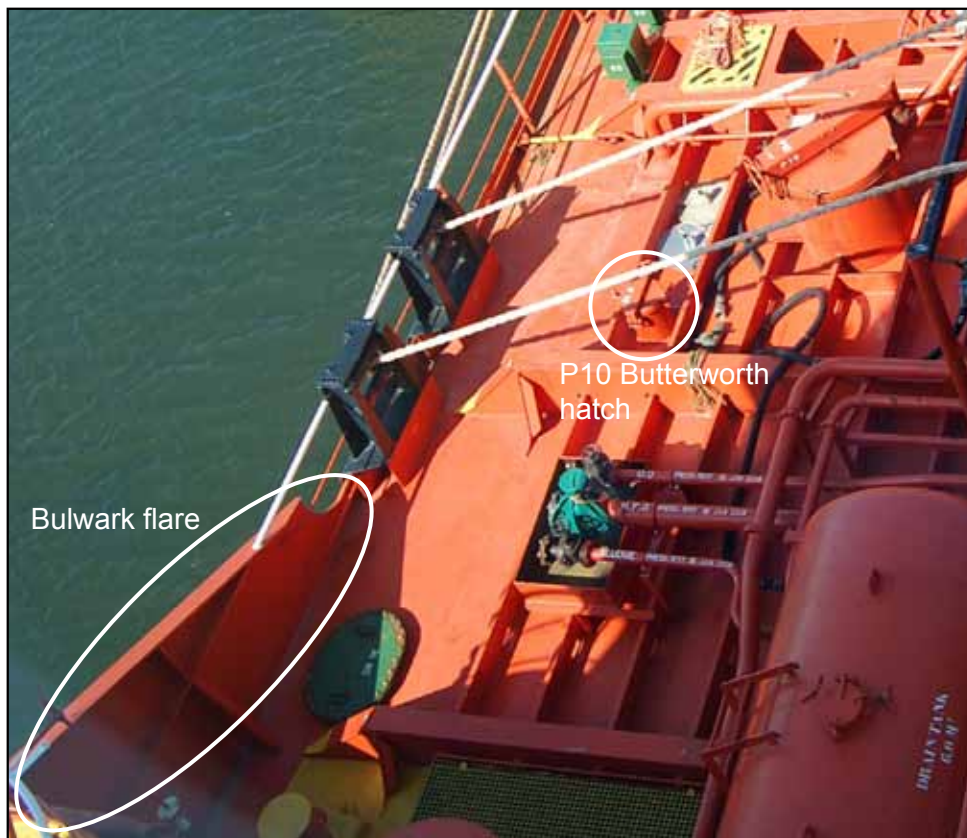
The outboard Butterworth hatch area was reasonably well exposed to airflows across deck, with the exception that it was partially shielded by the port bulwark flare adjacent to the ladder giving access to the upper deck from the main deck (**Figure 17**).

P10 outboard Butterworth hatch and port bulwark flare

It is reported that the outboard P10 Butterworth hatch cover had been dropped onto the washer hose, but the hatch cover could not possibly have formed a seal with the washer hose passing through the opening. However, unlike the inboard hatch, the area around the outboard hatch was more exposed to the environmental airflows and, therefore, the vapour would have dissipated more readily.

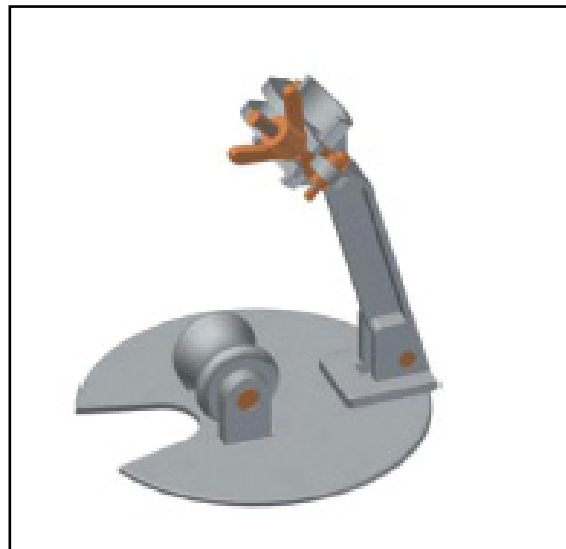
Figure 22

The inboard Butterworth hatch was left open, and as there was no hose guide or blank fitted to reduce the release of the cargo vapours, these eventually accumulated in the vicinity of P10 inboard Butterworth hatch. Portable hose saddle and guide systems are readily available to give the hose a good tank entry line and to reduce any vapour release (**Figure 22**).

Typical portable hose saddle and Butterworth hatch closing plate
