Report on the investigation of
the grounding of
HC Katia
while undergoing sea trials in the Solent
on
3 December 2003

Marine Accident Investigation Branch
First Floor
Carlton House
Carlton Place
Southampton
United Kingdom
SO15 2DZ

Report No 8/2004
July 2004

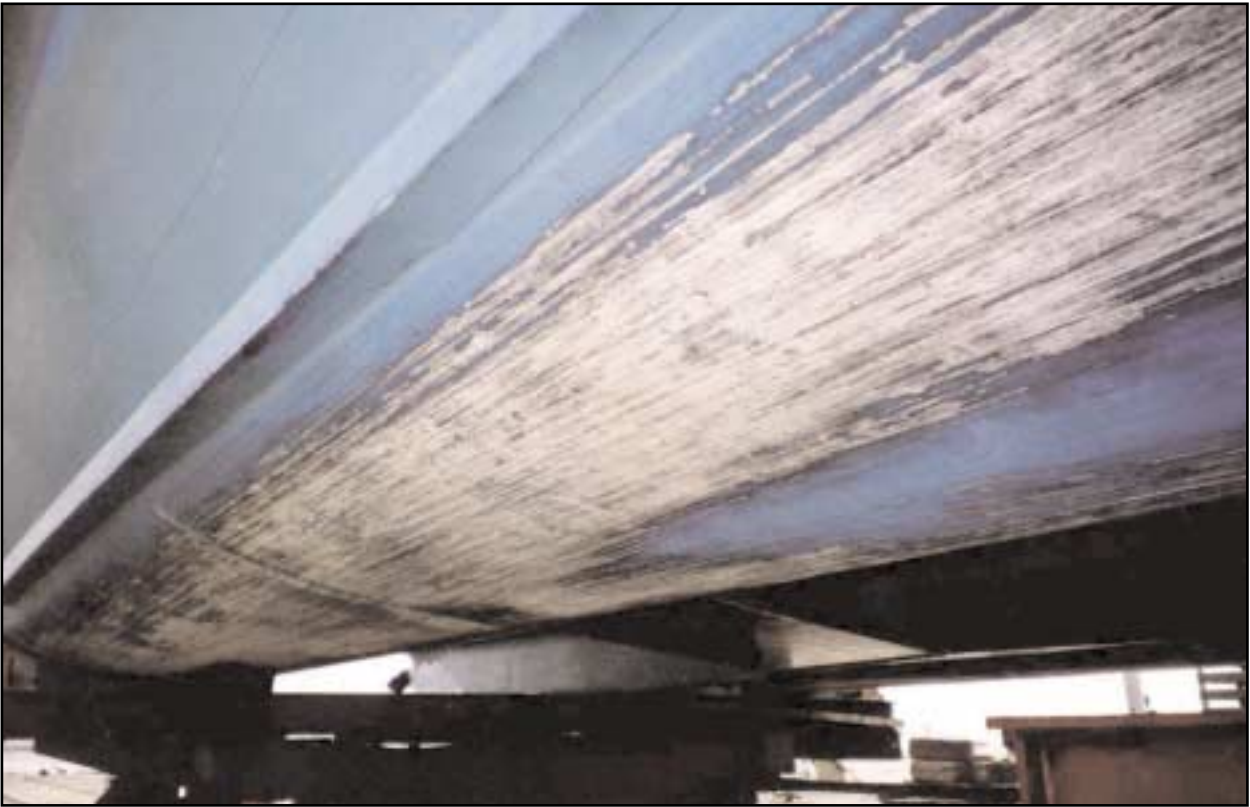
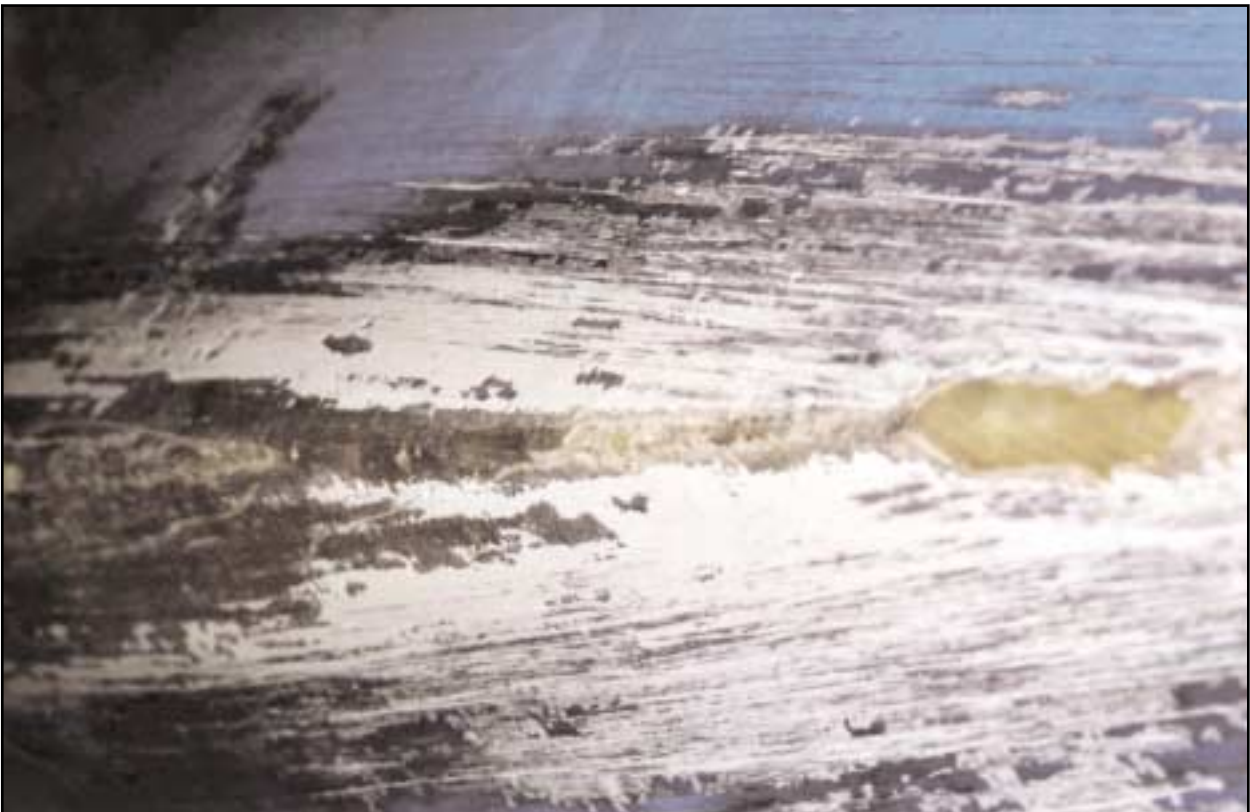
Figures 8 and 9 - Hull damage

Subsequently, the vessel was inspected out of the water. Both hulls were found to have suffered minor damage (**Figures 8 and 9**), and the water jet impellers were damaged by shingle and sand to the extent that two required replacing.

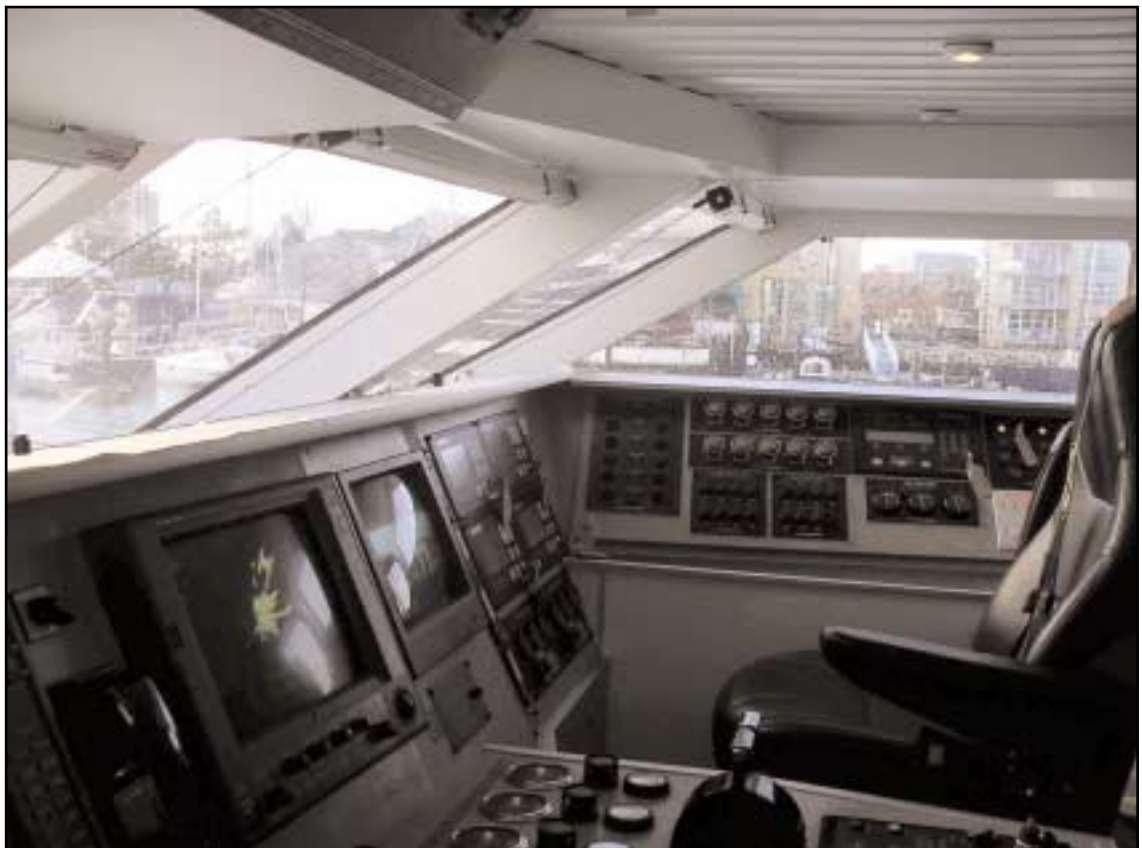
Figure 10

The builder fitted decorative mouldings around the large scantling stiffeners between the bridge front windows, to conceal wiring and pipework, which restricted the visibility from the pilot's control position.

Blind sectors shall be as few and as small as possible, and not adversely affect the keeping of a safe look-out from the operating station. If stiffeners between windows are to be covered, this shall not cause further obstruction inside the wheelhouse.

The total arc of blind sectors from right ahead to 22.5° abaft the beam on either side shall not exceed 20°. Each individual blind sector shall not exceed 5°. The clear sector between two blind sectors shall not be less than 10°.
