Report on the investigation of
the fire and subsequent sinking of

Lady Candida

off Corsica

Report No 4/2008
February 2008

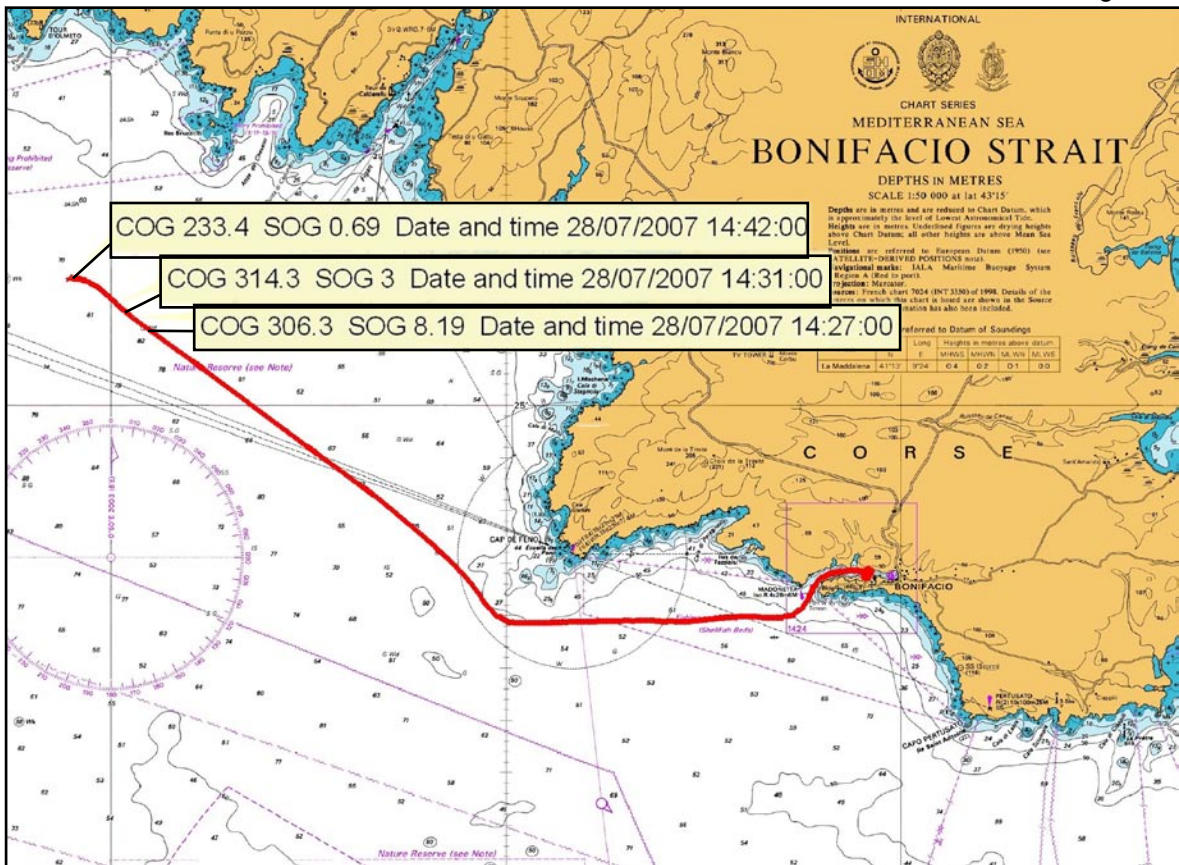
Figure 1

ECDIS extract taken from the captain's laptop computer

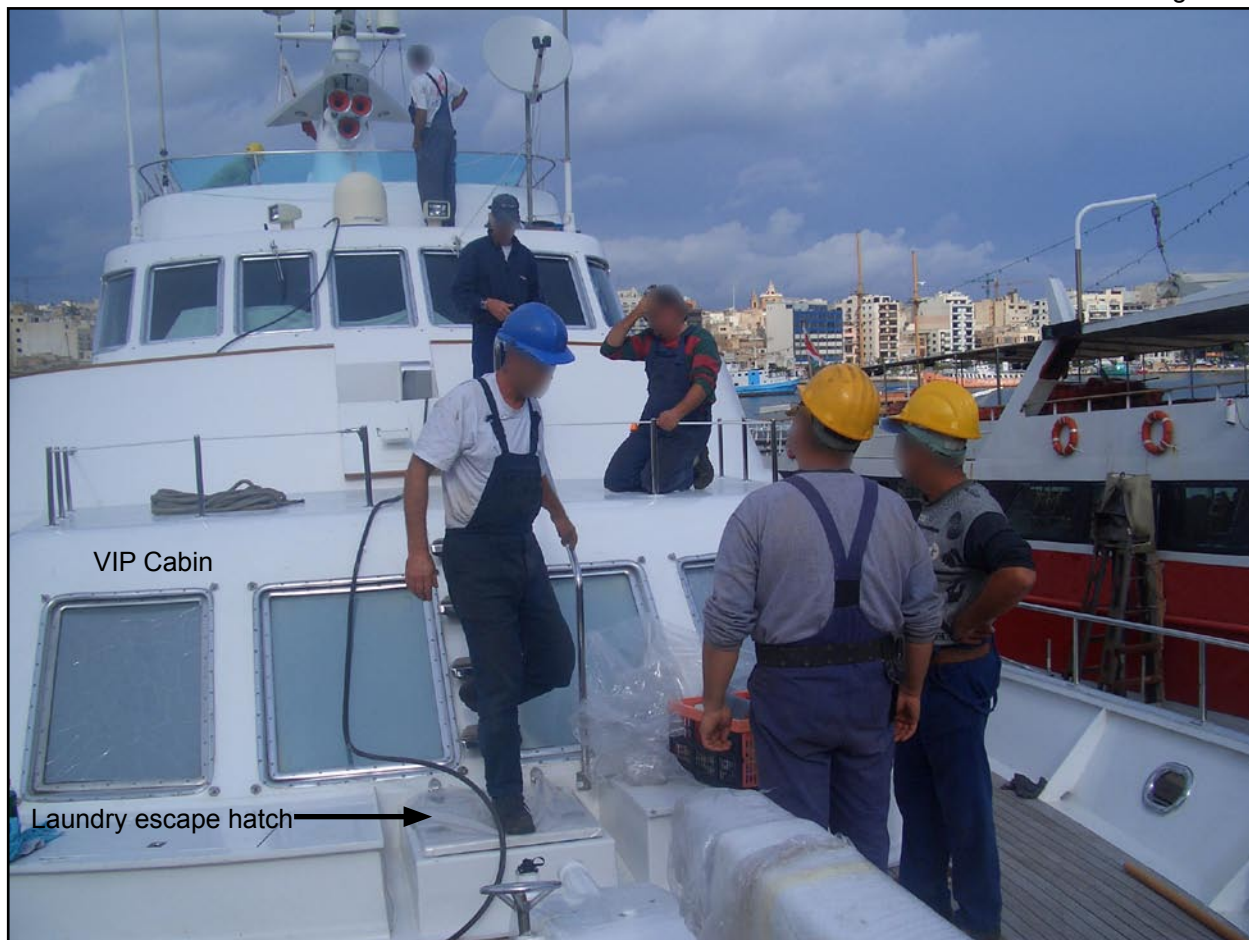
Foredeck, escape hatch and VIP cabin

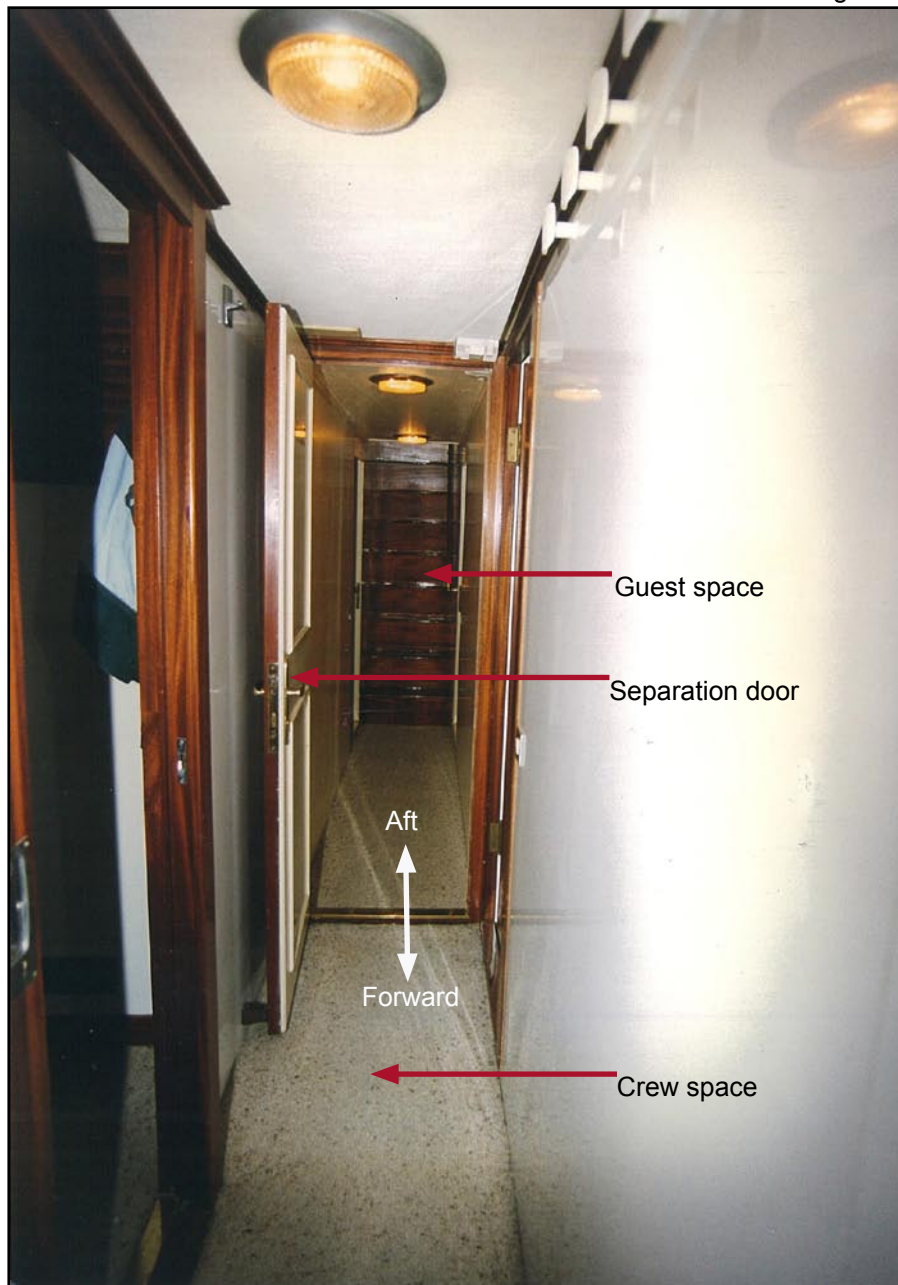
Figure 3

Internal alleyway

Internal access to the laundry was by an alleyway (**Figure 3**). At the forward end of the alleyway, a flight of three steps led to the laundry room and a crew cabin, which shared a common two-way door (**Figure 6**). The main control panels for the 110V DC windlass (**Figure 7**), which had a history of overheating, were sited behind the stairs.

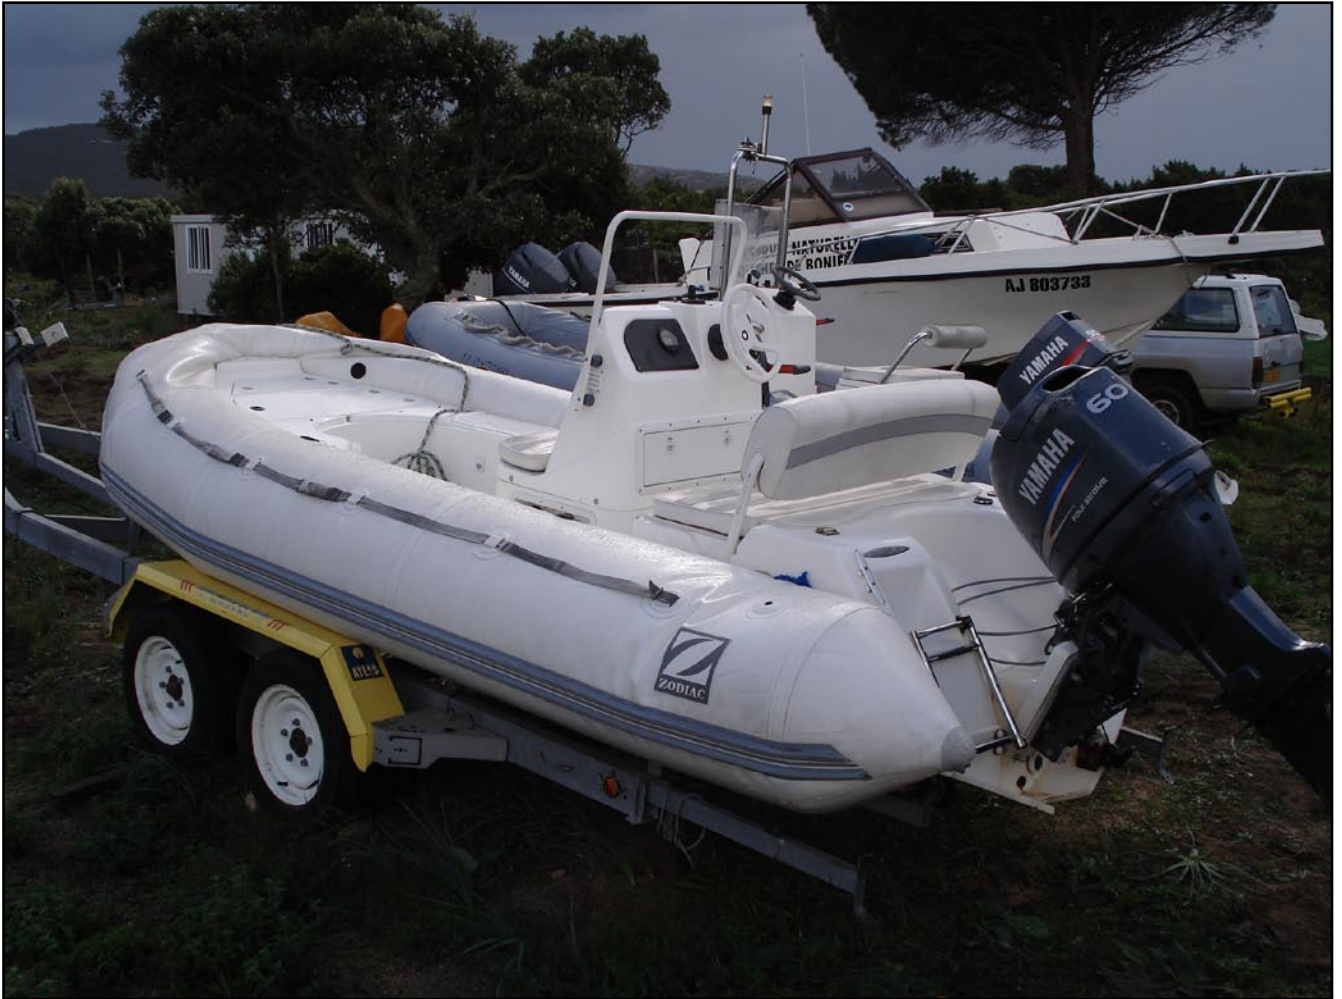
Figure 4

Zodiac tender model YL 480 DL

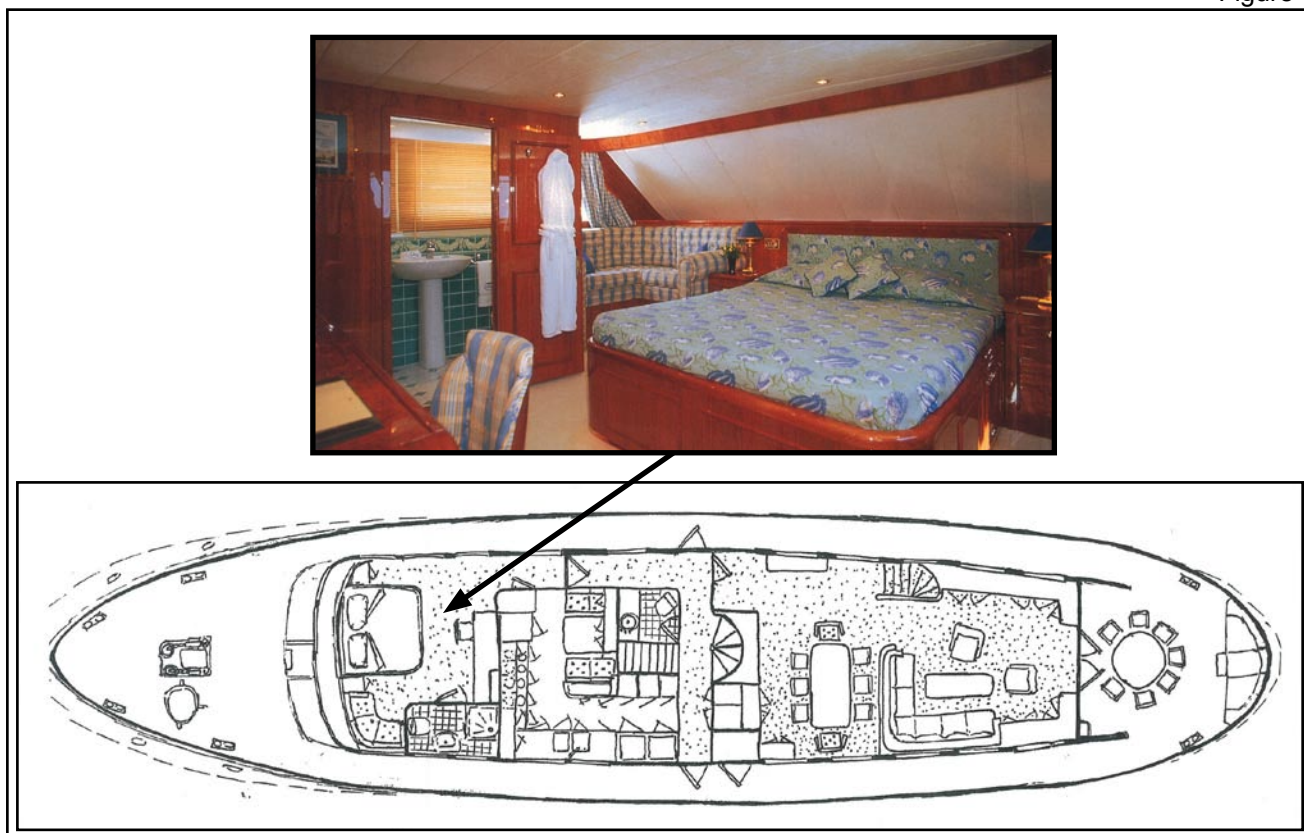
Figure 8

Above and aft of the laundry was the VIP cabin (**Figure 8**), which had been converted from a study. During the conversion, the stepped bulkhead below the cabin's front windows was cut away and a new sloping section, probably made from marine plywood, was inserted (**Figure 9**) to allow a bunk to be fitted as far forward as possible.

Position of VIP cabin

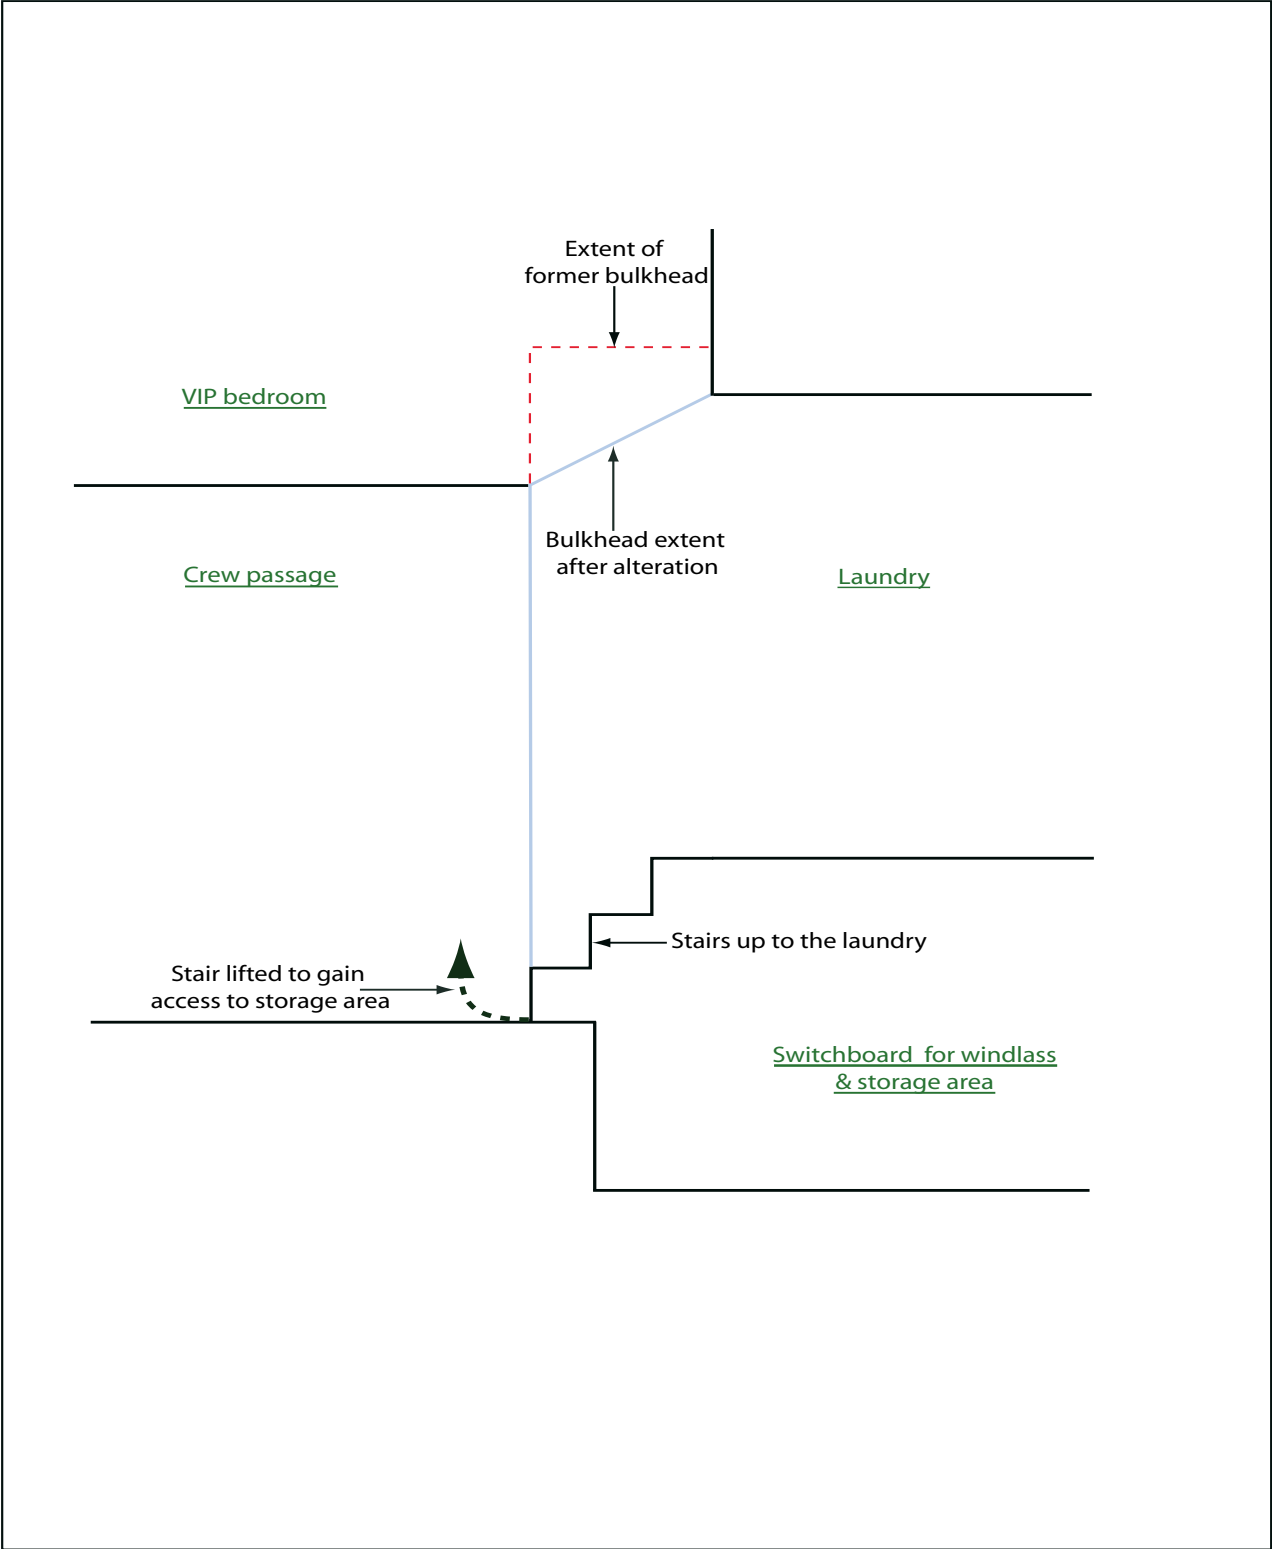
Figure 9

Internal bulkhead
