Report on the investigation into the foundering of the motor cruiser

Last Call

at Whitby

Report No 11/2008
June 2008

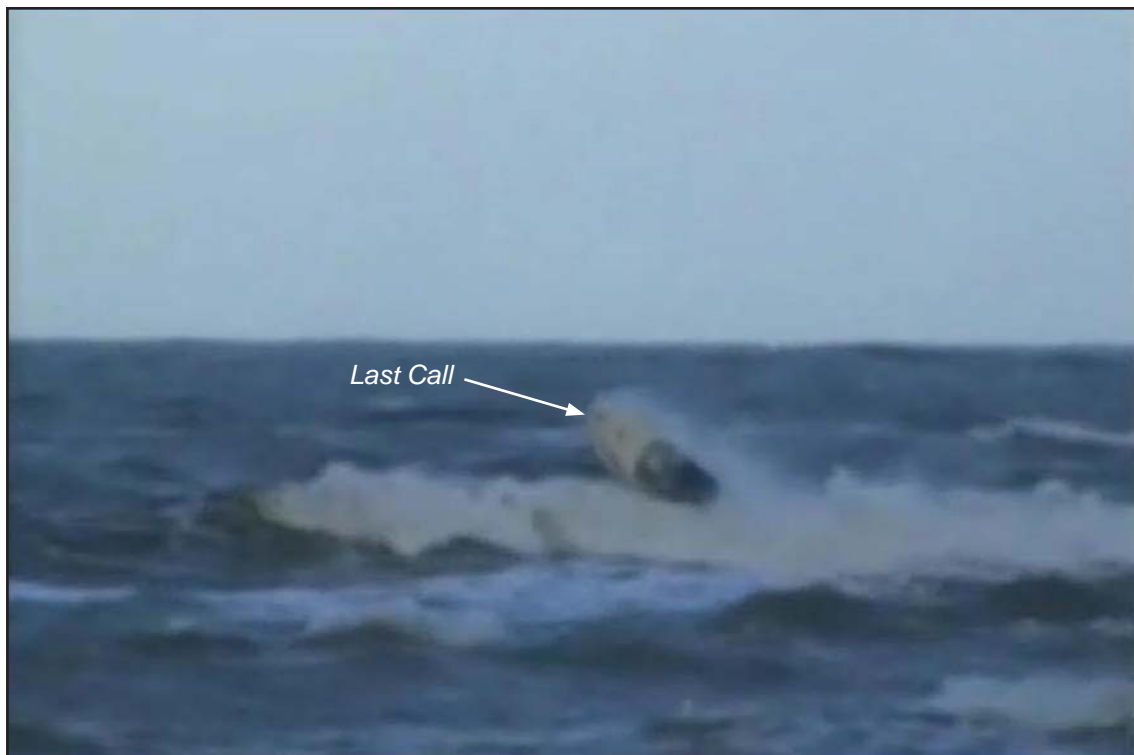
Figure 6

As *Last Call* approached the harbour entrance, it was set toward the east breakwater and encountered a steep breaking wave. The craft rose up almost vertically and one person was observed falling into the aft part of the cockpit. *Last Call* landed on its keel in a deep trough. It continued outbound, and rose up again vertically onto the crest of a second breaking wave, described by witnesses as higher than the boat itself. As the craft passed over the crest, control was lost, and it landed on its stern and took a sharp 270° turn to port (**Figure 6**). During the turn, two of the crew fell overboard, one wearing a lifejacket and one in dark clothing without. *Last Call's* engine then either stalled or the gear change engaged neutral, and the boat was swept by the wind and tide along the seaward side of the east breakwater extension (**Figure 7**).

Last Call as control was lost, turning 270° to port
(image captured from video)

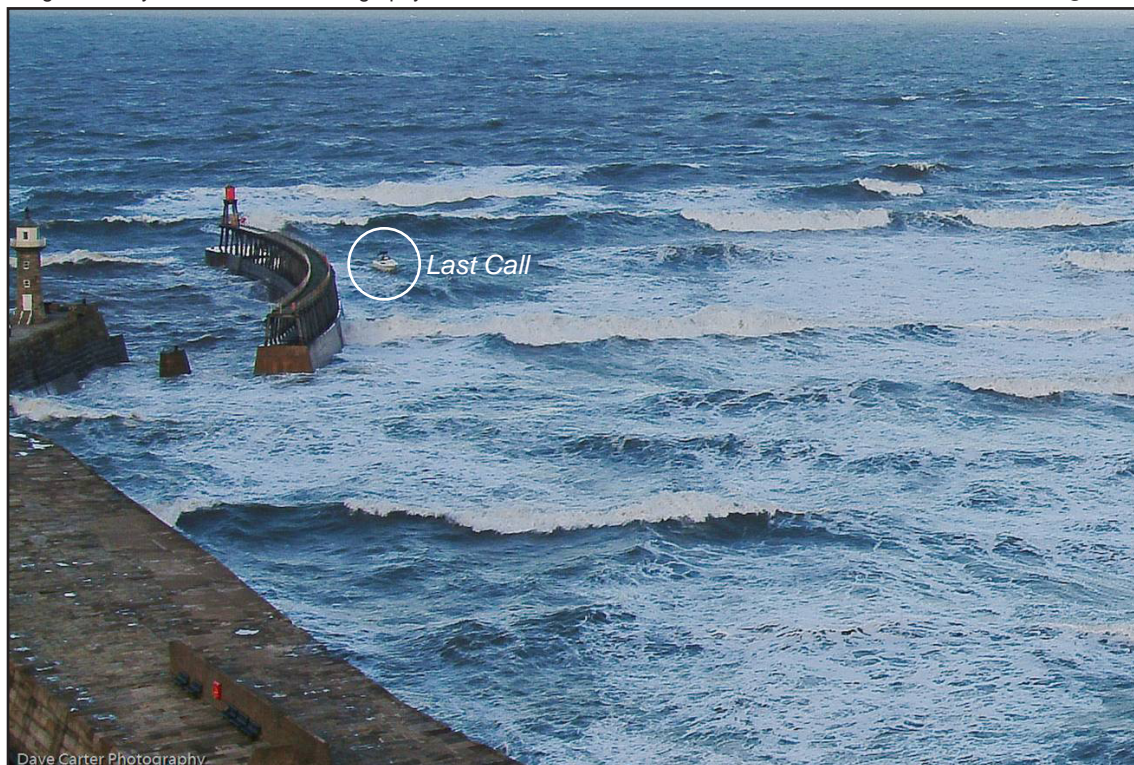
Figure 7

Last Call drifting along the east breakwater extension

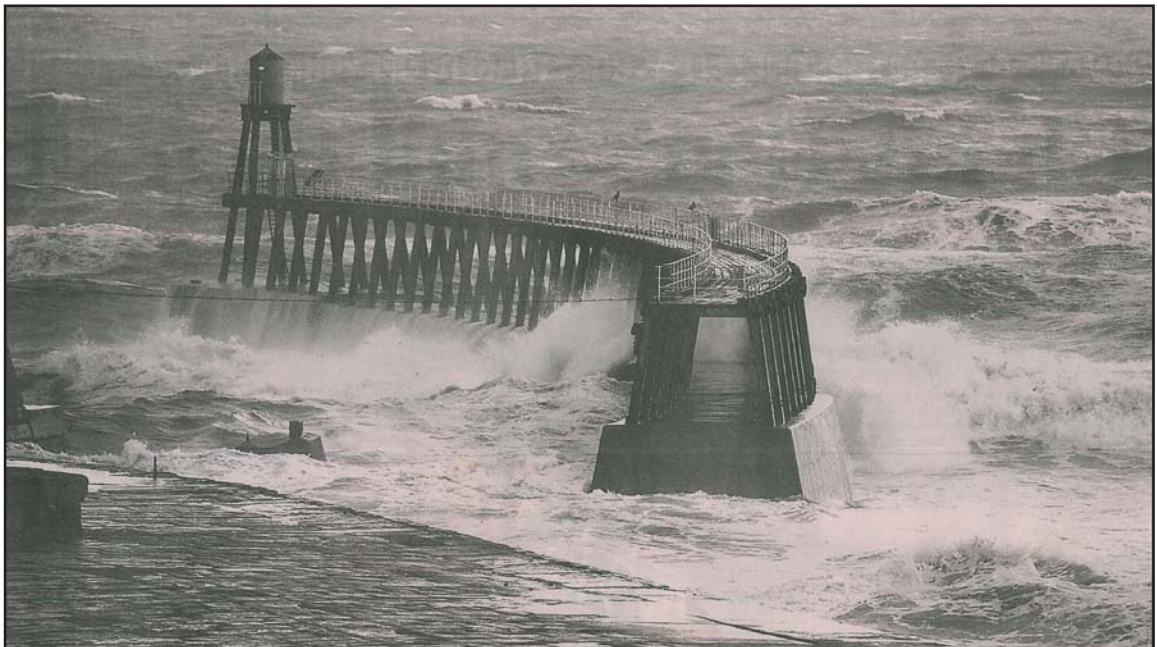
Figure 9

The conditions near the east breakwater extension at the time of the accident can be seen in **Figure 9**.

Weather conditions at the time of the accident - East Breakwater

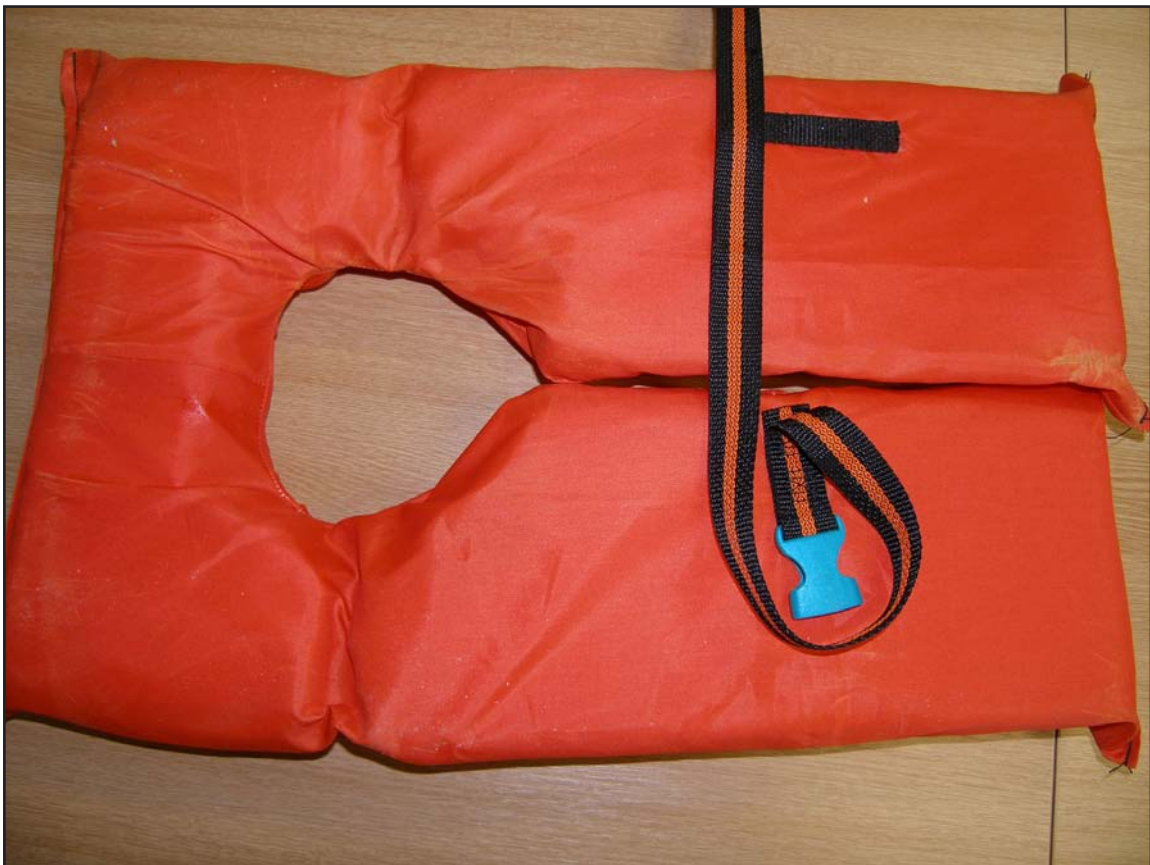
Figure 16

US Type II PFD

The Type II PFDs had other shortcomings that made them unsuitable for coastal use in rough conditions.

In this accident, although they provided their wearers with some support and increased their chances of survival, the Type II PFDs were being used in sea conditions far exceeding their design criteria.

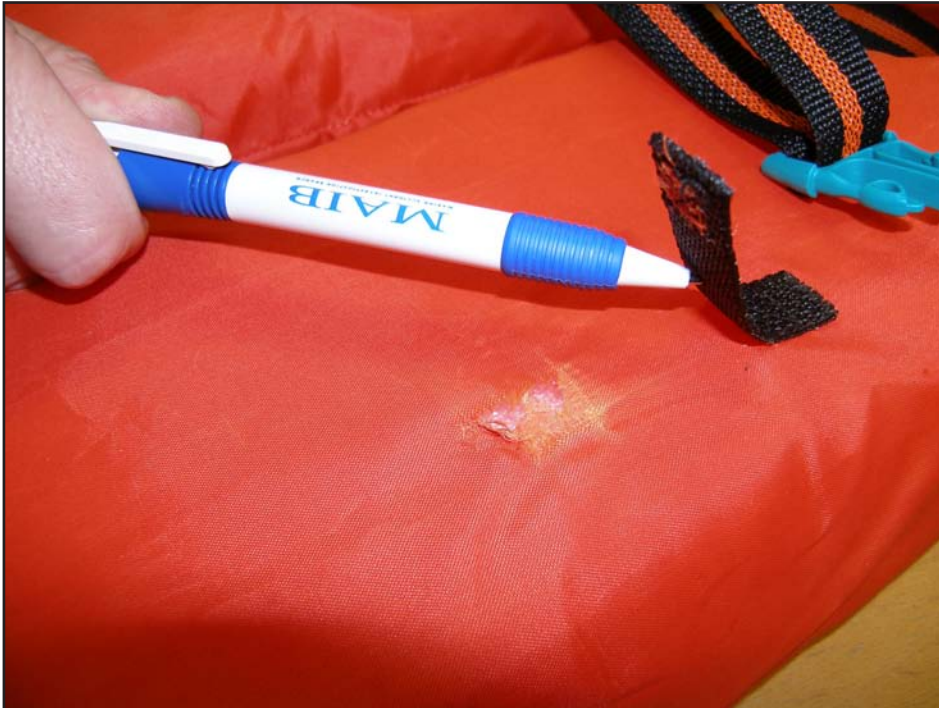
Figure 17

Inspection of the buoyant vests recovered from and worn by Andrew Carrick and Jill Russell, showed that their structure had remained intact, but the web securing strap had become detached from the front of the buoyancy chamber cover (**Figure 17**).

Detachment of web securing strap

Strength. On Andrew Carrick's Type II PFD, the straps, which held the foam collar in place, became detached when the fabric surrounding the collar ripped in the area of the strap stitching. This allowed one side of the foam buoyancy section to float free, and significantly reduced the Type II PFD's ability to hold its wearer's head above water. A flotation device similar to a Type II PFD, manufactured by a reputable UK company, incorporates double thickness material at webbing securing points to guard against the webbing becoming detached from the material during use.
