Part 3 – Leisure Craft

Keel Failure Leads to Loss of Life

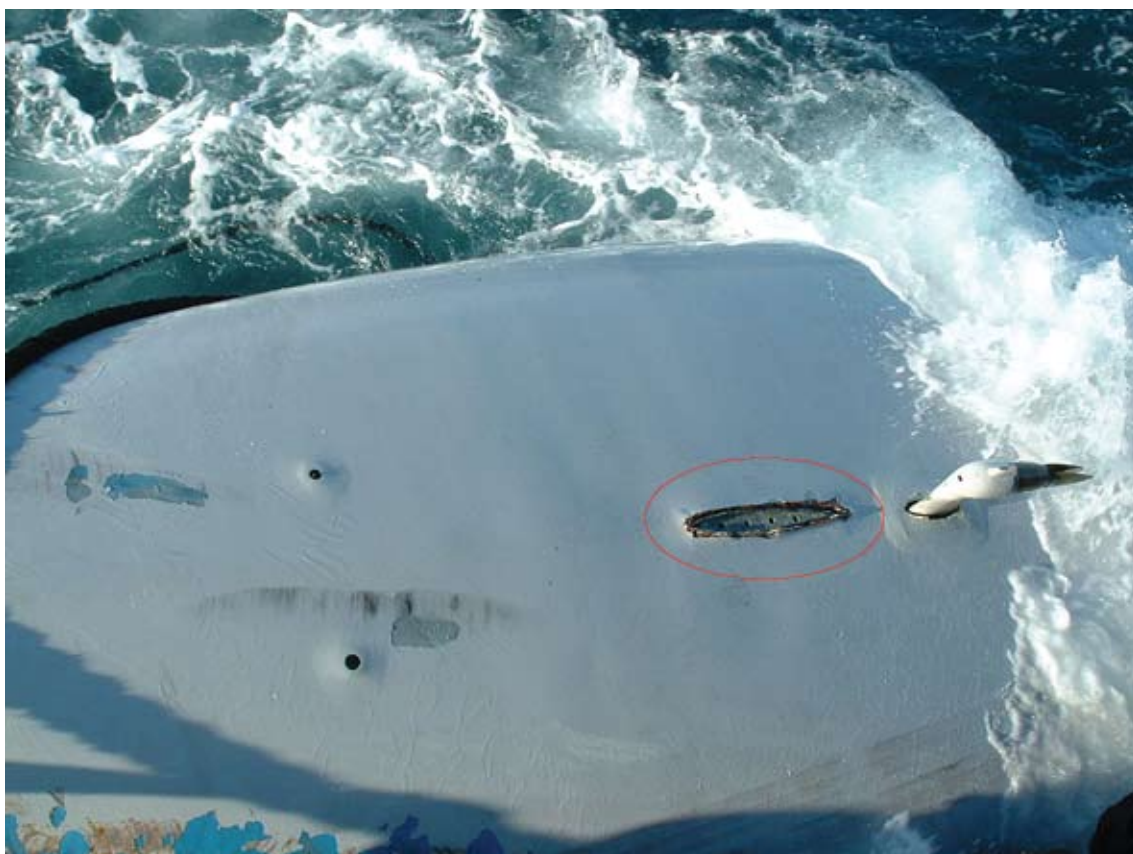
Figure 1

Investigations found that the fabricated steel keel had failed just below the fillet weld connecting the fin to the taper box (see Figure 1). Laboratory metallurgical analysis confirmed that the keel had suffered fatigue failure due to reverse bending stresses. Defects were also found in the keel taper box welds, and two of the three keel bolts had also failed.

It was further discovered that the boat builder had sub-contracted the hollow keel construction to a steel fabricator who had no marine experience. The fabricator changed the original design, and incorporated a fillet weld in a critical area. He did so to ease manufacture and reduce costs, but without the supporting calculations to assess the stresses to which the keel would be subjected. He did not consult with the designer on the changes. In 2005, 160kg of lead was added to the keel bulb for racing optimisation reasons. Once again there were no supporting calculations, nor were there detailed checks made against the “original” or “as built” designs to ensure that the modification was safe.

It was found that none of the designs achieved the required Safety Factor of 2. The addition of

the extra bulb weight exacerbated the problem and the keel was unable to withstand the “in service” bending stresses, and this led to the conditions of failure.

1. Yacht designers should ensure component designs satisfy the appropriate standard safety factor requirements. In this case, the keel steel’s full ultimate tensile strength was used in the calculations instead of yield strength, and thus an artificially high safety factor was achieved.

2. Changes to critical parts such as hollow, highly stressed keels, should be properly worked through and supported with calculations to ensure their suitability. Owners should seek expert professional advice, and wherever possible, reference should be made to design drawings, and the designer/builder consulted to check construction details and suitability of the modification.

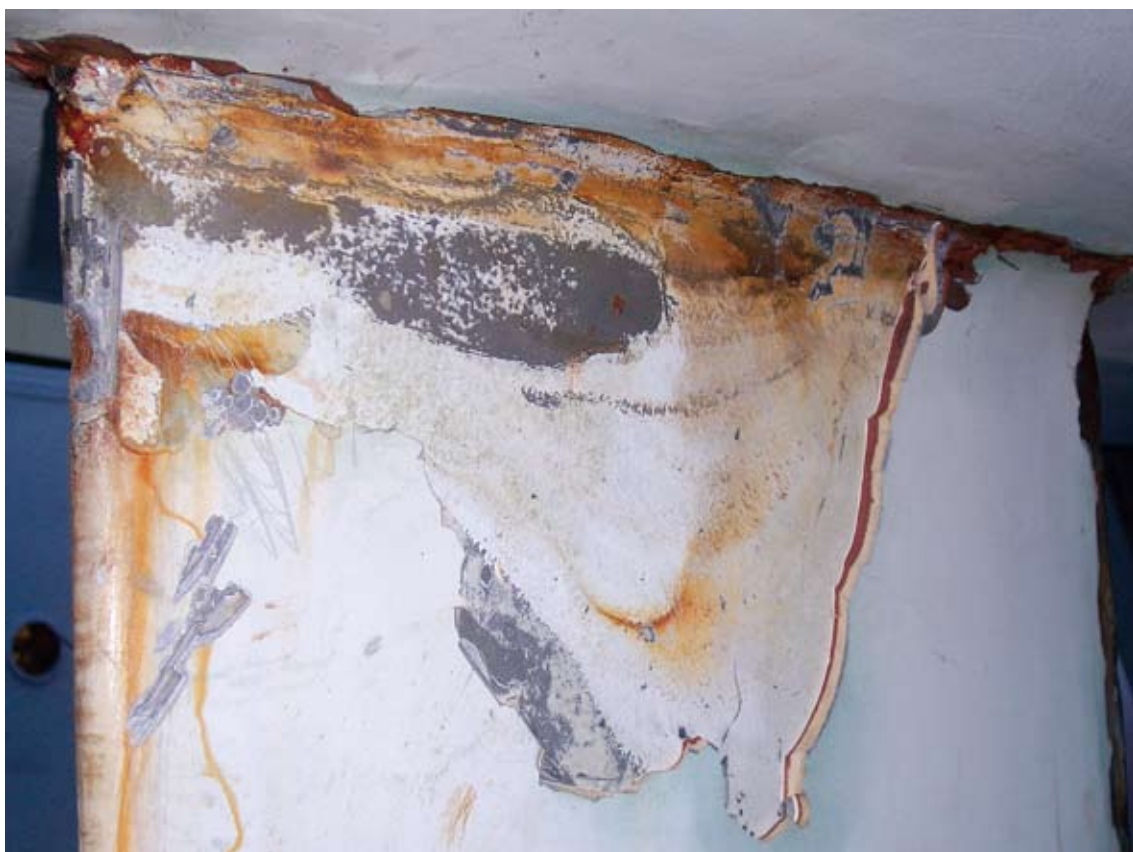
Figure 2

considerable detachment of the keel’s epoxy filler and anti-fouling was found (see Figure 2). There was also evidence of the likelihood of fine cracking in the steel adjacent to the fillet weld, but this went undetected by the repairer, so the last chance to prevent the accident was missed.

3. Do not dismiss the importance of keel coating detachment, or evidence of cracking of the coatings at the keel to hull interface; this may indicate more deep seated keel structural problems.

- Seek expert advice – you may need to use non-destructive procedures to check that the keel structure is sound. Also, regularly check the tightness of keel bolts and thoroughly investigate the cause of any failures. **Remember**, action at this stage could save your life.

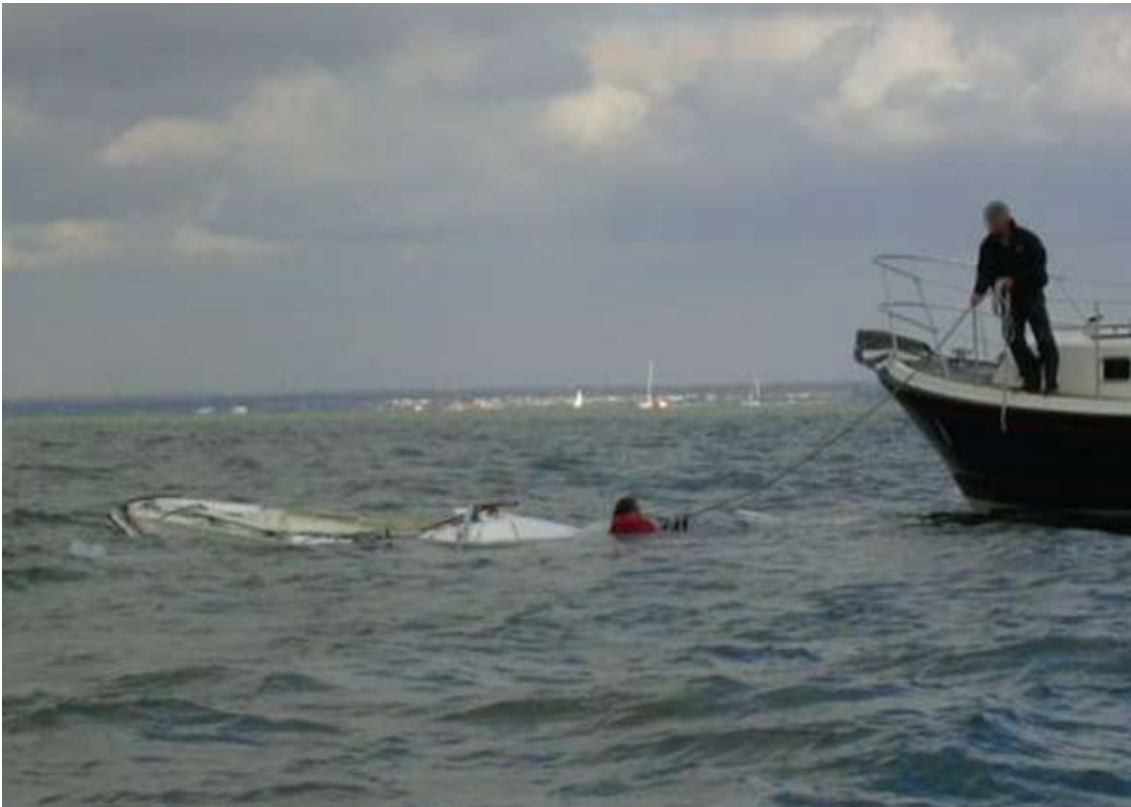
Vessel being recovered
