Report on the investigation of  
a fatal man overboard from the Reflex 38 yacht  
**Lion**

14.5 miles south of Selsey Bill, West Sussex

18 June 2011

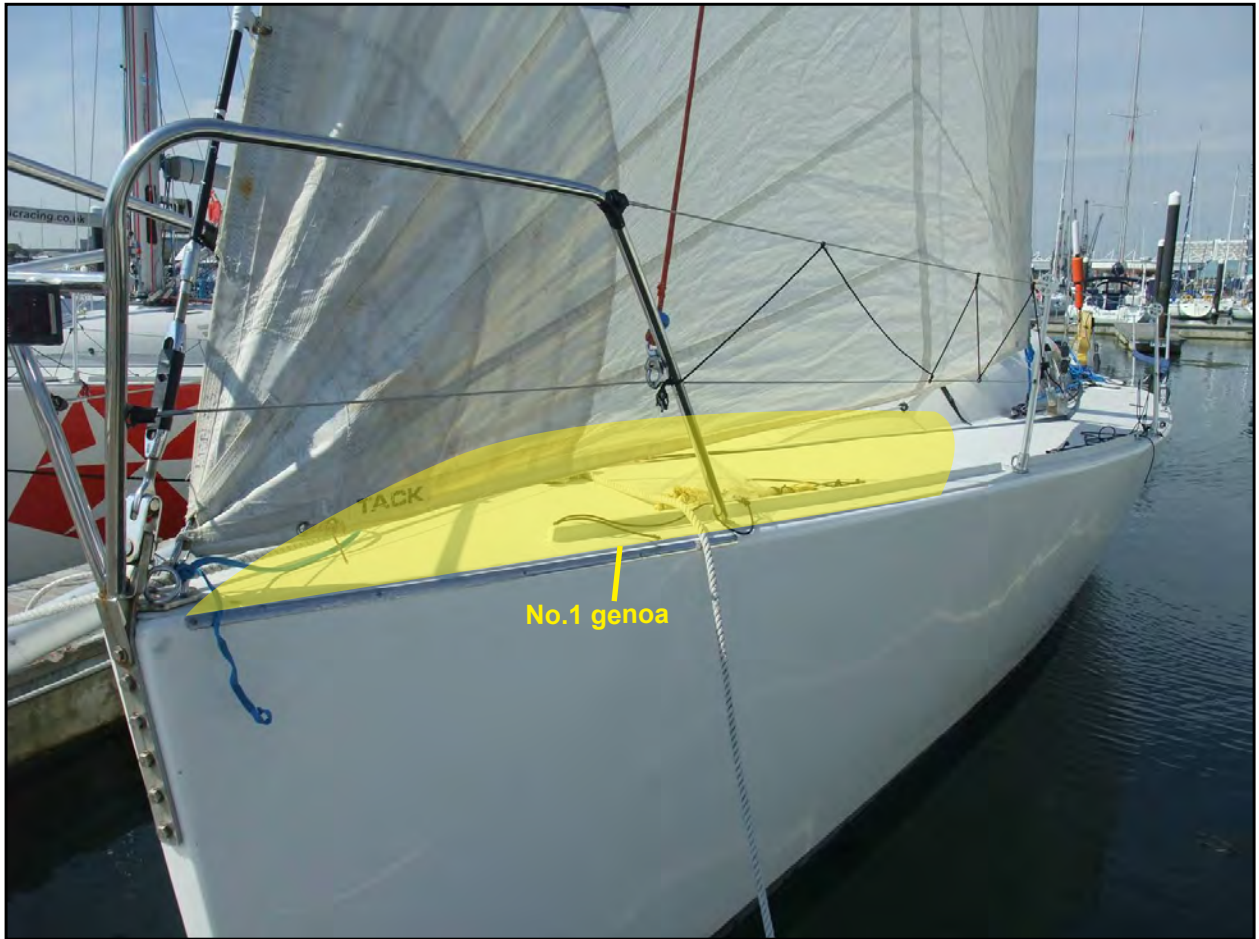
As the weather deteriorated, trimmer 2 noticed that the No.1 genoa was slipping from its lashings. He clipped his tether to the starboard jackline, went forward up the starboard side and used two additional sail ties to re-secure it.

At 0027, the helmsman felt the yacht's handling characteristics change. At the same time, he noticed that the No.1 genoa had slipped from its lashings and was streaming down the port side of the yacht. However, the tack remained secured to the forward pad eye, which prevented the sail from floating away. The skipper called the bow and mast men to the deck to help recover the sail if required. Meanwhile the helmsman concentrated on maintaining a steady course to assist the recovery operation. As the mast man entered the cockpit he noted the wind speed indicator was reading 38 knots. The yacht was heeling to port with her toerail dipping into the water.

**Figure 3:** Position of the lashed No.1 genoa

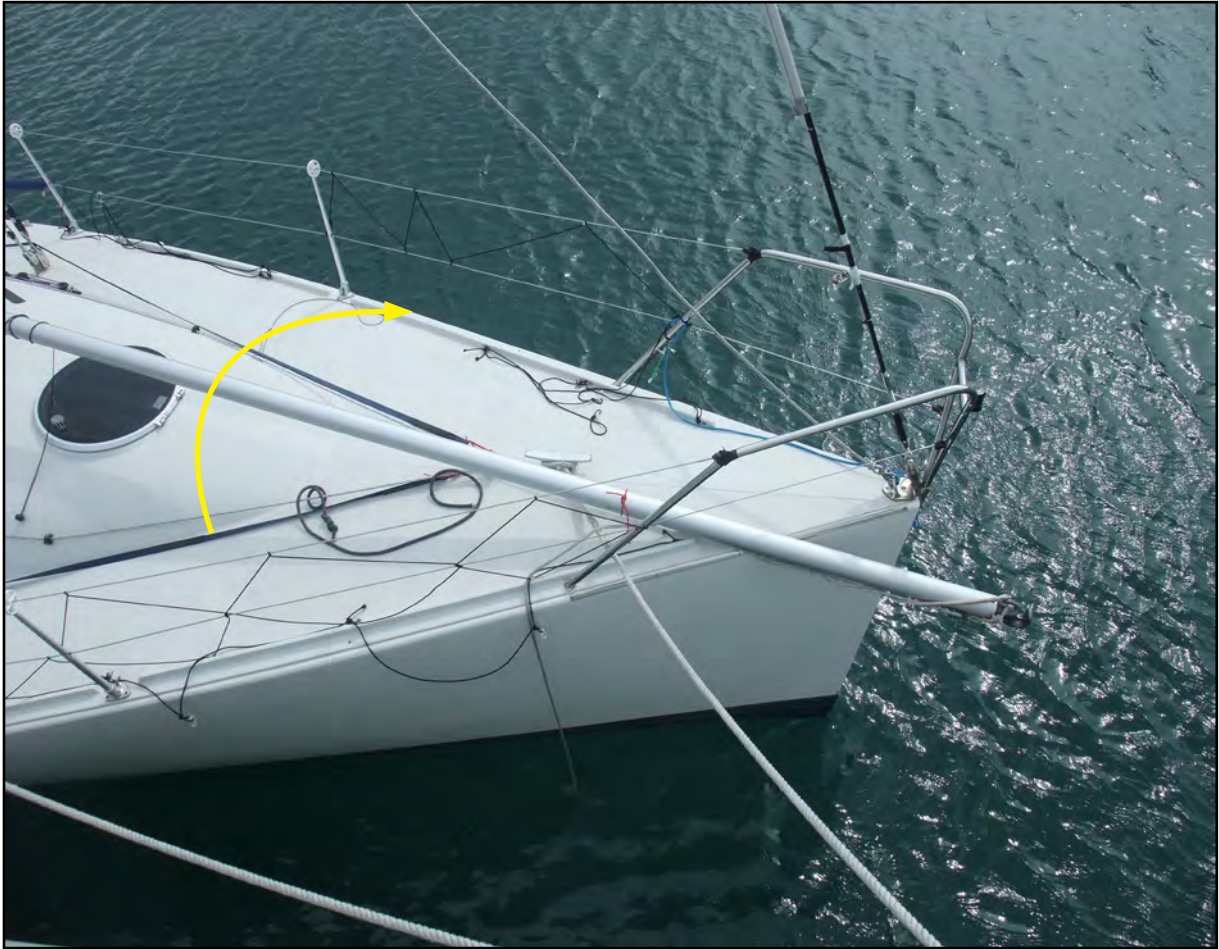
**Figure 7:** Approximate path believed to have been taken by the skipper when falling overboard

There is no doubt that the skipper went overboard on the port side. However, none of the crew could recall if his tether from the starboard jackline had passed over or under the spinnaker pole. A person, under momentum, could have passed through the 290mm gap under the pole, which could have also lifted as it was hinged to the mast. However, members of the recovery team do recall leaning over the spinnaker pole to pull on the skipper's tether. Had the tether passed under the pole, the weight of the skipper would have forced the tether to the deck and the crew would have suffered damage to their hands as they tried to gain grip on the tether with it pressed against the deck. In addition, had the skipper passed under the pole, it would have lifted as he was hauled inboard by the spinnaker halyard, which was connected to his tether. There is no evidence of this.

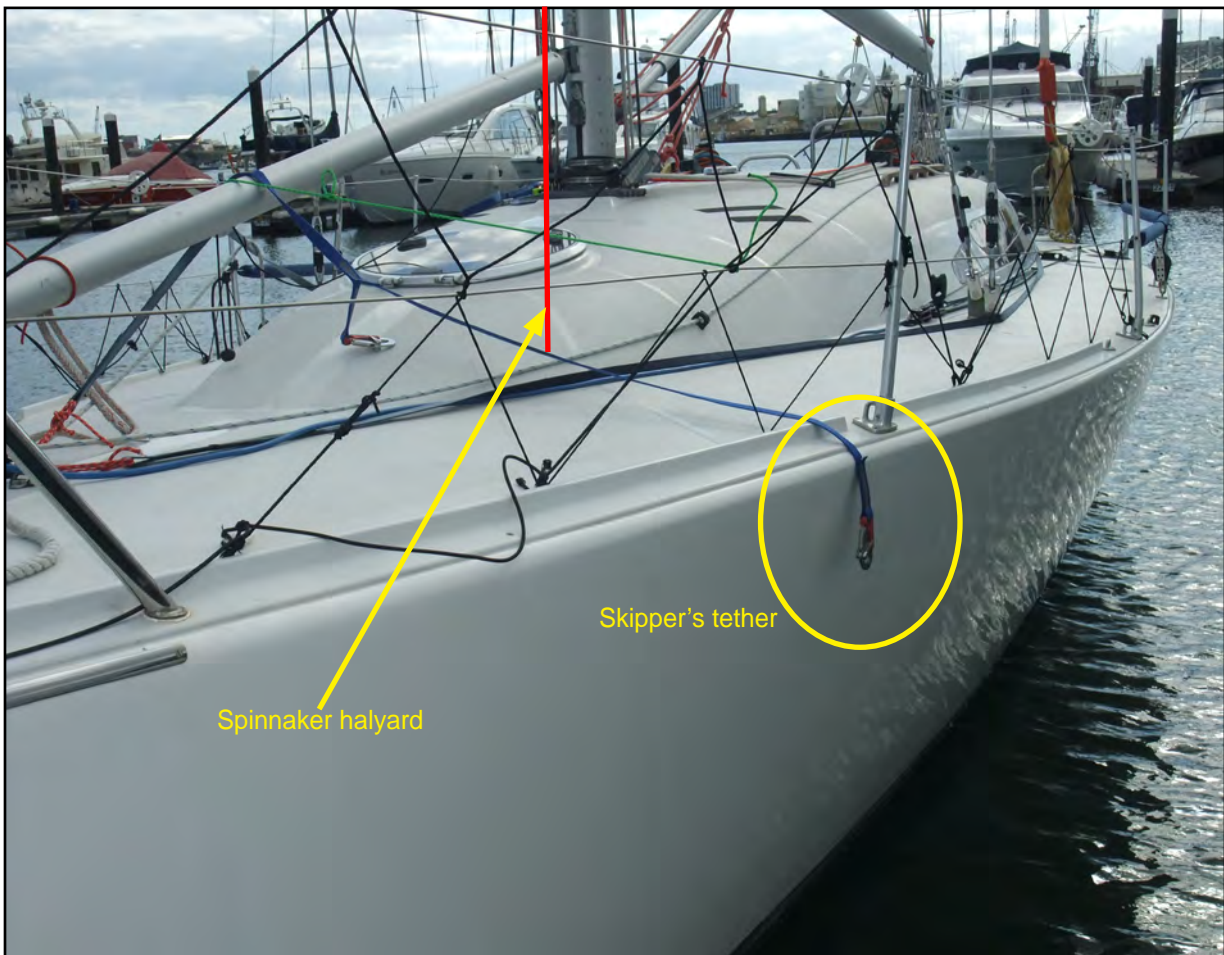
The skipper was found in the water on the port side with his lifejacket inflated and the lifejacket bladder over his head, obscuring part of his face. His tether was still connected to the starboard jackline and had passed over the spinnaker pole and under the lower guard wire between the pulpit and the first vertical stanchion (**Figure 7**). The mast and bow men went to the port side and attempted to pull the skipper out of the water. Trimmers 1 and 2 remained on the starboard side; they leant across the spinnaker pole and hauled on the skipper's tether. The team managed to raise the skipper's head above water, but there was no reaction from him. Attempts by the mast man to clear the skipper's airways and check for signs of life proved very difficult because of the obstructing lifejacket bladder.

**Figure 8:** Pictorial interpretation of the spinnaker halyard connected to the skipper's tether

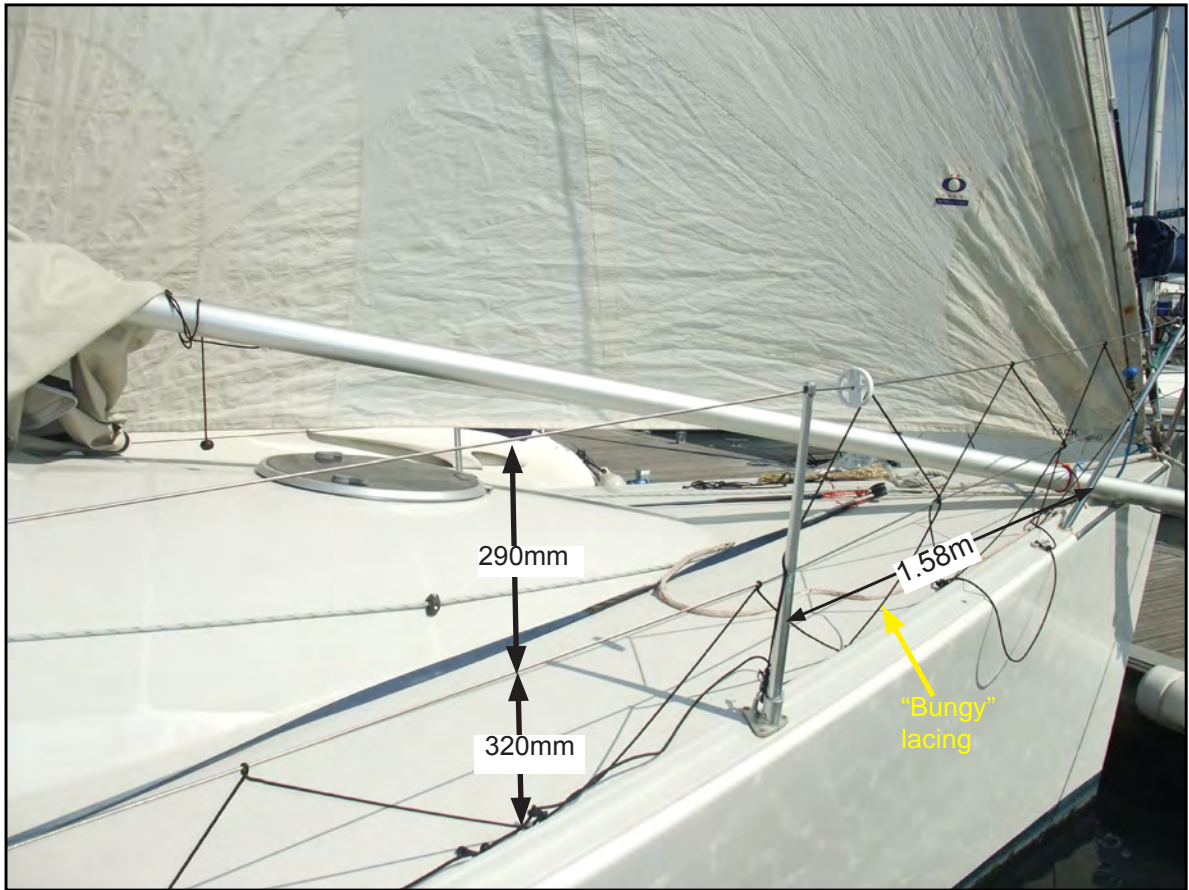
*Lion's* stainless steel vertical guard wire stanchions were 635mm high and equi-spaced at 2.14m intervals. The spacing between the lower end of the angled pulpit stanchion to the first vertical guard wire stanchion was 1.58m. Two stainless steel guard wires were fitted. The spacing from the deck to the lower guard wire was 320mm<sup>4</sup>, and from the lower to the upper guard wire, was 290mm.

A criss-cross combination of light “bungy” line and braided cordage lacing was used to help prevent sails from falling overboard. The lacing was fitted on each side from the deck to the upper guard wire between the pulpit after stanchion and the first vertical guard wire stanchion, and from the deck to the lower guard wire between the first and second vertical guard wire stanchions.

**Figure 10:** Stanchion, guard wire and lacing arrangements

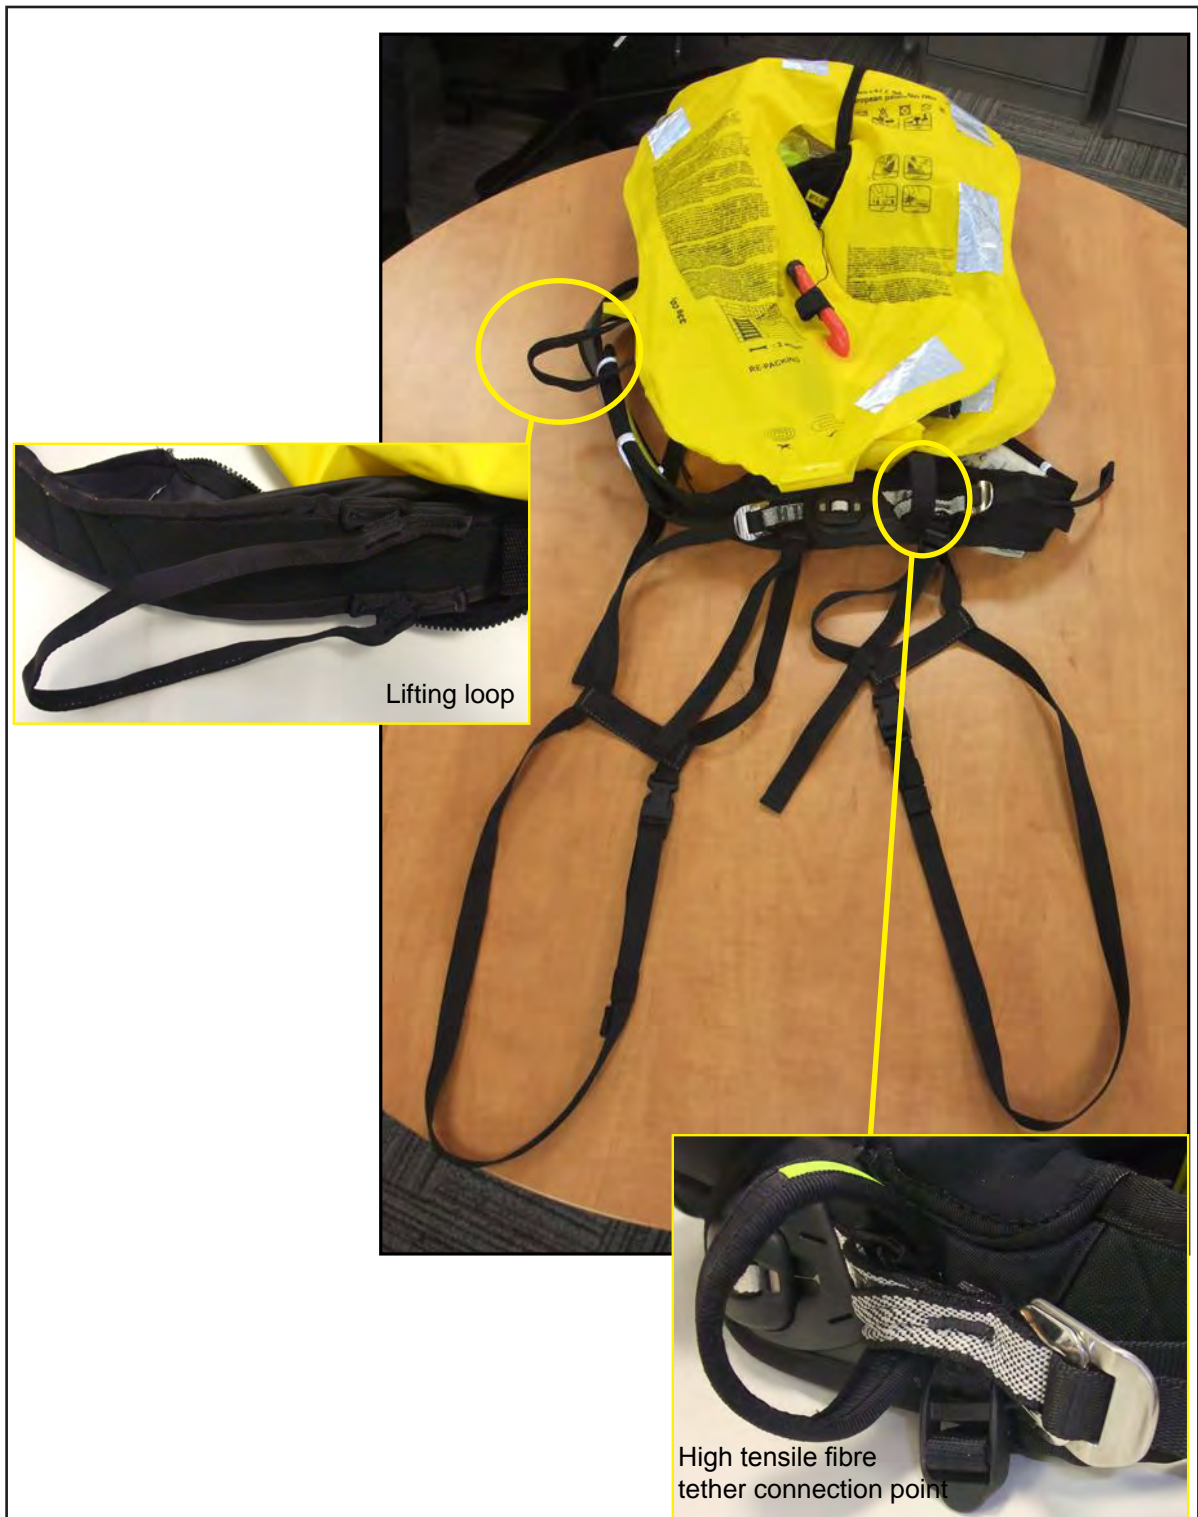
On inspection following the accident, the lifejacket, harness and thigh straps were found to be in good condition with no obvious damage to their components. The arrangement is shown at **Figures 12** and **13**.

**Figure 12:** Skipper's Spinlock Deckvest 150 Pro Sensor lifejacket, harness and thigh straps

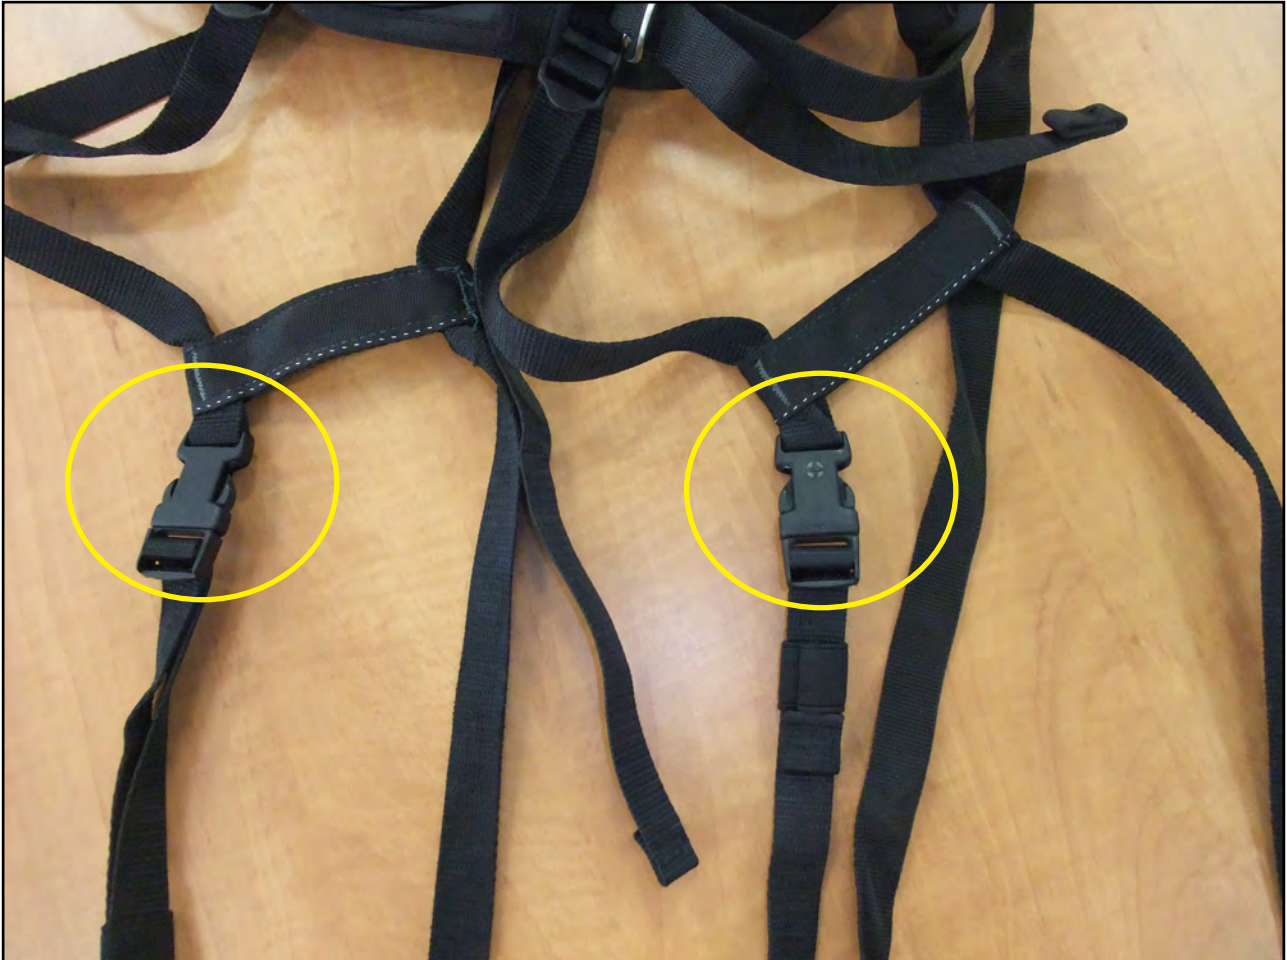
Following the accident it was noted that the thigh strap side release buckles were easily unclipped under straight load tension, and especially so under rotational load. Straight pull load tests showed that the left and right thigh strap buckles released when a load of 20 kilogram-force (kgf) and 40kgf was applied respectively. It is understood from the lifejacket manufacturer that the buckles should withstand a 50kgf load before unfastening.

**Figure 13:** Spinlock Deckvest 150 Pro Sensor lifejacket thigh strap side release buckles

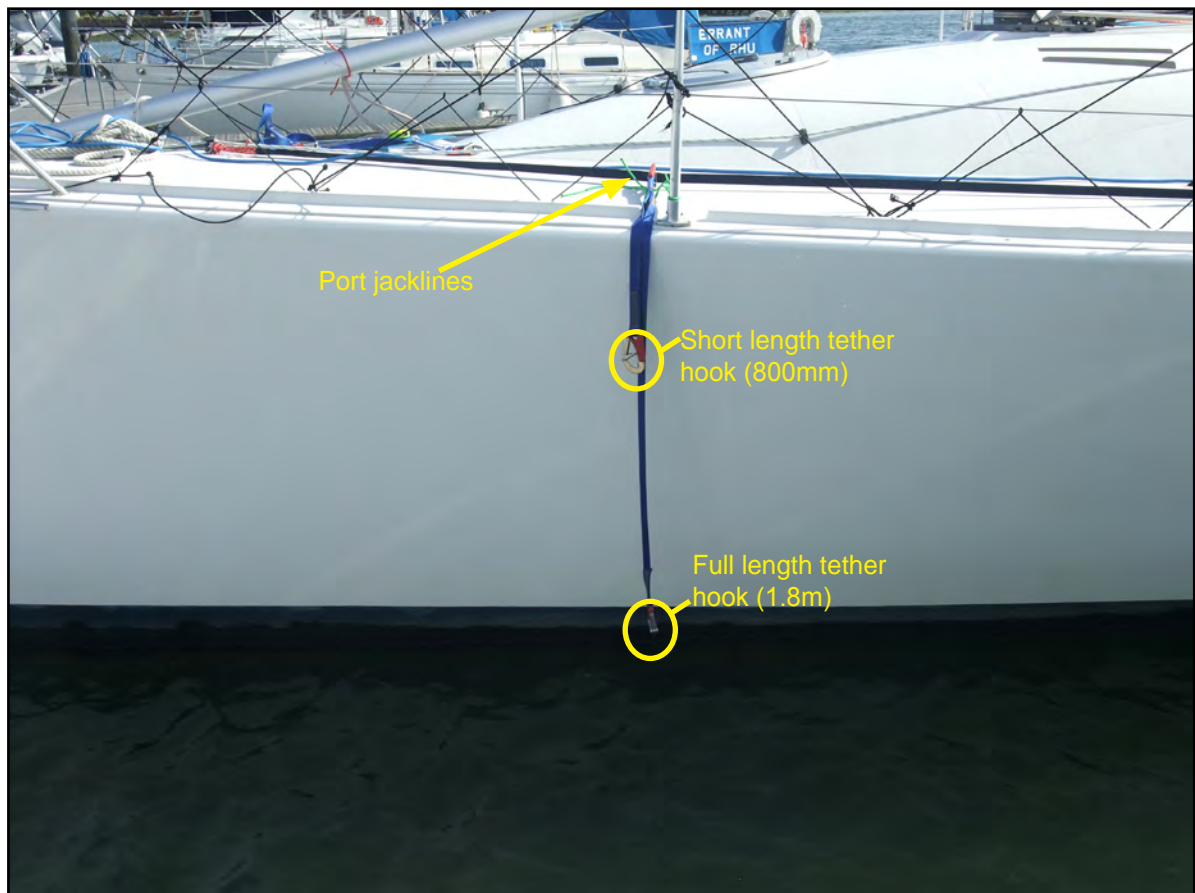
When a three-hook tether was connected to the deflected port jackline, the long and short tethers extended 1.2m and 500mm over the port deck edge respectively (**Figure 16**).

**Figure 16:** Three-hook tether connected to the port jackline

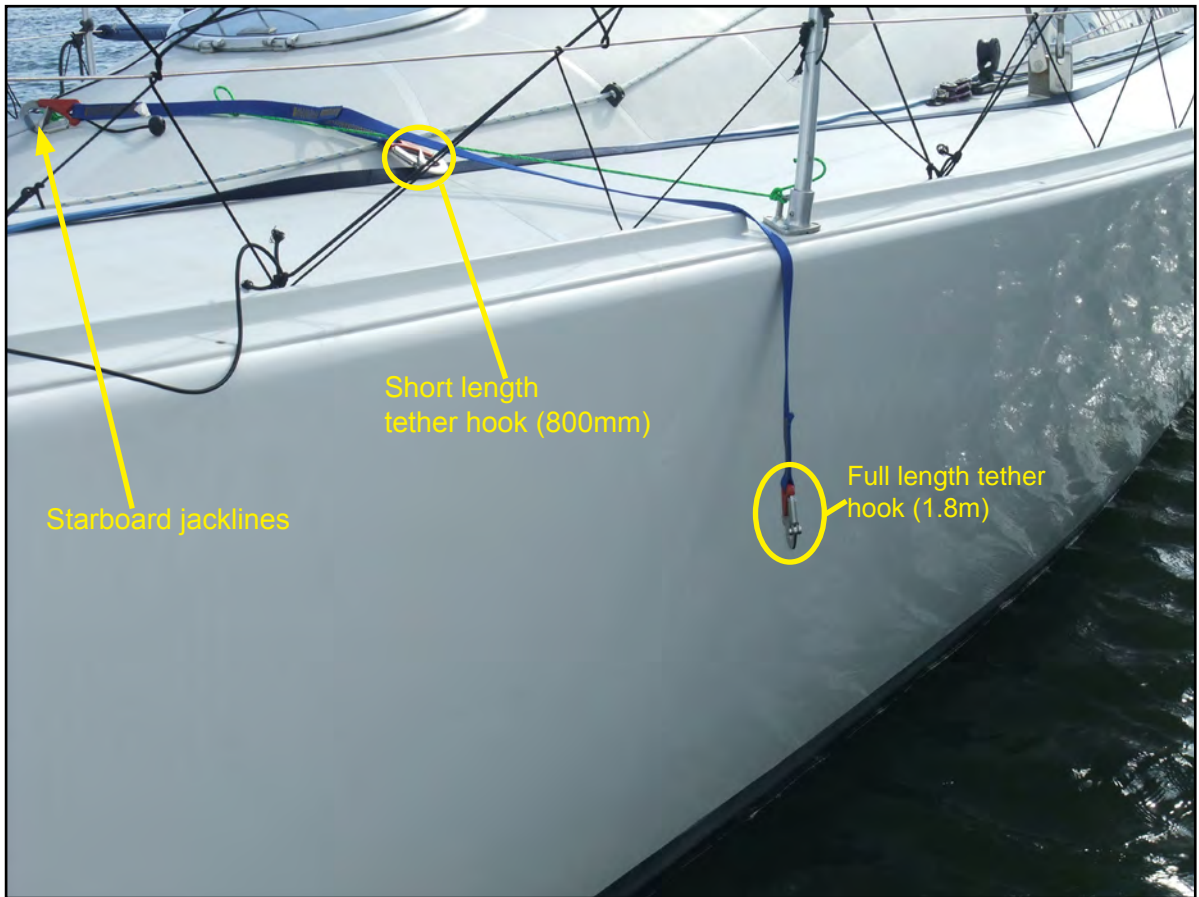
When the same three-hook tether was connected to the starboard jackline and passed under the spinnaker pole, the long tether extended 450mm over the port deck edge. When passed over the spinnaker pole it extended 250mm over the port deck edge (**Figure 17 and 18**). In both cases the short tether hook remained well clear of the port deck edge.

**Figure 17:** Three-hook tether connected to the starboard jackline and passing under the spinnaker pole
