Report on the investigation of
two accidents during berthing and unberthing
of

Logos II

St Helier, Jersey

Report No 1/2008
January 2008

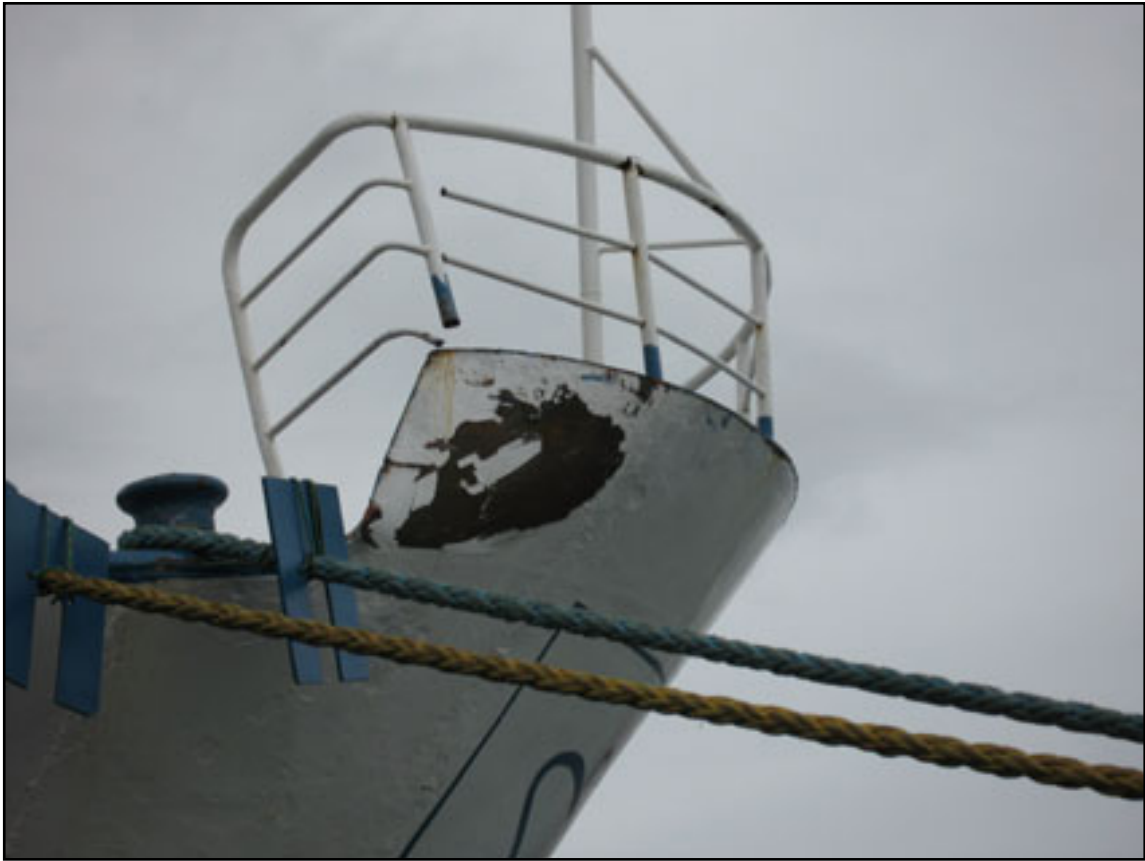
Figure 7

Time and date	:	2047 (UTC+1) on 20 June 2007
Location of incident	:	St Helier, Jersey
Persons on board	:	197
Injuries/fatalities	:	None
Damage	:	Vessel sustained indent on her starboard bow, bent pulpit railings and superficial damage to paintwork. Structural damage was caused to two small craft and minor damage to a shore crane.

As *Logos II* neared the berth, the vessel's bow started to close the pier much quicker than intended. This was commented upon by the master, and the DHM attempted to check this movement by ordering *Titan* to stop pushing and *Marineco Toomai* to push with full power. He also ordered the engines to full astern. These actions failed to check the vessel's movement, and at 2047 her bow made contact with the quay and a shore crane (**Figures 7 & 8**).

Damage to starboard bow of *Logos II*

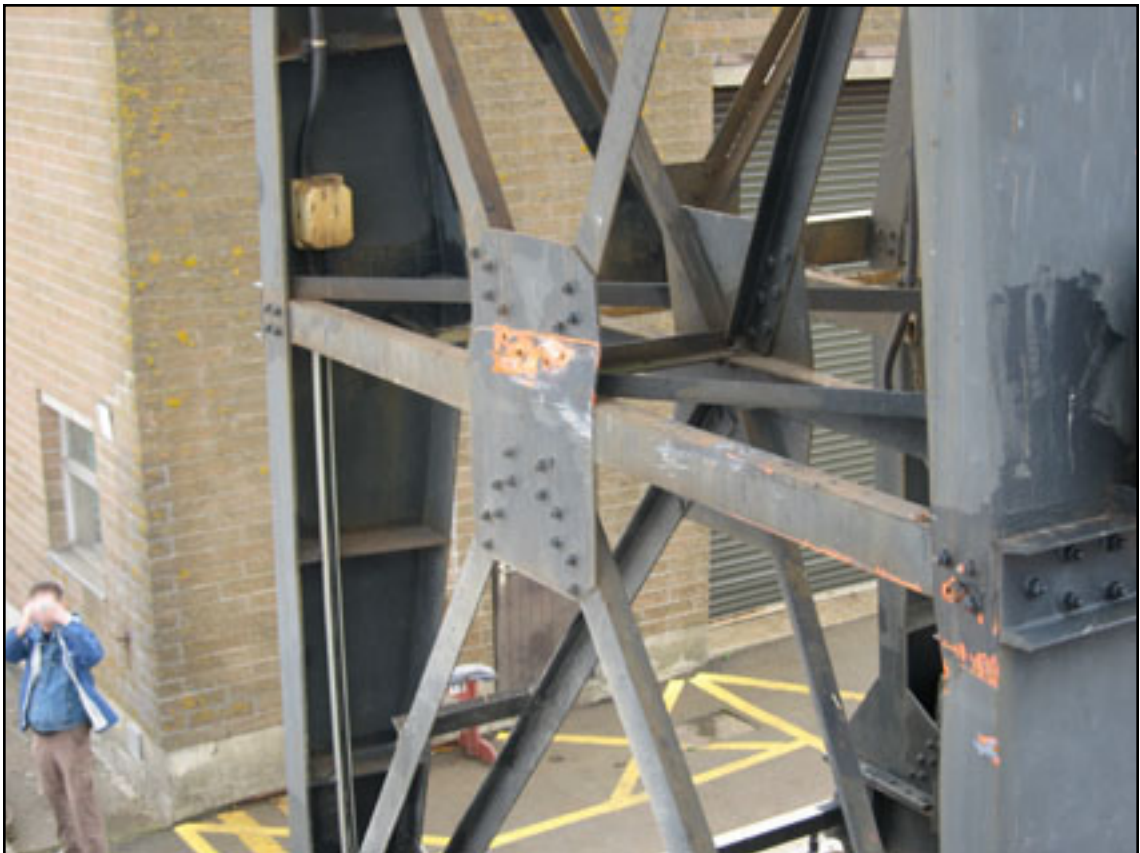
Figure 8

Damage to shore crane

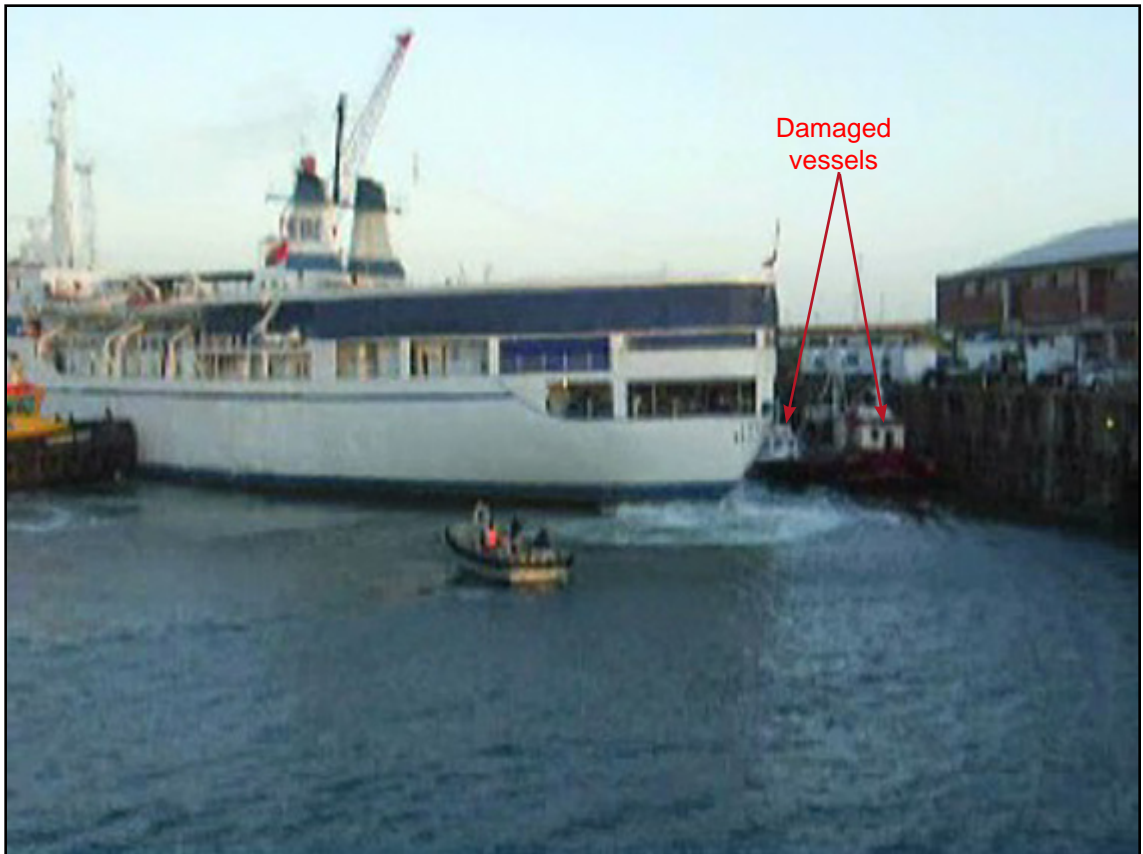
Figure 9

The DHM immediately ordered the engines to be stopped and then set to half ahead, and for the helm to be put to hard to starboard. The aft tug was also ordered to stop pushing, but the stern of *Logos II* made contact with two of the small boats (**Figure 9**).

Stern of *Logos II* prior to contact with boats moored at London Berth
(image captured from video)

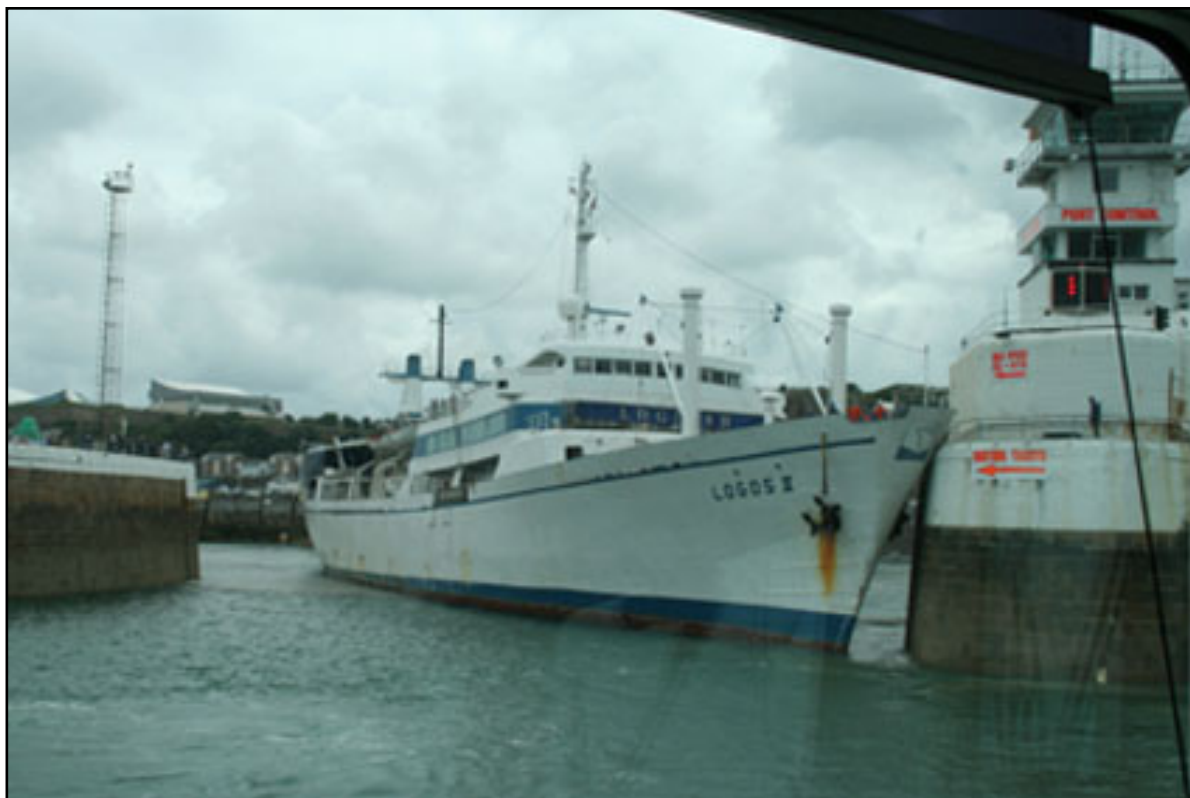
Figure 11

Without the assistance of the forward tug, *Logos II* came to rest with her port bow on the Victoria Pier head (**Figure 11**) at 1200. Damage to the vessel was superficial, but damage to the concrete and railings on the pier head was more extensive (**Figure 12**). A tow line was quickly re-secured to *Duke of Normandy*, and *Logos II* was pulled clear of the pier head. The tow was then released to allow the ship to increase speed, but when the AHM attempted to alter course to the south, *Logos II* again failed to respond to the helm, and the assistance of *Duke of Normandy* was required to push her bow towards her intended heading. The vessel then completed her departure from St Helier without further incident.

Logos II in contact with Victoria Pier head

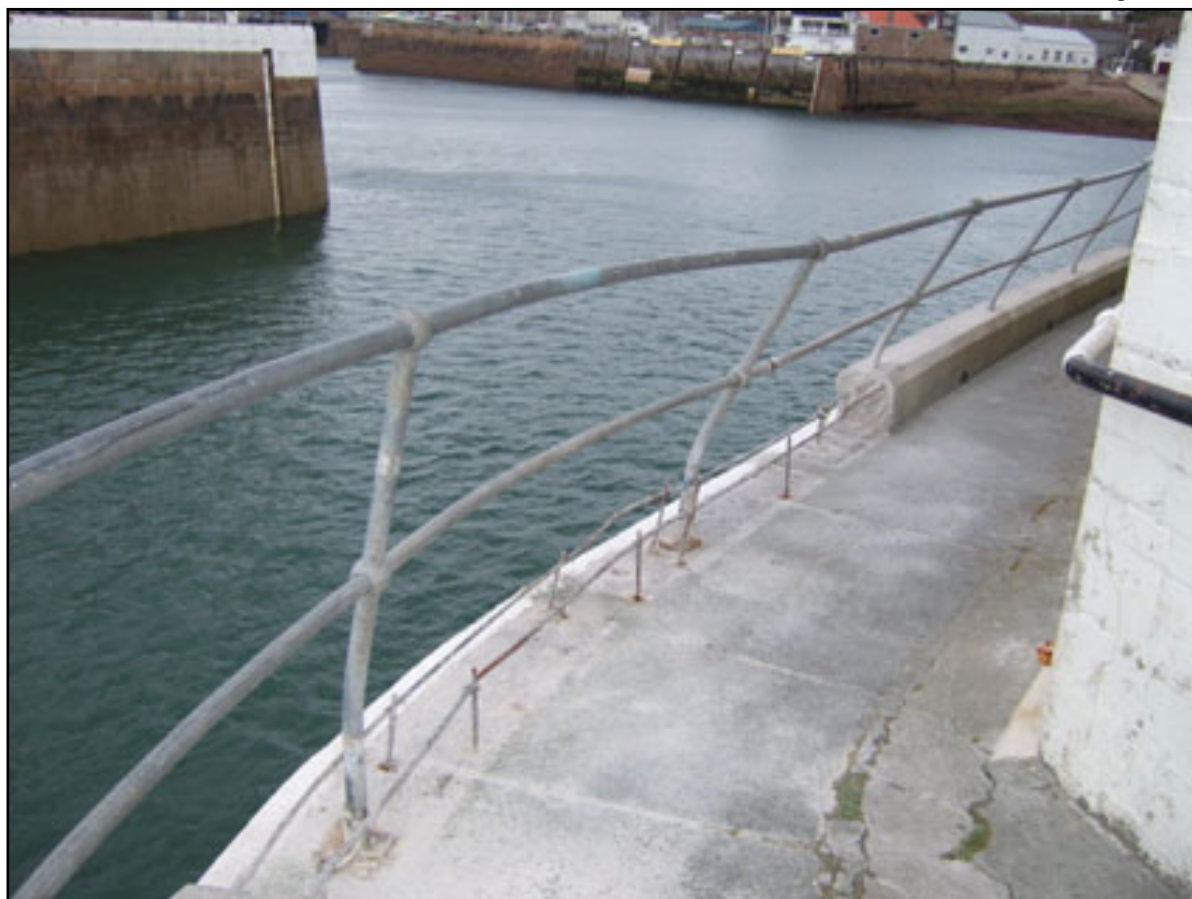
Figure 12

Time and date	:	1200 (UTC+1) on 26 June 2007
Location of incident	:	St Helier, Jersey
Persons on board	:	189
Injuries/fatalities	:	None
Damage	:	Structural damage was caused to concrete land ties and safety railings on Victoria Pier head.

Damage to Victoria Pier head
