Report on the investigation of
the close-quarters situation between the
ro-ro passenger ferry
Maersk Dover
the tanker
Apollonia
and the container vessel
Maersk Vancouver
in the Dover Strait
on 17 October 2006

Marine Accident Investigation Branch
Carlton House
Carlton Place
Southampton
United Kingdom
SO15 2DZ

Report No 9/2007
May 2007

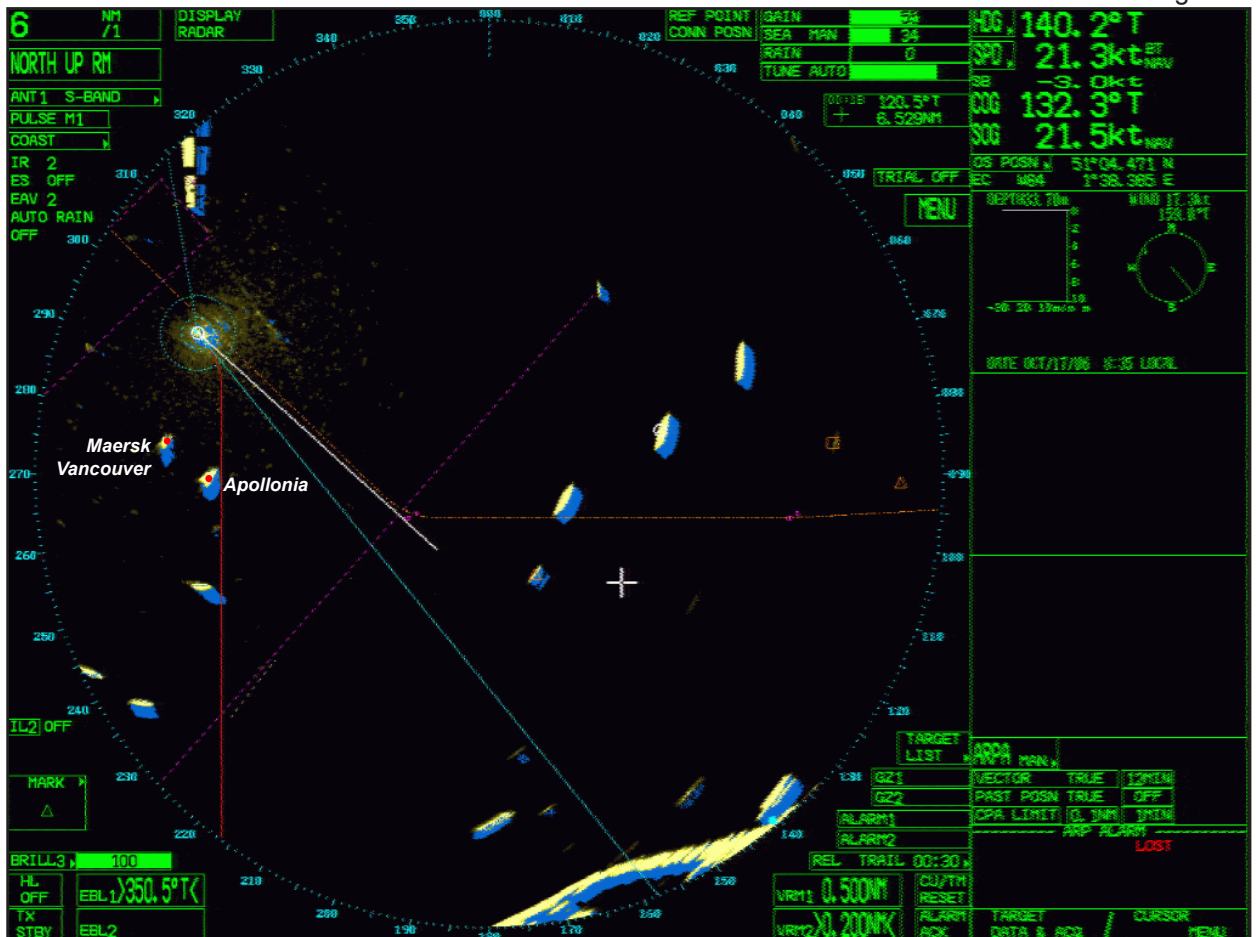
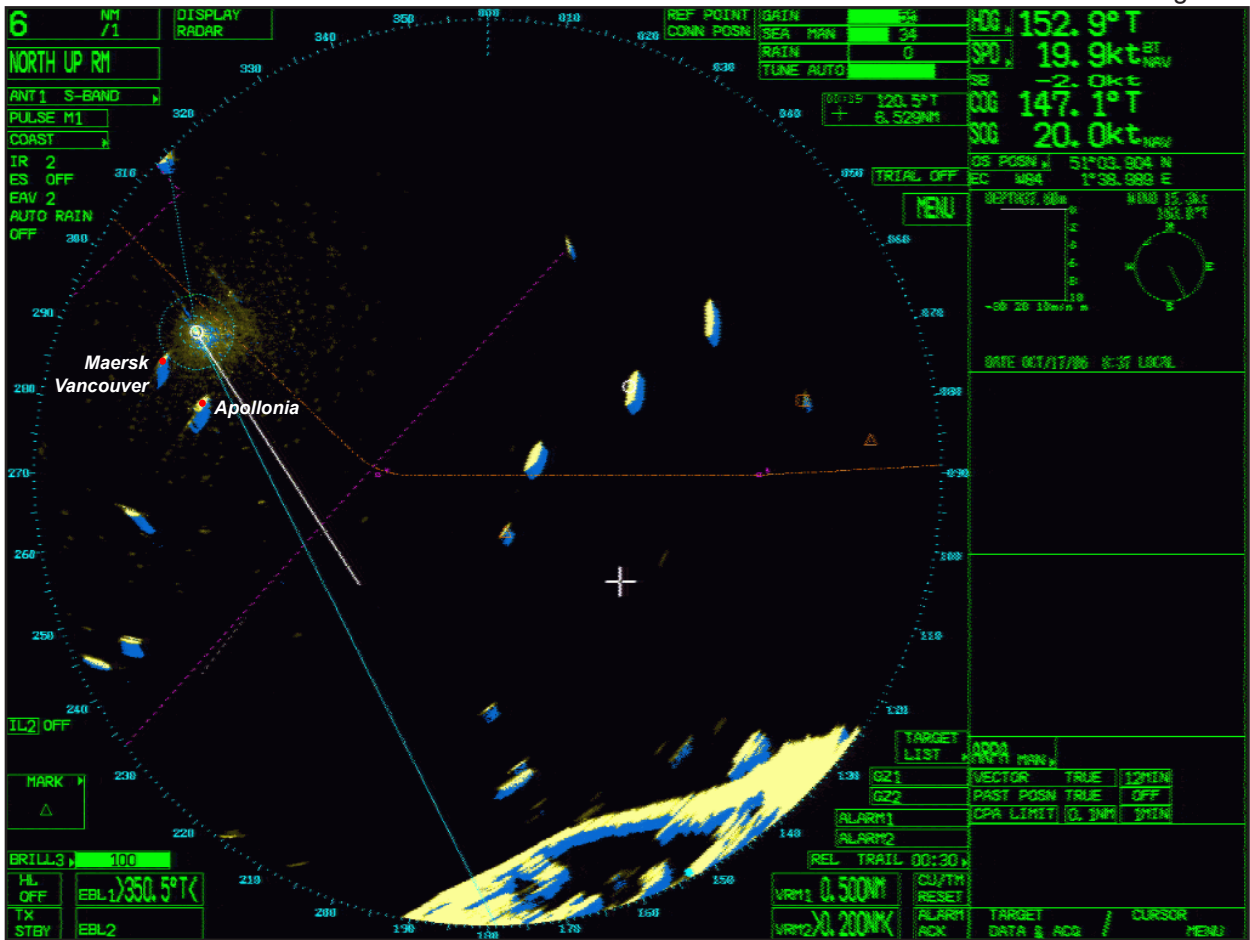
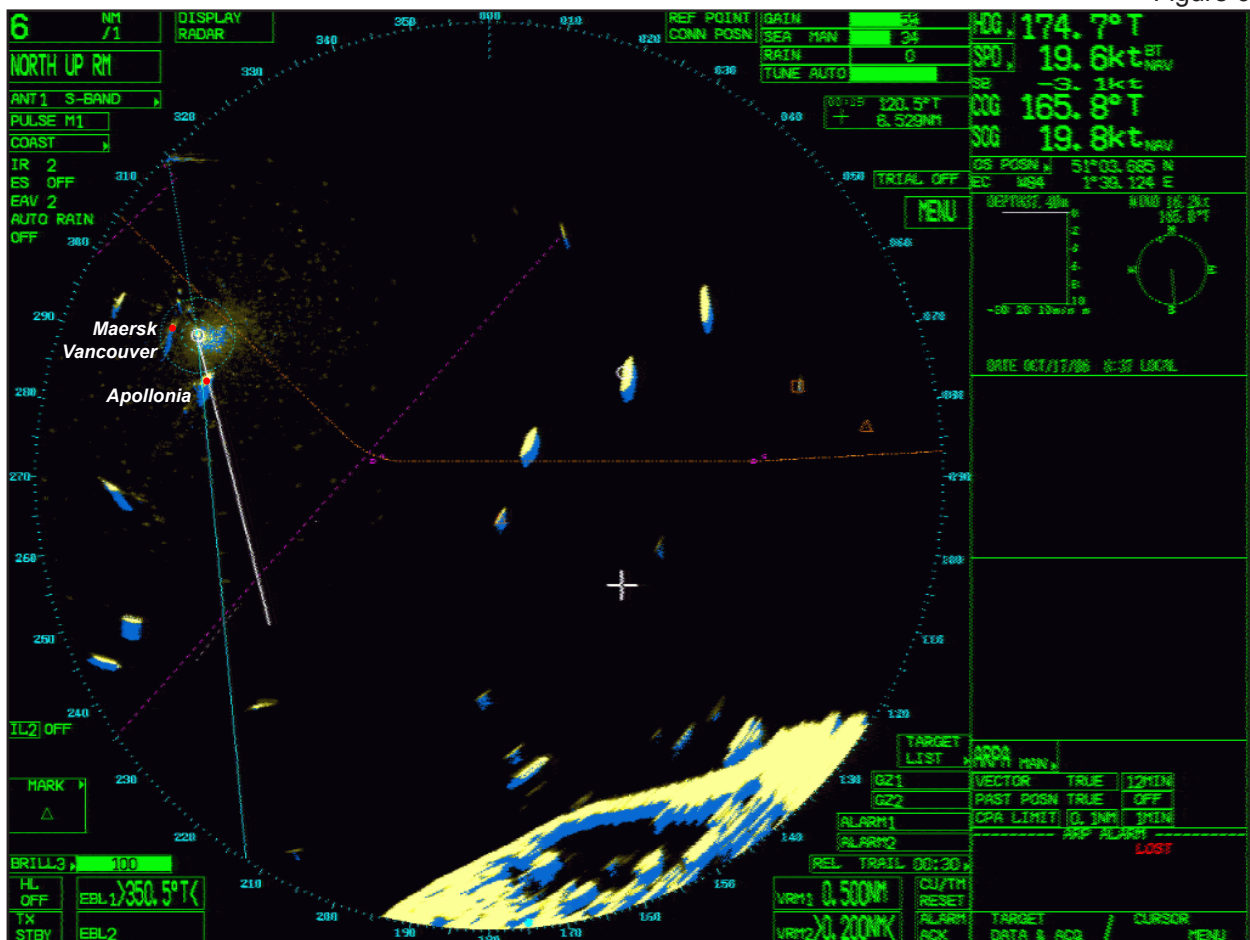
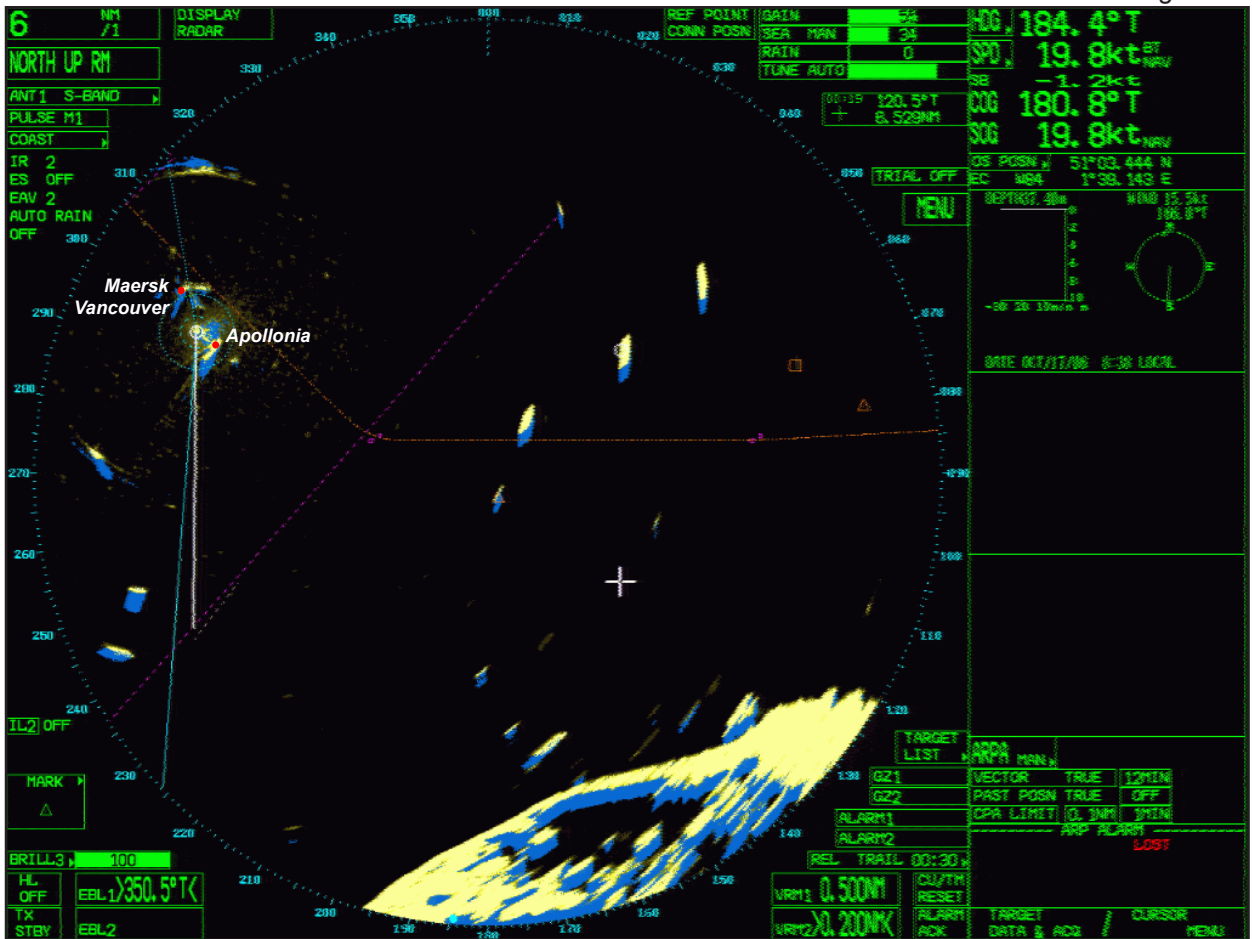
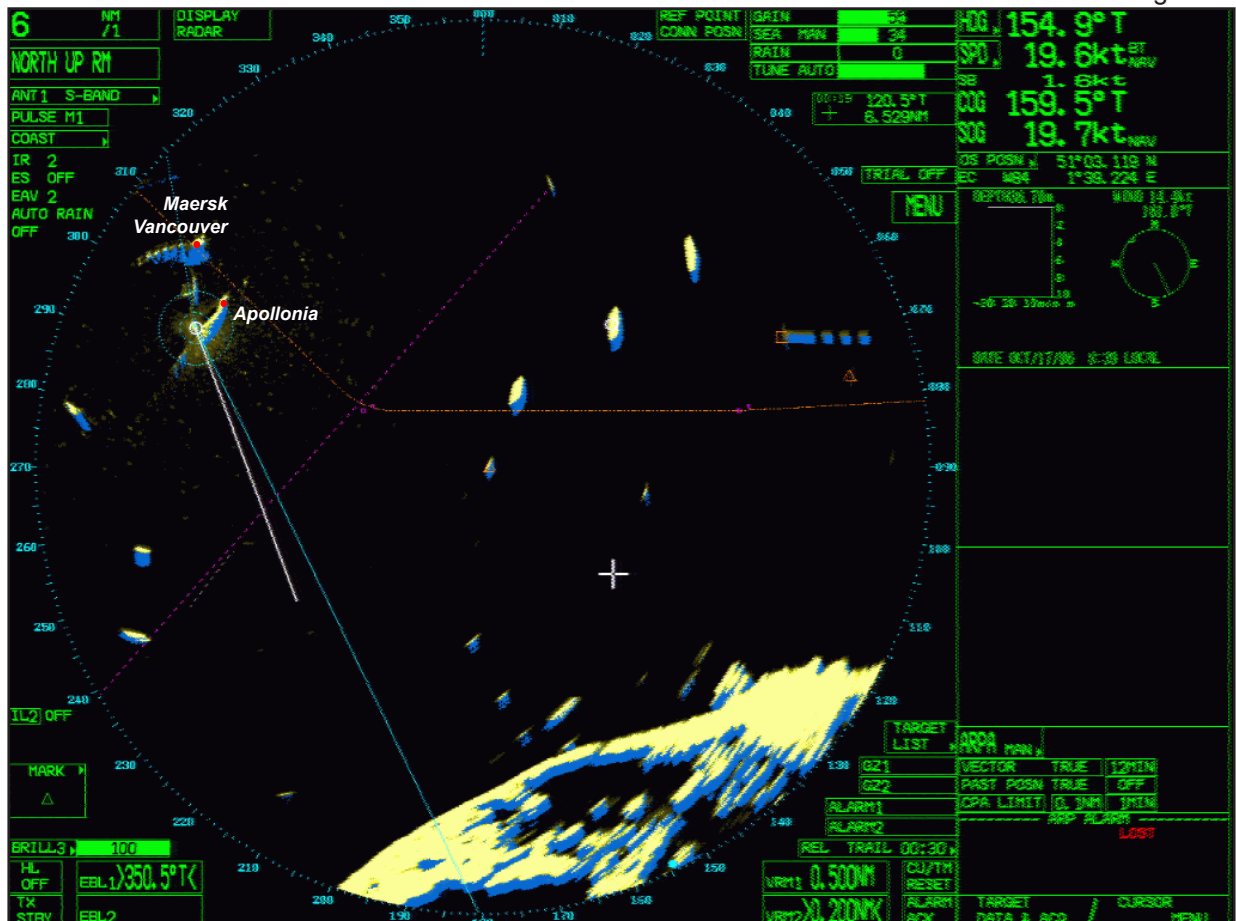
The VDR indicated that the bridge of *Maersk Dover* passed 5 cables ahead of *Maersk Vancouver*, resulting in a CPA of 3 cables on her starboard bow. This was followed, seconds later by closing *Apollonia* to 3 cables on the port bow, 2.5 cables on the port beam, and finally a CPA of 1 cable astern (Figures 7, 8, 9, 10, 11).

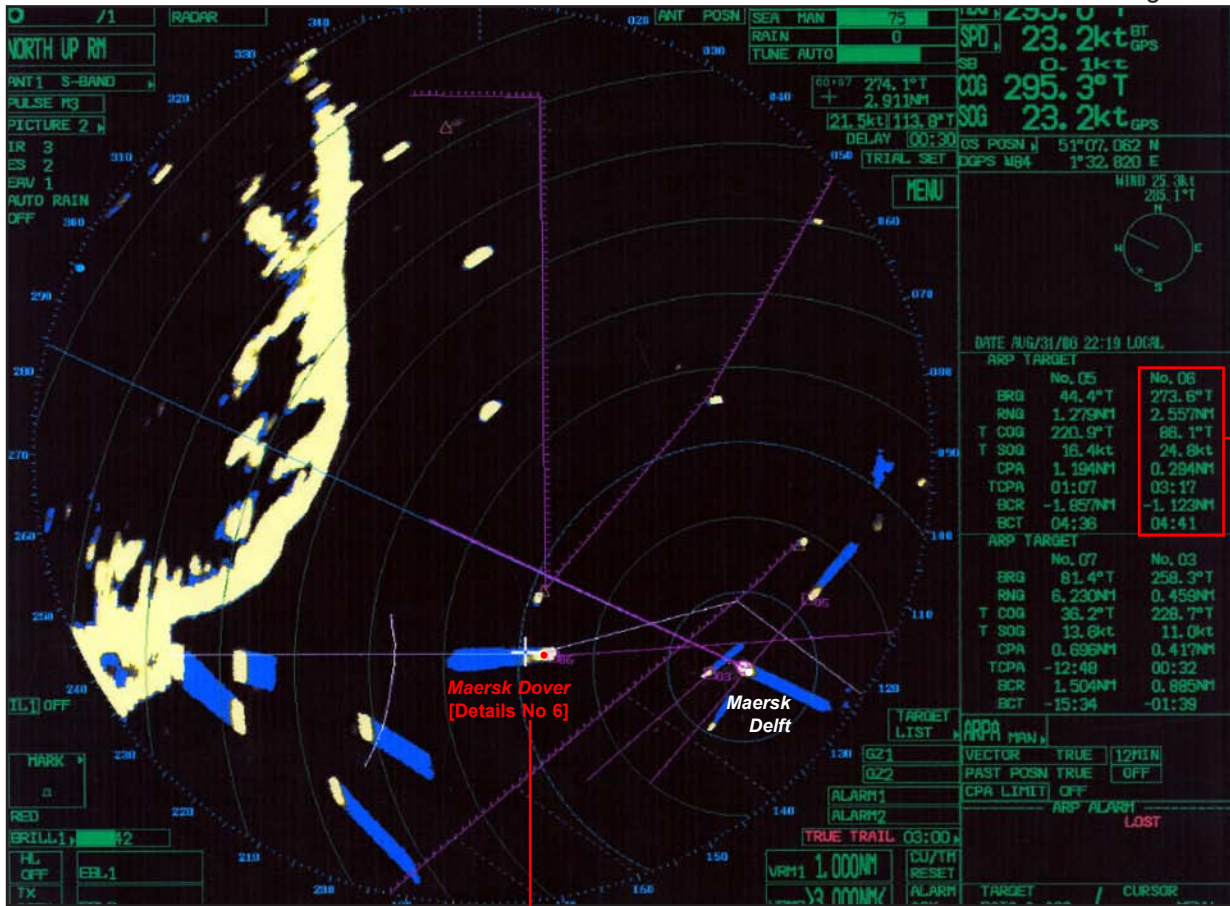
A close-quarters situation had been allowed to develop with *Maersk Dover* passing 1 cable or less, ahead of *Maersk Delft*.

Radar picture seen from *Maersk Delft*
