Report on the investigation of  
the grounding of  
***mv Maersk Kendal***  
on Monggok Sebarok reef  
in the Singapore Strait  
on 16 September 2009

Marine Accident Investigation Branch  
Mountbatten House  
Grosvenor Square  
Southampton  
United Kingdom  
SO15 2JU

**Report No 2/2010**  
**March 2010**

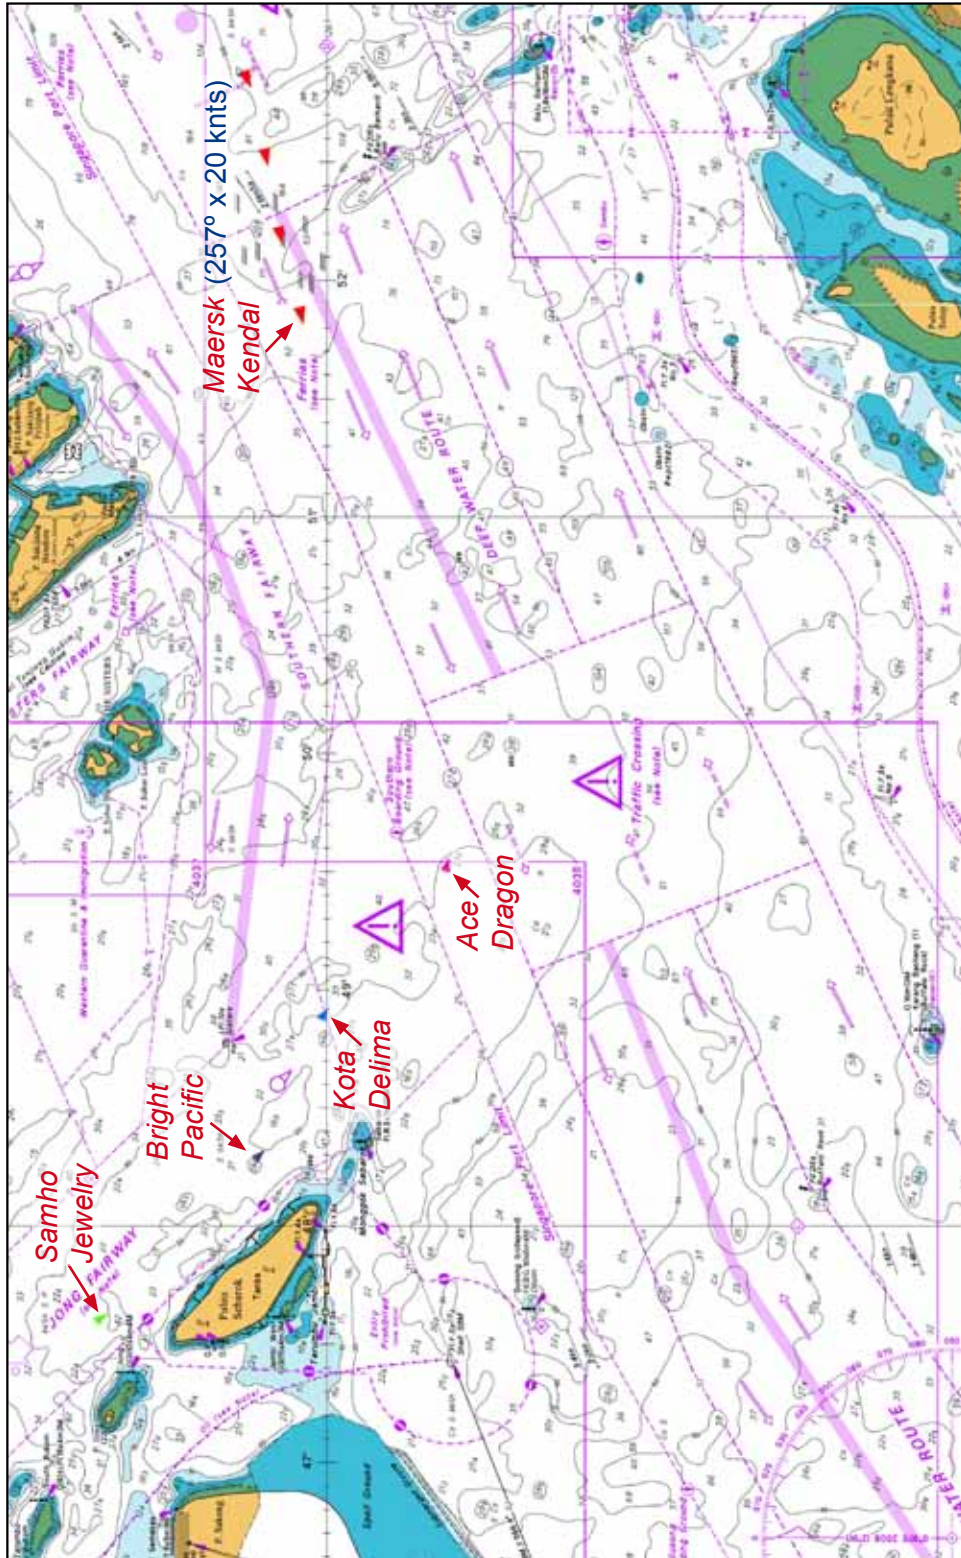
Figure 2

At 0703 (**Figure 2**), VTIS called *Maersk Kendal* and advised the vessel:  
*'Maersk Kendal, require you to slow down, require you to slow down.  
Three ships coming out of the Jong channel'*

Plot of vessels at 0703

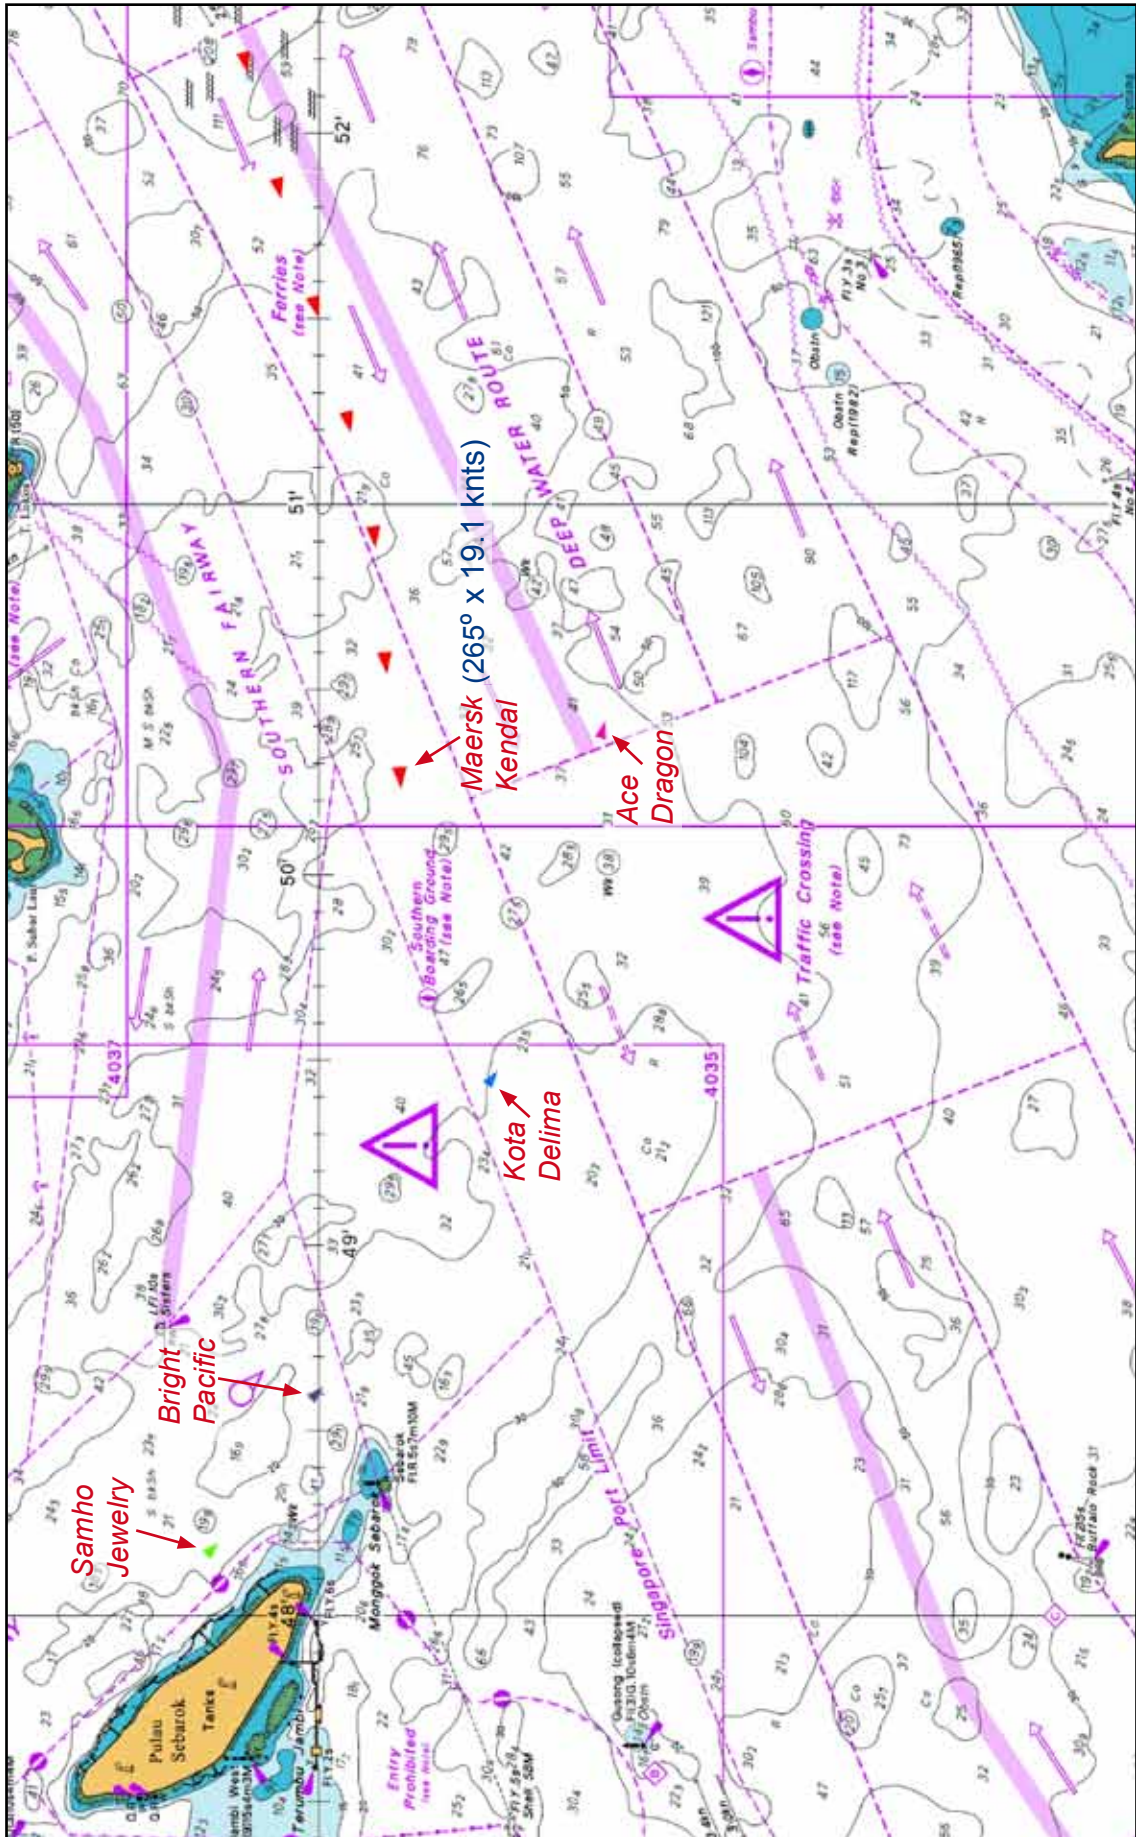
Figure 3

At 0708 (**Figure 3**), VTIS called *Maersk Kendal* and advised her to reduce speed as it was still high and the vessel was about to enter port limits. This message was acknowledged by the chief officer, and the master set the engine telegraph to slow ahead. Course and speed over the ground were recorded as 265° and 19.1 knots. The master then ordered a further alteration of course to starboard and steadied the vessel on a course of 273°.

Plot of vessels at 0700

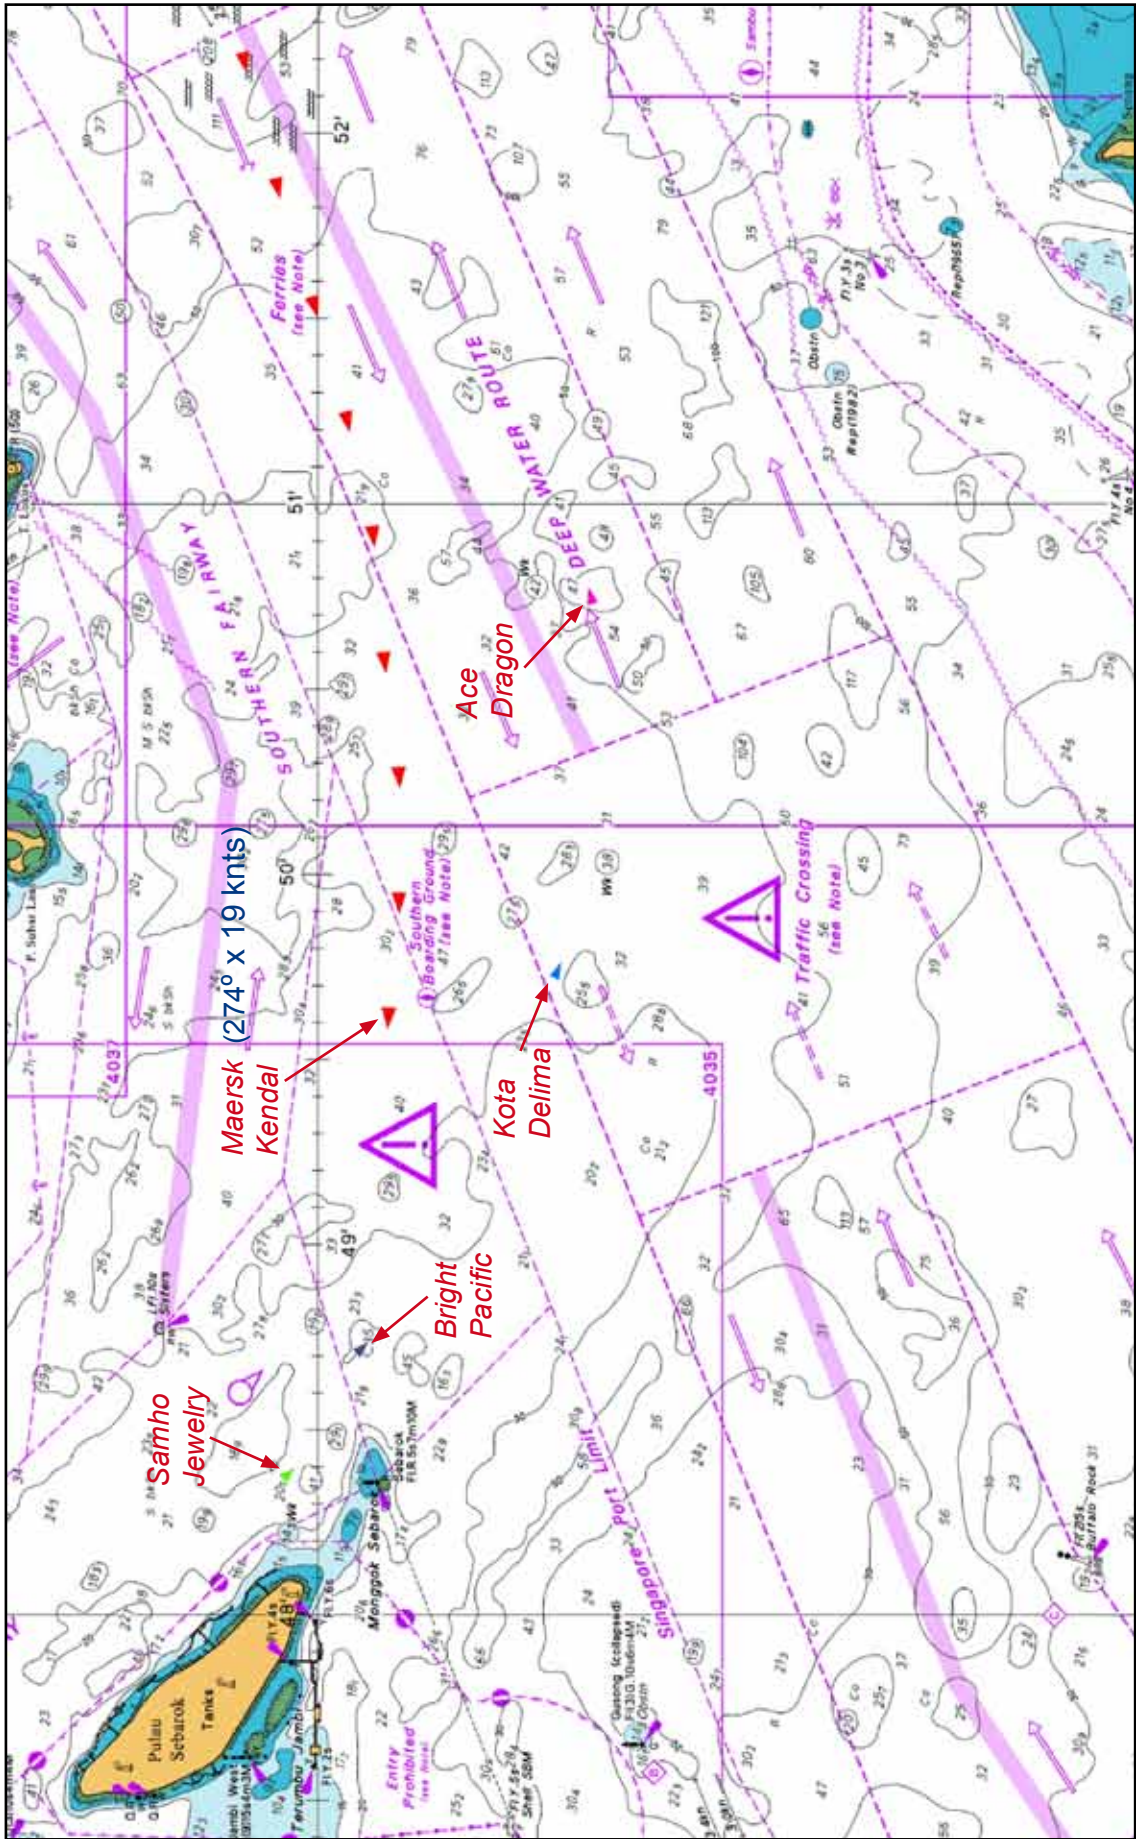
Figure 4

At 0710 (**Figure 4**), with *Maersk Kendal* proceeding on a course of 274° at 19 knots, VTIS called the vessel to confirm if the master was on the bridge, to advise him that the vessel had already entered Singapore port limits, and to request the vessel to slow down. The master responded by advising VTIS:

Plot of vessels at 0710

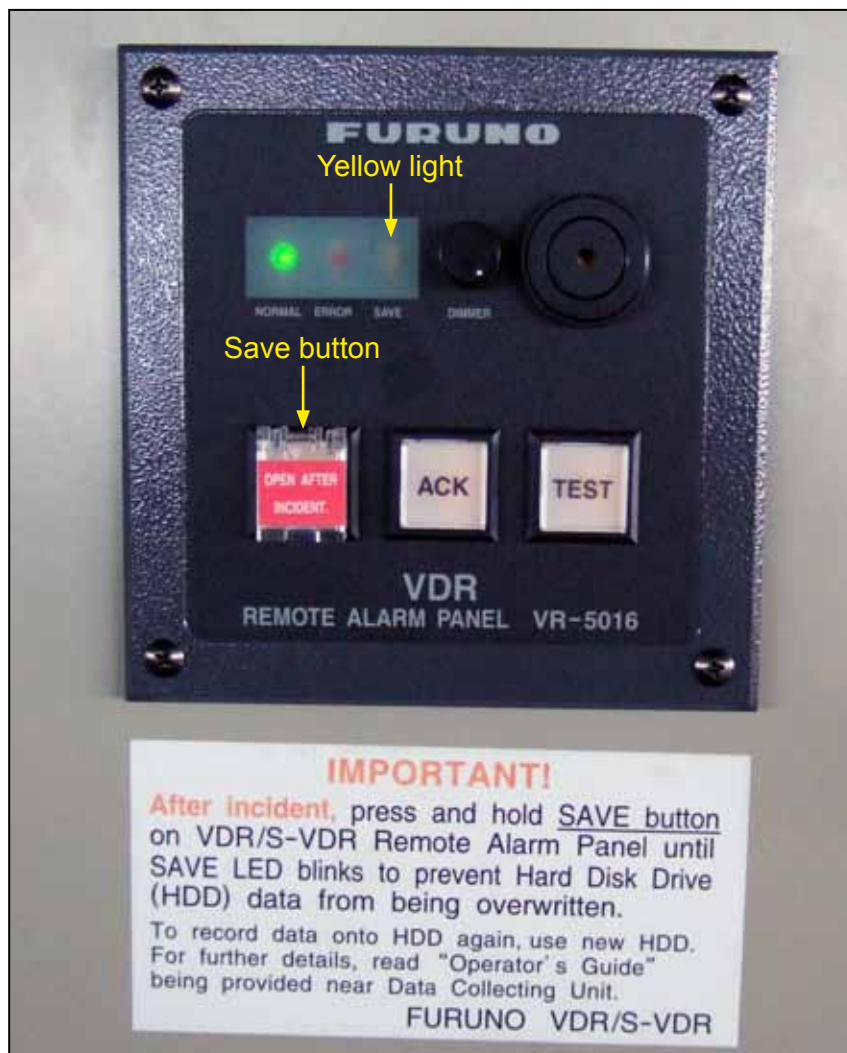
Figure 8

The master depressed the 'save' button (**Figure 8**) on the Voyage Data Recorder (VDR) and then notified the vessel's managers of the accident and that the VDR data had been saved. No general alarm was sounded, no crew muster was undertaken, and the checklist provided by the company for use in the case of grounding (**Annex C**) was not referred to.

VDR - Remote alarm panel showing 'save' button

On 17 September, a shore technician was contracted to extract the VDR data recordings on board. He found that the data had not been saved.

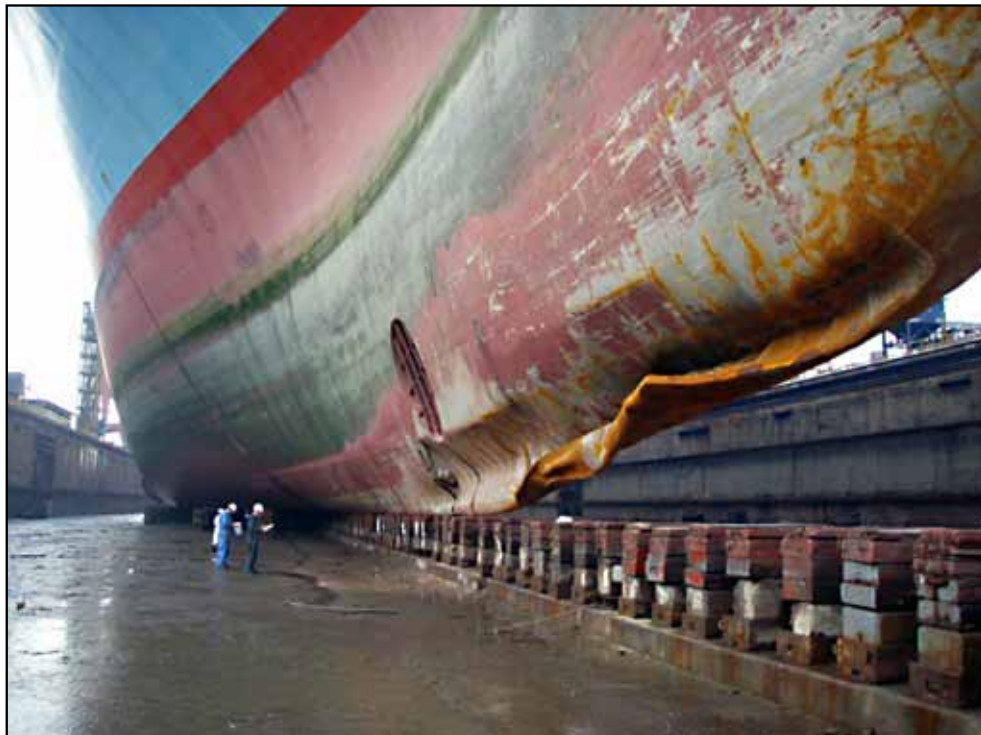
Figure 9

Fore peak - severe buckling of internal frames and hull plating extending from the tip of the bulbous bow for about 15 metres. The echo sounder and speed log compartments were also damaged.

Bow thruster room – damage to all electrical equipment including the bow thruster motor due to ingress of sea water and extensive buckling to the vessel's structure, mainly on the starboard side.

No. 1 void and No. 1 water ballast tank – extensive damage to the hull plating and internal frames (**Figure 9**).

Survey of damage in dry dock

The damage was repaired in the dry dock. An estimated 120 tonnes of steel was renewed before the vessel resumed service on 12 November.

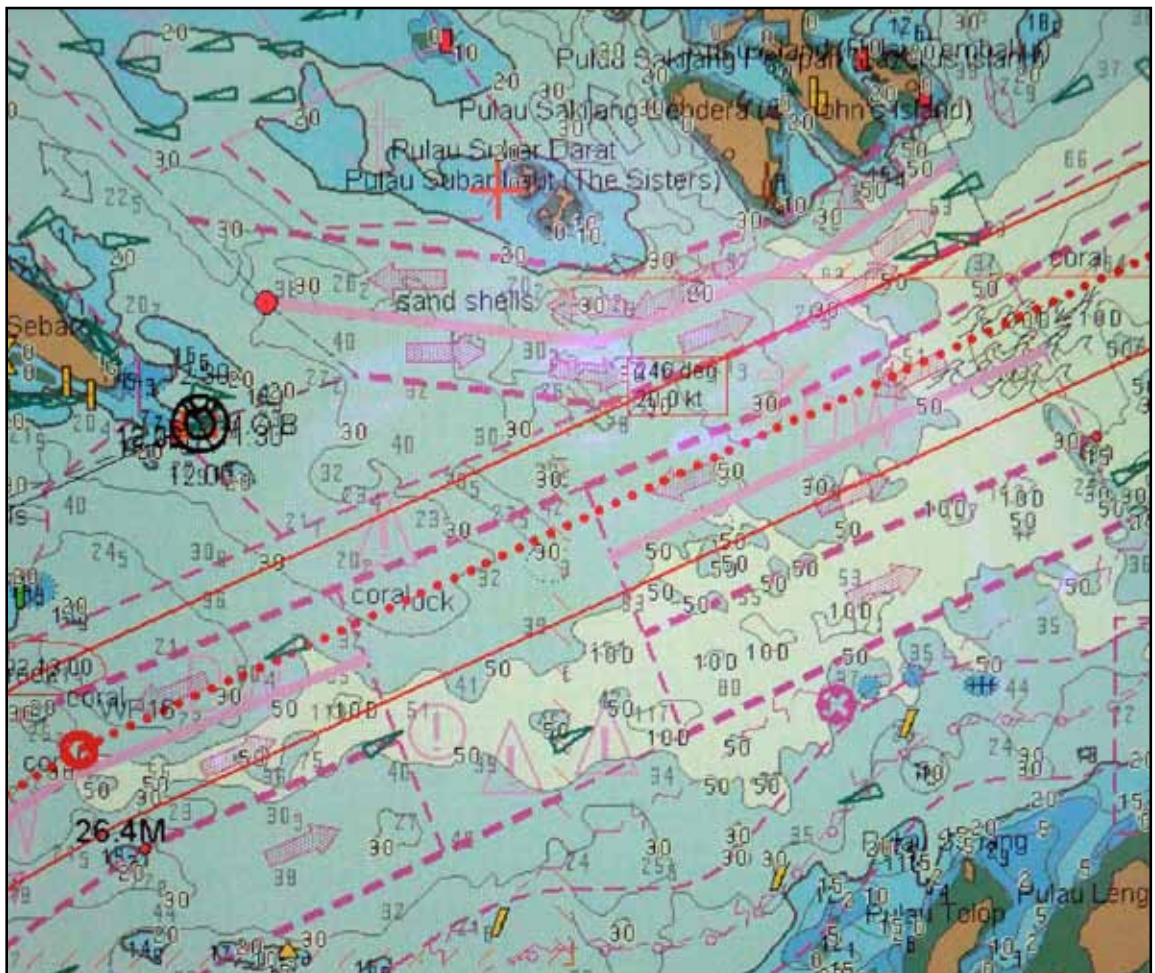
Figure 12

The planned course lines were also entered in the ECDIS. Inspection of the ECDIS after the accident revealed that only a safety contour of 20m and a cross track error of 1 cable had been configured. No safety depth, danger areas, look ahead or predicted movement indicator had been set up (**Figure 12**).

ECDIS passage plan
