Report on the investigation of the fatal injury of a crew member
and the serious injury of a second crew member
in heavy weather on board the UK registered container ship

Maersk Kithira

23 September 2008

Report No 9/2009
April 2009

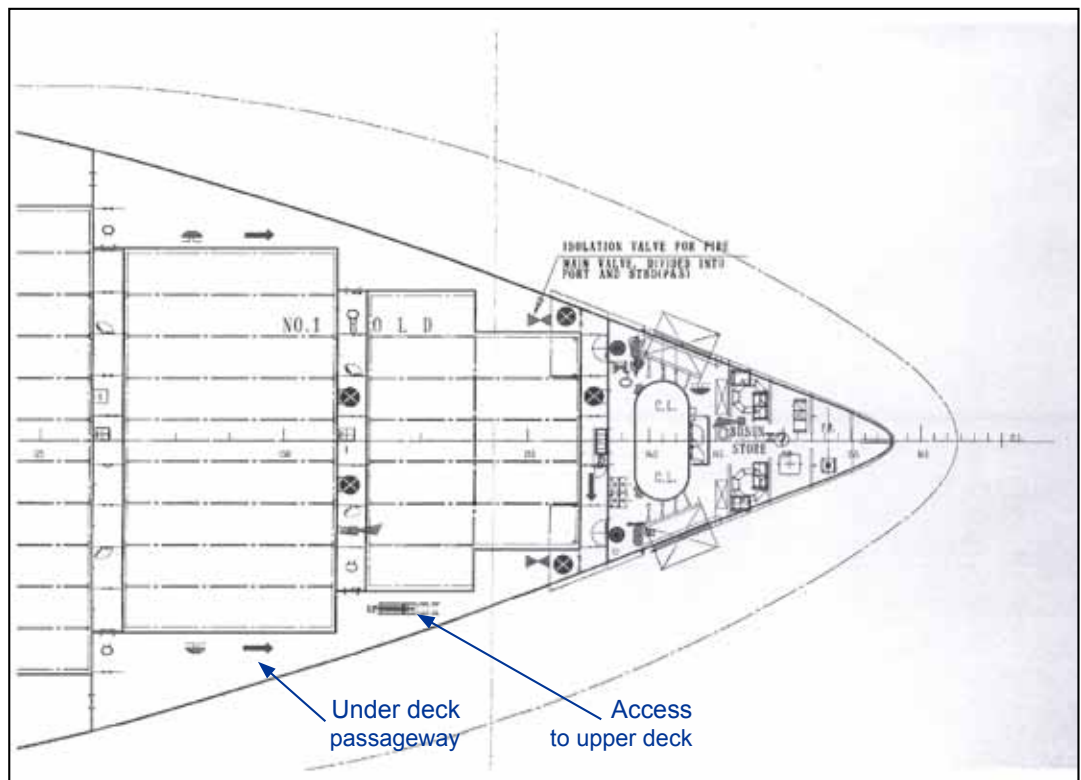
Figure 1c

On arrival at the bosun's store (**Figure 1**), the chief officer and chief engineer found that the deck was wet, and that water was entering through the forecandle deck stores hatch cover seal. Shortly afterwards, at 2007, they reported to the bridge by telephone what had been found.

Plan of Bosun's Store - *Maersk Kithira*

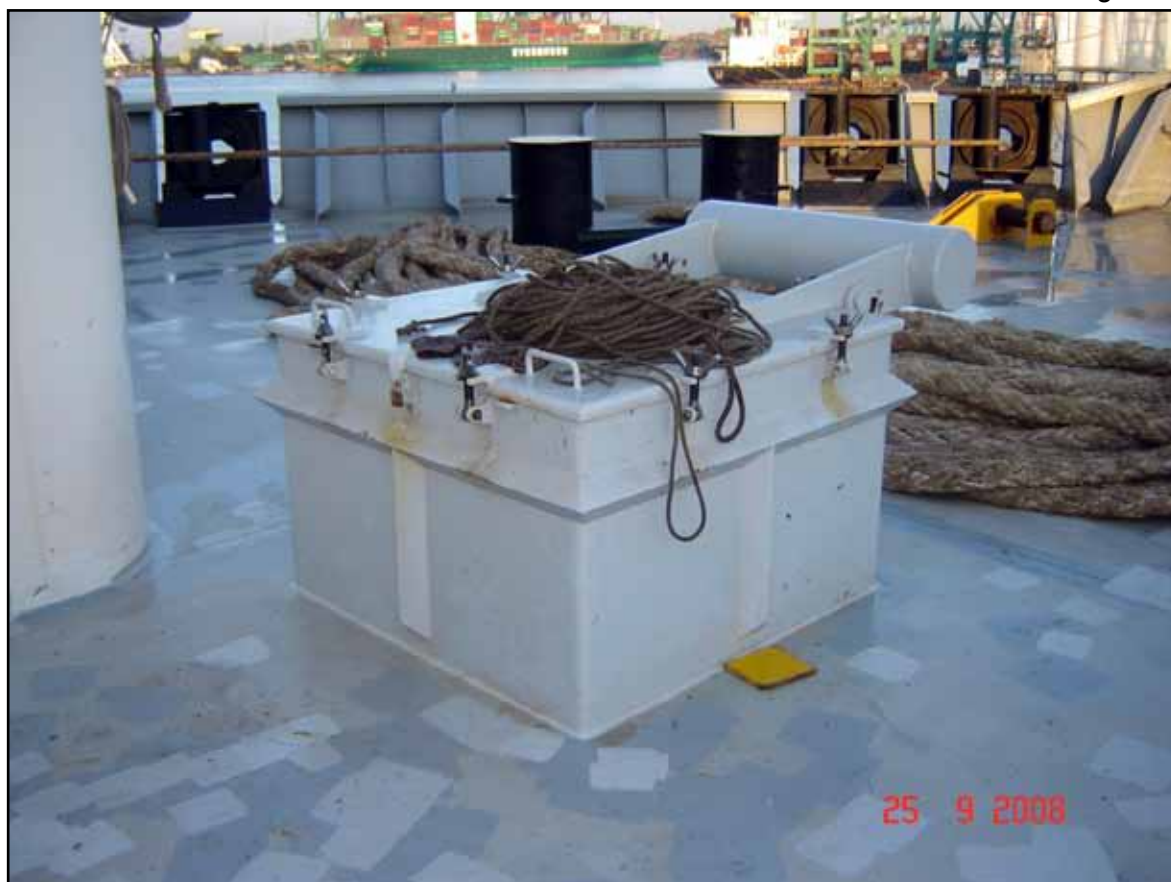
Figure 2

The master, chief engineer and chief officer jointly agreed that it would be necessary to tighten the dogs securing the forecastle stores hatch (**Figure 2**) to prevent further water from entering the space. The third officer switched on the foredeck floodlights, and the chief officer and chief engineer waited briefly at the top of the access to the upper deck for the master to give permission for them to proceed. At 2010, permission was given, and the two men went onto the upper deck. Ship movement was such that neither found it difficult to stand. They made their way initially to the access port in the breakwater (**Figure 3**), and stood in the shelter of the breakwater to assess the motion of the ship, and gauge the amount of water being shipped on the deck. Noting that the only water coming onto the deck was spray coming up through the hawse pipe, they decided that it was safe to go onto the forecastle, and at 2011, informed the master by UHF radio of what they were doing.

The forecastle stores hatch

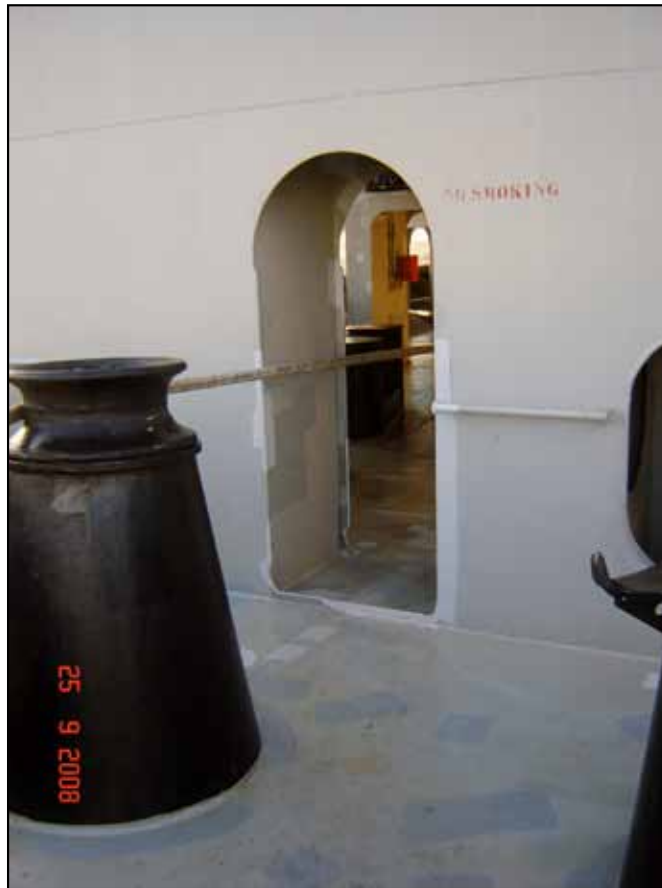
The access through the forecandle breakwater

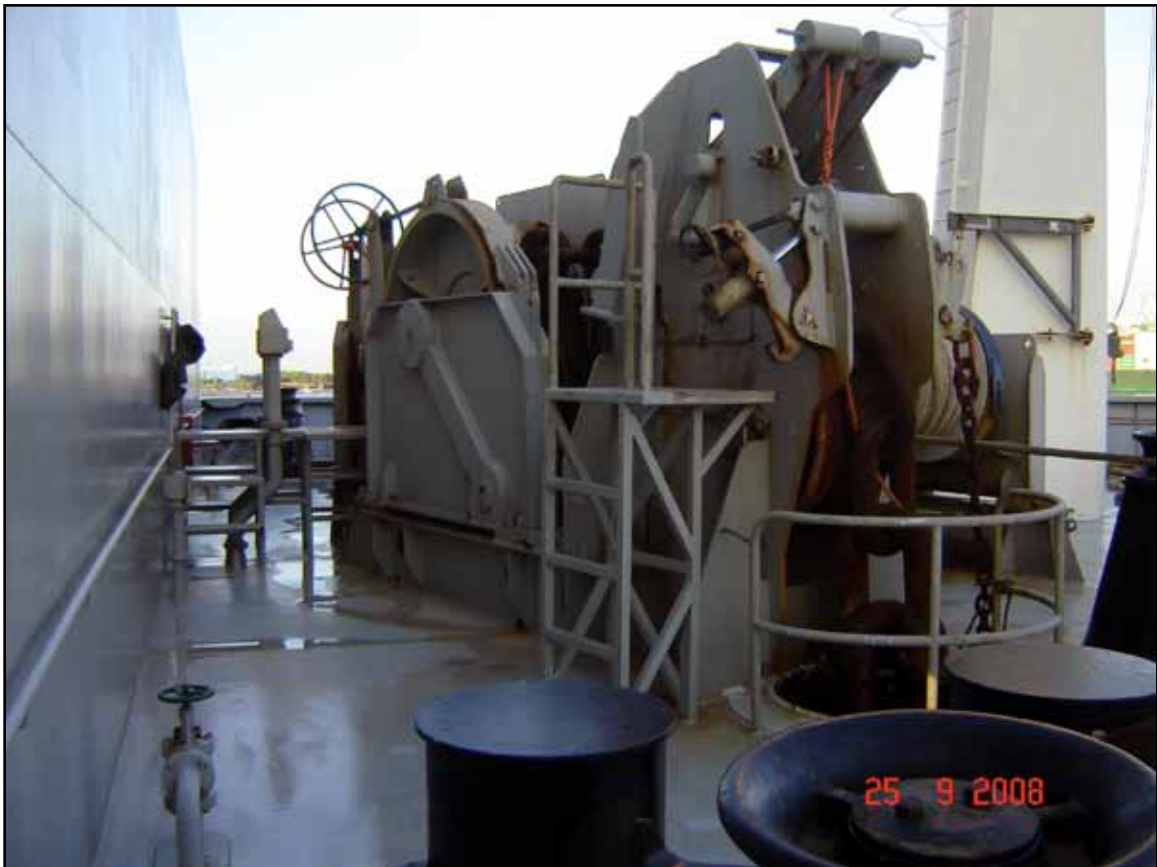
Figure 4

The chief officer and chief engineer returned to the forecastle and set about tightening the anchor cable securing chain. This required one man to mount the windlass platform (**Figure 4**) to release the securing chain locking screw, while the other remained at deck level to adjust the securing chain through a link of the anchor cable. The chief engineer mounted the platform, and released the locking screw, allowing the chief officer to adjust the chain. As the chief engineer then re-tightened the locking screw, a wave broke over the forecastle and washed him off the platform. The wave also knocked the chief officer off his feet and propelled him into the windlass, rendering him unconscious. No wave impact was seen or felt by either the master or third officer on the bridge.

The starboard anchor windlass
