Report on the investigations of
heavy weather damage
on board the container ship
Maersk Newport
50 miles west of Guernsey
on 10 November 2008
and fire
alongside at the container berth in Algeciras, Spain
on 15 November 2008

Report No 13/2009
June 2009

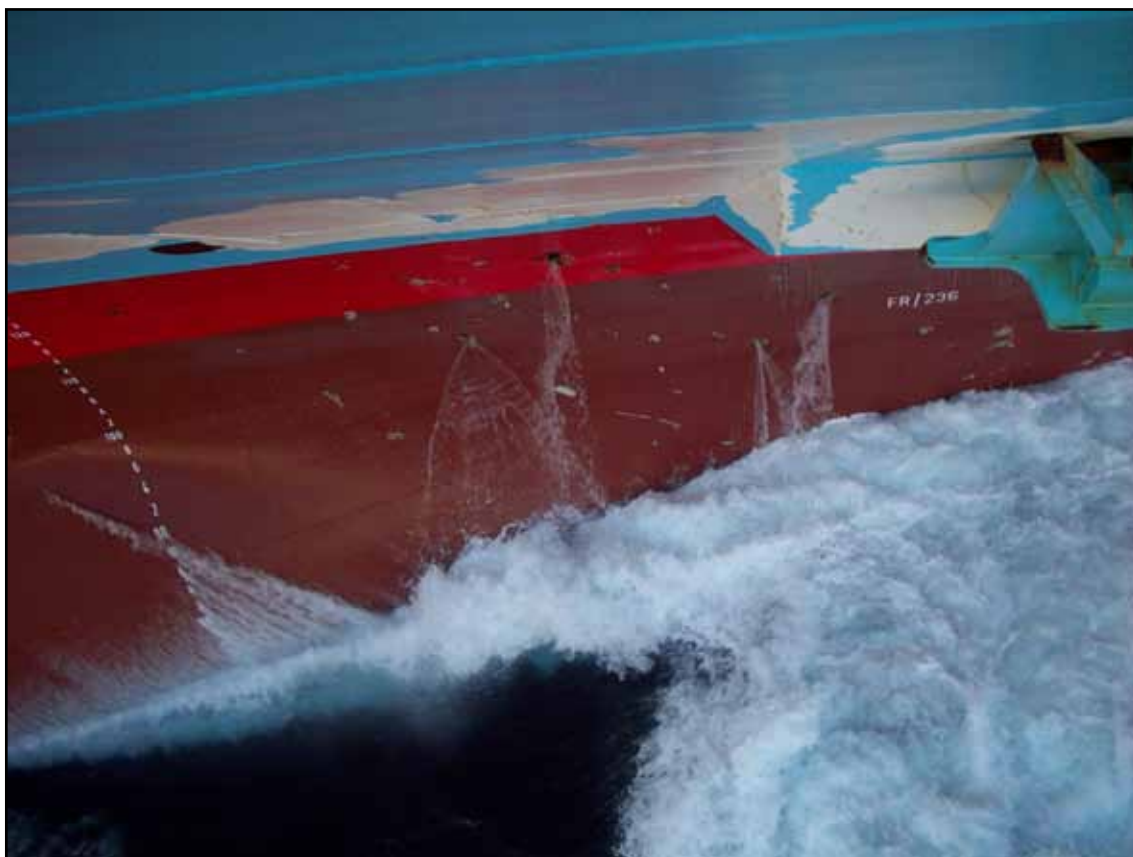
The bosun was sent to get wooden wedges and neoprene rubber with which to stem the flow of water. On his way he went to the forecastle head with the incoming chief engineer and chief officer to investigate the damage from the outside. On looking over the port side, the port anchor was seen to be below the sea surface, and there were numerous indentations and splits in the vicinity of the port side of the bow thruster room. As the bow pitched, water was seen spraying out from more holes in the forepeak area, **Figure 5**.

Damage to the port side of the hull seen from the forecastle

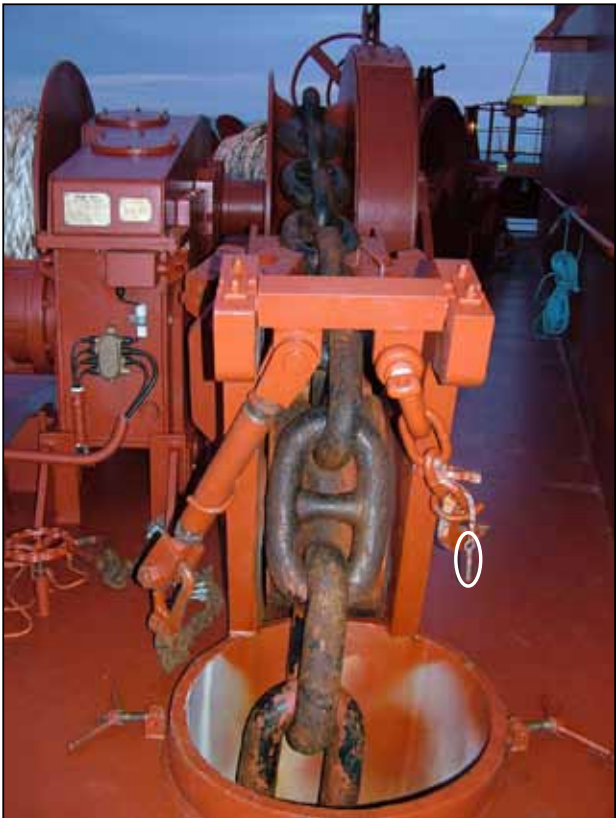
Figure 7

The forecastle team found that about $\frac{1}{2}$ to $\frac{3}{4}$ shackle of the port anchor cable had been released. The lashing chain Senhouse slip tapered securing pin had become detached from the slip and was hanging by its chain (**Figure 7**) and that the lashing chain was hanging loose. It was also found that the forward guillotine block was in the upright open position while the after guillotine block was in the horizontal closed position – **Figure 8**. Before the anchor cable was recovered, the chief officer checked the winch brake and managed to apply one full turn of the brake handwheel. After the port anchor was fully secured, checks were made to confirm that the starboard anchor was also fully secured.

Senhouse slip securing pin in detached position

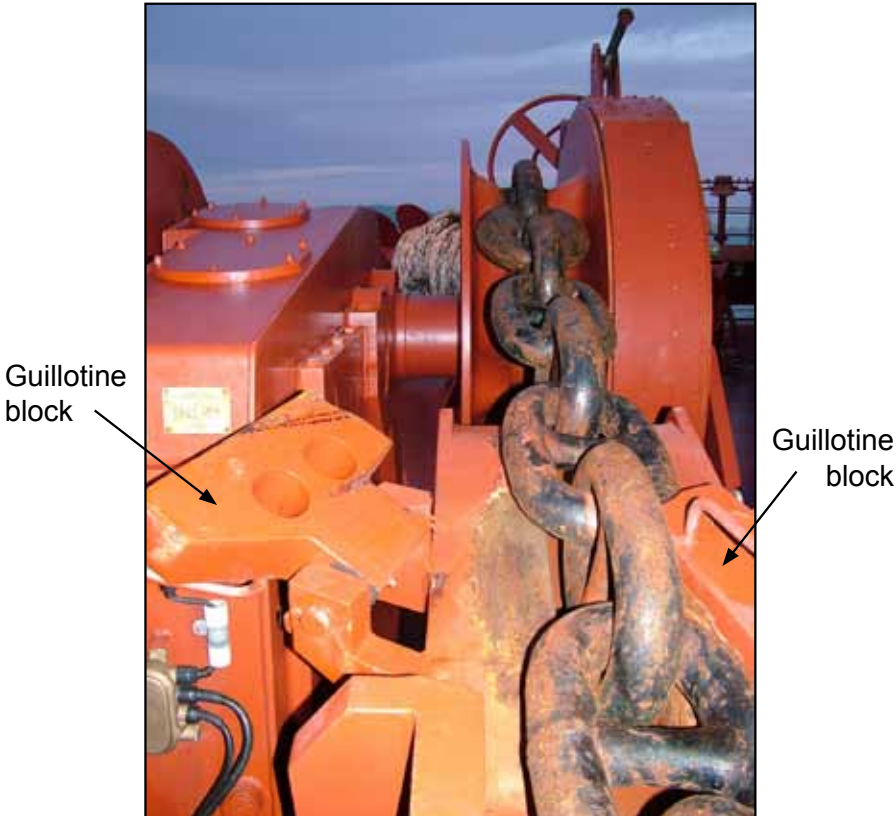
Figure 8

Position of the port anchor guillotine blocks

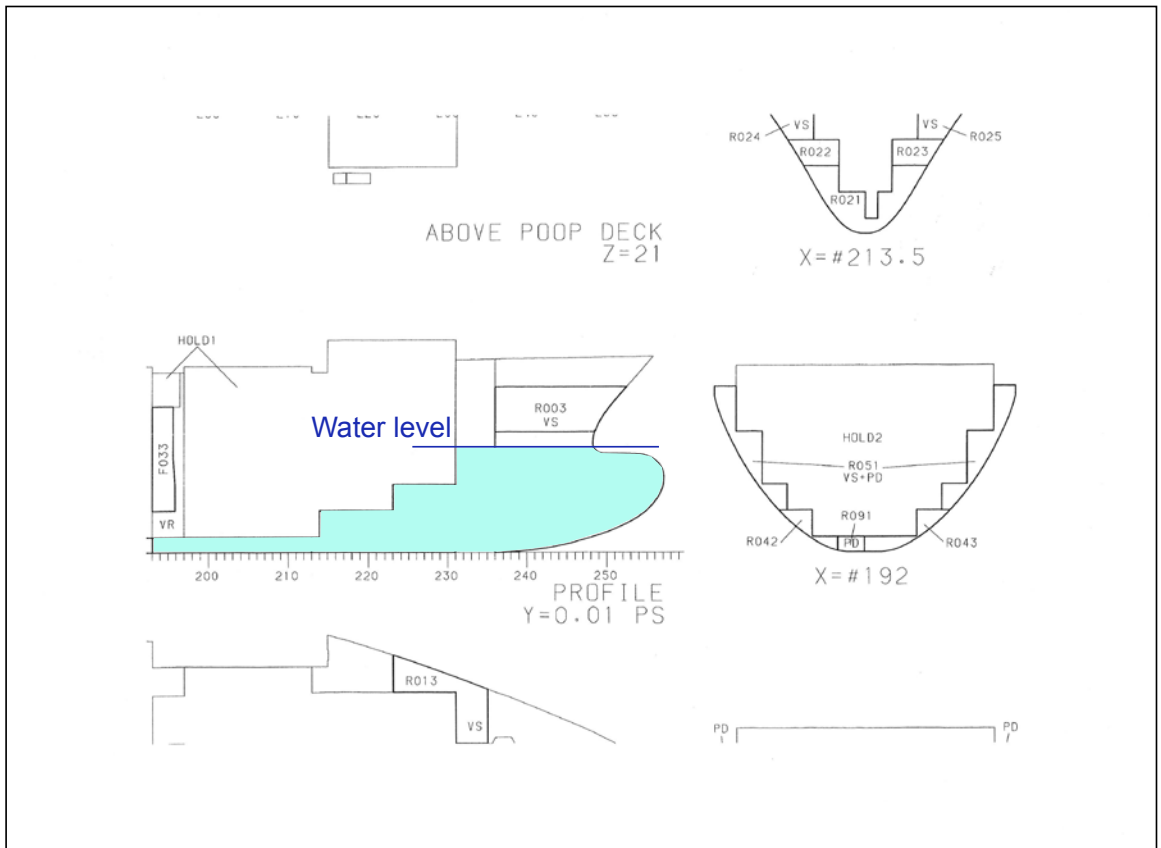
Figure 9

The water level in the bow thruster room was constantly monitored throughout the remainder of the day and night and was found to be slowly rising. By late evening the following tanks/spaces were found to have been breached (**Figure 9**):

Ship's section showing extent of flooding

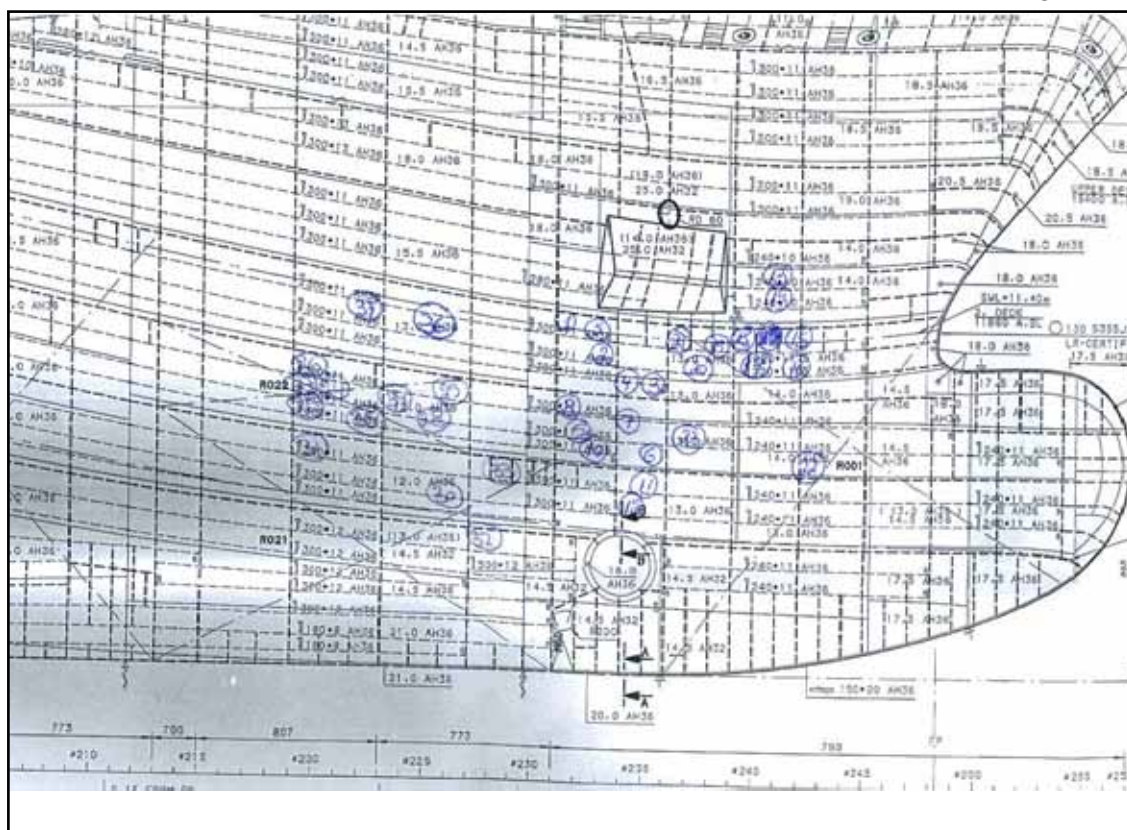
Location of insert plate repairs

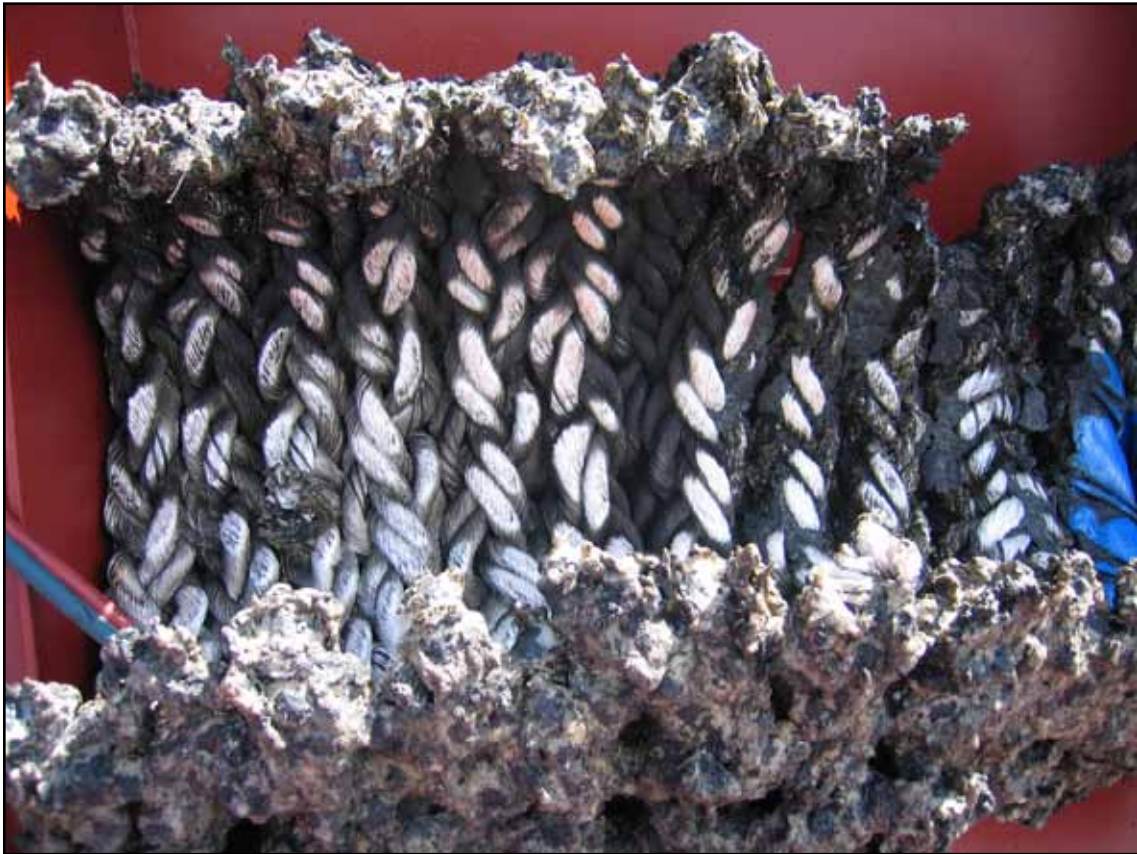
Figure 16

Fire damaged mooring rope from the port windlass winch drum

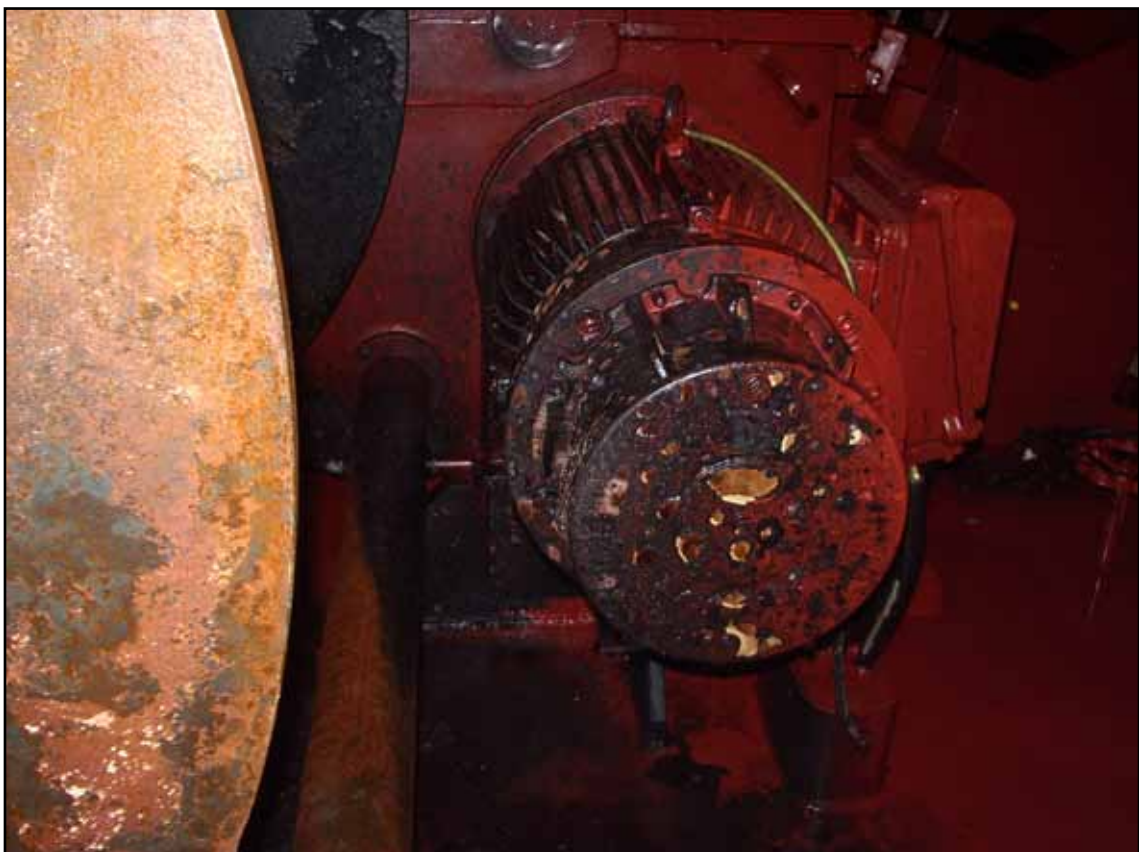
Figure 17

Fire damage to the port windlass winch

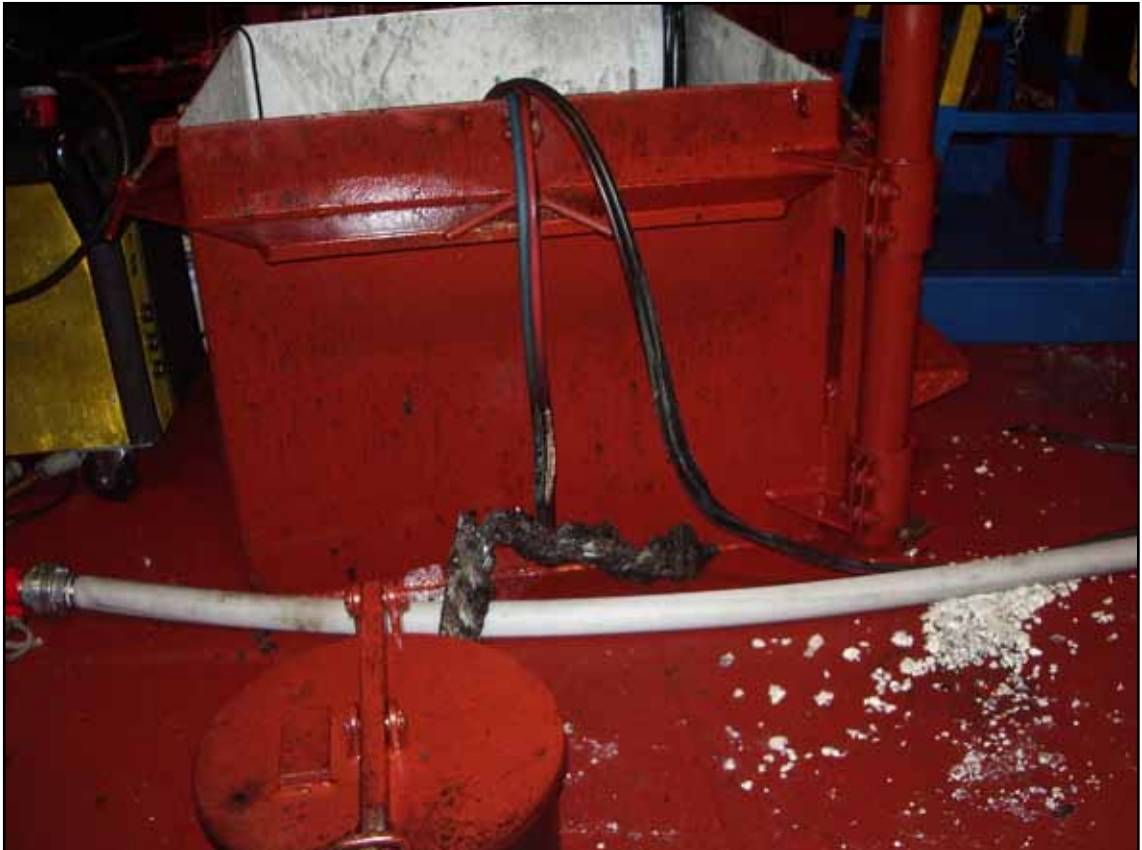
Figure 18

About 10m of the contractor's three oxygen and acetylene gas hoses were burnt through (**Figure 18**), but the remaining 40m were unaffected. The hose non-return valves and flame arrestors fitted to the bottle regulators had been largely destroyed as had most of the acetylene and oxygen bottle regulating valves.

Acetylene and oxygen hose fire damage

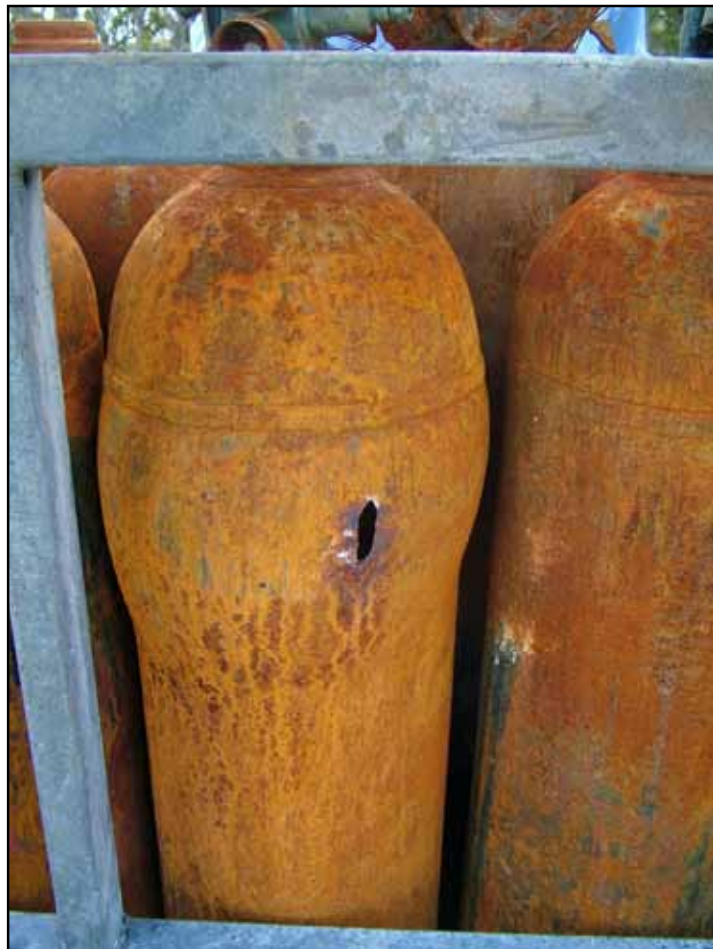
Figure 20

Distorted acetylene bottles

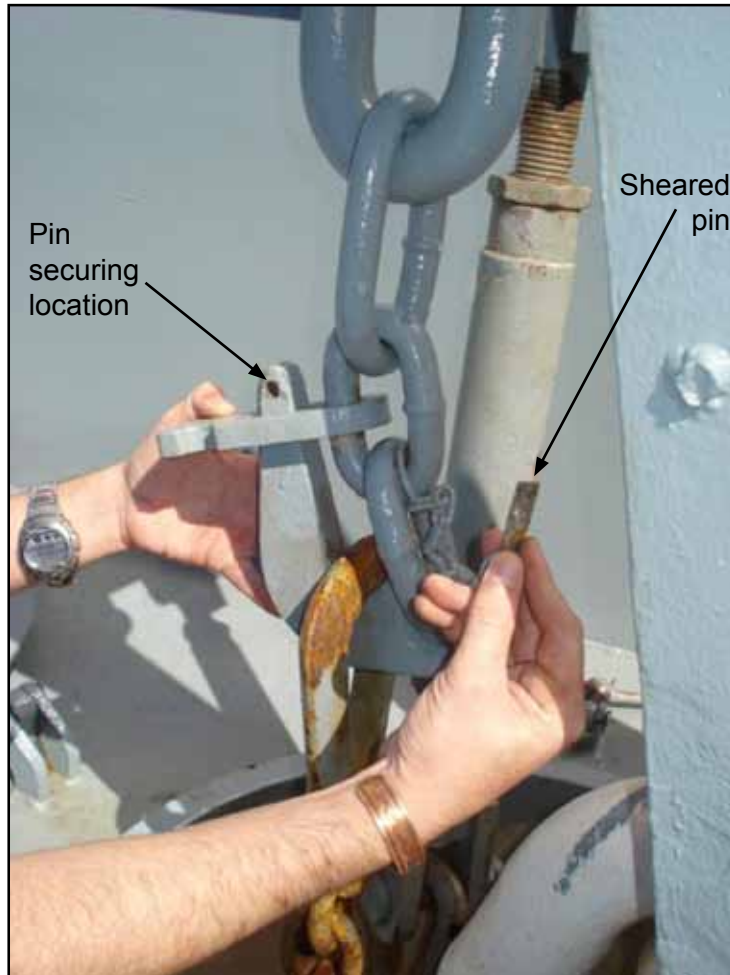
Figure 29

Safmarine Nyassa's starboard anchor Senhouse slip sheared tapered securing pin

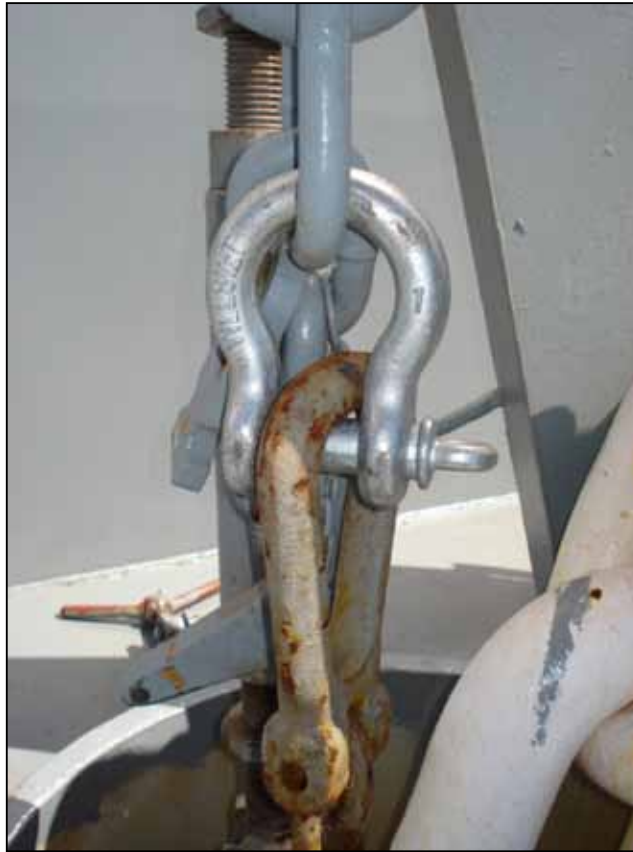
Safmarine Nyassa's starboard anchor Senhouse slip sheared tapered securing pin bow shackle replaced arrangement
