Report on the investigation of a
manoverboard accident

FV Maggie Ann

on 12 February 2009

Report No 19/2009
September 2009

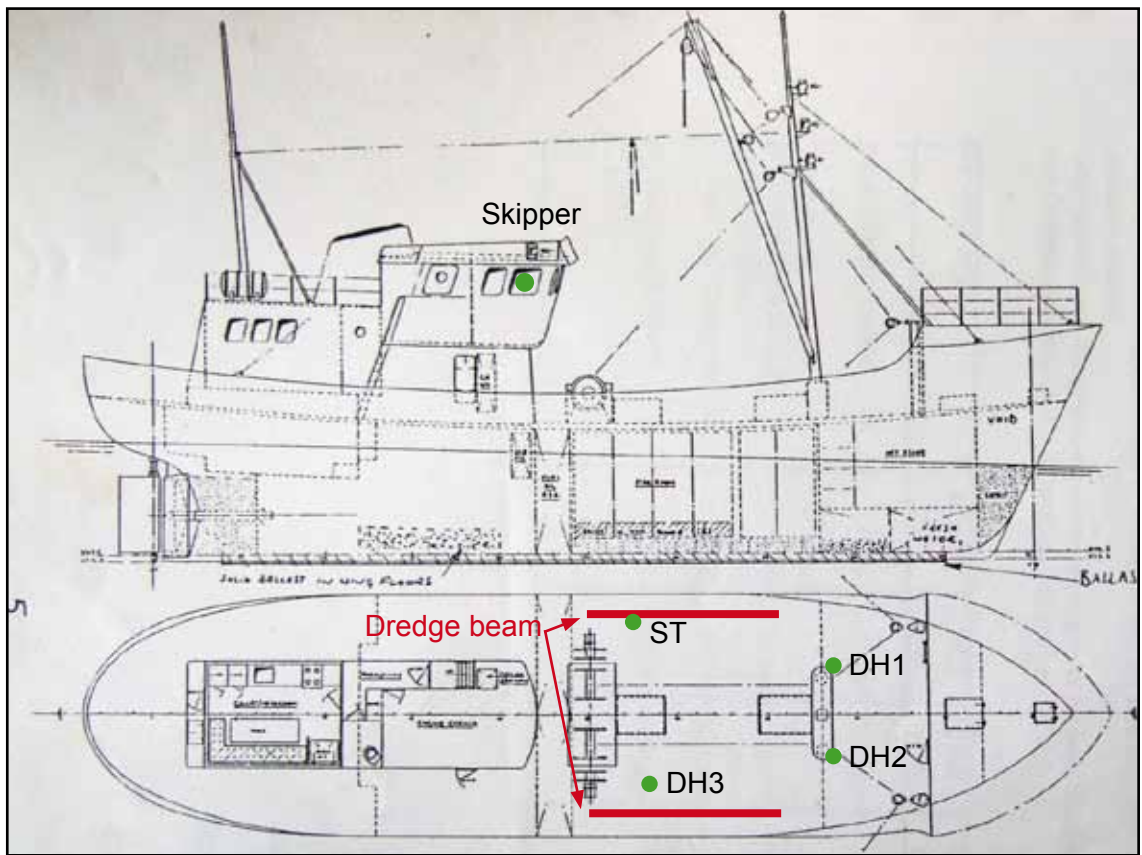
Figure 2

Position of the crew at the time of the accident (1300)

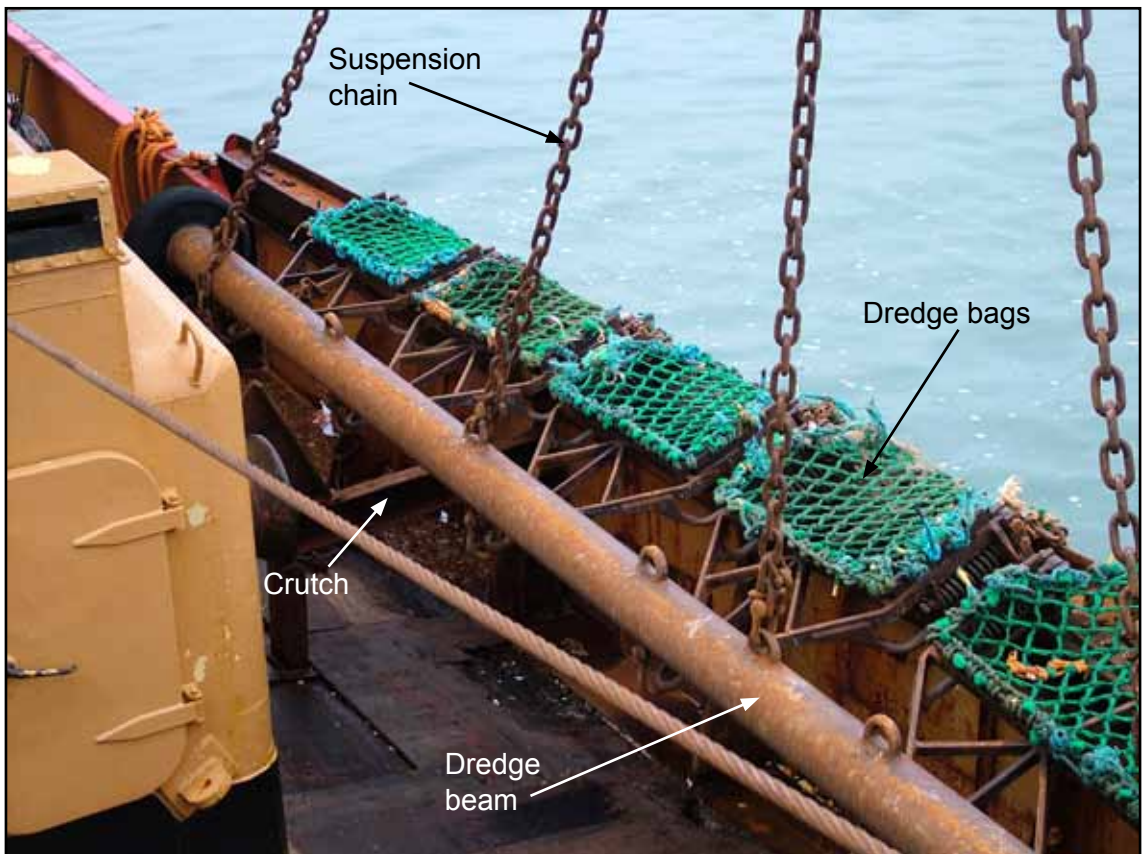
Figure 3

Dredge beam and attached dredge bags

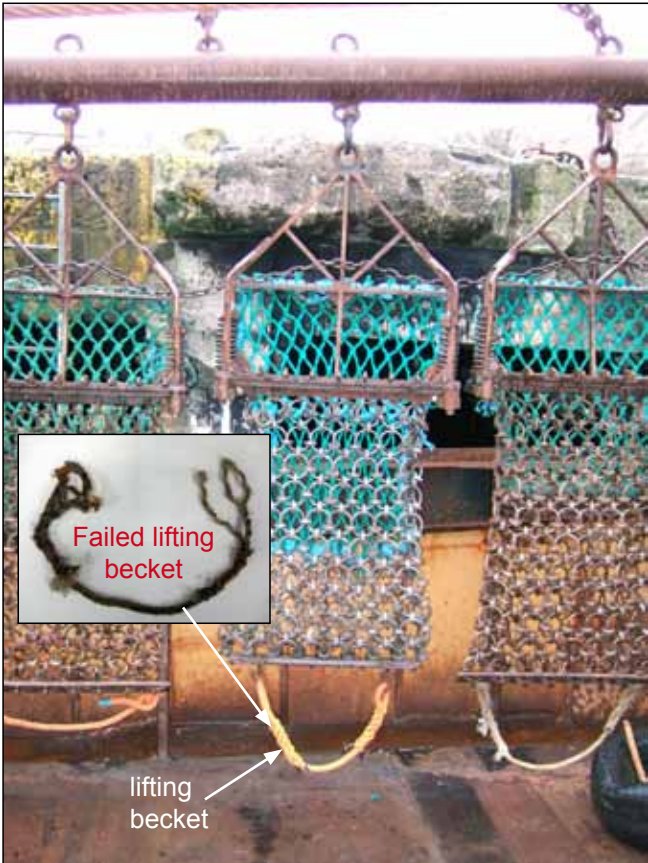
Figure 4

Dredge bags and the parted lifting becket

The lifting becket was made of polypropylene rope and was attached to two metal rings on the scallop dredge by means of an informal splice. The area of attachment was prone to particular wear and degradation. The lifting becket (**Figure 4**) recovered on board *Maggie Ann* after the accident indicates this to be the point at which the rope parted.

The wear on the parted lifting becket was not identified prior to the vessel departing port, nor was it identified during the fishing cycle prior to the accident.

If the lifting becket on the dredge bag had not failed, the accident would not have happened. The failure was due to the wear at the point of attachment to a metal ring on the dredge. Such wear is inevitable given that rope (rather

It is possible, but not certain, that the wear might have been detectable on the previous haul or on inspection before sailing. Inadequate maintenance was, therefore, a possible contributory factor. The accident provides an object lesson in the need for a robust inspection and maintenance regime of working gear.

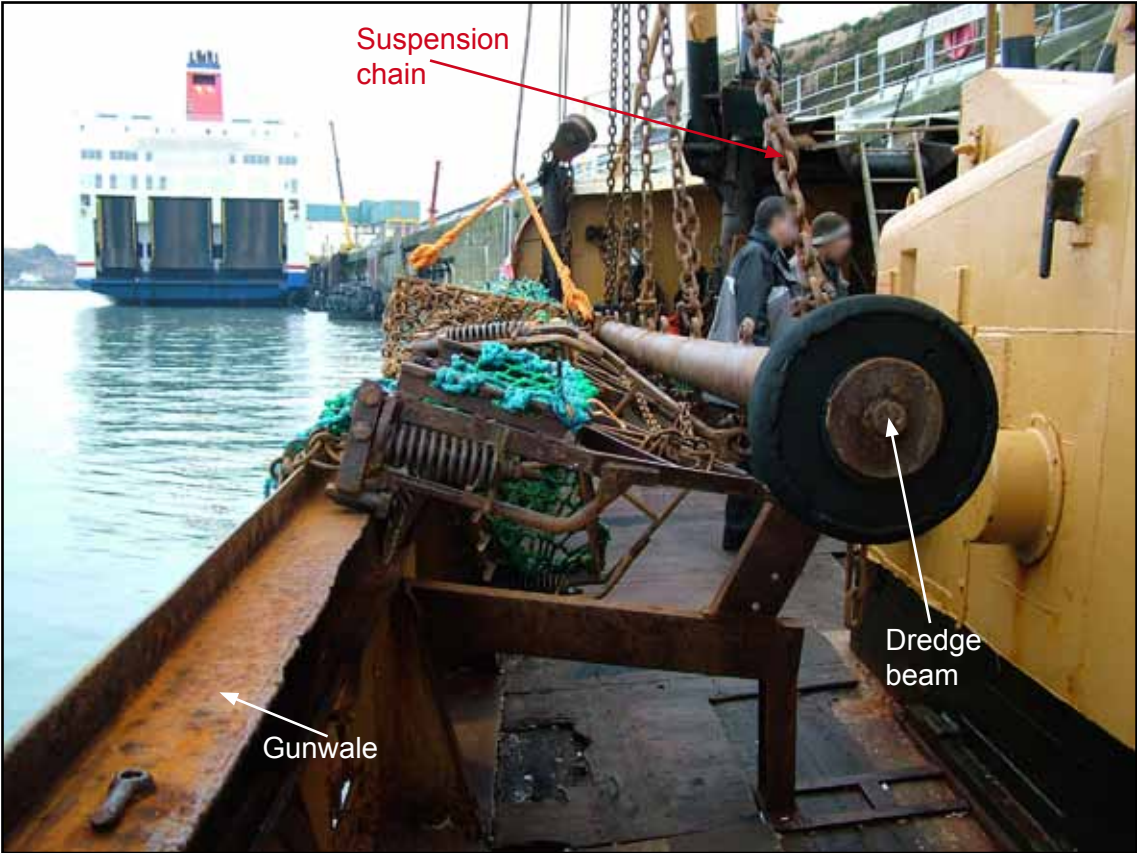
Figure 5

The port and starboard dredge beams were lifted and swung inboard, and the deckhands secured each beam (**Figure 3**) with its respective fore and aft lashings. The skipper then attempted to land the beams in the designated crutches, fitted just above the deck level, with the dredge bags (**Figure 4**) resting on the gunwale. The dredge bags were full of stones as well as scallops, which prevented the beam from being lowered into the crutches. This resulted in the beams remaining suspended and almost level with the gunwale on either side of the vessel (**Figure 5**).

Simulated position of dredge beam at time of accident

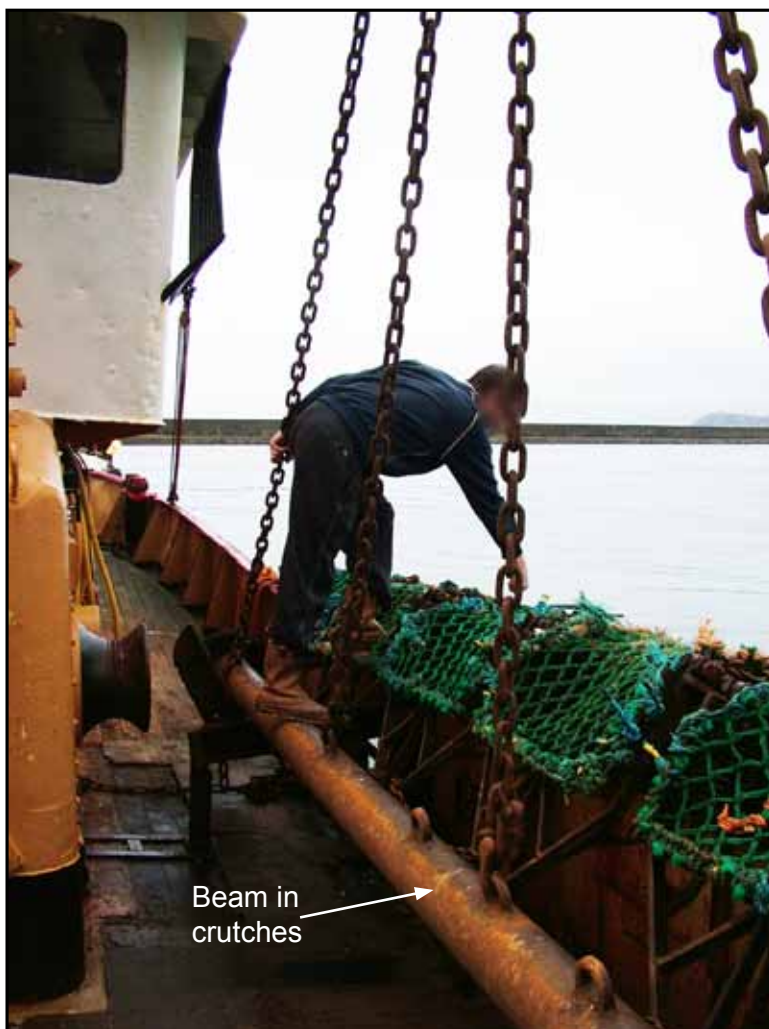
Figure 6

Simulation by deckhand - snaring the lifting becket

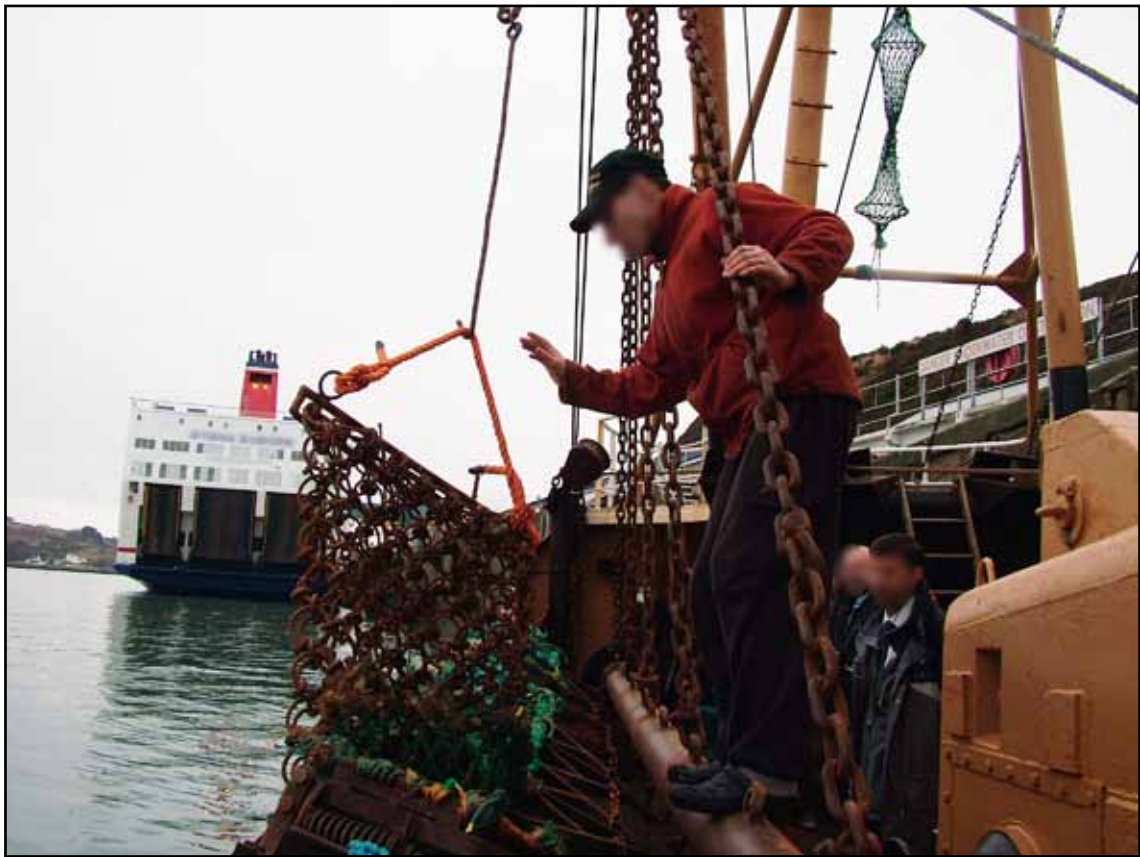
To assist the process of emptying the second dredge bag, Stefan let go of the chain and used both hands to shake the bag (**Figure 7**). As he did so, the lifting becket parted, causing him to fall overboard. DH1, who witnessed the event, immediately raised the alarm and threw a lifebuoy in his direction.

Simulation by deckhand - shaking the dredge bag

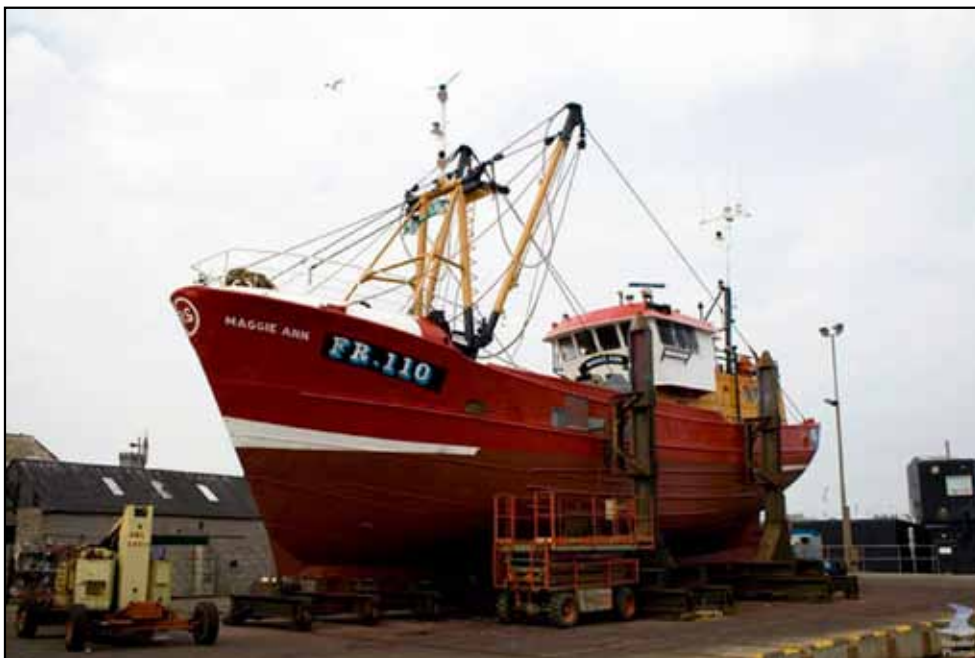
Figure 9

In July 2006, the previous owner levelled the gunwale on either side of the vessel and fitted a 9 metre length channel section on top of it. The modification effectively increased the height of the bulwark by up to about 250mm (**Figure 9**). This allowed the scallop dredges to be taken on board in a more controlled manner; the level gunwale enabled the teeth of all of the dredges to be engaged in the channel section simultaneously, and thereby allowed the dredge bags to be emptied in turn without any further adjustment.

Maggie Ann - showing modification to the bulwark

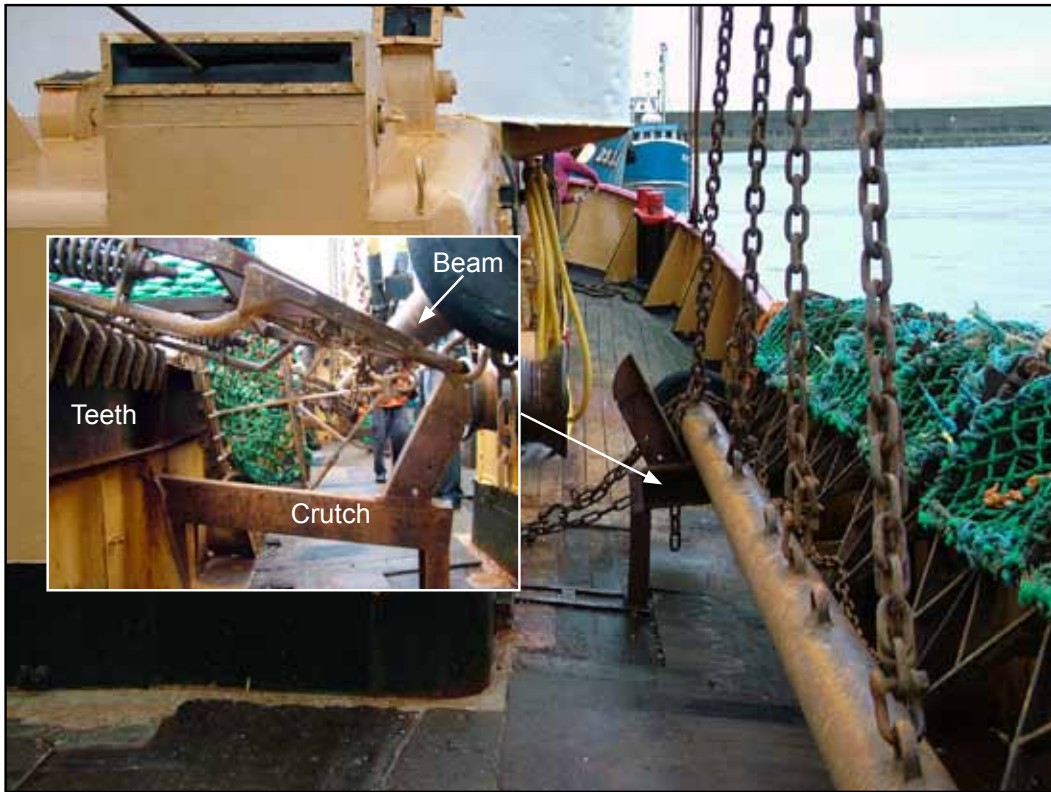
Figure 10

The increased bulwark height improved crew safety, but the dredge beam could no longer be lowered onto the deck. To allow the dredge beam to rest in a secure position while the dredge bags were being emptied, the owner fitted a pair of crutches to the deck (**Figure 10**) into which the dredge beam was lowered. When the dredge bags were full, the dredge beam had to be pulled inboard and down, by means of a separate line that led to a whipping drum on deck (**Figure 11**), to enable it to be landed in the crutches. This resulted in the scallop dredge teeth (**Figure 10**) passing inboard of the bulwark with the dredge bags resting on top of the gunwale. The current skipper did not usually make use of the additional line to land the beams onto the crutches, resulting in the dredge beam remaining suspended and almost level with the gunwale when the dredge bags were full and about to be emptied.

Position of dredge beam when resting on crutches

Following the modifications, the increased height of the bulwark, together with the added protection against movement of the dredge beam provided by the crutches, improved the crew's safety. However, the new arrangement resulted in exposing the crew to new hazards because they were required to stand on an elevated beam to snare the lifting becket and empty the dredge bags. The risks of falling off the beam and of falling overboard also increased significantly when the beam was not lowered into the crutches and instead remained suspended, almost level with the gunwale.

These risks could have been mitigated by pulling the beam down into the crutches, a practice discontinued by the current skipper, or by wearing a safety harness, as recommended by MGN 311 (F). Alternatively, a 'tipping' bar, commonly used on scallop dredgers (**Figure 12**), could have been fitted. This would have enabled all the dredge bags to be inverted at the same time and have avoided the need for deckhands to step onto the dredge beam or to lean over the gunwale.

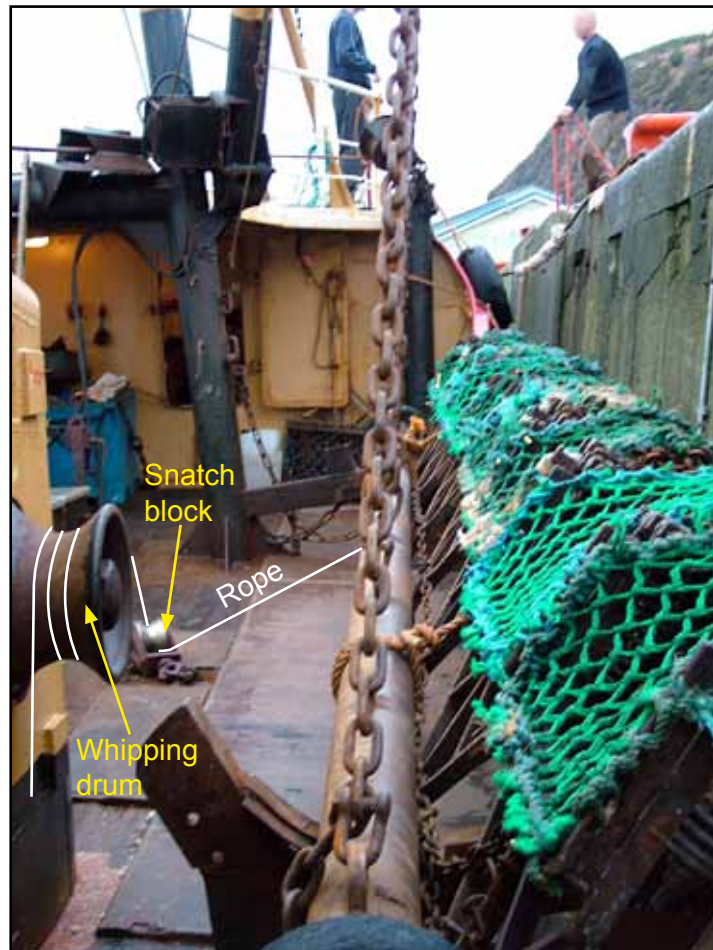
Figure 11

Bowsing in arrangement

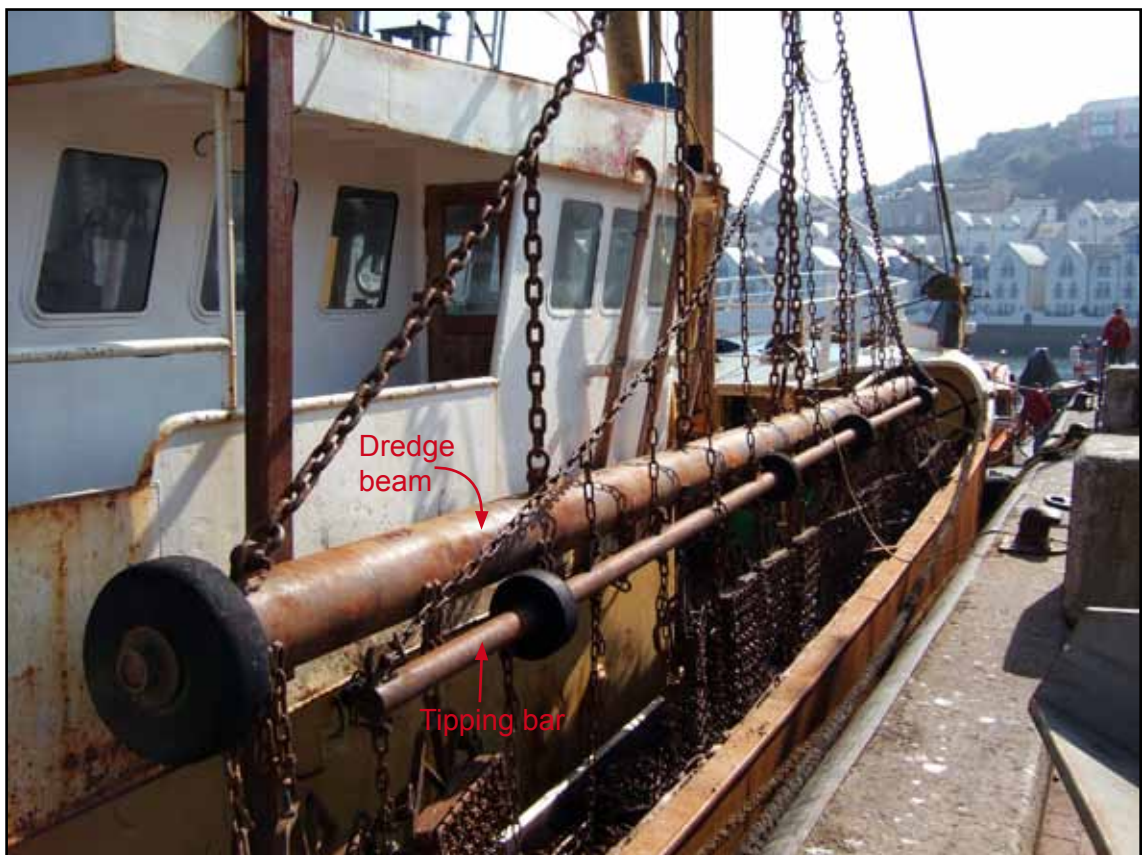
Figure 12

Fitted 'tipping bar' arrangement
