Part 1 – Merchant Vessels

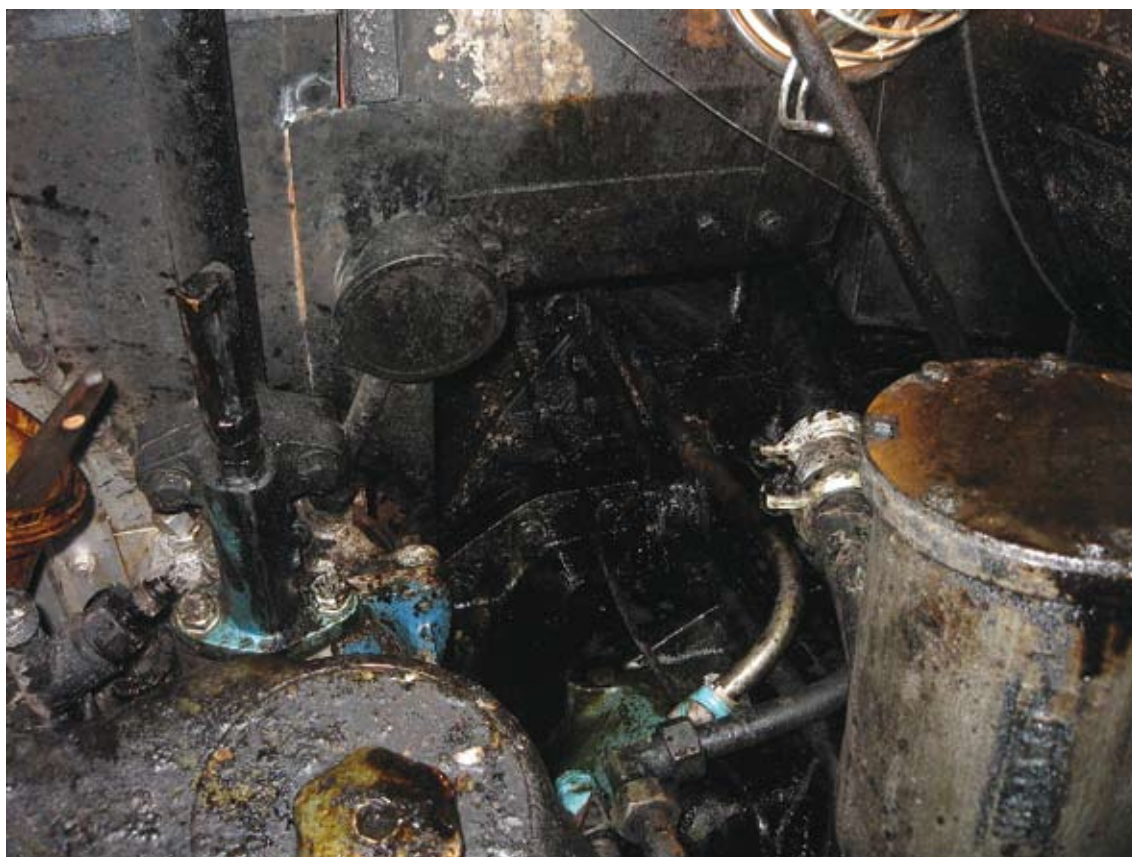
Figure 1 – Burst fuel pipe

100mm long had become detached. Pre-heated fuel oil had then spilt between the two banks of the V configured main engine and, despite splash guards being in place, ignited.

The fire caused severe damage in an area of 6m radius around the fractured pipe. Engine controls, the governor, cables, a turbocharger

2. Fuel and lubrication pipework should be inspected regularly and replaced if there are signs of any leakage or wear.
3. While it is always good practice to clamp pipework securely, clamps must fit correctly so that they do not introduce more stresses into the pipework.

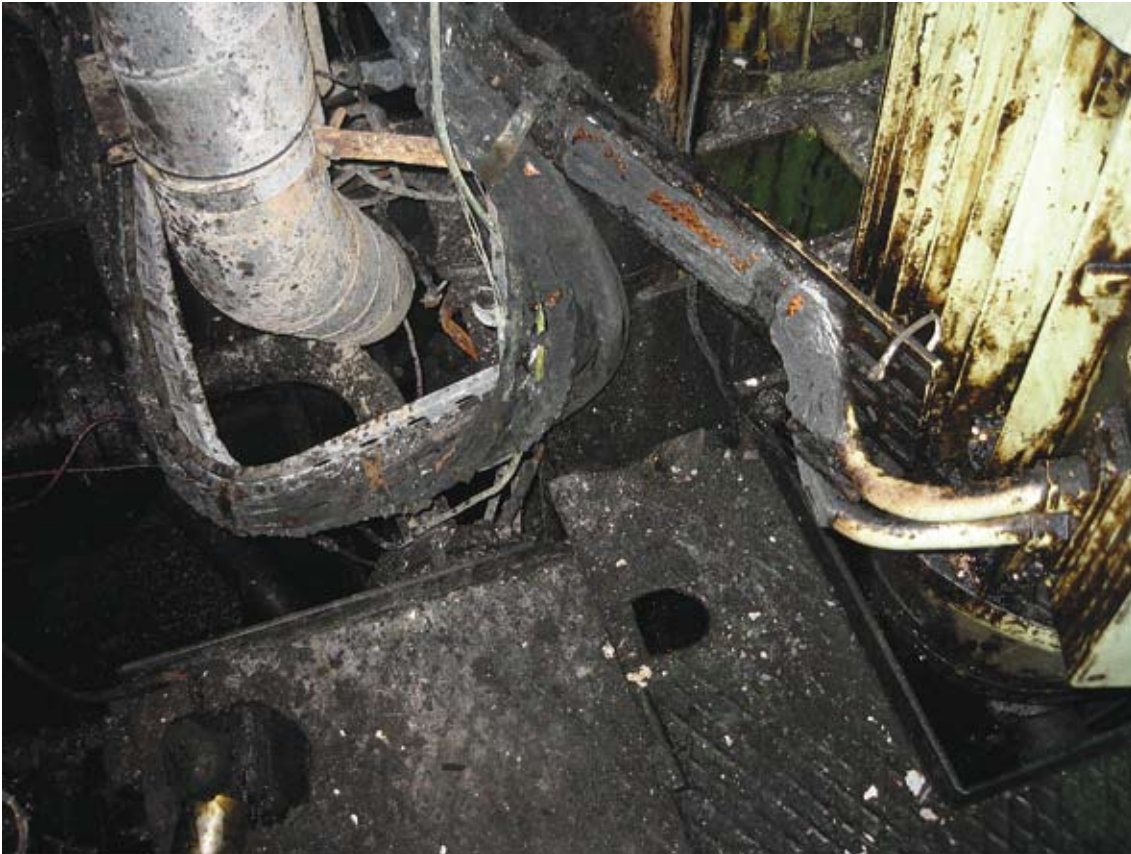
Figure 2 – One metre from the start of the fire

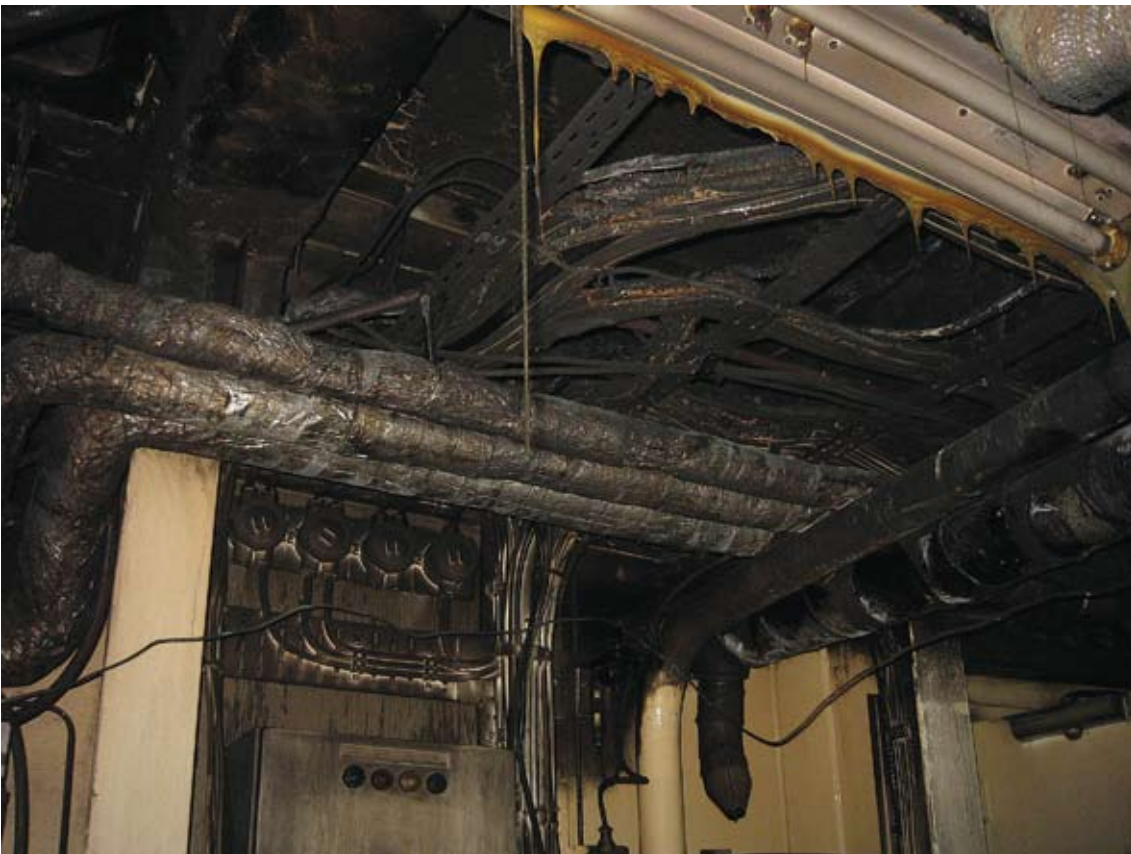
Figure 3 – Port side of main engine under deck

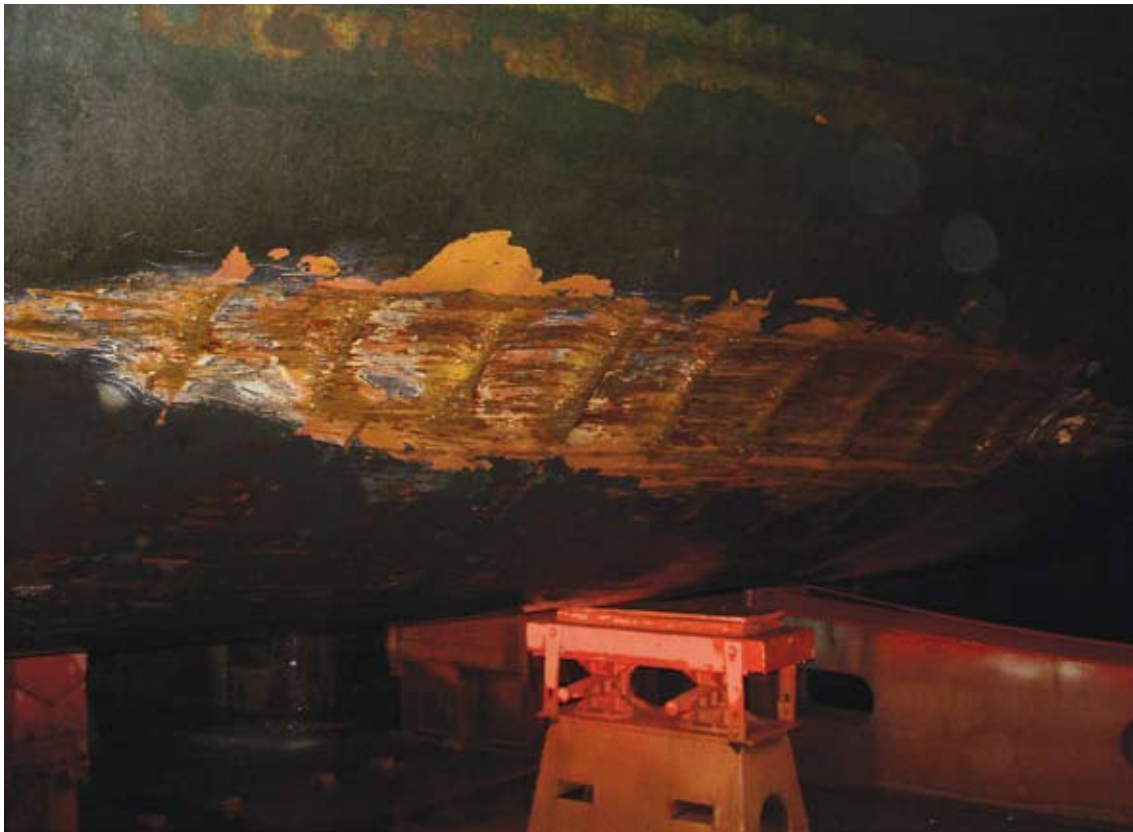
Fortunately, a pilot launch was able to pass a line to the vessel, which was re-floated within 5 minutes of grounding. The vessel was holed below the waterline in her forepeak and two double bottom tanks (see figures).

Damage below the waterline

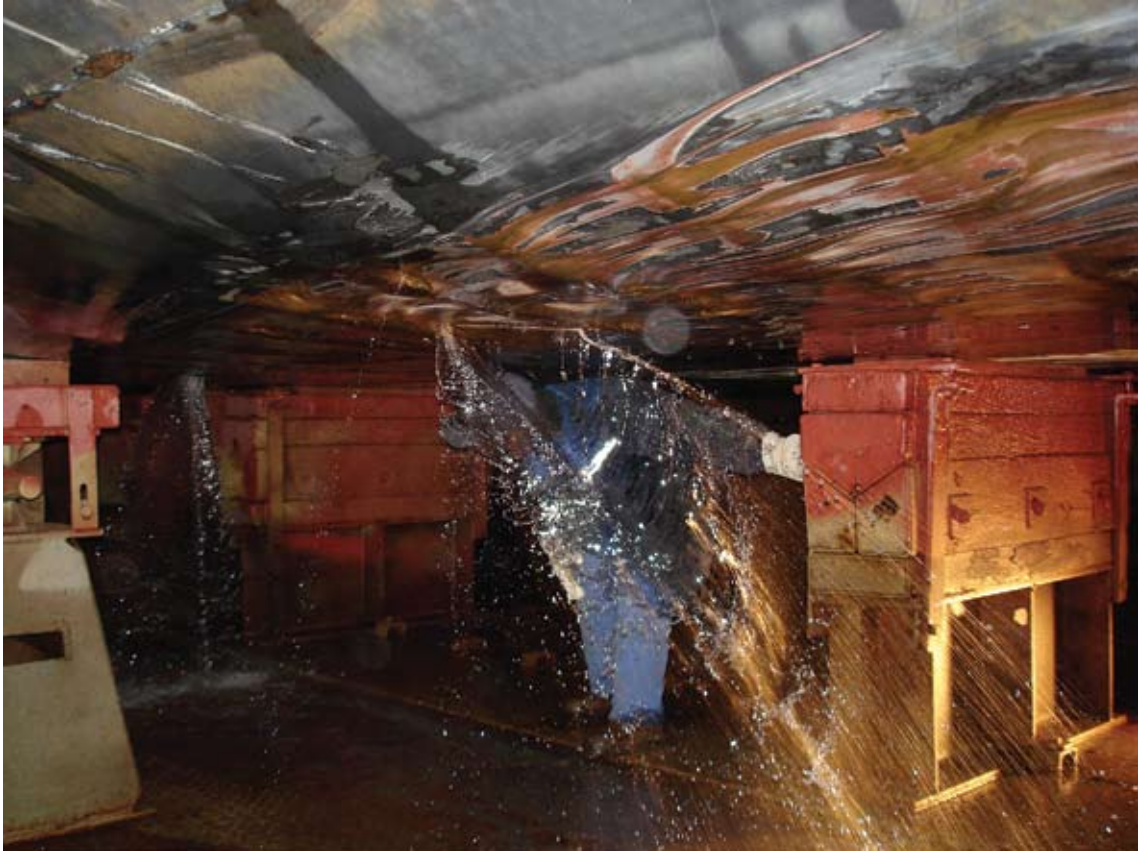
Damage below the waterline

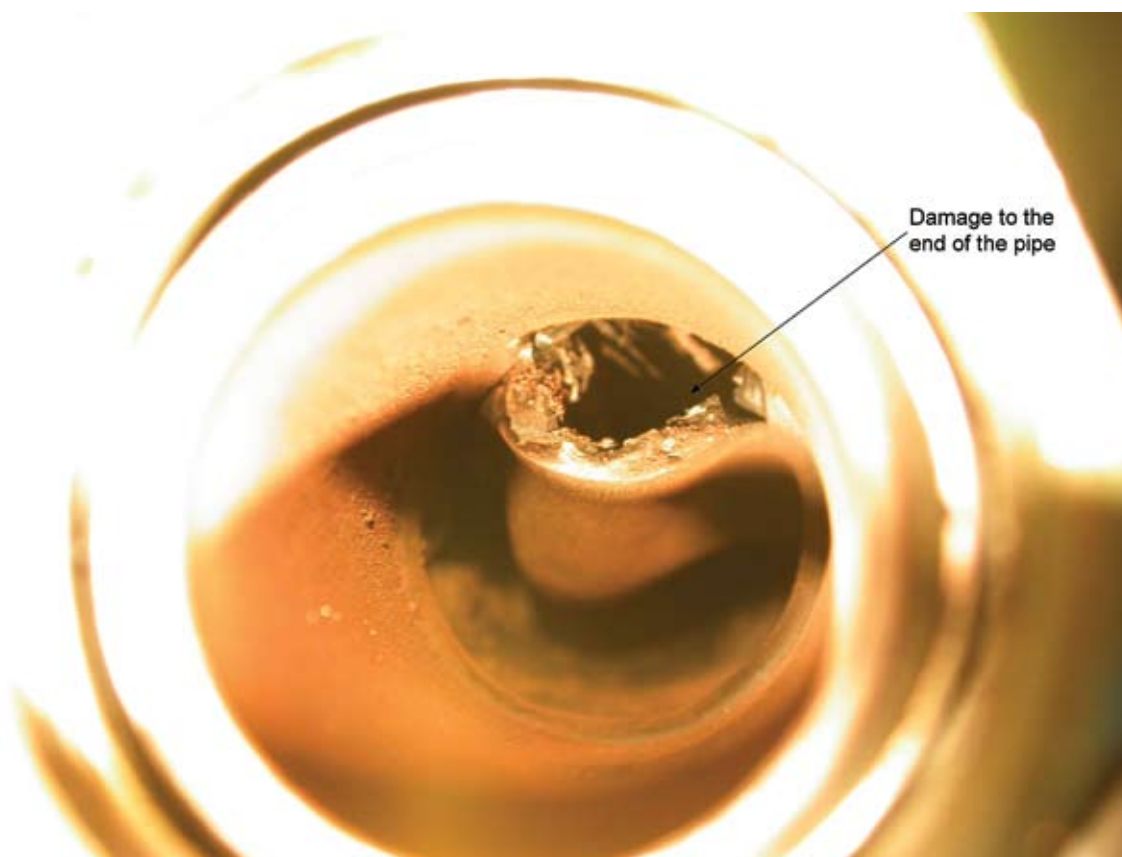
Figure 1

The cause of the fire was a ruptured low pressure fuel hose spraying marine gas oil on to exposed sections of the engine exhaust pipe. Laboratory tests carried out on the flexible pipe revealed a small area of damage to one end where it was crimped to a metal collar forming part of its end fixture. The inner layer had opened up slightly, causing gas oil to enter the space between the inner and outer layers (Figure 1). This resulted in the outer layer degrading gradually and

tearing. There were no shields fitted above the pipe to deflect any accidental release of fuel into the bilges. When the pipe ruptured, marine gas oil at 6 bars pressure sprayed on to the exposed sections of the engine exhaust pipe. A similar exposed section of exhaust

4. Rubber hoses do not last forever; even if the manufacturer's instructions do not specify the shelf life, it is a good idea to discuss this issue with them and to implement a flexible hose replacement programme.

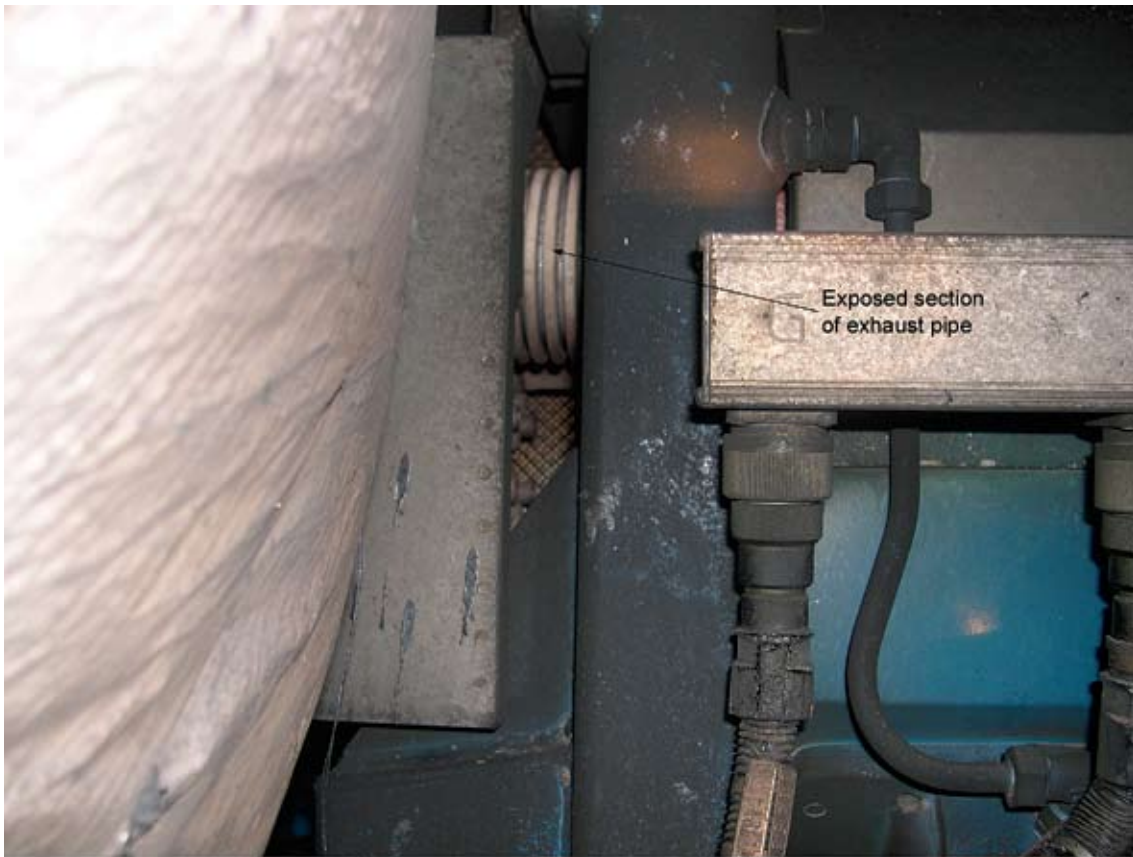
Figure 2

pipe on another of the ship's engines is shown at Figure 2. The fuel spray ignited, and spread to the bilges, where a substantial amount of fuel had accumulated. The fire continued to be fed by more fuel from the leaking hose.

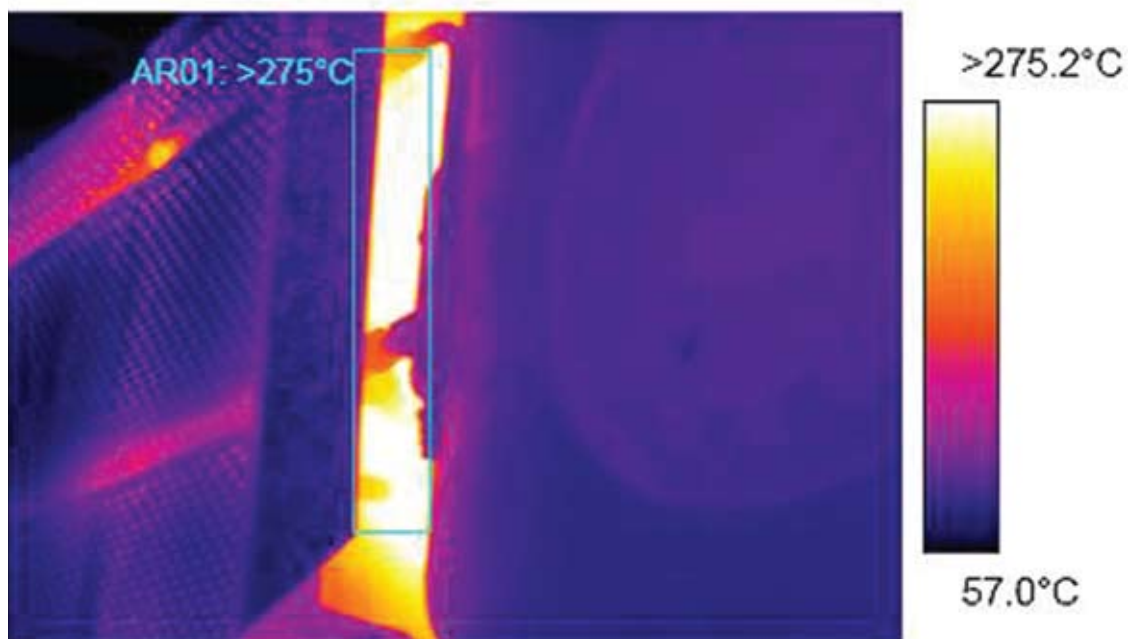
Figure 3 (Source: SeaTec U.K. Limited)

1. Fires can be very costly. Prevention is generally far less expensive.
2. Although SOLAS requires all surfaces which are above 220°C to be insulated, it is common to find such insulation to be incomplete on awkward areas such as indicator valves, pyrometers and other sensor attachments, lifting lugs and inspection manhole covers. While a good visual examination can spot many of these deficiencies, regular infrared thermal imaging surveys greatly increase the probability of identifying all the exposed surfaces (Figure 3).

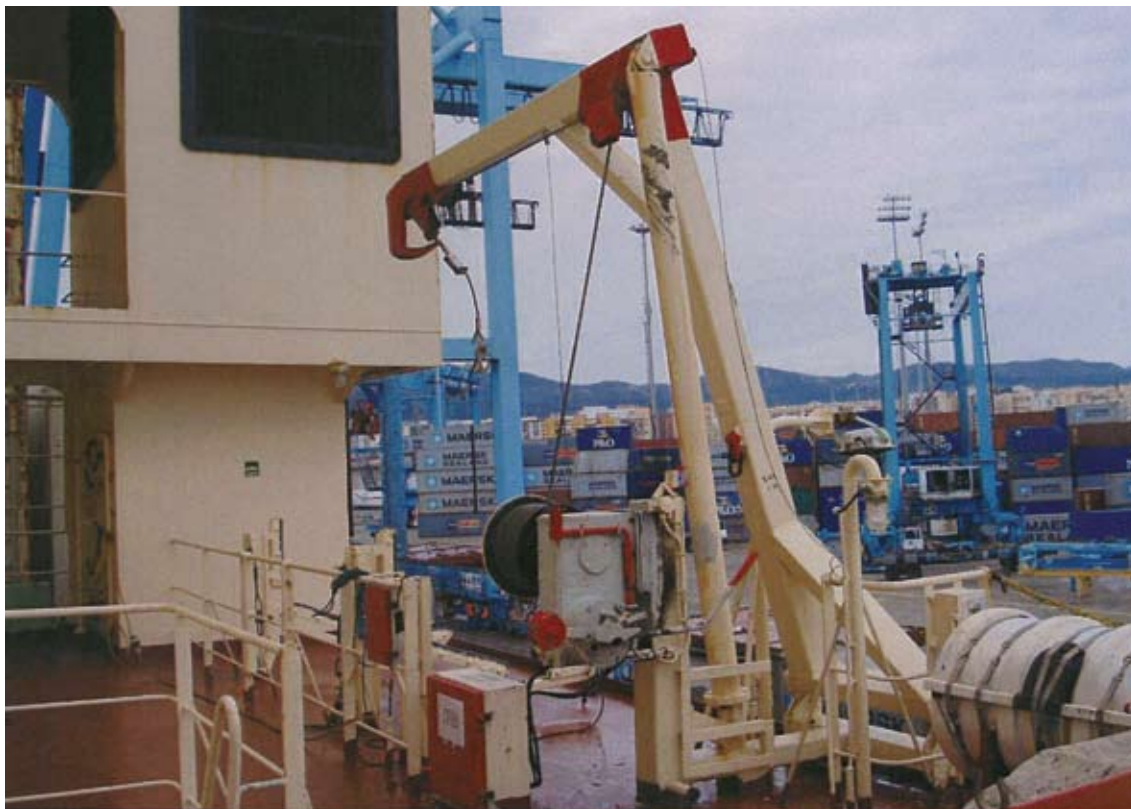
Figure 1

As the cable continued to heave in, the bob weight operated the limit switch (Figure 1), but once again the motor failed to stop and the cable continued to be heaved in. With the hook now hard up against the davit head, the heaving load was transferred to the structure. The winch bedplate gave way, and it fell into the water together with the rescue boat.

Investigations found that two out of three winch motor starter contacts had welded together. This prevented the manual stop and limit switch from isolating the electrical power. The contacts were static welded together due to excess current being drawn across them. This happened because they had, at some time prior to the accident, been changed from the original specification to a much lower maximum rating than that drawn by the winch motor.

In particular, ensure that contactors have the appropriate current carrying capacity. If an overload condition occurs with inadequate current rating contactors, then there is the risk of an electrical fire, or inability to control equipment.

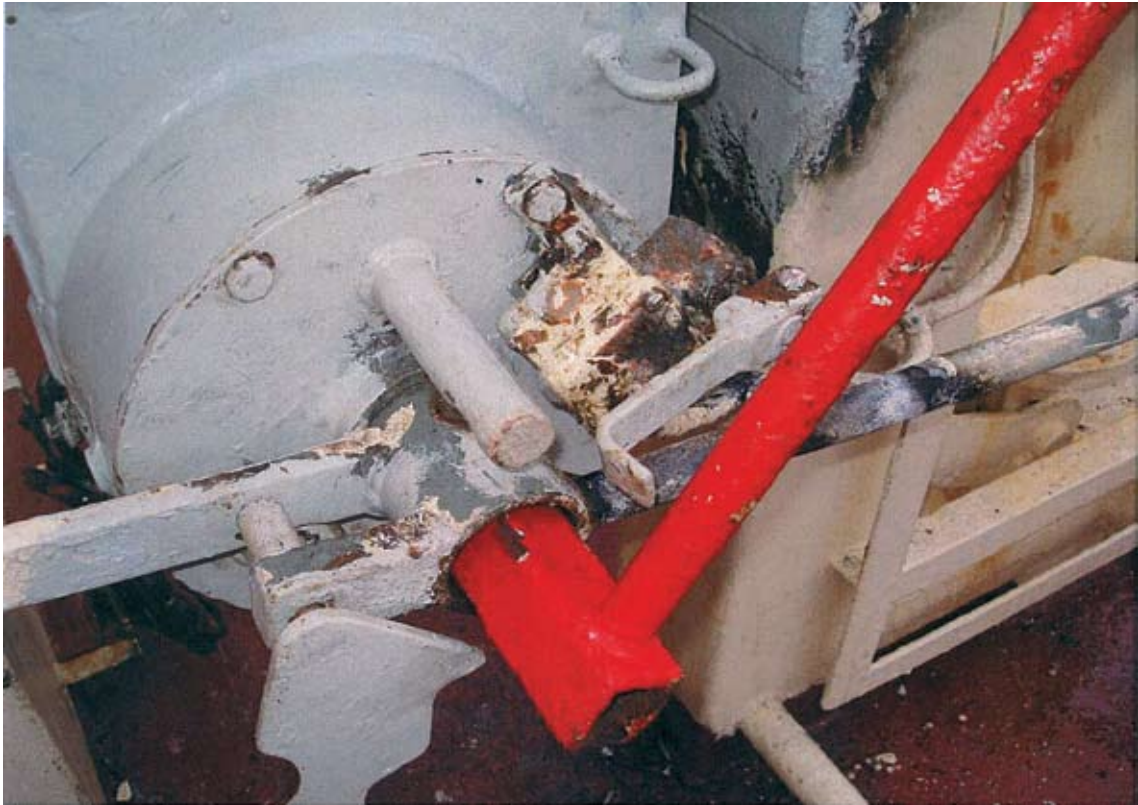
Figure 2 – Safety interlock handle

operation handle interlock was incorrectly adjusted (Figure 2), and would not have operated when the handle was inserted into the drive boss. This dangerous situation would have left electrical power connected while in manual operation mode.

2. When replacing items in electrical starters, or in any electrical components, make sure the alternative to the manufacturer's item(s) is suitable.
3. Electrical interlocks are fitted to ensure safe operation of equipment, either as part of normal operation sequencing, or to safeguard the system in the event of a fault. Interlock functional testing should be a periodic maintenance item – do not get caught out: check interlocks regularly and attend to defects without delay.

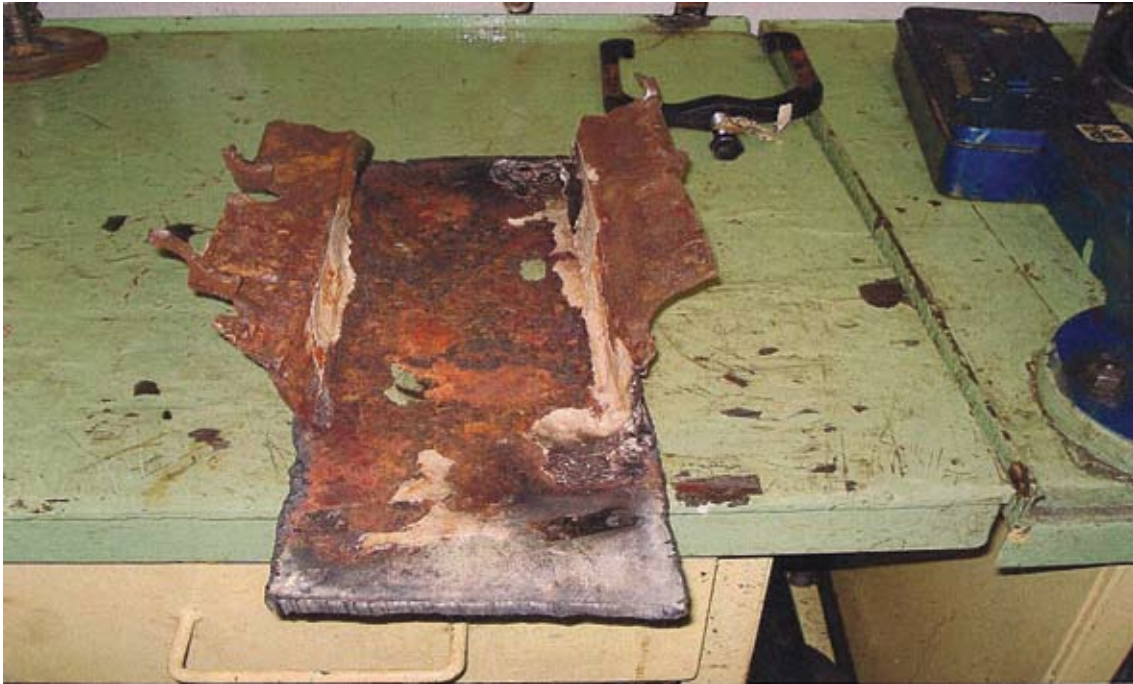
To complete this sorry tale, the winch bedplate was found to be badly corroded, which caused it to become detached from the winch (Figure 3). Access to the plate was difficult, so little attention had been paid to its preservation.

Figure 3 – Old bracket

4. Consideration should be given to fitting an emergency stop button to equipment where a risk assessment identifies that it is justified.
5. Dealing with structural corrosion is part and parcel of everyday life at sea. Access difficulties all too often mean areas of corrosion are neglected. Note the signs, because these areas will warrant extra attention – as this accident clearly illustrates.

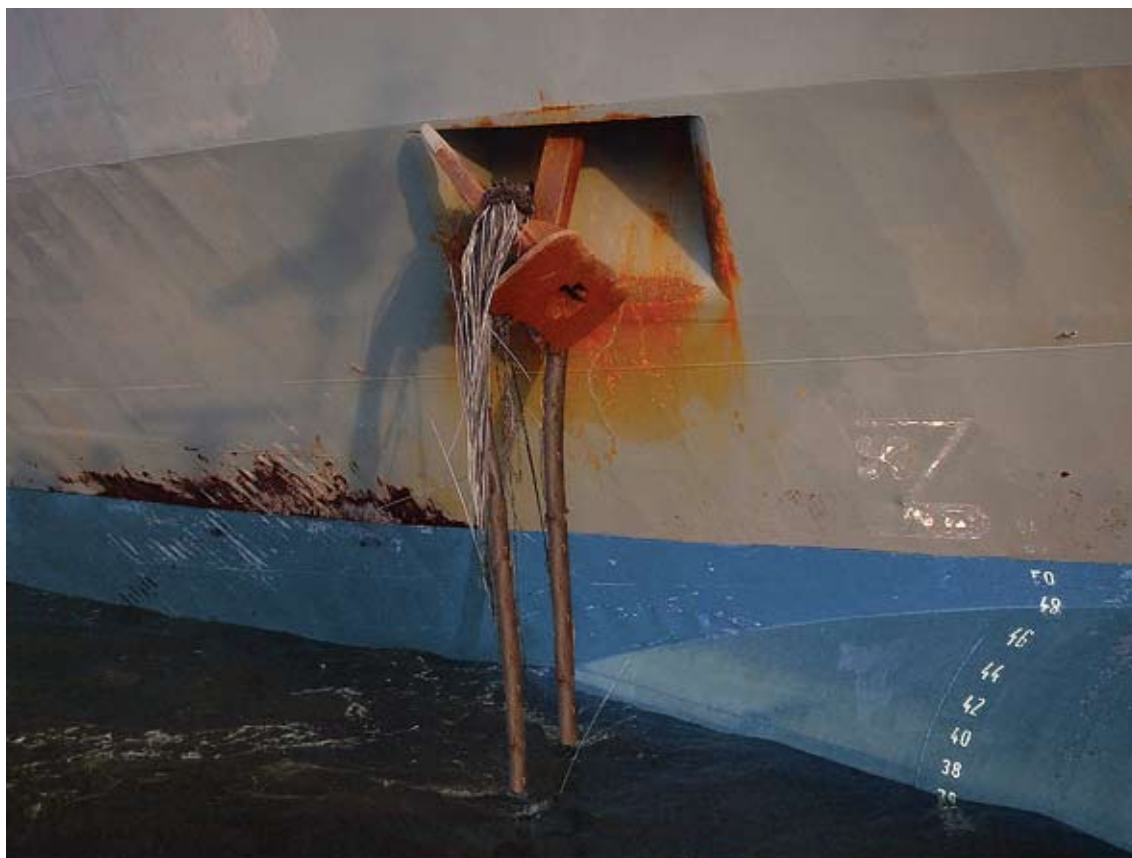
Vessel's anchor, fouled with a power cable

working on deck, heard a slow but loud banging noise from forward. Accompanied by another seaman, he went forward to investigate the noise and discovered that about 2 shackles of cable were outboard and banging against the hull. The windlass brake had not failed.

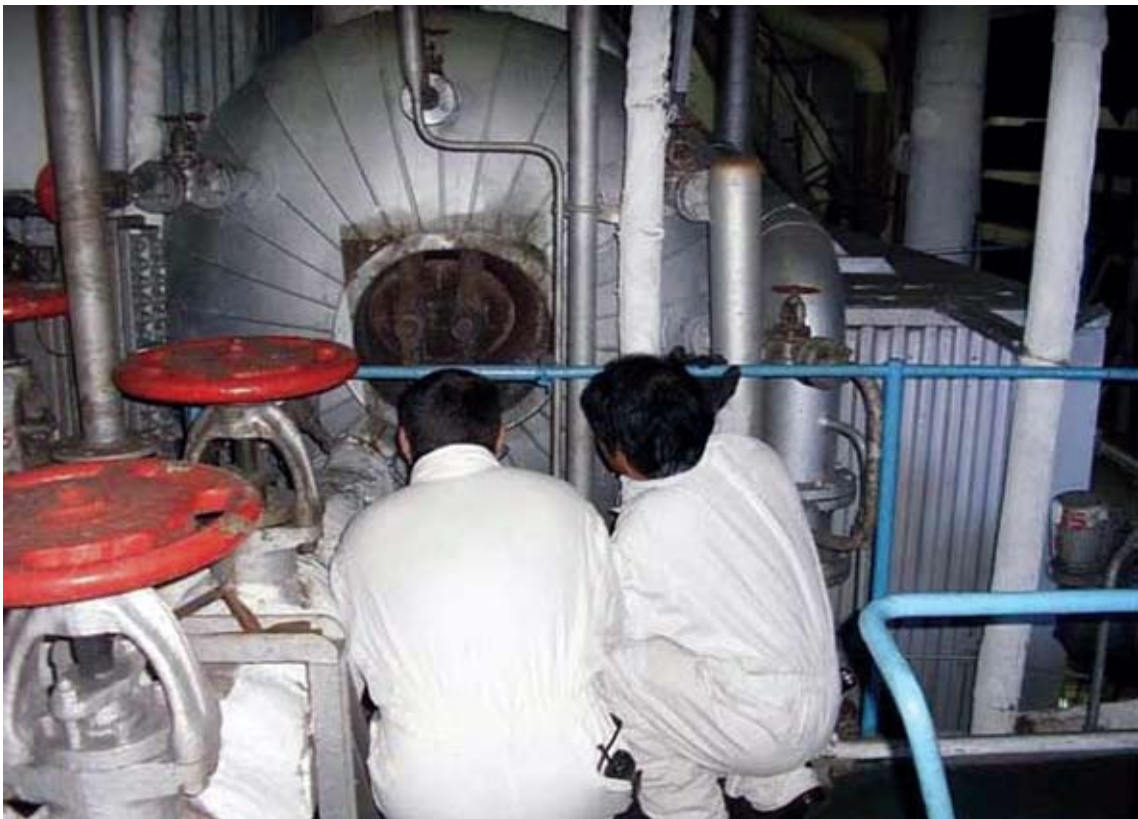
Figure 3

At 2200 both of the cleaning experts approached the steam drum door (Figure 3). No tests were conducted to check the steam drum atmosphere for either toxic or flammable gases. The UK expert picked up the halogen lamp (Figure 4) and placed it just inside the steam drum. The Danish expert saw a small flame or spark, and an explosion immediately followed.

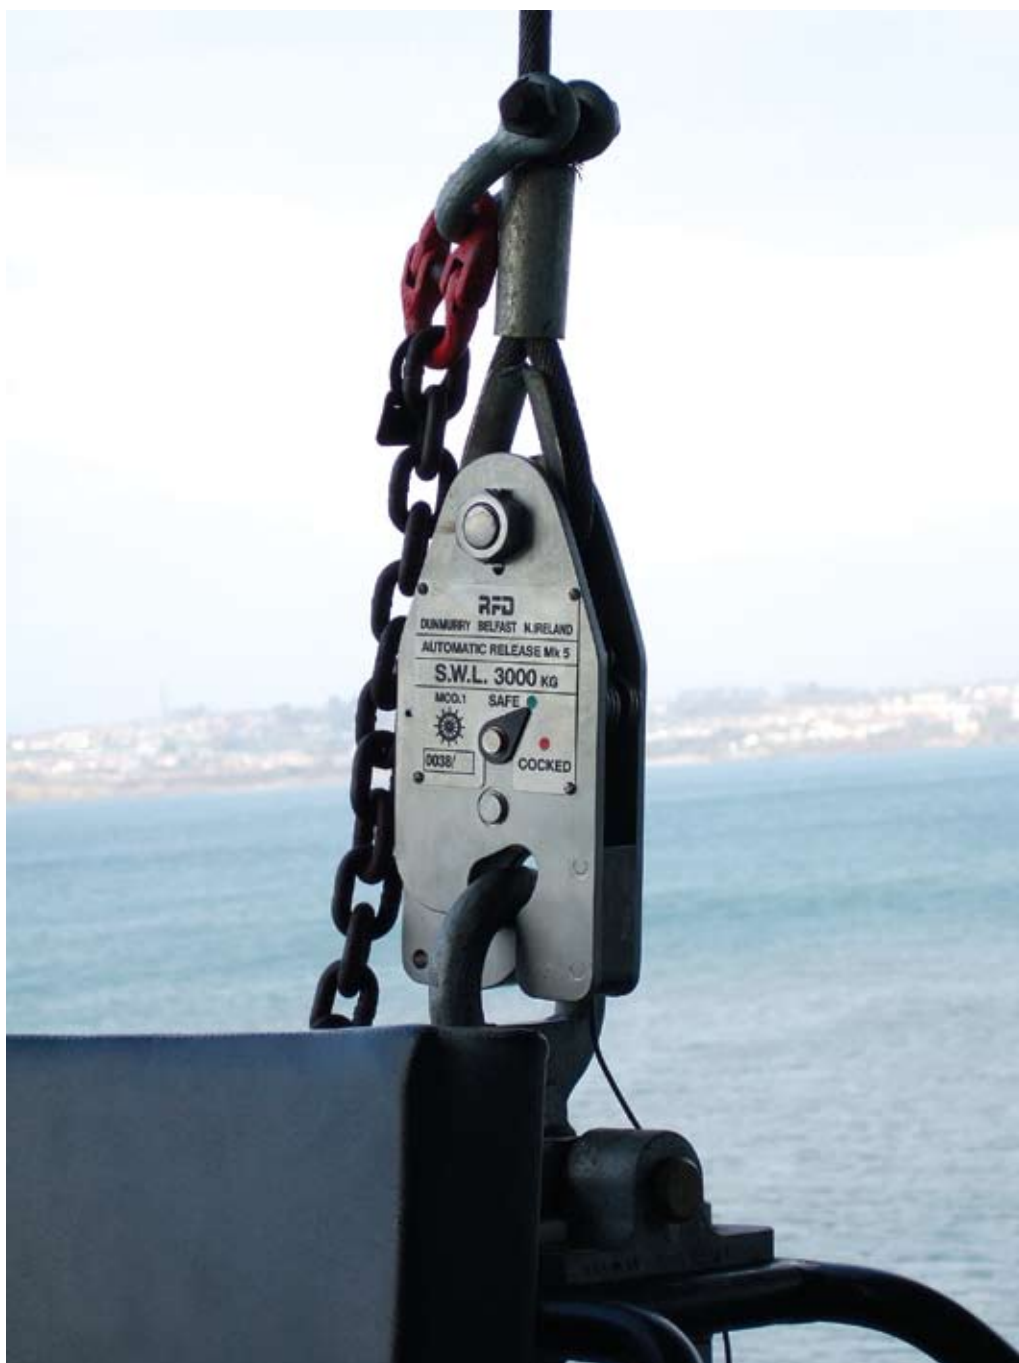
Figure 2 – Quick release hook

When the port FRC was recovered, still attached to the ARH, the hook would not release from the FRC lifting cradle D ring. The ARH was forcibly removed and subsequently landed ashore for testing, where it was found that a build up of salt contamination, both internally and externally, combined with insufficient lubrication, had caused the hook not to release. Once the ARH was cleaned and lubricated, it operated correctly.

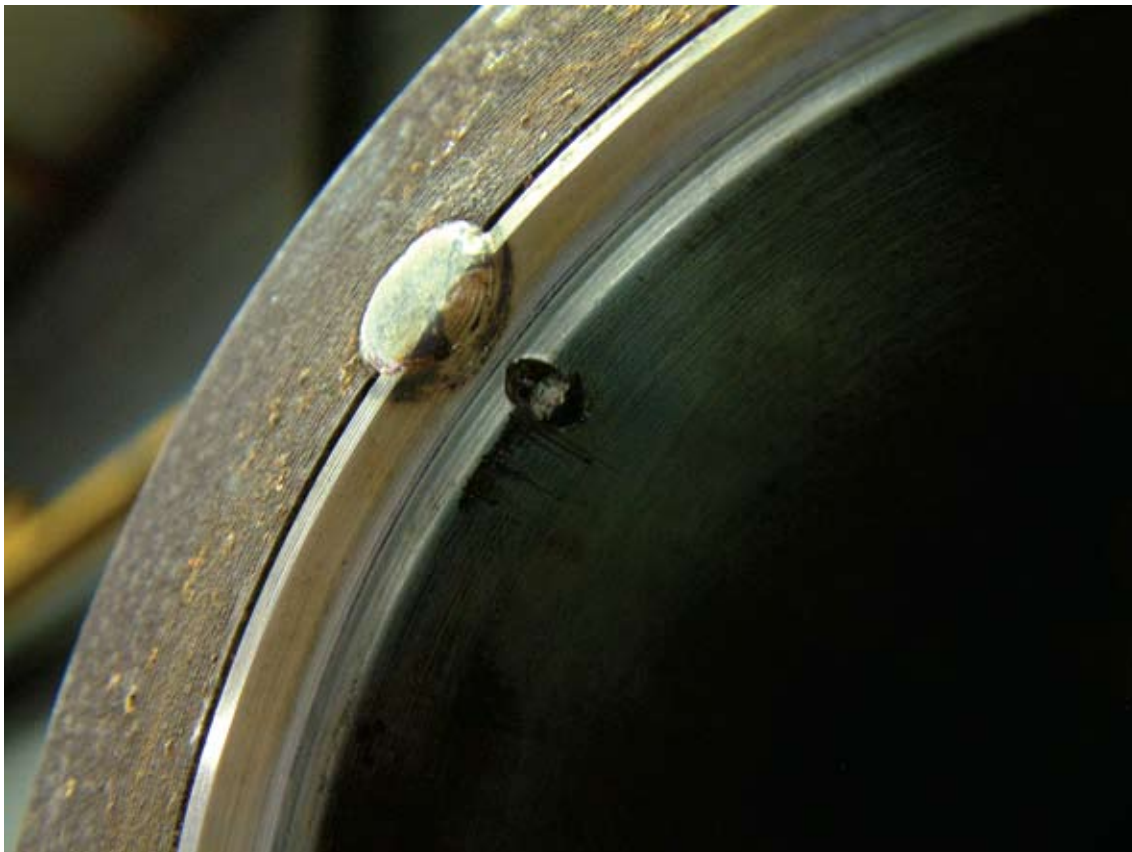
Burr on gas valve

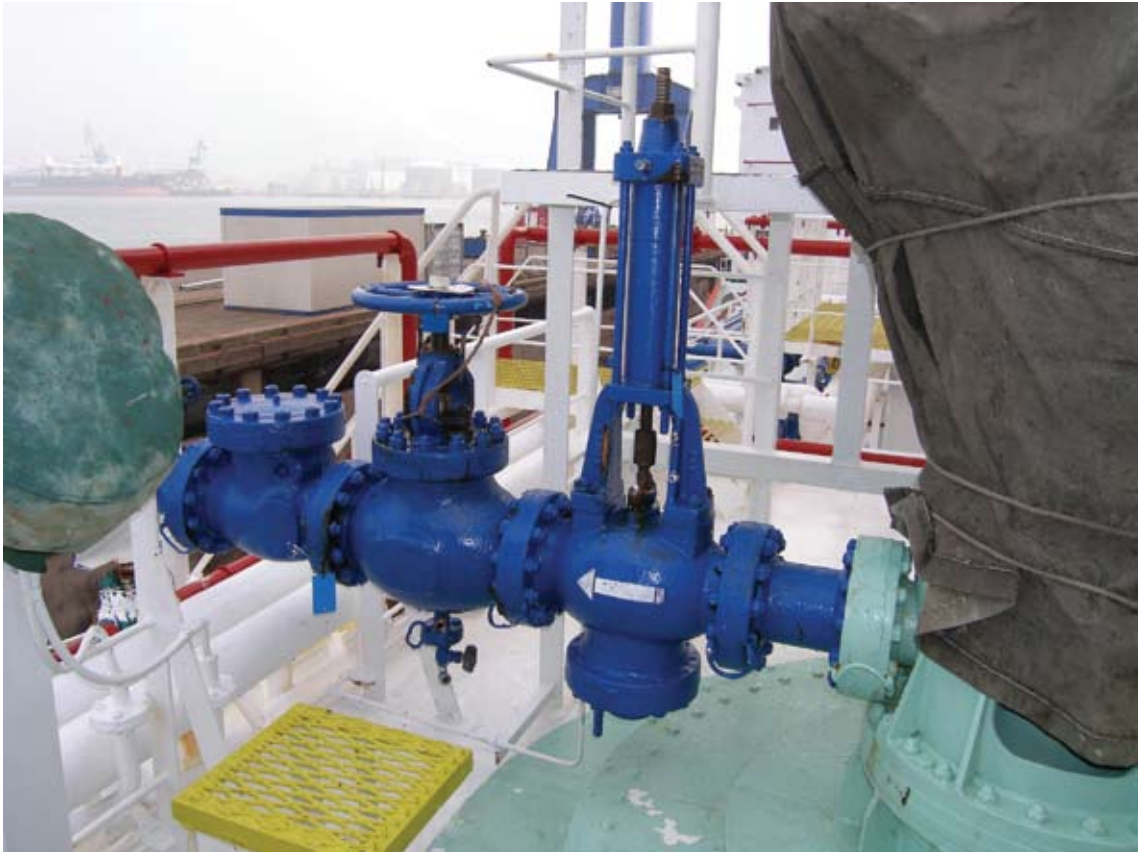
The chief officer saw and heard a gas leak, and immediately activated the emergency shut down (ESD) valves. Attempts were then made to refit the sampling valve, but the 11 bar pressure of the cargo and the formation of ice on the connection made it impossible. It soon became apparent that the ESD valve between the tank and the sampling connection was not holding.

Sampling point and ESD valve

4. The revised sampling point was inadequate for the intended task. Remember, you are opening the contents of your cargo tank, potentially, to atmosphere when sampling, so make sure your sampling arrangement is safe and meets industry guidelines³.

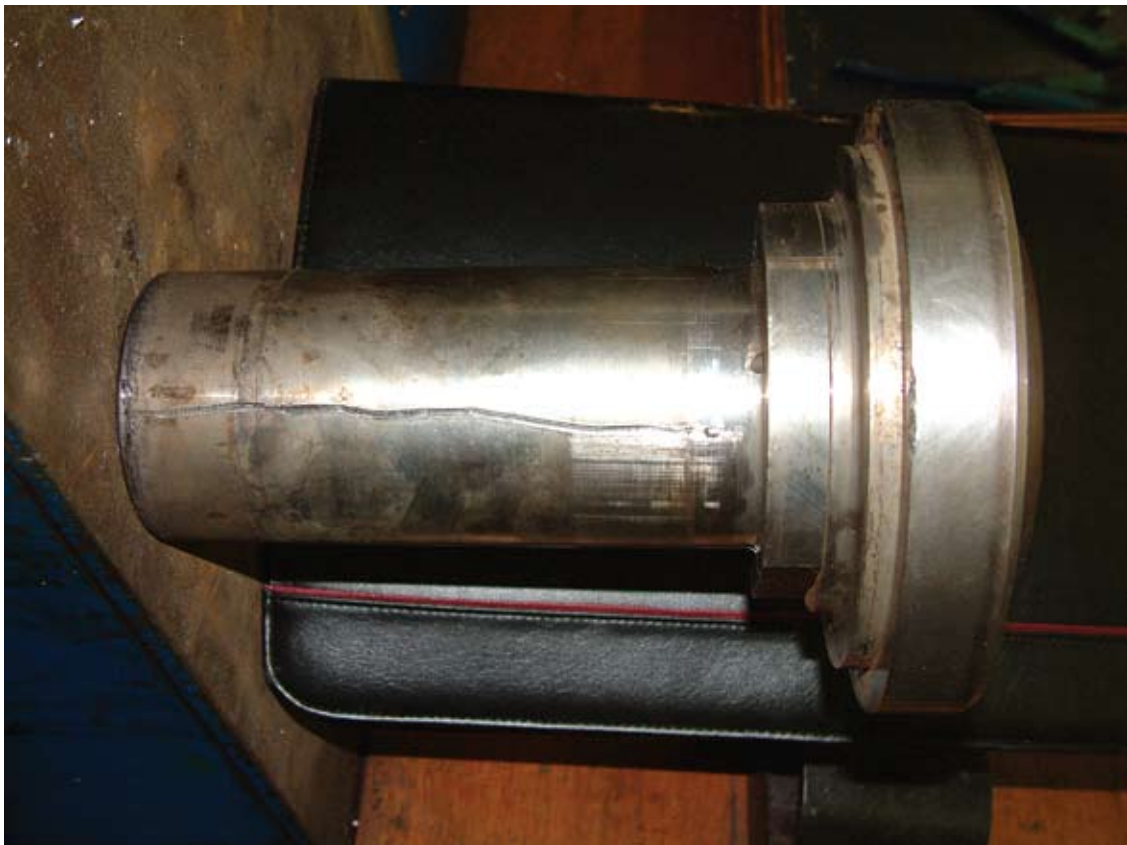
Scoring damage on valve disc body
